## Uncontrolled Impact With Terrain, Fine Airlines Flight 101, Douglas DC-8-61, N27UA, Miami, Florida, August 7, 1997

## AIRCRAFT ACCIDENT REPORT

UNCONTROLLED IMPACT WITH TERRAIN  
FINE AIRLINES FLIGHT 101  
DOUGLAS DC-8-61, N27UA  
MIAMI, FLORIDA  
AUGUST 7, 1997

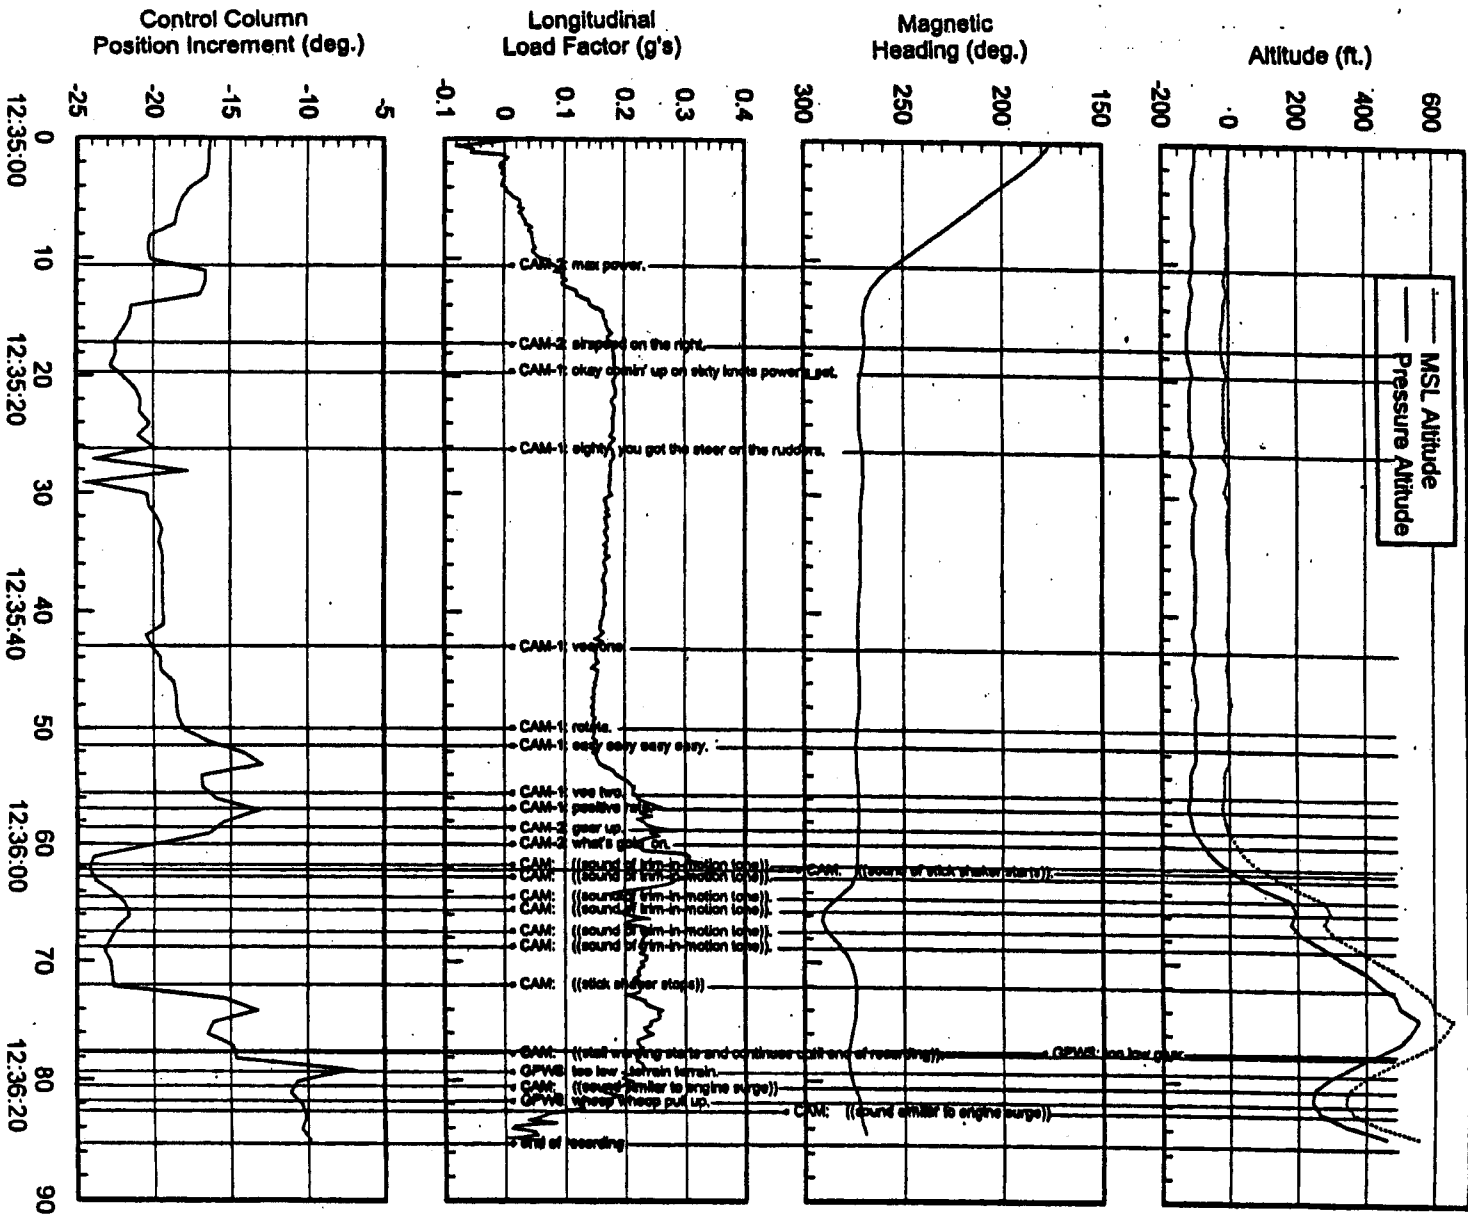
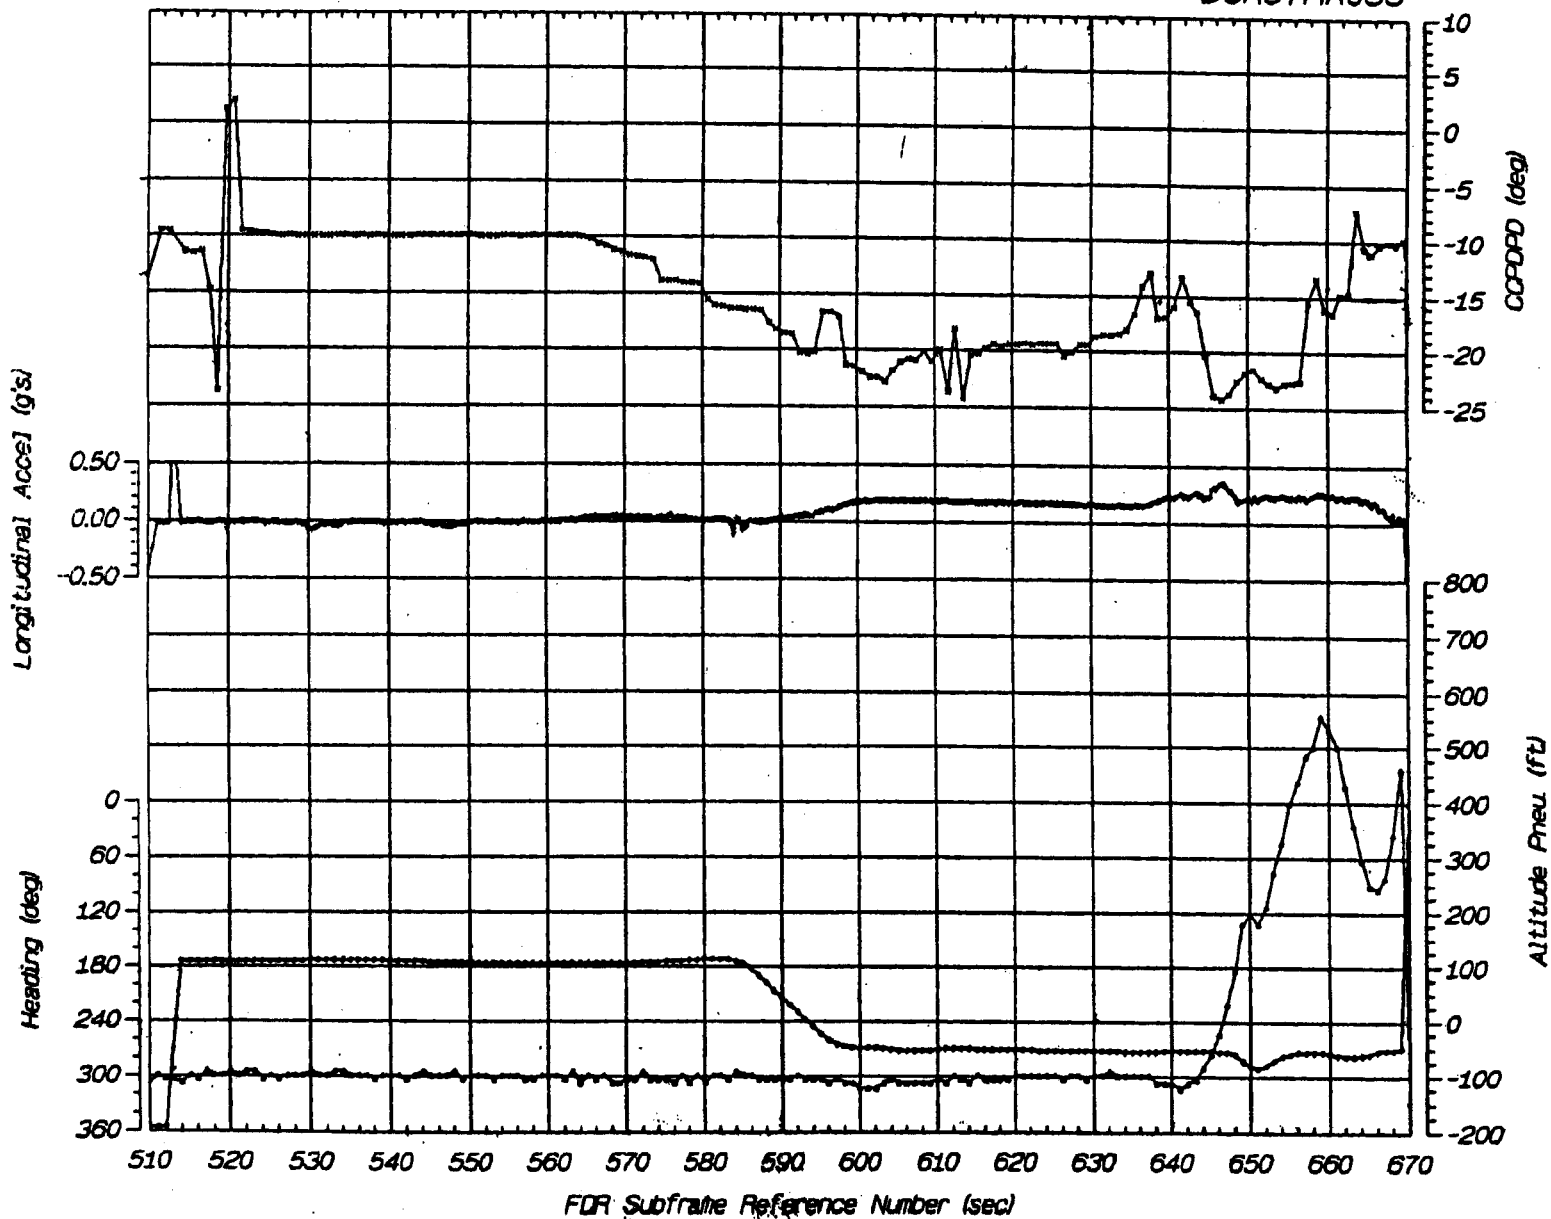
Fine Air Flight 101 - DFDR Data with Cockpit Voice Recorder Events

An examination of the transcribed FDR data indicated that the heading values on the tape produced a heading 180° opposite of the actual takeoff heading when the conversion formulas provided by Fine Air were applied. Previous flights retained on the FDR tape<sup>37</sup> were examined and were also determined to be off by 180° when compared with their flight plans. It was determined that the values recorded for the heading parameter were exactly opposite to actual headings, suggesting that the heading sensor was installed improperly or the FDR documentation was not correct.

Because six parameters (including engine data, airspeed, pitch and roll attitudes, and vertical acceleration) were not recorded by the accident airplane’s FDR, the Safety Board’s study of the airplane’s performance was based on the following combined data and evidence: ground impact scars, damage/markings on surface structures, runway markings (indications of tail strikes or unusual tire marks), aircraft parts on the runway,<sup>47</sup> approach and airport surveillance radar (ASR) data, the five useable FDR data parameters (altitude, CCP, longitudinal load factor, heading, and time), and CVR information.
