## Runway Overrun During Landing, American Airlines Flight 1420, McDonnell Douglas MD-82, N215AA, Little Rock, Arkansas, June 1, 1999

## AIRCRAFT ACCIDENT REPORT

RUNWAY OVERRUN DURING LANDING  
AMERICAN AIRLINES FLIGHT 1420  
MCDONNELL DOUGLAS MD-82, N215AA  
LITTLE ROCK, ARKANSAS  
JUNE 1, 1999

**NTSB/AAR-01/02  
PB2001-910402  
Notation 7195A  
Adopted October 23, 2001**

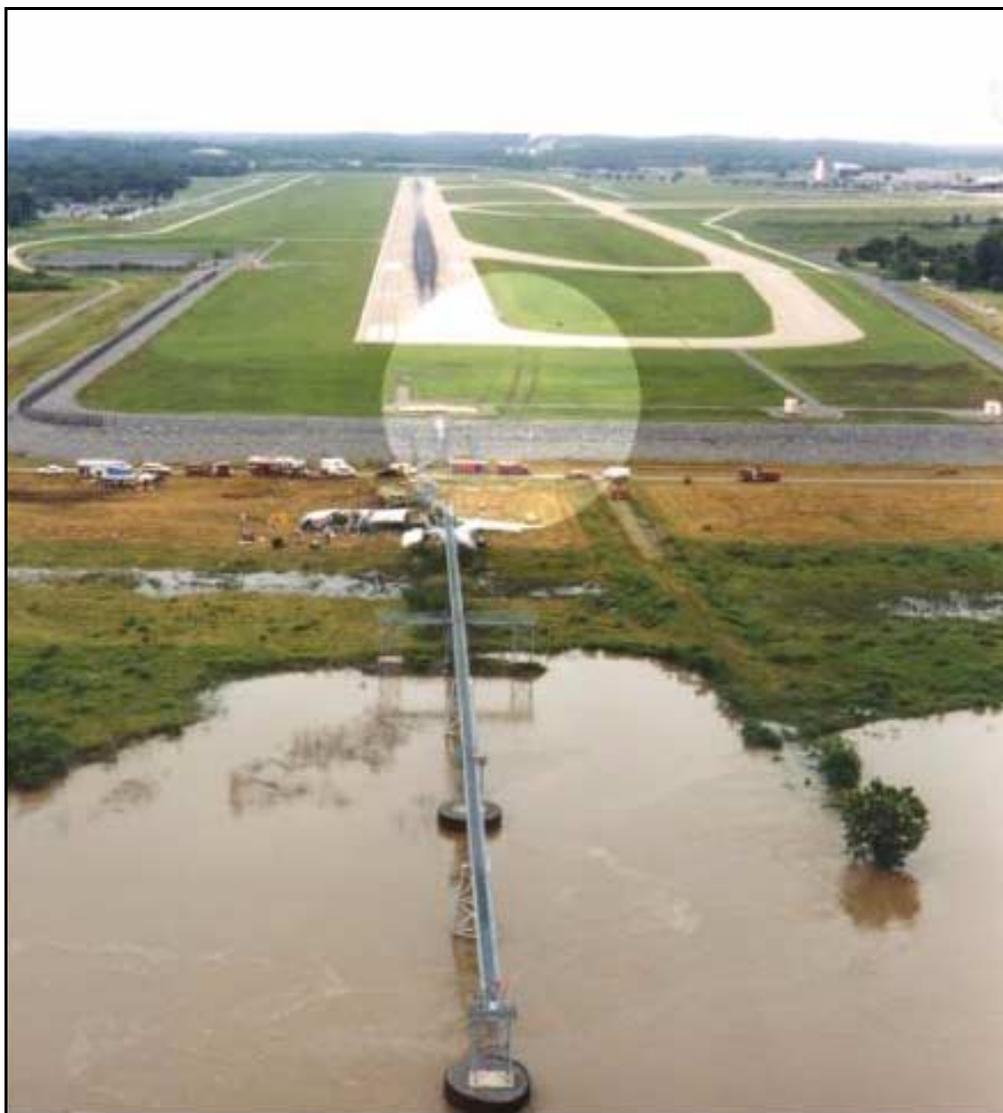
The airplane destroyed several tubes extending outward from the left edge of the runway 4R ILS localizer array, part of a chain link security fence, and approximately 250 feet of the runway 22L approach lighting system support structure and walkway. The damage was estimated at \$325,000.

Figures 12 through 14 are photographs of the airplane wreckage. Figure 12 shows the airplane wreckage, the tire tracks off the end of runway 4R, and the damage to the runway 22L approach lighting system.<sup>77</sup> Figure 13 shows the airplane wreckage and the runway 22L approach lighting system. Figure 14 shows a closer view of the airplane and the runway 22L approach lighting system. Additional details about the airplane wreckage are presented in sections 1.12.2 through 1.12.4.

**Figure 12.** Aerial Photograph of Runway 4R/22L, Airplane Wreckage, and Runway 22L Approach Lighting System

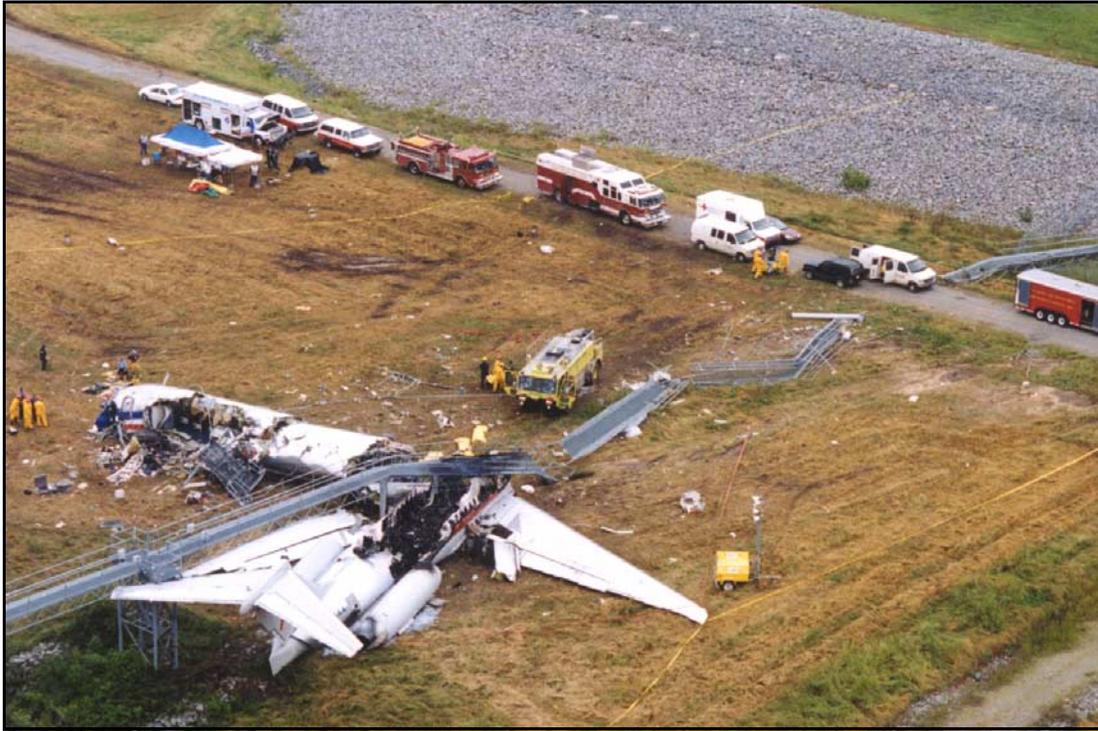
**Figure 13.** Airplane Wreckage and Runway 22L Approach Lighting System

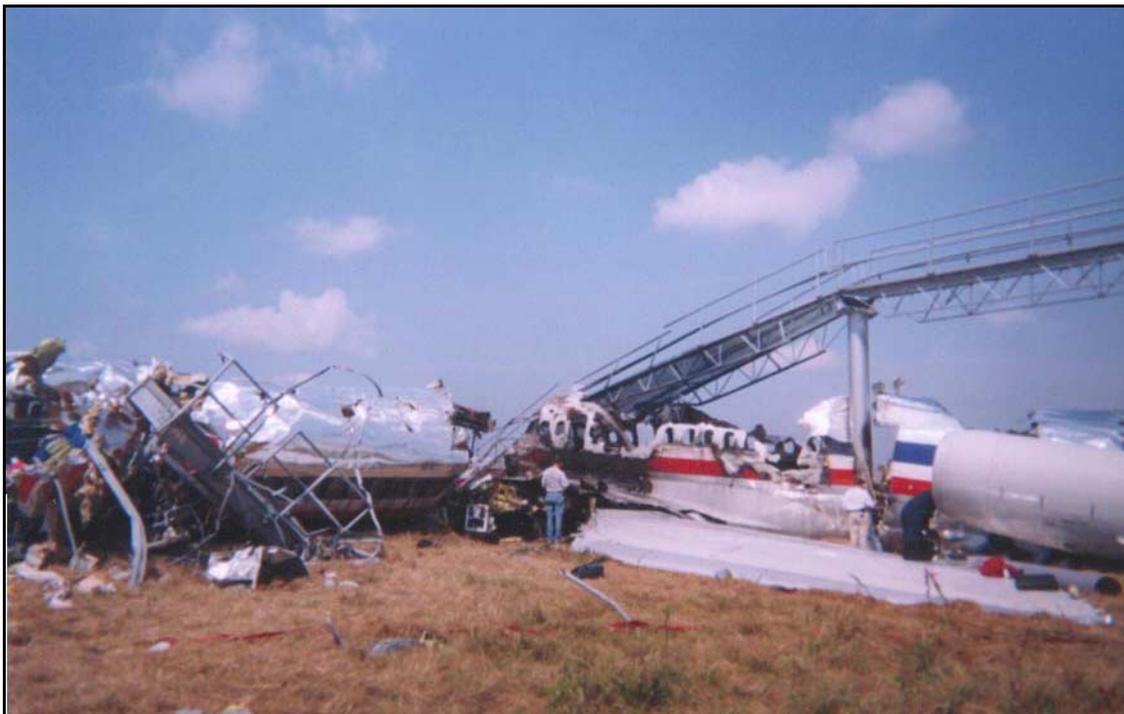
**Figure 14.** View of Left Side of Airplane Wreckage and Runway 22L Approach Lighting System

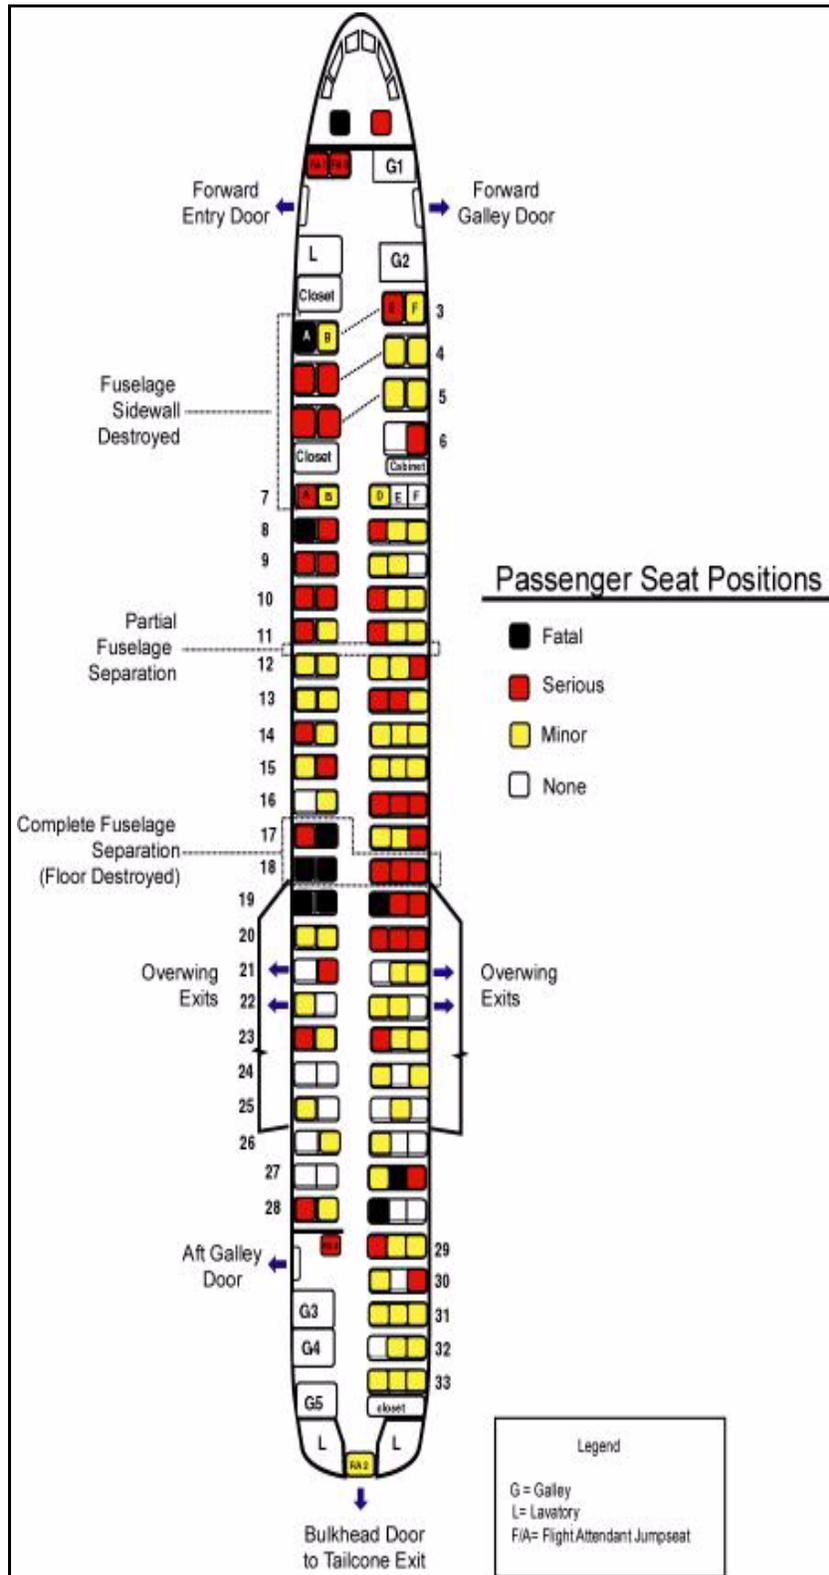
Figure 15. Interior Airplane Configuration and Occupant Injuries
