## **In-flight upset, EgyptAir Flight 990, Boeing 767-366ER, SU-GAP, 60 Miles South of Nantucket, Massachusetts, October 31, 1999**

PB2002-910401  
NTSB/AAB-02/01  
DCA00MA006

## **Aircraft Accident Brief**

**EgyptAir Flight 990  
Boeing 767-366ER, SU-GAP  
60 Miles South of Nantucket, Massachusetts  
October 31, 1999**

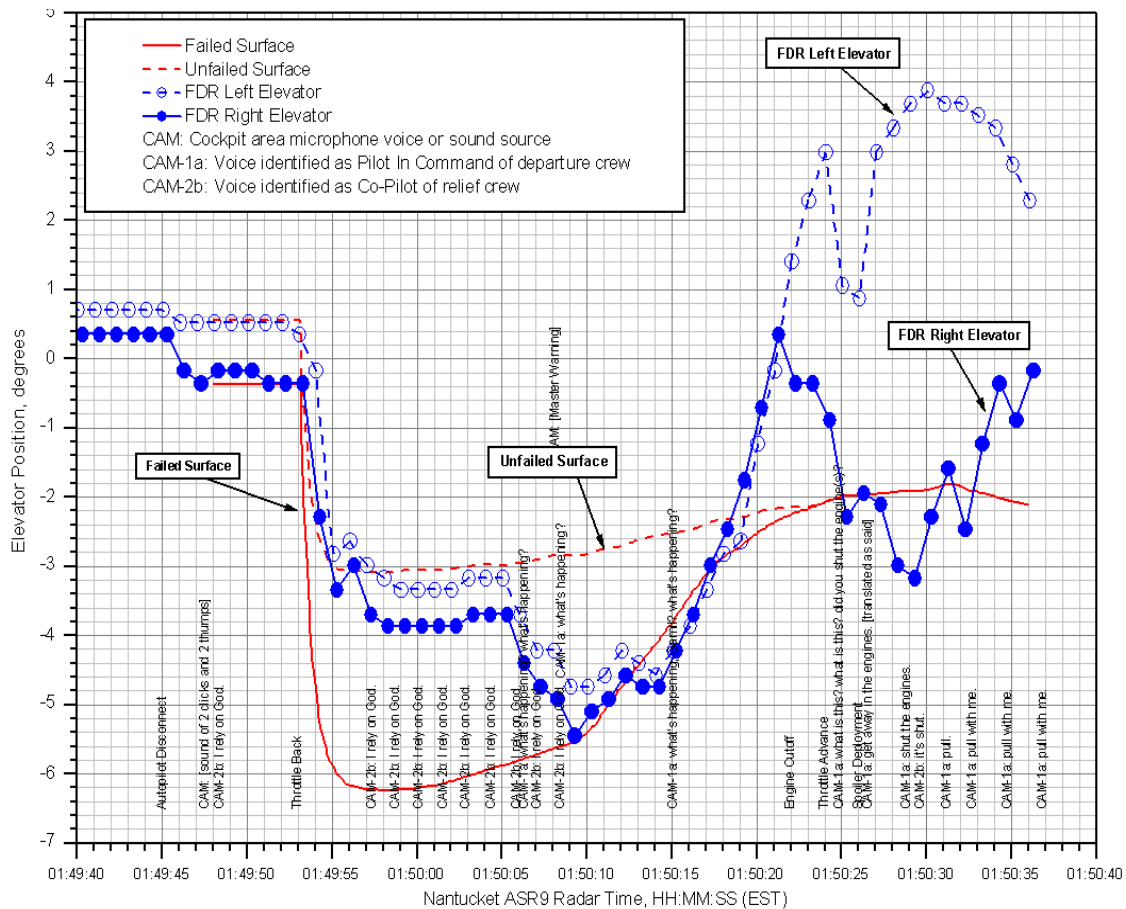
the forces produced by the two failed PCAs would overpower the opposing force produced by the one nonfailed PCA. The resultant initial force on the elevator surface in the failed direction would be equivalent to a single functioning PCA operating at 100 percent of its maximum force. The failed PCAs would resist the backdriving force<sup>31</sup> with a force equivalent to about 130 percent of a single functioning PCA. The high internal pressures required for activation of the PCAs' pressure relief valves allow the PCAs' pistons to resist the aerodynamic backdriving movement with more force than normal operating pressures would allow. Therefore, if a dual PCA failure occurred in flight, the elevator would initially move to a position consistent with a single functioning PCA operating at 100 percent of its maximum force, balanced against the aerodynamic forces affecting the elevator surface. As the airspeed increases, the failed elevator surface would remain at this initial position until the backdriving forces exceeded those of a single PCA operating at 130 percent of its normal capability, at which point the deflection of the failed elevator surface would decrease.<sup>32</sup> (Figure 2 is a comparison of the elevator positions recorded by the accident airplane's FDR with failed and nonfailed elevator positions following a dual PCA failure.)

**Figure 2.** Comparison of the elevator positions recorded by the accident airplane's FDR with failed and nonfailed elevator positions following a dual PCA failure.

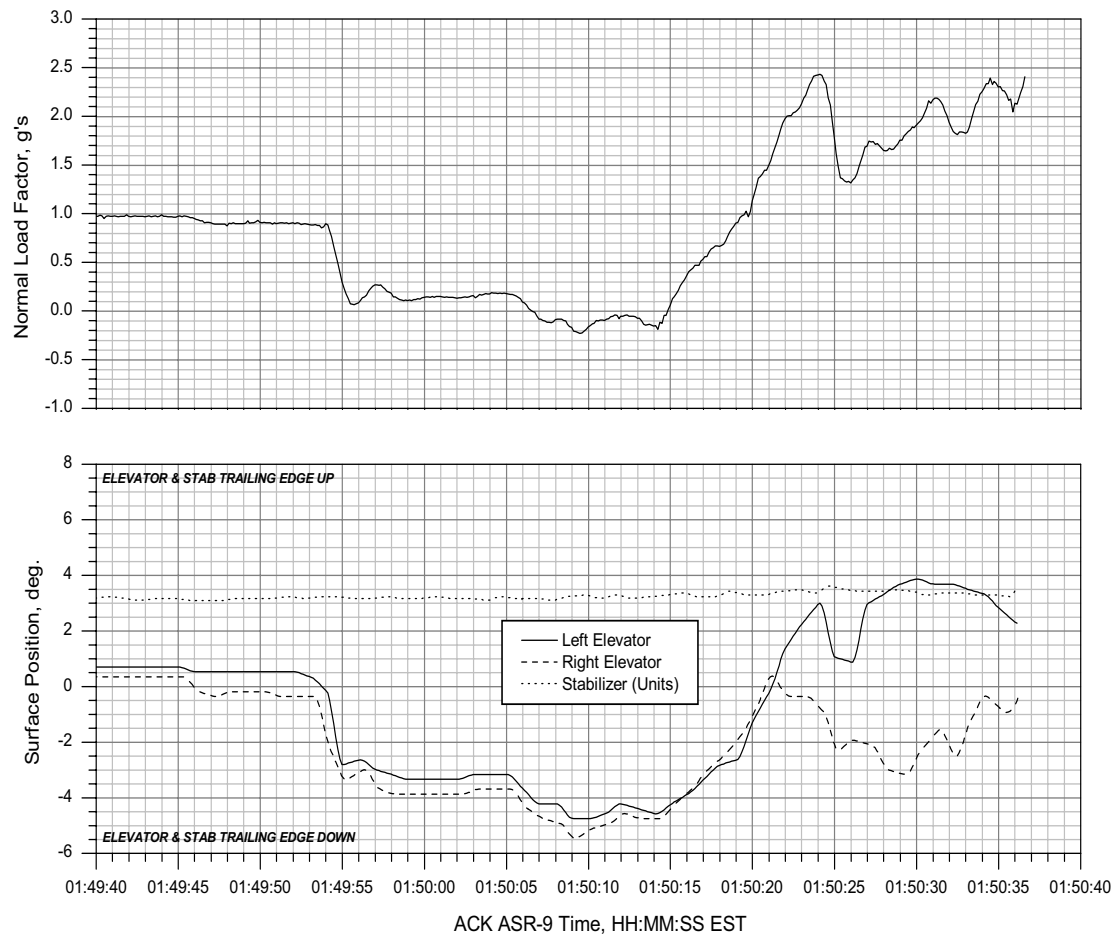
**Figure 4.** Graphs depicting the accident airplane's normal load factor response to elevator and stabilizer movement.
