## Loss of Control and Impact with Pacific Ocean, Alaska, Airlines Flight 261, McDonnell Douglas MD-83, N963AS, About 2.7 Miles North of Anacapa Island, California, January 31, 2000

**Investigative Body:** National Transportation Safety Board (NTSB), USA

**NTSB/AAR-02/01  
PB2002-910402  
Notation 7263E  
Adopted December 30, 2002**

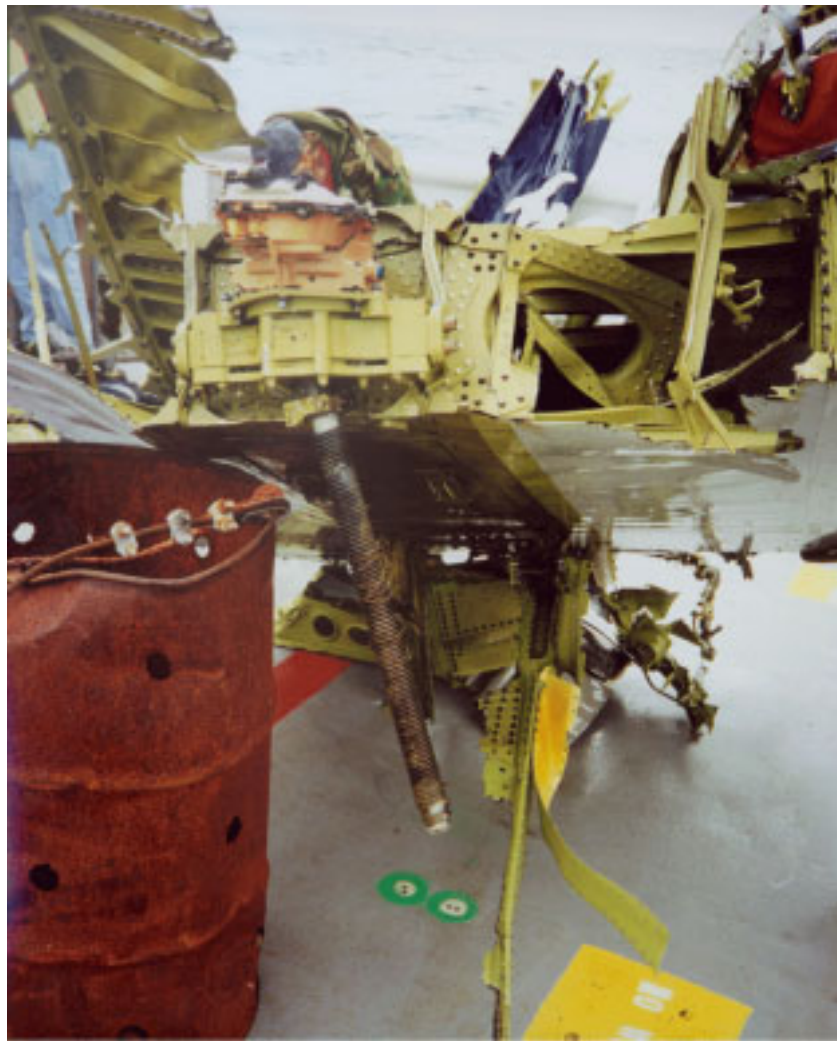
wrapped around the central part of the acme screw.<sup>116</sup> (Figures 12a and 12b show the acme screw immediately after it was brought on board the recovery ship and immediately after it was brought to shore, respectively; figure 12c shows the acme screw during initial inspection.) The acme screw was rinsed with fresh water immediately after its recovery by directing the water from a hose similar to a garden hose over the gearbox and allowing the water to flow down over the screw. To preserve the acme screw and the thread remnants wrapped around the screw in their as-recovered condition, the stream of water used to rinse the screw was not directly sprayed on it. The acme screw might have been rinsed again with a garden-type hose after it was brought to shore.

**Figure 12a.** The acme screw immediately after it was brought on board the recovery ship.

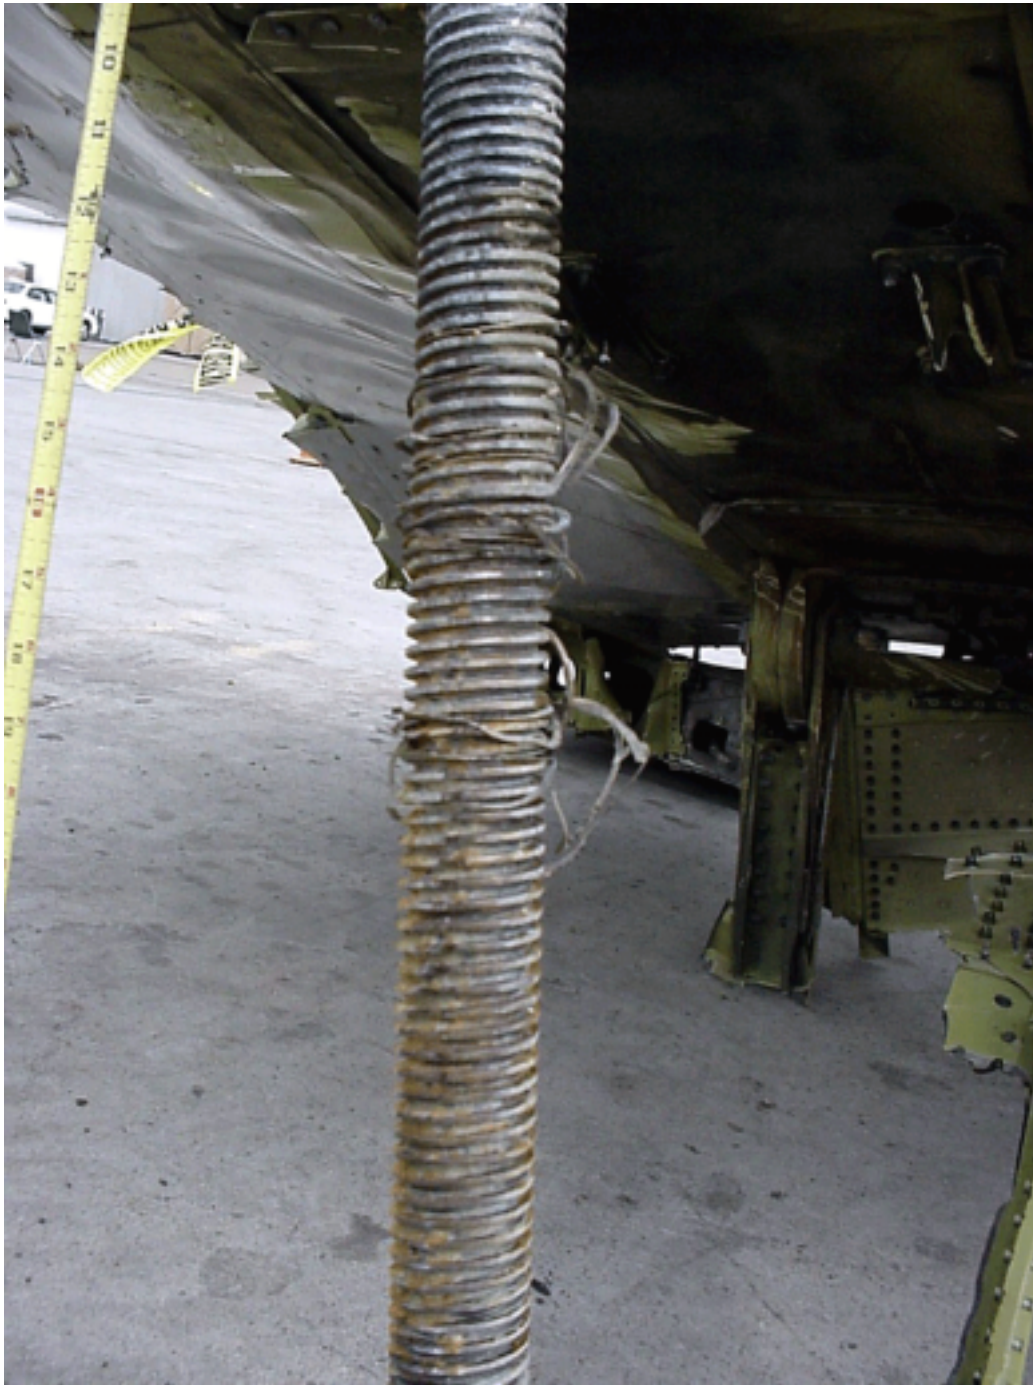
**Figure 12b.** The acme screw immediately after it was brought to shore.

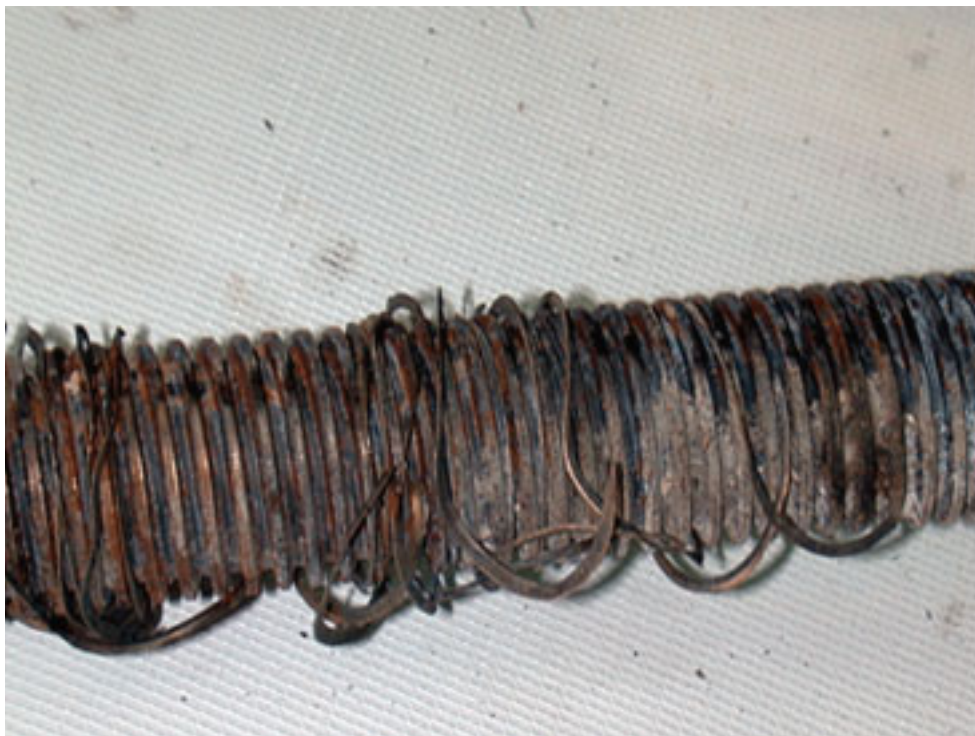
**Figure 12c.** The acme screw during initial inspection.

The upper mechanical stop was found attached to the splines of the acme screw, and the clamp bolt for this stop was in place. The lower mechanical stop and its clamp bolt were recovered as a separate unit from the acme screw. Several impact/scrape marks were found on the upper surface of the lower mechanical stop, and a round impact mark was found on the lower surface of the stop. Evidence of damage to the splines on the inside diameter of the lower mechanical stop was observed.<sup>117</sup>

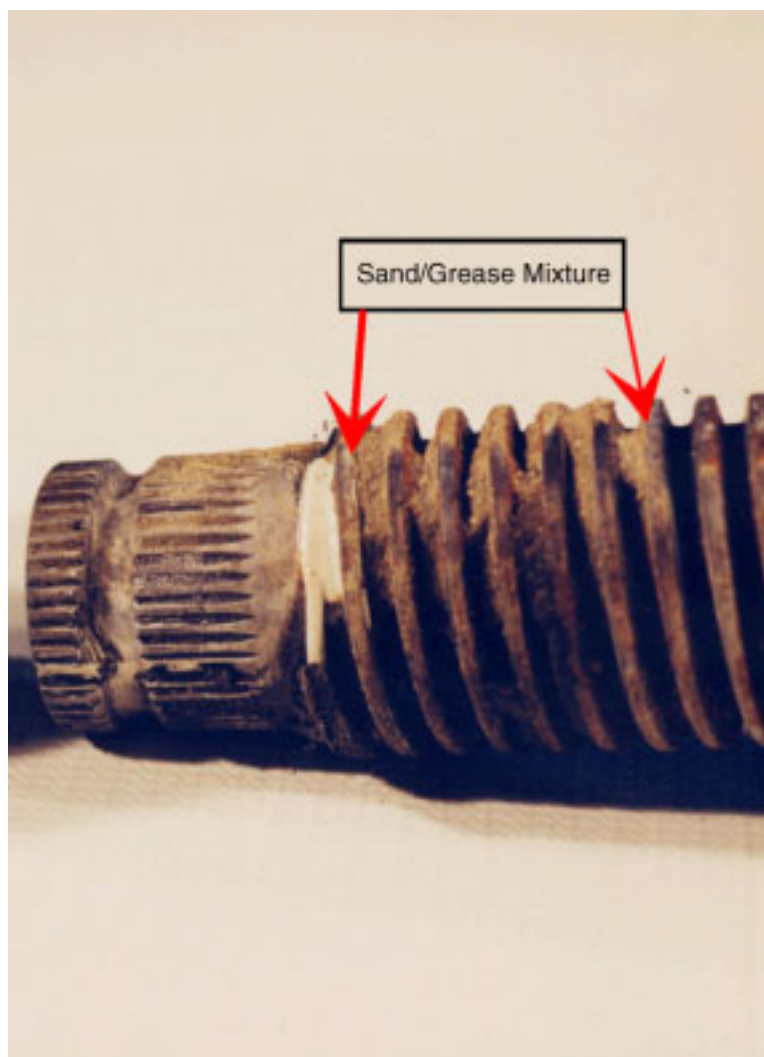
On-scene visual and tactile inspections by Safety Board metallurgists of the acme screw's threaded areas found no evidence of grease in any condition, either semi-fluid (that is, fresh) or solid/dry (that is, old or degraded), or other lubricants in the central "working region" of the screw threads.<sup>129</sup> Laboratory examinations found small flakes of dried and hardened grease attached to some of the thread remnants in this region. The acme screw's lower threads (which are outside of the working region) were found partially packed with a mixture consistent with sand and grease. (Figure 14 shows the sand/grease mixture packed between the acme screw's lower threads.) Parts of the acme screw's upper six to eight threads had an oily sheen, and small deposits of greaselike material were found between the threads.

**Figure 14.** A photograph of the sand/grease mixture packed between the acme screw's lower threads.

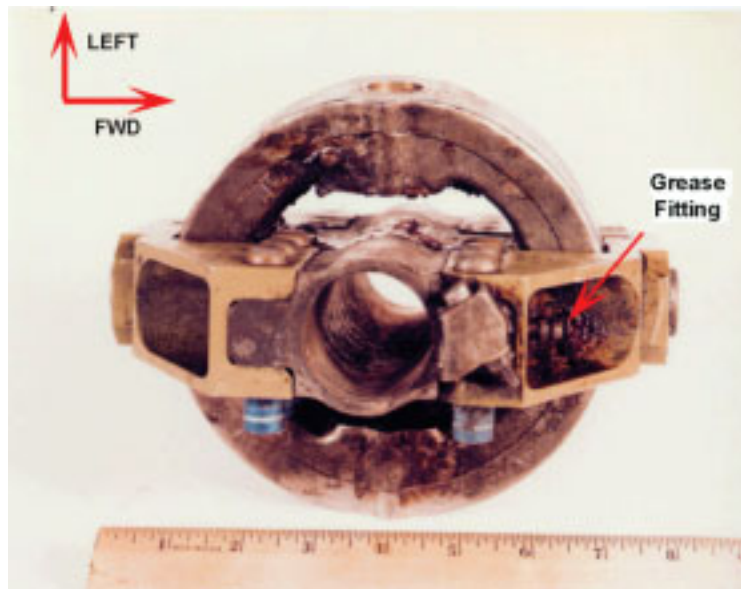
green-tinted, black and red grease deposits were found on the surrounding airplane structure.

**Figure 15.** A photograph of an overall view of the recovered acme nut assembly.

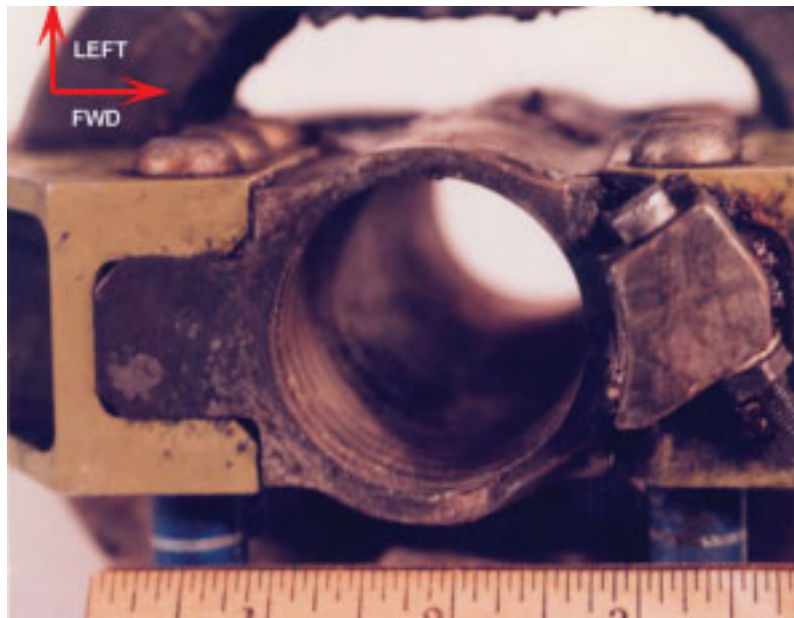
**Figure 16.** A photograph of a closer view of the interior of the acme nut.

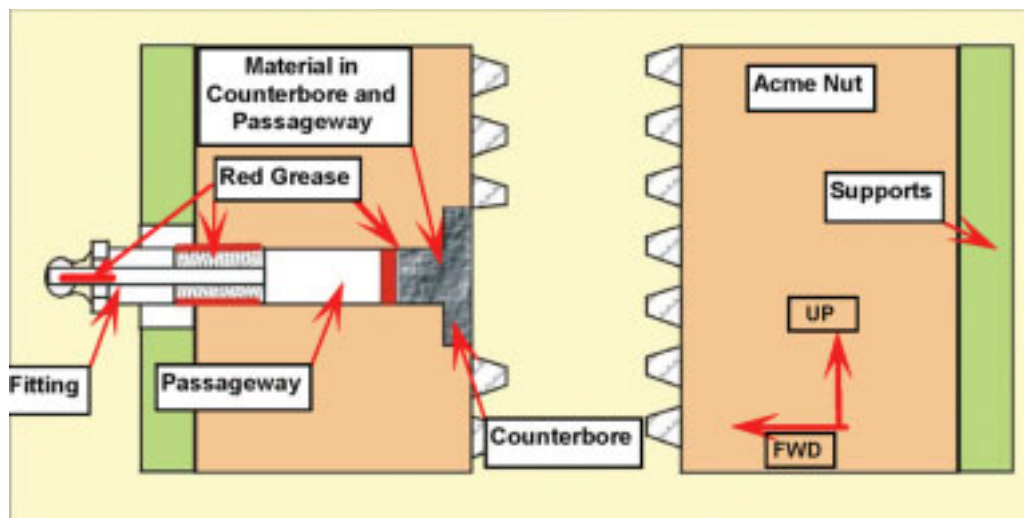
The acme nut has a grease fitting on the forward, upper side of the nut through which grease can be applied to the acme nut threads. A solid, black, claylike, dry residue coated with white, powdery material was found in the internal counterbore of the acme nut's grease passageway where it intersected the inside surface of the nut, as well as in the smaller diameter grease passageway behind the counterbore. When the grease fitting was

removed to allow collection of material samples from the grease passageway, translucent, reddish grease consistent with the appearance of Mobilgrease 28 was observed on the fitting's external threads. (Figure 17 shows a cross-section through the acme nut's grease passageway and fitting.) Traces of translucent, reddish grease were also found inside the grease passageway in the acme nut and in the bore of the grease fitting, a section distinct from the grease passageway. (Figure 18 shows the grease passageway and counterbore after the acme nut was sectioned.) Microscopic examination determined that the sample from the counterbore consisted mostly of black powdery material, larger chunks of black and white material, and particles of copper-colored metallic debris identified as acme nut material.

**Figure 17.** A diagram of a cross-section through the acme nut's grease passageway and fitting. Red areas denote the locations where red grease was found, and gray areas denote the location where the dry residue was found.

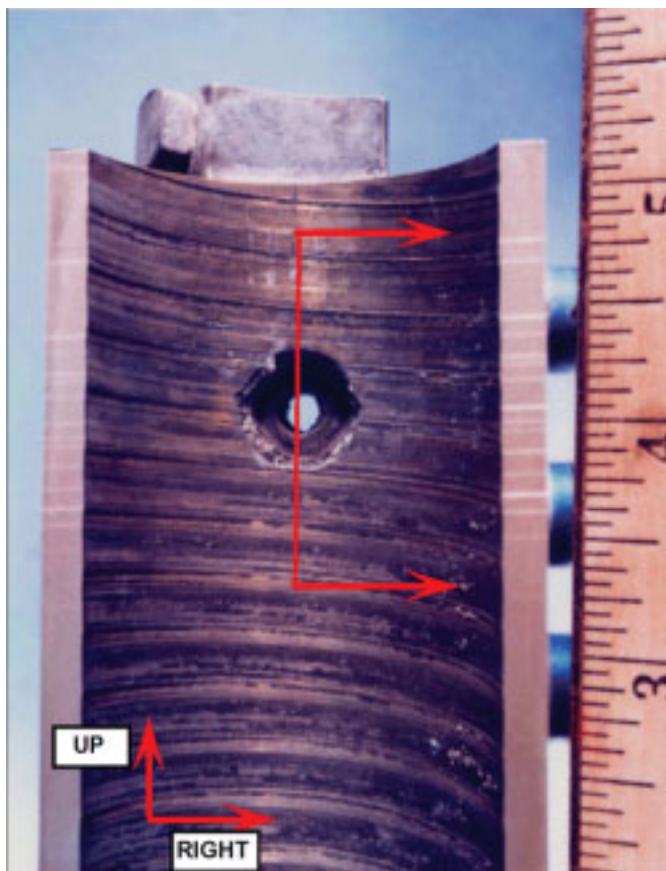
**Figure 18.** A photograph of the grease passageway and counterbore after the acme nut was sectioned.

Magnified visual inspections of the acme nut's interior after the nut was longitudinally sectioned confirmed the presence of the spiraling pattern consistent with the original location of the internal nut threads. For comparison with the accident acme nut interior, an exemplar nut was similarly sectioned.<sup>136</sup> The spiral patterns comprised a small raised ridge followed by a lustrous depression with spiral machining or wear marks transitioning into a dark band of surface deposits that rose to the next ridge. Under higher magnifications, longitudinal smearing and shear fractures were identified on the raised edges. The smearing and shearing directions were consistent with upward movement of the acme screw threads in relation to the nut body. Material was observed folded upward and smeared over adjacent surfaces along most of the ridges. Typical ridges were between 0.013 and 0.020 inch wide.

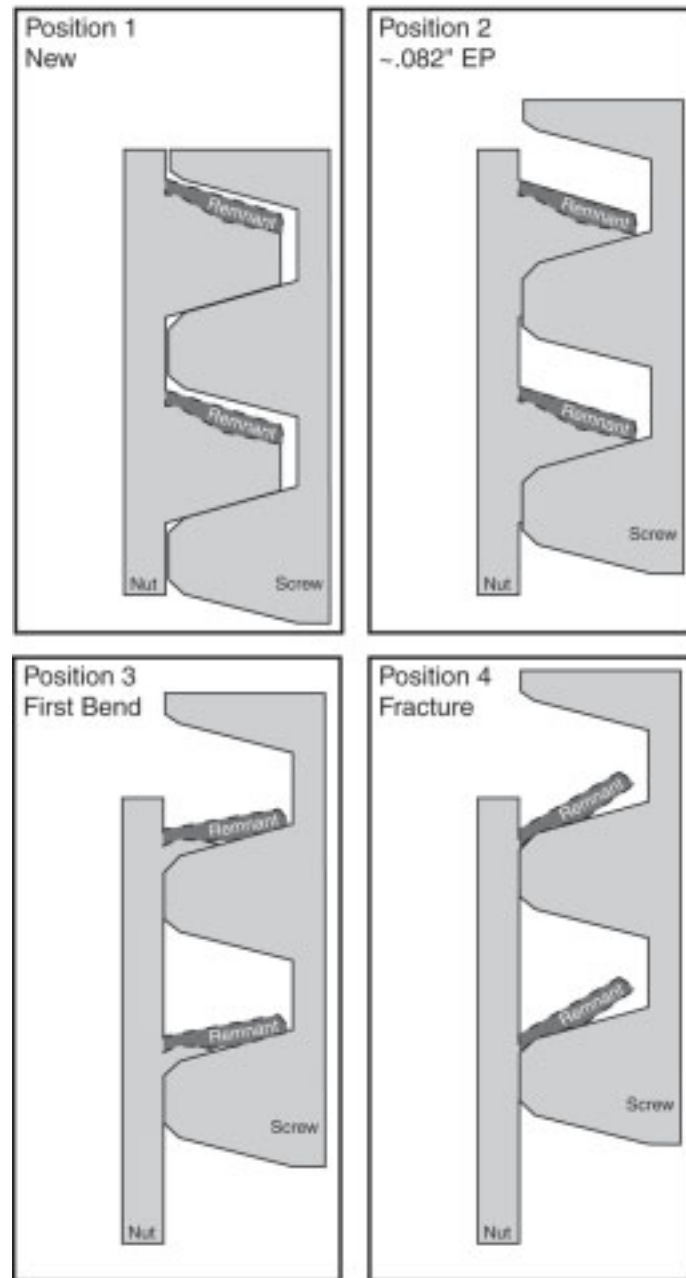
<sup>216</sup> It was theorized that, as the last of the acme nut thread remnants shear fractured and the screw threads tried to override the resulting ridges in the nut as the screw was pulled upward by aerodynamic loads and rotated circumferentially by the primary trim motor, the combined pinching and friction loads became greater than the combined aerodynamic and primary trim motor forces.

**Figure 20.** A graphical depiction of the stages of acme nut thread wear to the point of fracture.
