Landed short, Avjet Corporation, Gulfstream III, N303GA, Aspen, Colorado, March 29, 2001

Aircraft Accident Brief

Accident Number:	DCA01MA034
Operator:	Avjet Corporation
Aircraft and Registration:	Gulfstream III, N303GA
Location:	Aspen, Colorado
Date:	March 29, 2001

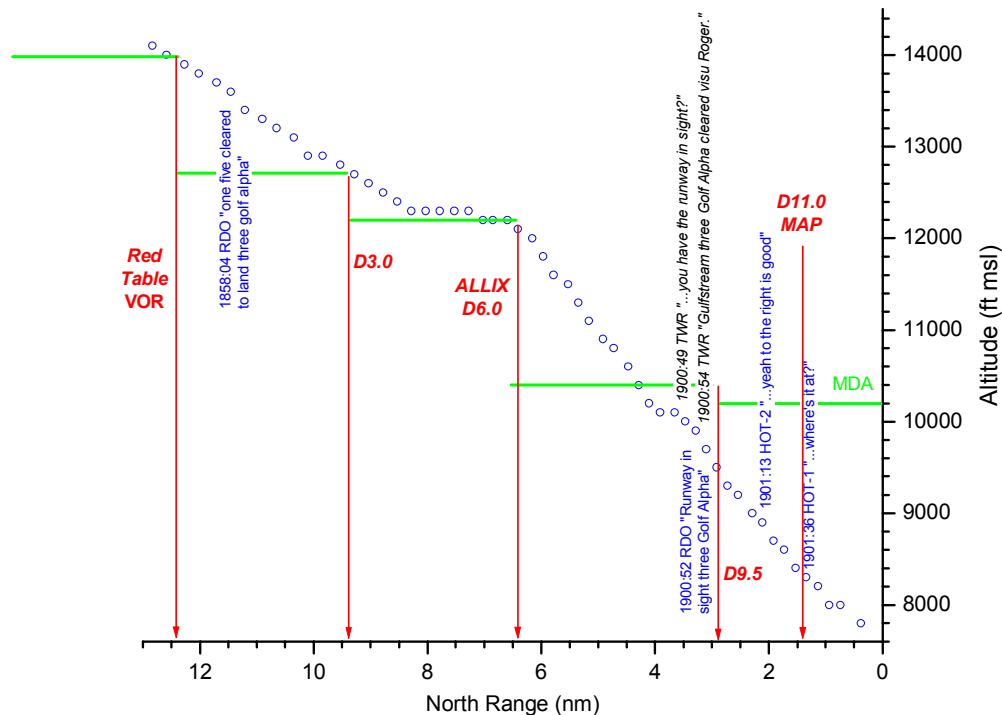
Figure 3. Profile view of N303GA's approach to ASE.

RDO, radio communication transmitted to and from N303GA; TWR, radio transmission from ASE local controller; HOT-2, first officer's audio panel information; MAP, missed approach point; HOT-1, captain's audio panel information; MDA, minimum descent altitude.

The airplane passed the step-down fix located 9.5 DME south of the Red Table VOR about 1901:00 at an altitude of 9,500 feet, 900 feet below the specified minimum altitude (see figure 3). Because the airplane was still in instrument meteorological conditions, the first officer should have announced this altitude deviation to the captain, but the CVR did not record any such callout.
