In-Flight Separation of Vertical Stabilizer, American Airlines Flight 587, Airbus Industrie A300-605R, N14053, Belle Harbor, New York, November 12, 2001

Micro-summary: The vertical stabilizer of this Airbus A300 separated from the airplane shortly after takeoff, resulting in the loss of the airplane.

Investigative Body: National Transportation Safety Board (NTSB), USA

NTSB/AAR-04/04

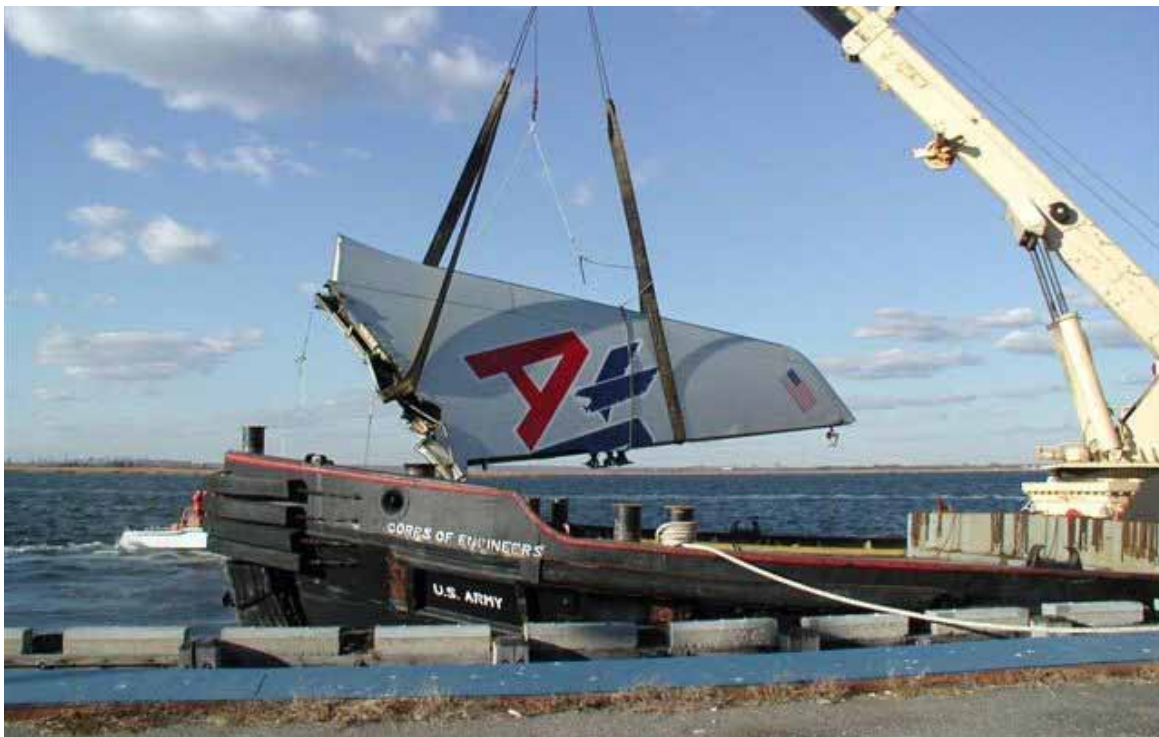
Figure 11. Vertical Stabilizer After Recovery From Jamaica Bay

The vertical stabilizer was mostly intact. The left and right skin panels did not exhibit any significant damage, but the six main attachment fittings and the three pairs of transverse load fittings were fractured.

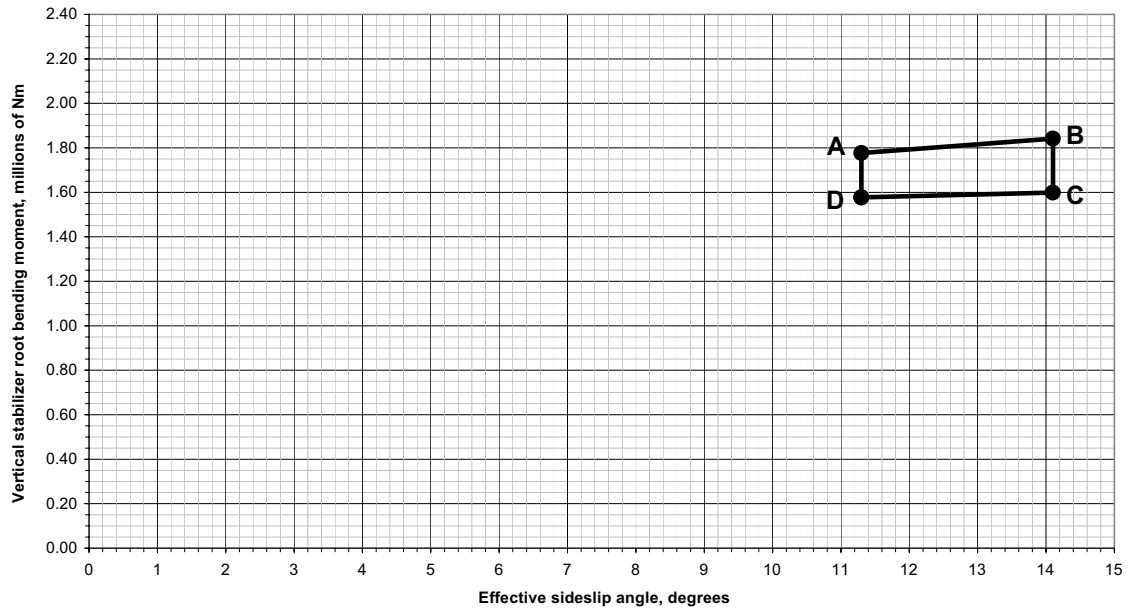
Figure 14. Bending Moment Load Range at the Time of Vertical Stabilizer Separation

Note: The calculated range of the root bending moment is defined by points A through D, which are described in addendum 2 to the airplane performance study. See the public docket for this accident for more information.

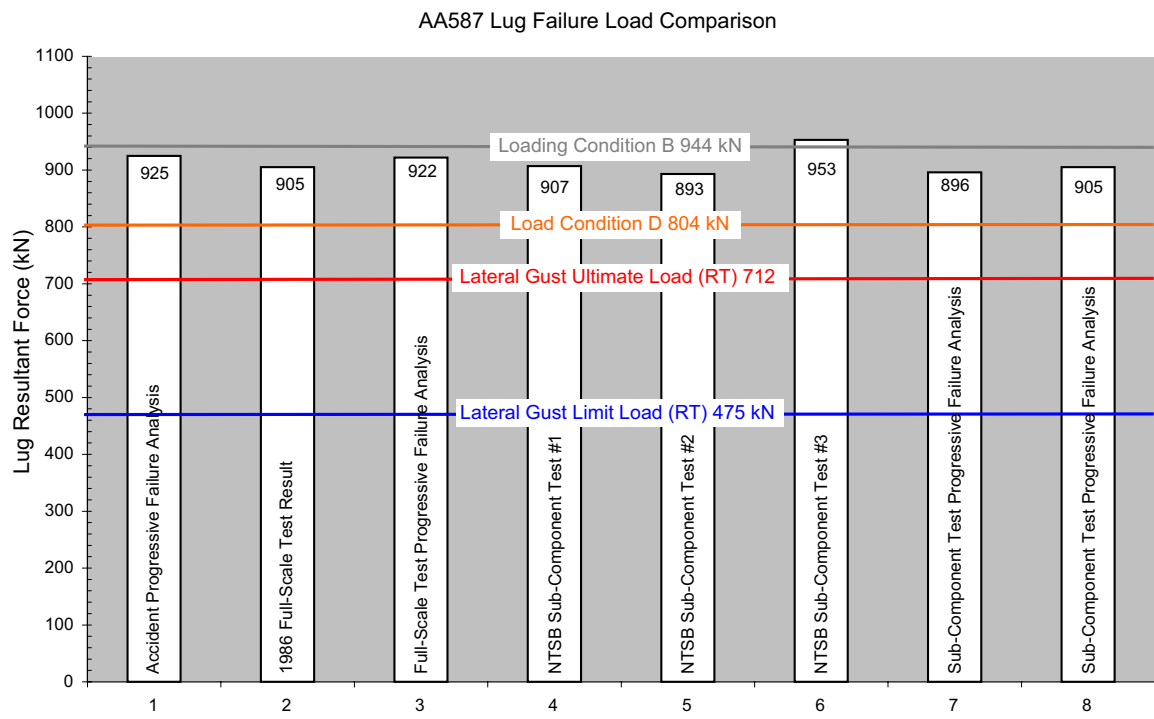
Figure 16. Comparison of Lug Forces at the Time of Fracture

Note: The lug forces defined by the gray and orange lines correspond to the conditions defined by the gray and orange triangles shown in figure 15.

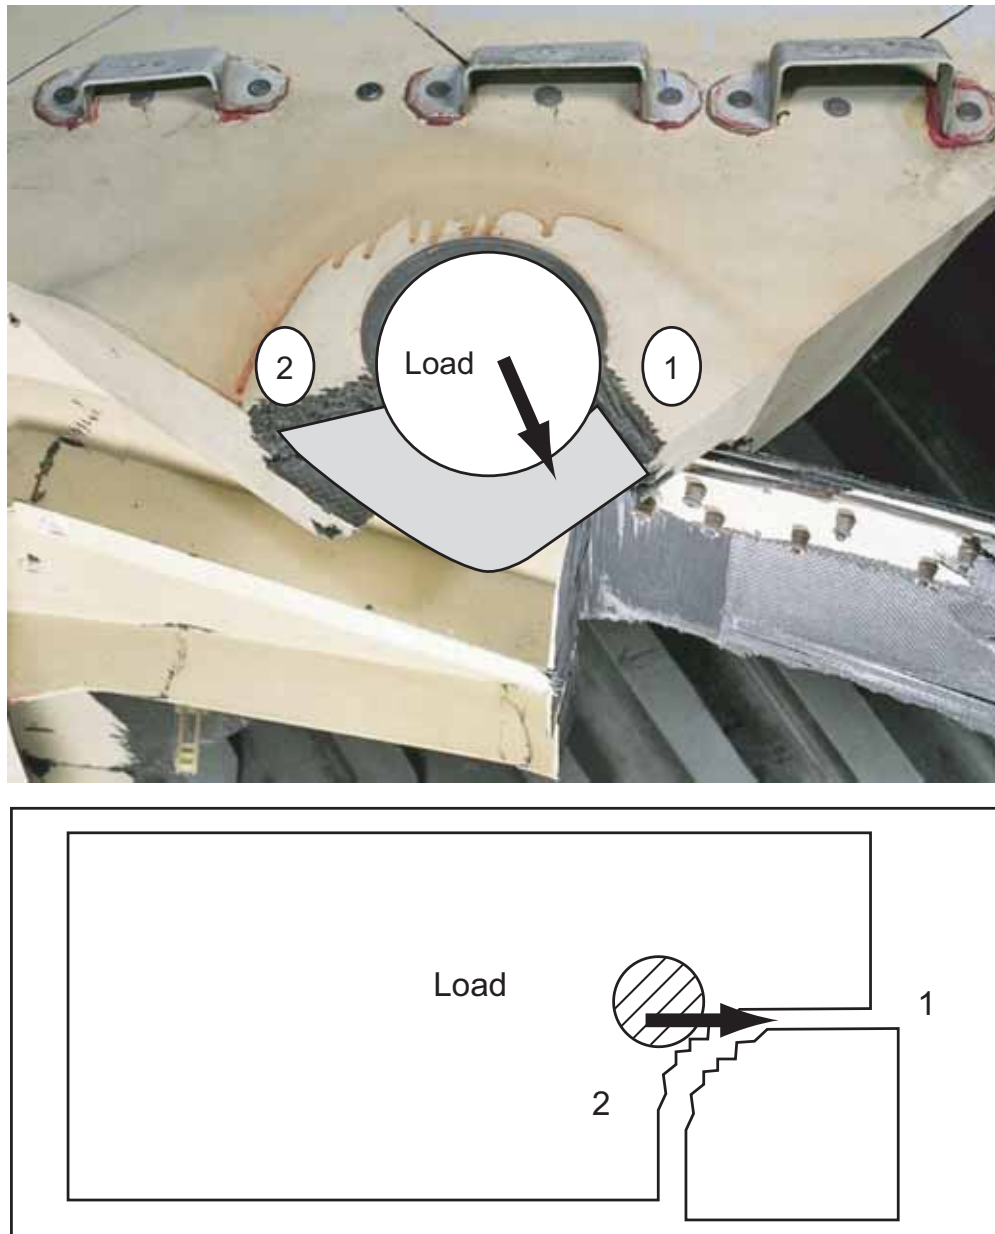
Figure 17. Load on the Flight 587 Right Rear Main Attachment Lug and a Depiction of the Cleavage-Tension Failure Mode

NASA's and Airbus' FEA models determined that failure of the right rear main attachment lug was the most probable initial failure. The FEA models and NASA's PFA model also determined that the failure initiated at the final observed maximum vertical stabilizer root bending condition during the accident flight, when the vertical stabilizer

The stresses developed exceeded the strength values for the CFRP material used in the manufacturing of the lugs; thus, the accident lug and the tested lugs fractured because of a tensile static overload. The physical evidence and the structural analyses showed that the accident lug’s and the tested lugs’ fracture features were consistent with a cleavage-tension failure observed in composite-bolted joints. Figure 17 shows the load on the flight 587 right rear main attachment lug and a depiction of the cleavage-tension failure mode.

Note: Number 1 is the initiating fracture, and number 2 is the secondary fracture. The circle indicates the location of the pin and bushing, which were missing from the lug when it was found in the wreckage.
