Collision With Trees on Final Approach, Federal Express Flight 1478, Boeing 727-232, N497FE, Tallahassee, Florida, July 26, 2002

**Collision With Trees on Final Approach
Federal Express Flight 1478
Boeing 727-232, N497FE
Tallahassee, Florida
July 26, 2002**

NTSB/AAR-04/02

On July 26, 2002, about 0537 eastern daylight time, Federal Express flight 1478, a Boeing 727-232F, N497FE, struck trees on short final approach and crashed short of runway 9 at the Tallahassee Regional Airport (TLH), Tallahassee, Florida. The flight was operating under the provisions of 14 *Code of Federal Regulations* Part 121 as a scheduled cargo flight from Memphis International Airport, in Memphis, Tennessee, to TLH. The captain, first officer, and flight engineer were seriously injured, and the airplane was destroyed by impact and resulting fire. Night visual meteorological conditions prevailed for the flight, which operated on an instrument flight rules flight plan.

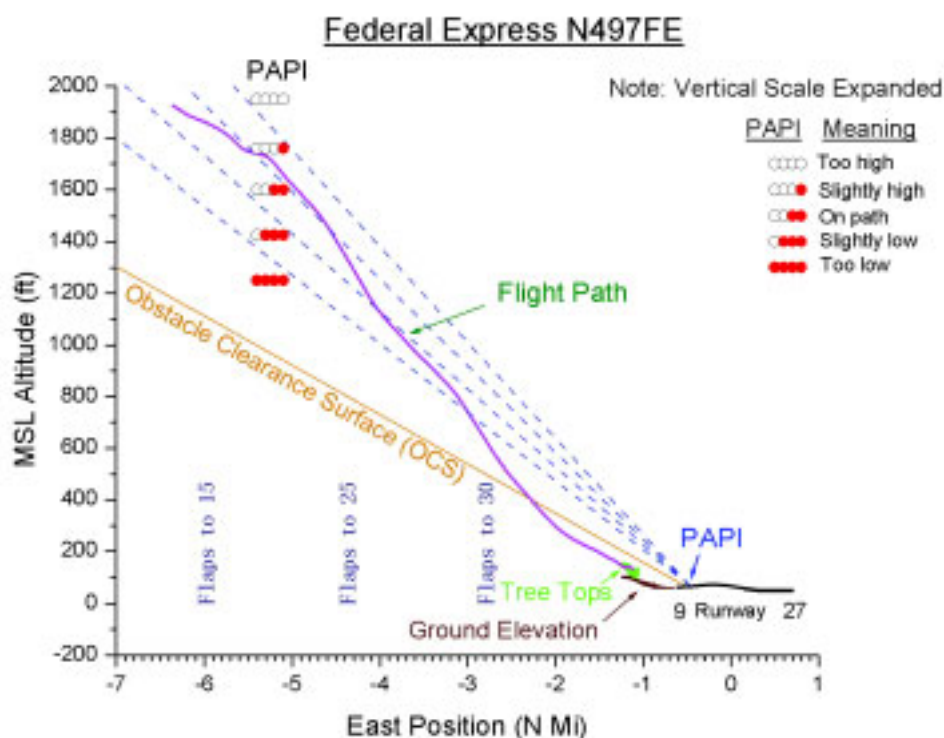
Figure 1. Descent profile of FedEx flight 1478.

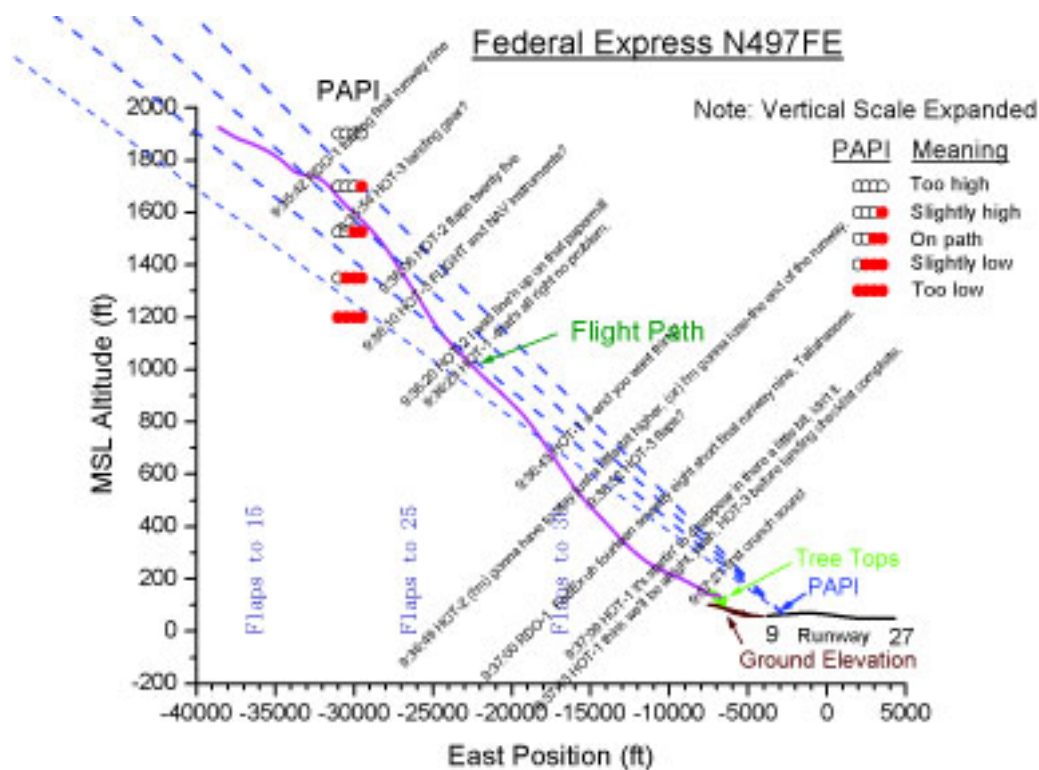
Figure 2. Descent profile of FedEx flight 1478, with select CVR comments overlaid.

Also about 0536:49, the CVR recorded the first officer stating, “[I’m] gonna have to stay just a little bit higher...I’m gonna lose the end of the runway.” About 0536:51, the captain responded, “yeah...yeah, okay.” About 0536:52, the flight engineer asked, “flaps?,” and the captain responded, “thirty thirty green light.” About 0536:56, the flight engineer asked, “landing clearance?,” and the captain responded, “clear to land runway...nine.”

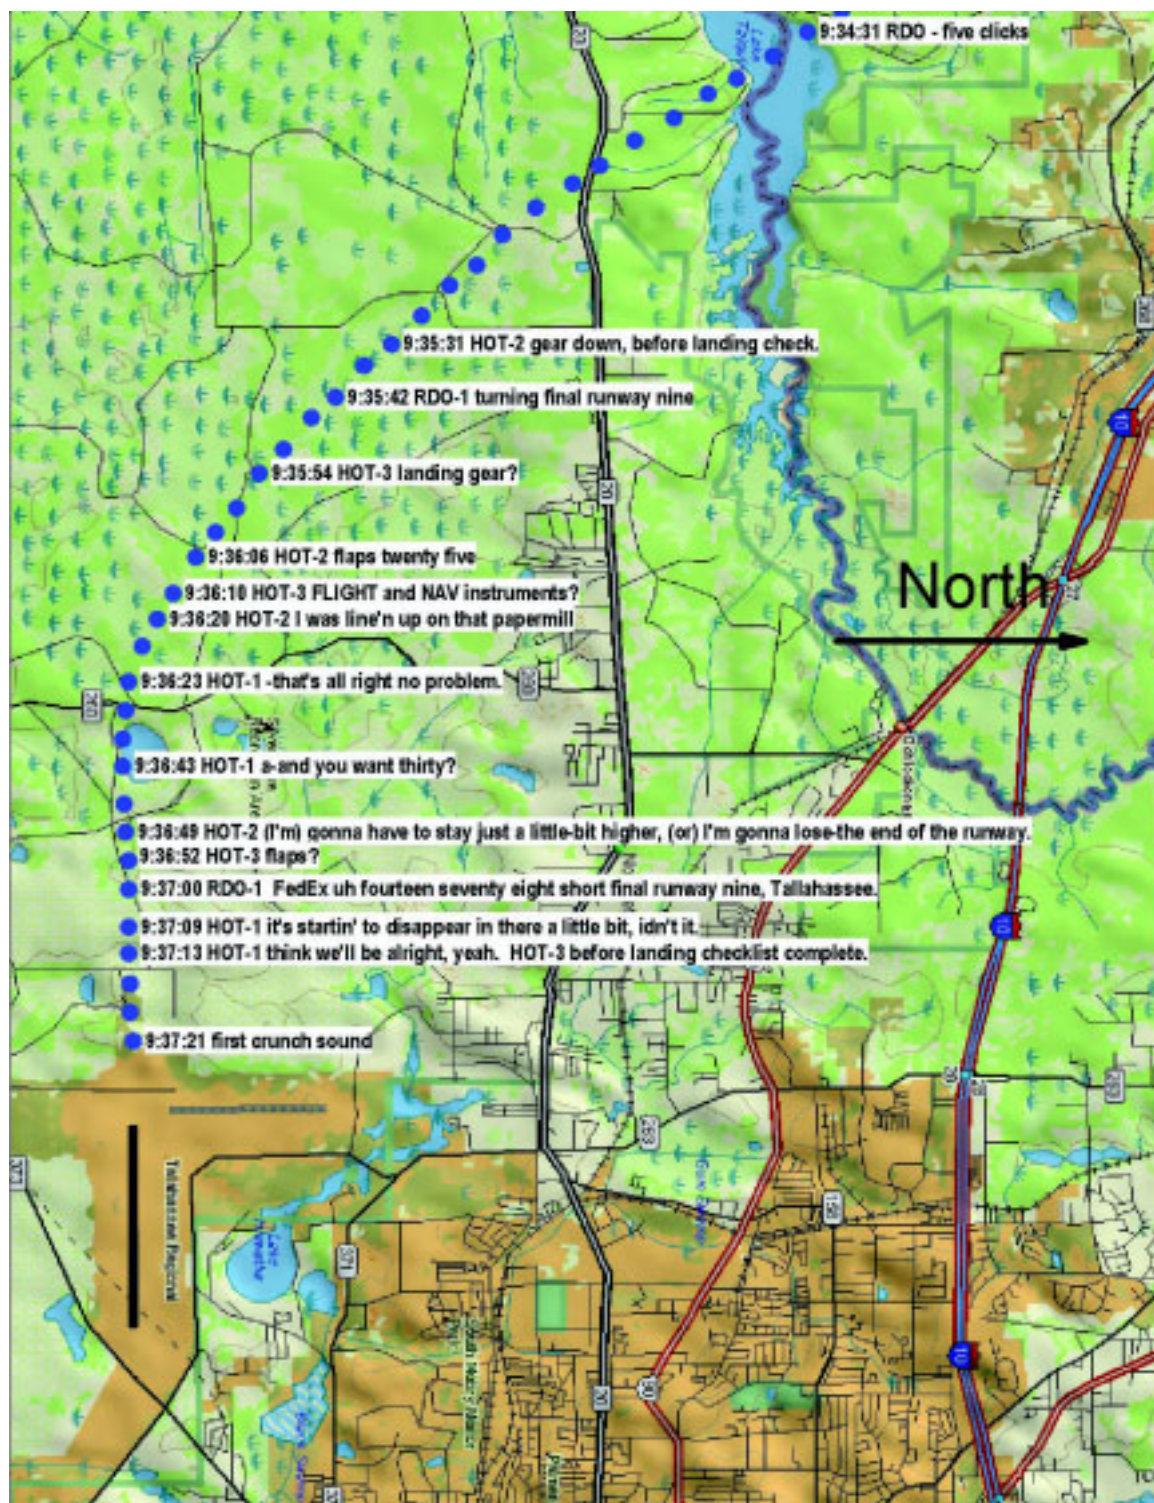
Figure 3. A map overlay of FedEx flight 1478's radar track into runway 9 at TLH, with excerpted CVR comments.

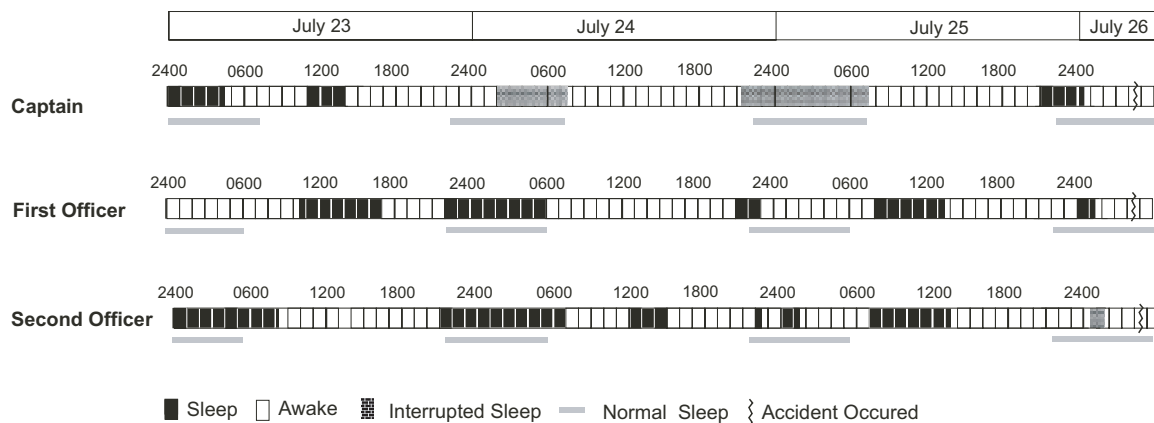
Figure 4. The three crewmembers' estimated sleep schedule during the 72 hours before the accident.

The captain stated that he did not sleep well that night. He reported that he stayed awake for a “couple of hours” after he got home to take care of the family dog, which was in deteriorating health. He indicated that he slept on the couch the rest of that night so he could more easily care for the dog during the night and stated that his sleep was accordingly interrupted three times during the night. He stated that his rest period ended about 0730 on July 24 and that he engaged in routine activities throughout the day. He went to bed about 2130 that evening, again sleeping on the downstairs couch and getting up several times during the night to care for the sick dog. He stated that he awoke about 0730 on July 25, 2002, and described his sleep quality as “marginal, not really good.”

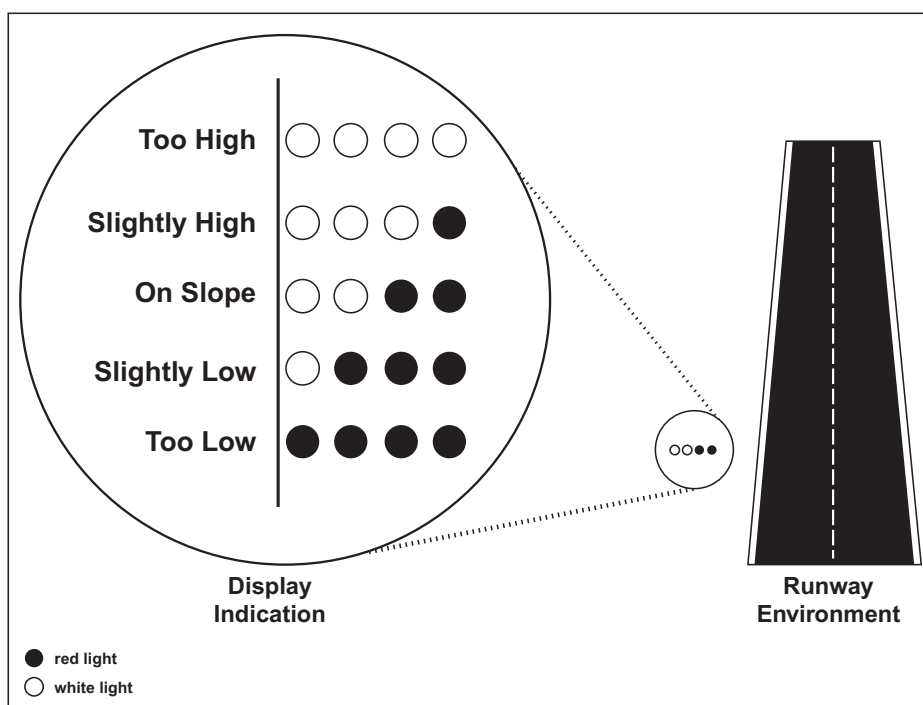
The PAPI lighting system installed on the left side of the approach end of runway 9 was an ADB, ALNACO, Inc. (a subsidiary of Siemens Airfield Solutions) model L-880, style A, and consisted of four identical light boxes mounted along a line perpendicular to the runway centerline about 1,000 feet from the approach end of the runway. Each of the four boxes contained two 200-watt lamps and optical apparatus to split the lamp beams horizontally into red (lower) and white (upper) beams. The lamps in each of the four light boxes were positioned so that each box projected a signal at a prescribed angle above the horizon, relative to a 3° glidepath.⁴³ An on-glidepath signal is represented by the two left-side boxes showing white lights and the two right-side boxes showing red lights. If an airplane is beneath the glidepath, more red lights would be visible to the pilots; if an airplane is above the glidepath, more white lights would be visible. Figure 6 shows PAPI indications from various approach path angles.

Figure 6. PAPI indications from various approach path angles.

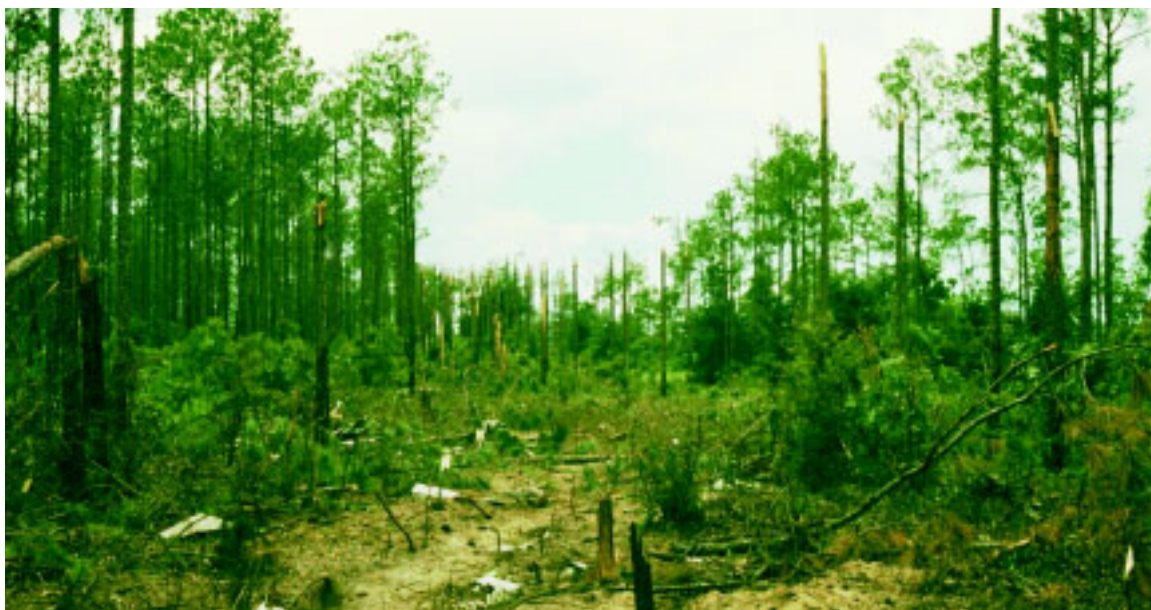
broken trees continued to the edge of the wooded area (about 1,130 feet from the initial impact), where the trees on the right and left sides of the swath were broken at 7.9 feet and 31.7 feet, respectively. (Figure 7 shows the swath of damaged trees, looking from east to west, with the first ground scars and airplane wreckage in the foreground.) Pieces of the right wing (including the right wing leading-edge flap, trailing-edge flap, wing tip, strobe light, flap jack screws, and slat tracks) were located in the wooded area.

Figure 7. A swath of trees damaged by impact with FedEx flight 1478.

The first evidence of ground impact was located near the edge of the wooded area, about 170 feet from open terrain. The ground scars continued in the open terrain, increasing in width from about 29 feet near the edge of the trees to about 120 feet near the main wreckage. There was evidence of fire along the wreckage path for about 800 feet leading to the main wreckage, which was destroyed by impact and postimpact fire.
