Crash into terrain, Beech King Air 200, N501RH, Stuart, Virginia, October 24, 2004

Aircraft Accident Brief

Accident Number: IAD05MA006
Aircraft and Registration: Beech King Air 200, N501RH
Location: Stuart, Virginia
Date: October 24, 2004
Adopted on: February 7, 2006

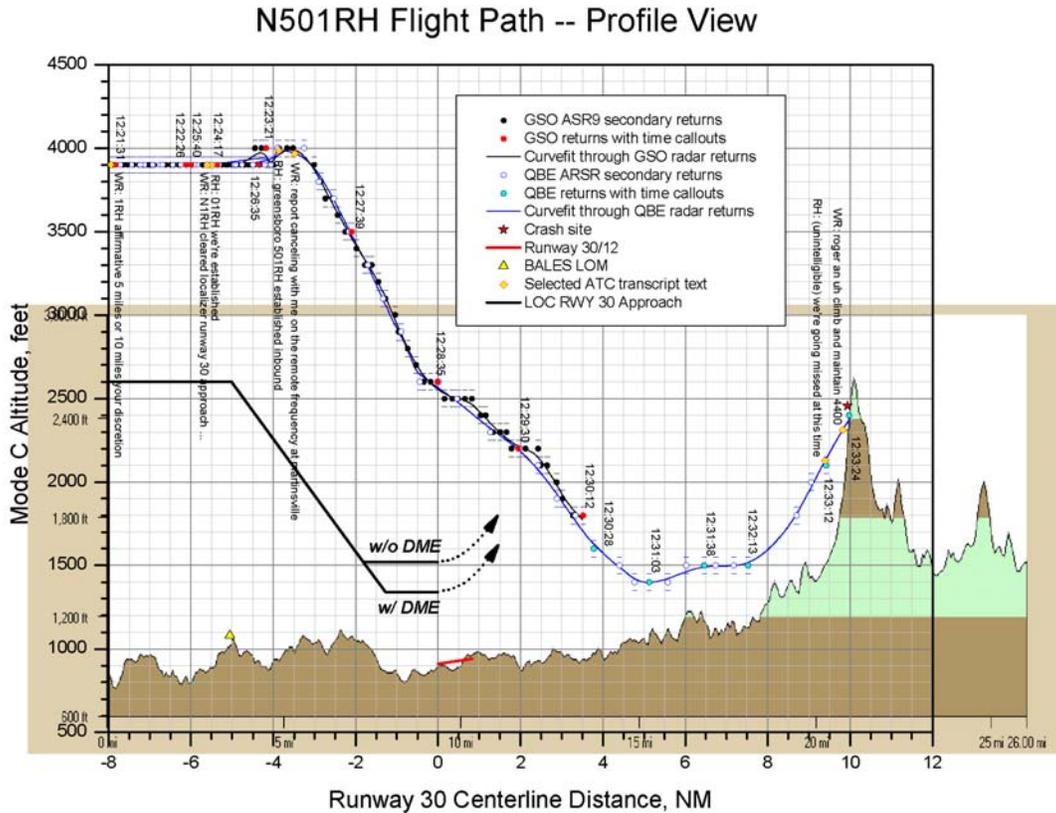
Figure 3. Accident airplane's altitude profile.

At 1226:53, the flight crew advised the controller that the airplane was “established inbound” on the approach. At 1227:04, the controller cleared the airplane for the approach and approved a radio frequency change from the approach control frequency to the common traffic advisory frequency (CTAF).⁴ At 4 DME, or 2 nm after crossing the BALES LOM on the inbound course, the airplane started to descend from 4,000 feet (see figure 3). The airplane leveled off at 2,600 feet as it passed the MAP. About 1 nm past the MAP and over the runway, the airplane began a descent to 1,400 feet and continued on an approximate heading of 305°.

The airplane leveled at 1,400 feet, about 4 nm beyond MTV and 5 nm beyond the MAP. The airplane maintained level flight between 1,400 and 1,500 feet for the next 1 minute 13 seconds. At 1232:13, about 8 nm beyond MTV, the airplane initiated a straight-ahead climb.
