### In-Flight Engine Failure and Subsequent Ditching, Air Sunshine, Inc., Flight 527, Cessna 402C, N314AB, About 7.35 Nautical Miles West-Northwest of Treasure Cay Airport, Great Abaco Island, Bahamas, July 13, 2003

# Aircraft Accident Report NTSB/AAR-04/03

In-Flight Engine Failure and Subsequent Ditching Air Sunshine, Inc., Flight 527 Cessna 402C, N314AB About 7.35 Nautical Miles West-Northwest of Treasure Cay Airport, Great Abaco Island, Bahamas July 13, 2003

NTSB/AAR-04/03 PB2004-910403 Notation 7671A Adopted October 13, 2004

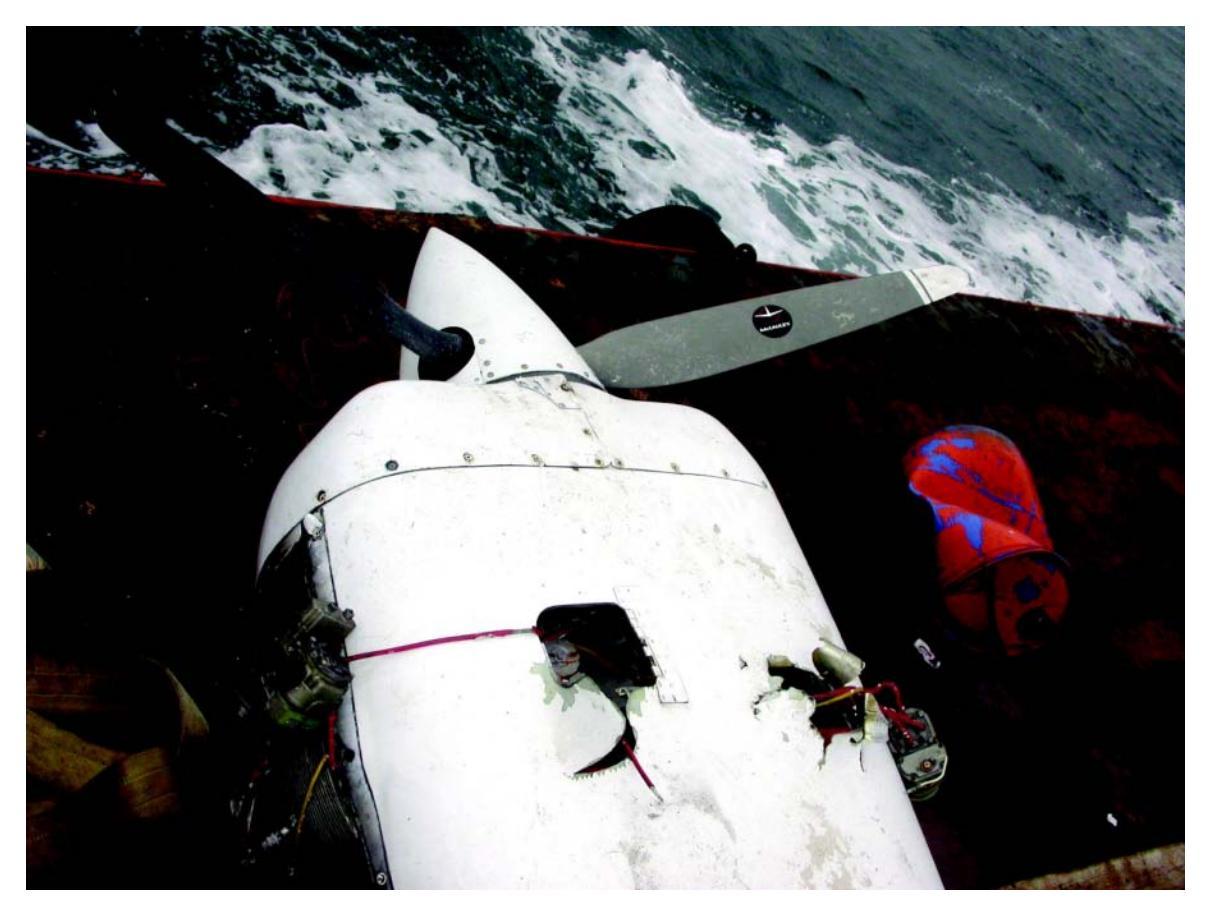
Figure 3. Exterior of the upper outboard engine cowling.

The right engine was attached to the airframe in its normal position, and the propeller was attached to the engine. Damage was noted on the leading edge skin from the engine outboard to the wing tip; the leading edge skin from the engine nacelle inboard of the wing root was crushed up and aft. The lower inboard engine cowling was separated and was not recovered; the lower outboard engine cowling was in place.

The right engine No. 2 (inboard aft) cylinder was found separated from the engine crankcase, exposing a portion of the crankshaft, and held onto the engine by the exhaust pipe tubing and by an electrical cable that was secured to the cylinder assembly by an adel clamp. The two magnetos were found protruding through the upper outboard engine cowling but remained attached to the engine by ignition leads. (See figure 3.) Two 6-point flanged nuts, one 12-point flanged nut with a fractured threaded piece, and a nonfractured connecting rod were recovered from the engine compartment area. Piston ring pieces were found in the partially separated No. 2 cylinder assembly.

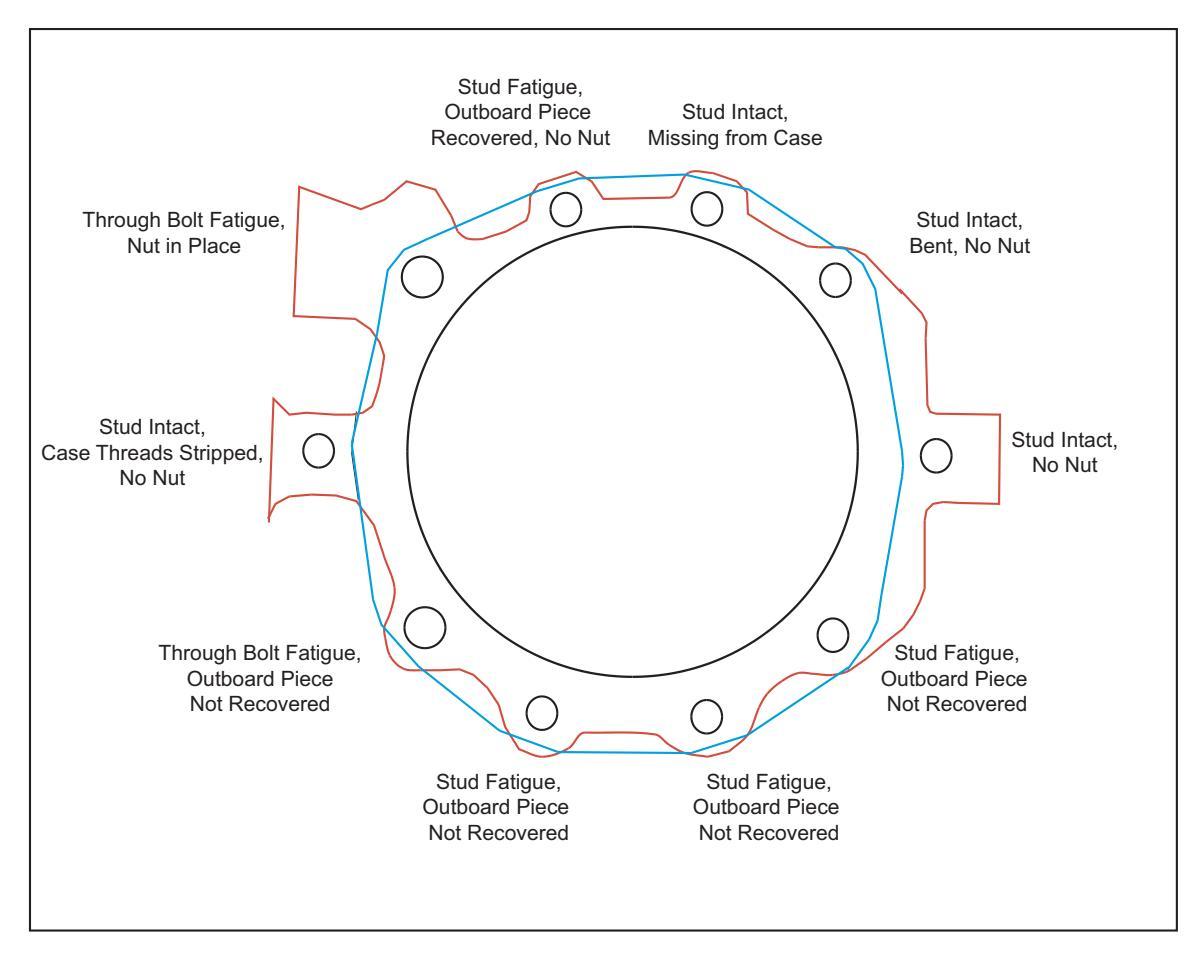
**Figure 4.** The condition in which the right engine No. 2 cylinder retention system components were found.

The outboard portions of one of the fractured hold-down studs and one of the fractured through bolts were recovered. The stud piece was found without a nut attached,

and the through bolt piece was found with a nut attached. The outboard portions of the other three fractured studs were not recovered. The other fractured through bolt, which is where the nut would normally be, was not recovered. Figure 4 shows the condition in which the right engine No. 2 cylinder retention system components were found.

Note: The cylinder base flange is outlined in blue, and the mounting surface is outlined in red.
