# Nosewheel collapse on landing, Trans World Airlines, Inc., Boeing 707-131B, N757TW, Los Angeles International Airport, Los Angeles , California, January 16, 1974

# AIRCRAFT ACCIDENT REPORT

TRANS WORLD AIRLINES, INC. BOEING 707-131B, N757TW LOS ANGELES INTERNATIONAL AIRPORT LOS ANGELES, CALIFORNIA JANUARY 16, 1974

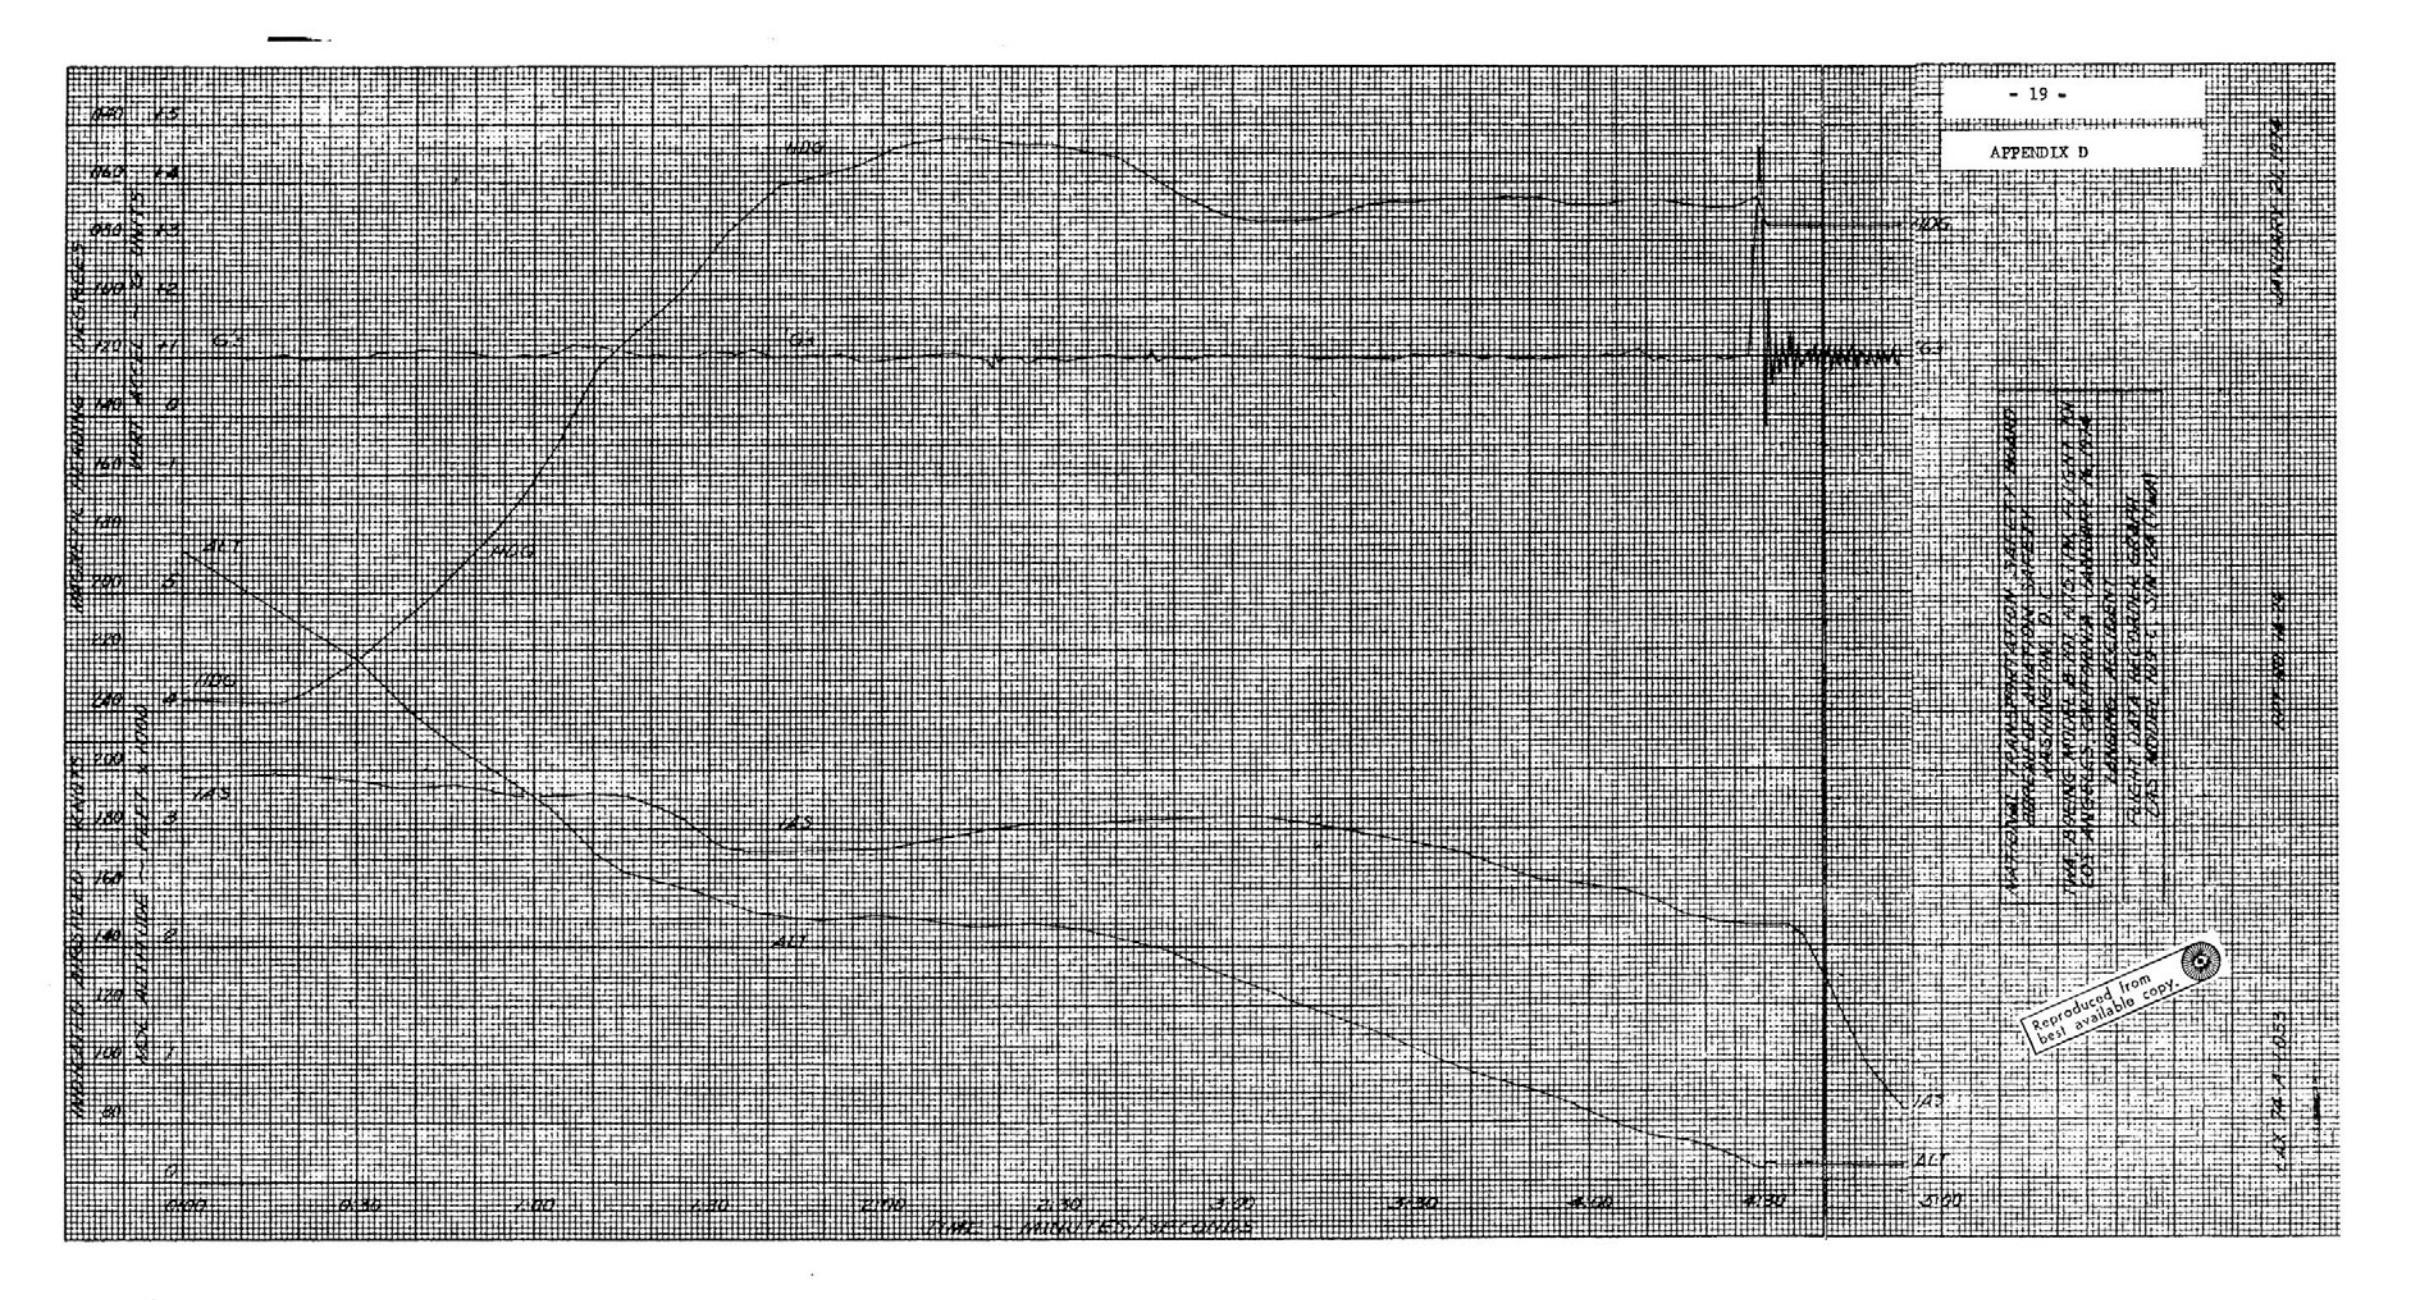
The foil recording medium of the FDR was undamaged and all parameters were recorded. According to the FDR, from 17 seconds to 9 seconds before touchdown, the aircraft's average rate of descent was 375 feet per minute and the indicated airspeed decreased from 157 kn to 150 kn. From 9 seconds before touchdown to touchdown, the average rate of descent was 1,400 feet per minute and the indicated airspeed decreased from 150 kn to 147 kn. Immediately following touchdown, the vertical acceleration, measured in g's, recorded a +4.60 g load, which was immediately followed by a recorded - 0.2 g load.

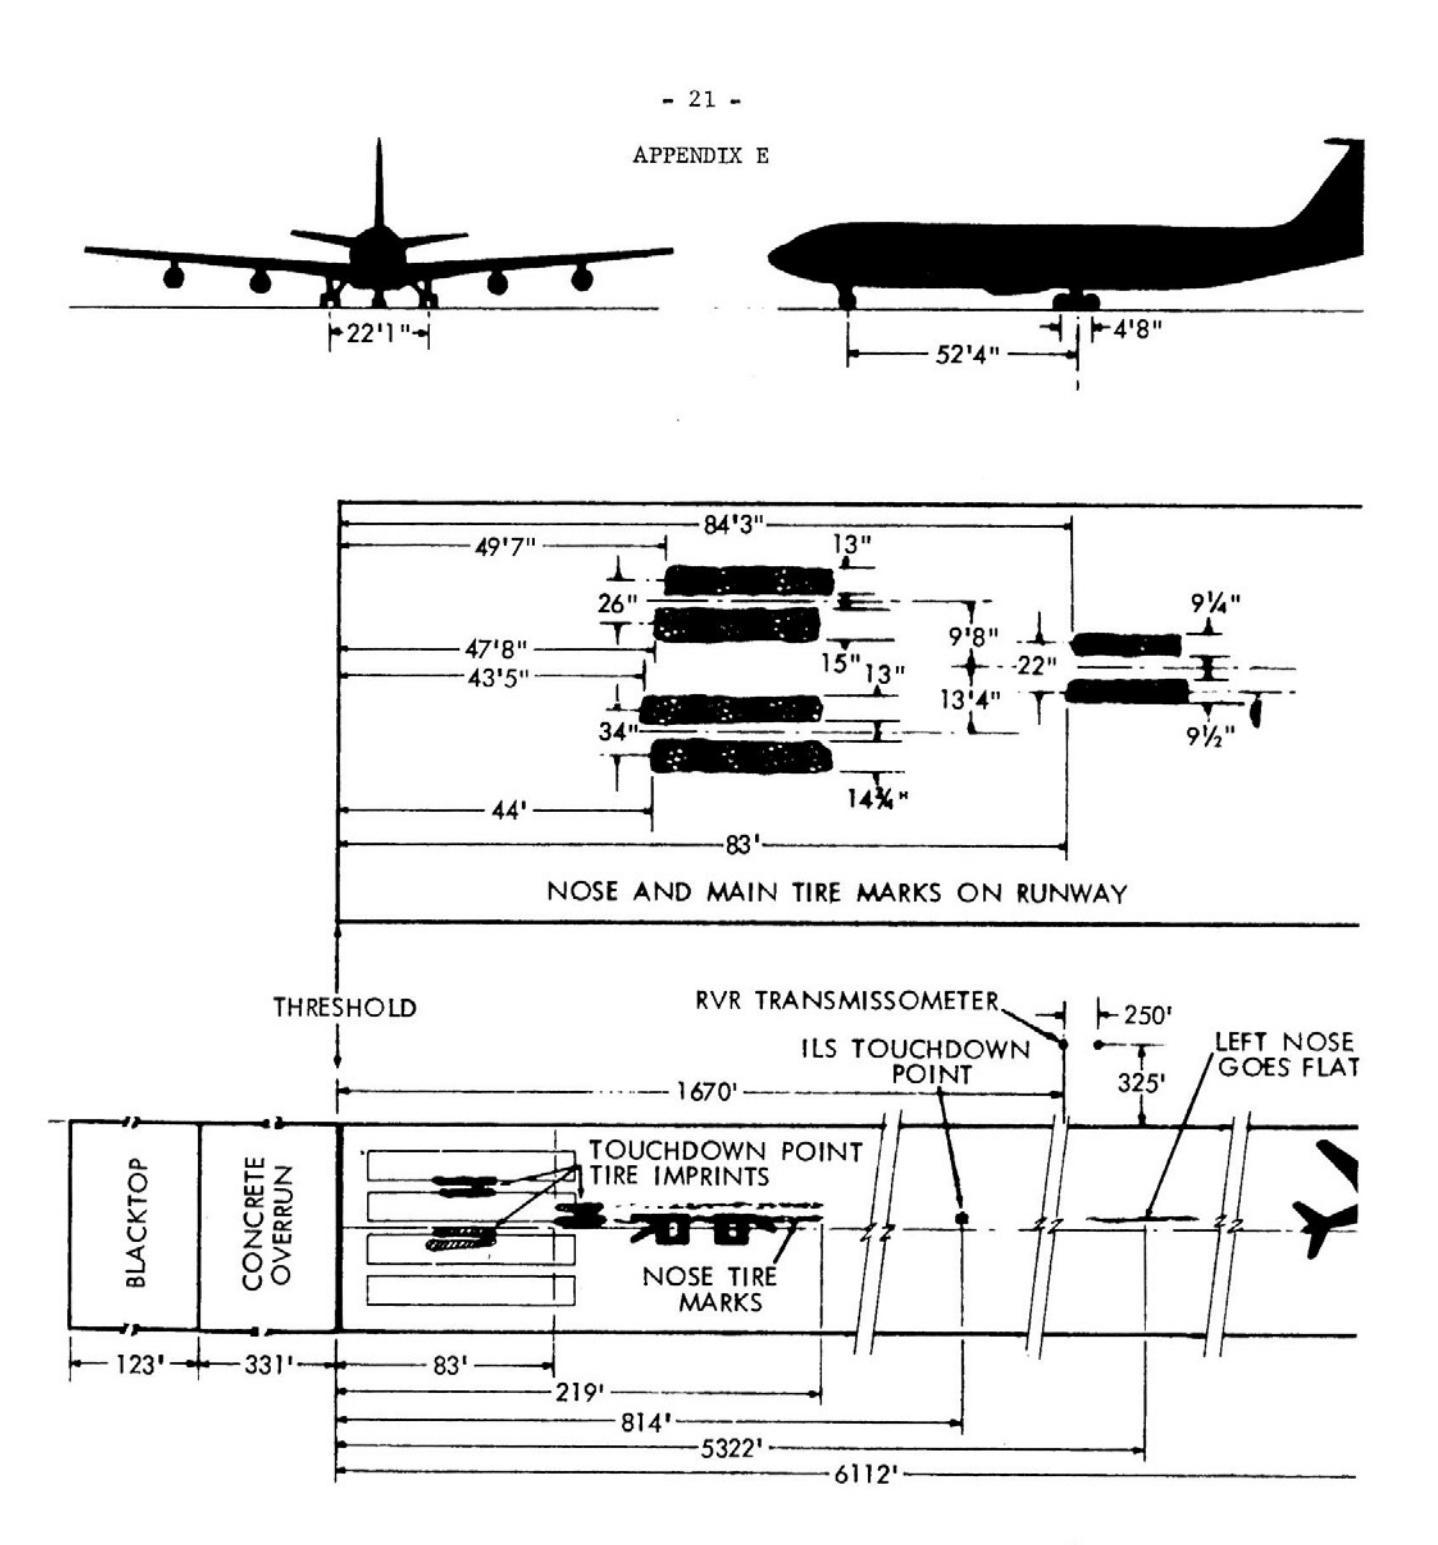
The longitudinal distance between the center of the main landing gear and the center of the nose landing gear is 52 feet 4 inches. The tire marks on the approach end of runway 6R disclosed that the aircraft's right main landing gear initially contacted the runway, 43 feet 5 inches beyond the threshold, and that the nose gear initially contacted the runway, 83 feet beyond the threshold. Tire marks on the runway also disclosed that the left nose gear tire flattened 5,322 feet beyond the runway threshold. The aircraft stopped on the runway about 6,112 feet beyond the threshold and 15 feet to the left of the runway centerline.

Contrary to the crew's belief that all three landing gears touched down simultaneously, the tire marks on the runway confirm that the nose wheel touched down first. The 1,400-foot per minute rate of descent in the 9 seconds before touchdown, and the vertical acceleration trace reading of +4.60g on the FDR upon touchdown, indicate an unchecked high sink rate and a resultant hard landing. The approach should have been discontinued under these conditions.
