NTSB/AAR-90/04

AIRCRAFT INCIDENT REPORT

USAIR FLIGHT 105 BOEING 737-200, N283AU KANSAS CITY INTERNATIONAL AIRPORT, MISSOURI SEPTEMBER 8, 1989

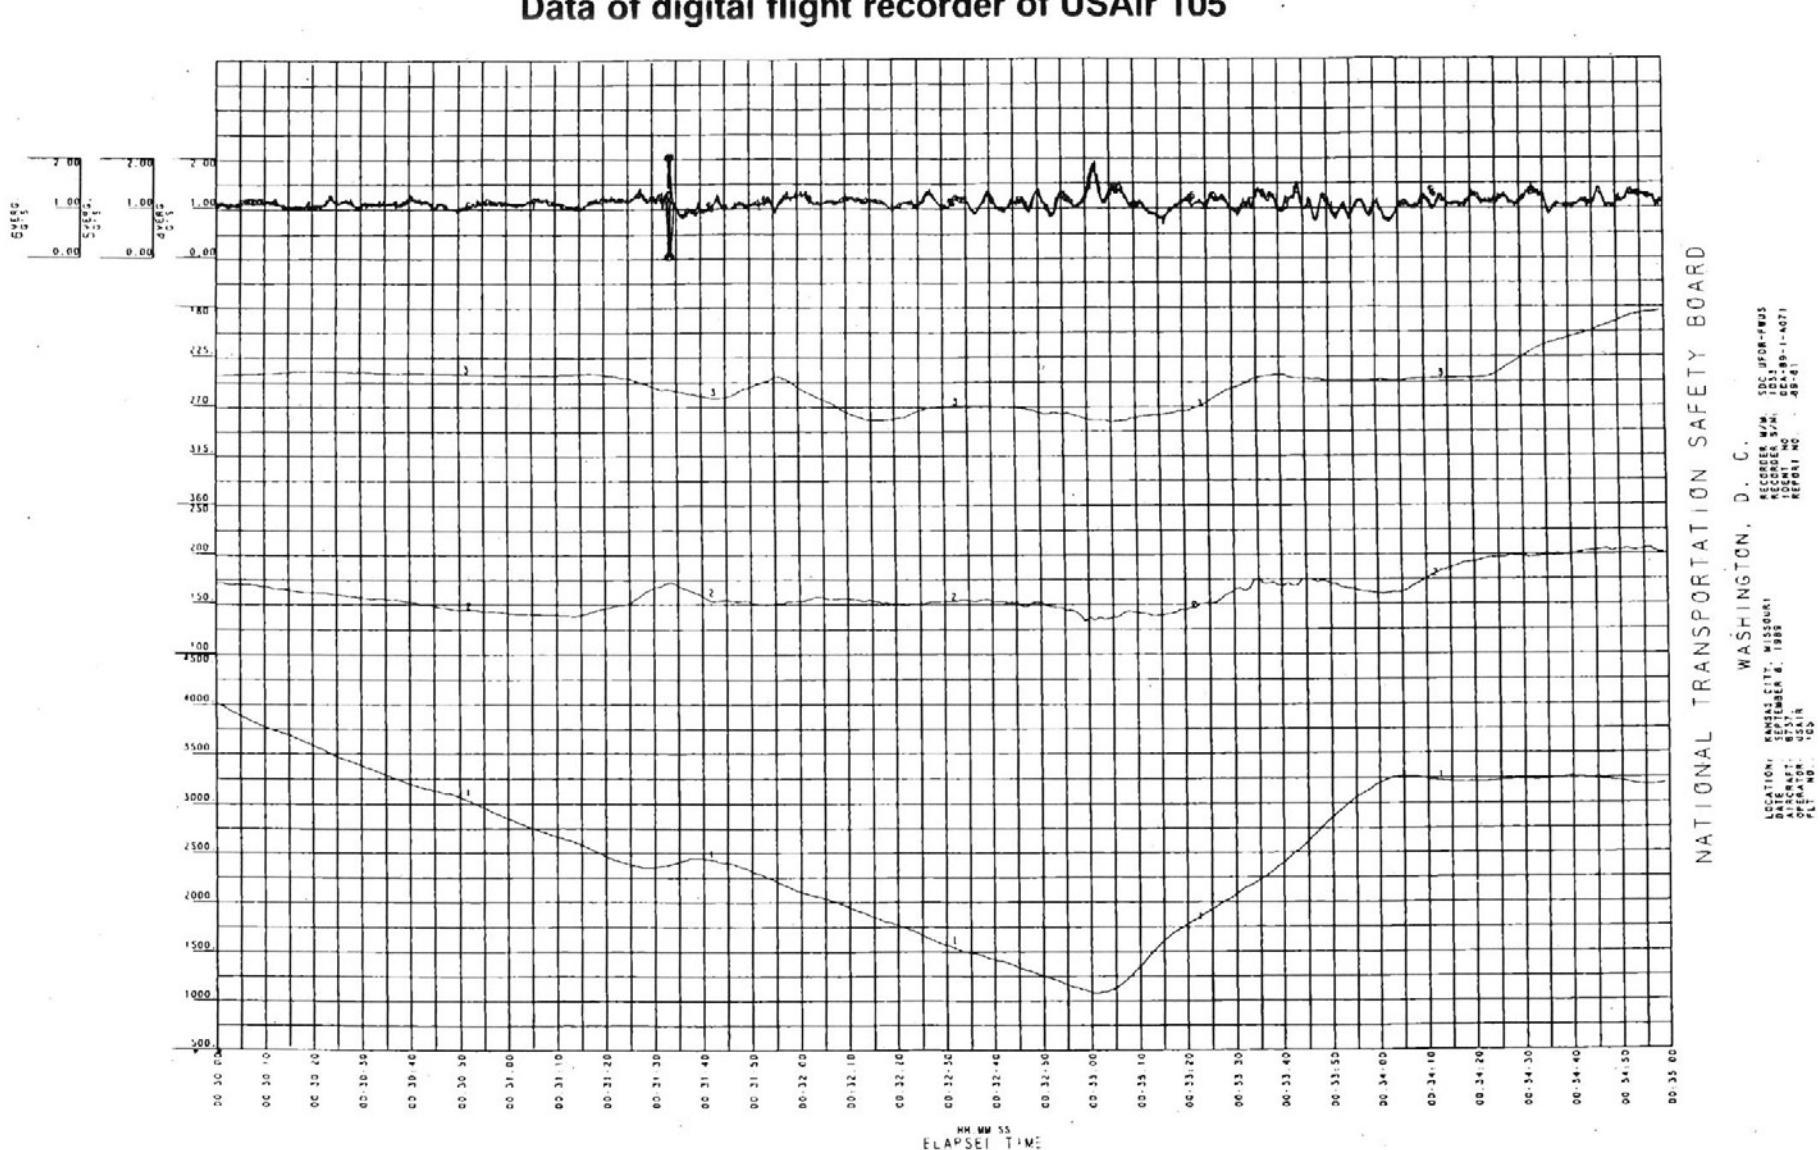
Appendix F Data of digital flight recorder of USAir 105

As the airplane descended through 2,500 feet msl, the airspeed increased by about 30 knots, from about 140 knots to about 170 knots, and the airplane leveled off. These changes may have been associated with passage through the leading edge of a gust front. About 20 seconds later, the descent was resumed. Thereafter, the airspeed remained stabilized about 150 knots and the descent remained fairly constant through MDA until the wire strike. A slight decrease in airspeed beginning about 10 seconds before the wire strike was most likely caused by thrust and configuration changes. Consequently, the Safety Board found no evidence that the airplane was affected by windshear at the time of the incident. Therefore, the Safety Board concludes that, despite the fact that the flightcrew should not have initiated the approach because of the prevailing visibility, weather factors did not affect the ability of the flightcrew to avoid the wires that USAir 105 struck.
