In-Flight Fire Leading to Collision with Water, Swissair Transport Limited, McDonnell Douglas MD-11 HB-IWF Peggy's Cove, Nova Scotia 5 nm SW, 2 September 1998

In-Flight Fire Leading to Collision with Water

Swissair Transport Limited
McDonnell Douglas MD-11 HB-IWF
Peggy's Cove, Nova Scotia 5 nm SW
2 September 1998

Report Number A98H0003

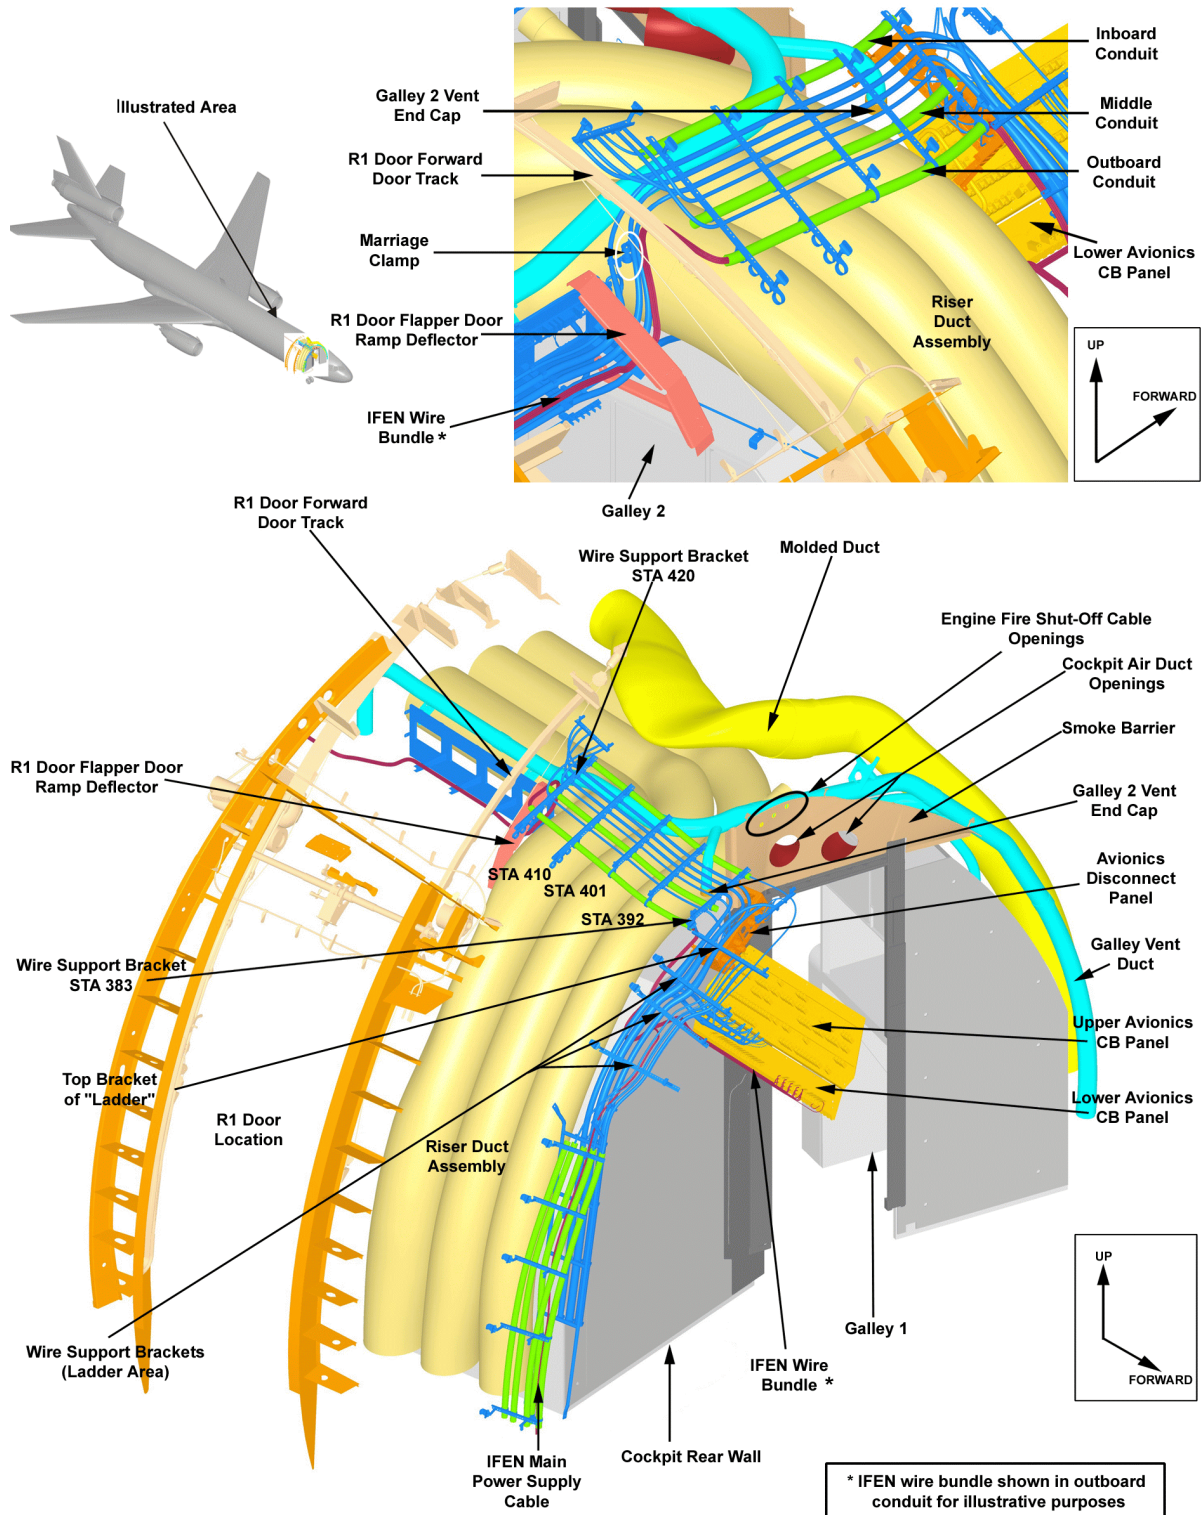
Figure 3: Cockpit attic and forward cabin drop-ceiling areas

Examination of other Swissair MD-11 aircraft in the Swissair fleet disclosed that openings existed in the smoke barriers, and in areas adjacent to the barrier. Some of these openings were located at conduit and wire run locations that pass through or above the cockpit rear wall. The top edge of the rear, right cockpit wall near STA 383 has a cut-out in it to permit the passage of wire bundles and conduits. (See Figures 4 and 5.)

Three 102-centimetre (cm) (40-inch) long conduits¹⁴ and five wire bundles pass over the cockpit rear wall at this point, and continue aft over the top of Galley 2 between STA 383 and STA 420. (See Figures 3, 4, 5, and 7.) The ends of the conduits were not required to be sealed and were found unsealed in other MD-11 aircraft that were examined. These conduits and wire bundles are attached by straps to a series of wire support brackets located at STA 383, 392, 401, 410, and 420. The wire bracket positioned at STA 383 is at a slight angle relative to the cockpit wall, which is directly below it. The top edge of this bracket, and attached wire bundles, are in contact with the metallized polyethylene terephthalate (MPET)-covered insulation blanket. Each of the conduits protrude forward of the cockpit wall by varying amounts because of the angle of the wall to the bracket.

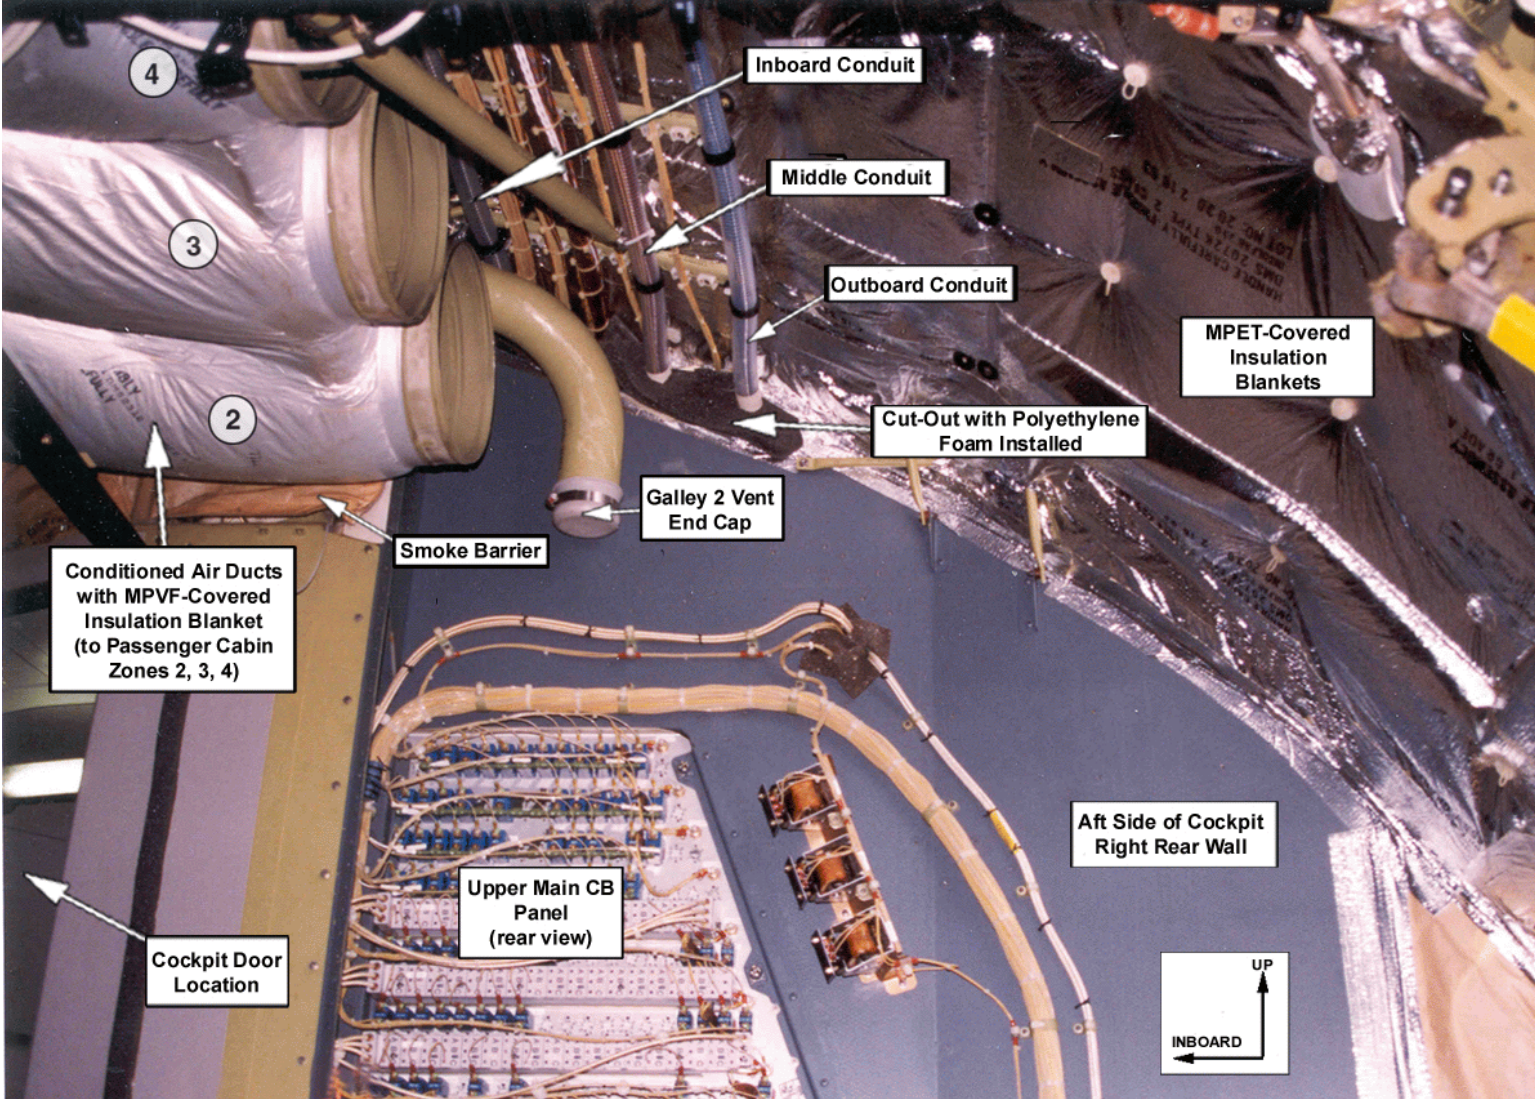
Figure 4: Area behind cockpit rear wall (Galley 2 and riser duct assembly removed)

In the Swissair MD-11s, the forward end of the muff assembly comes into close proximity to the lower right edge of the smoke barrier, and to the vent duct assembly for Galley 2. The galley vent duct, which is designed to exhaust odours and hot air from the galley when in operation, was not connected to the top of Galley 2, as Galley 2 was not electrically powered and not in service. A silicone elastomeric end cap was placed over the vent duct to close it off. The cap was located between the aft side of the cockpit rear wall and the forward side of one of the three riser ducts (see Figures 4 and 6).

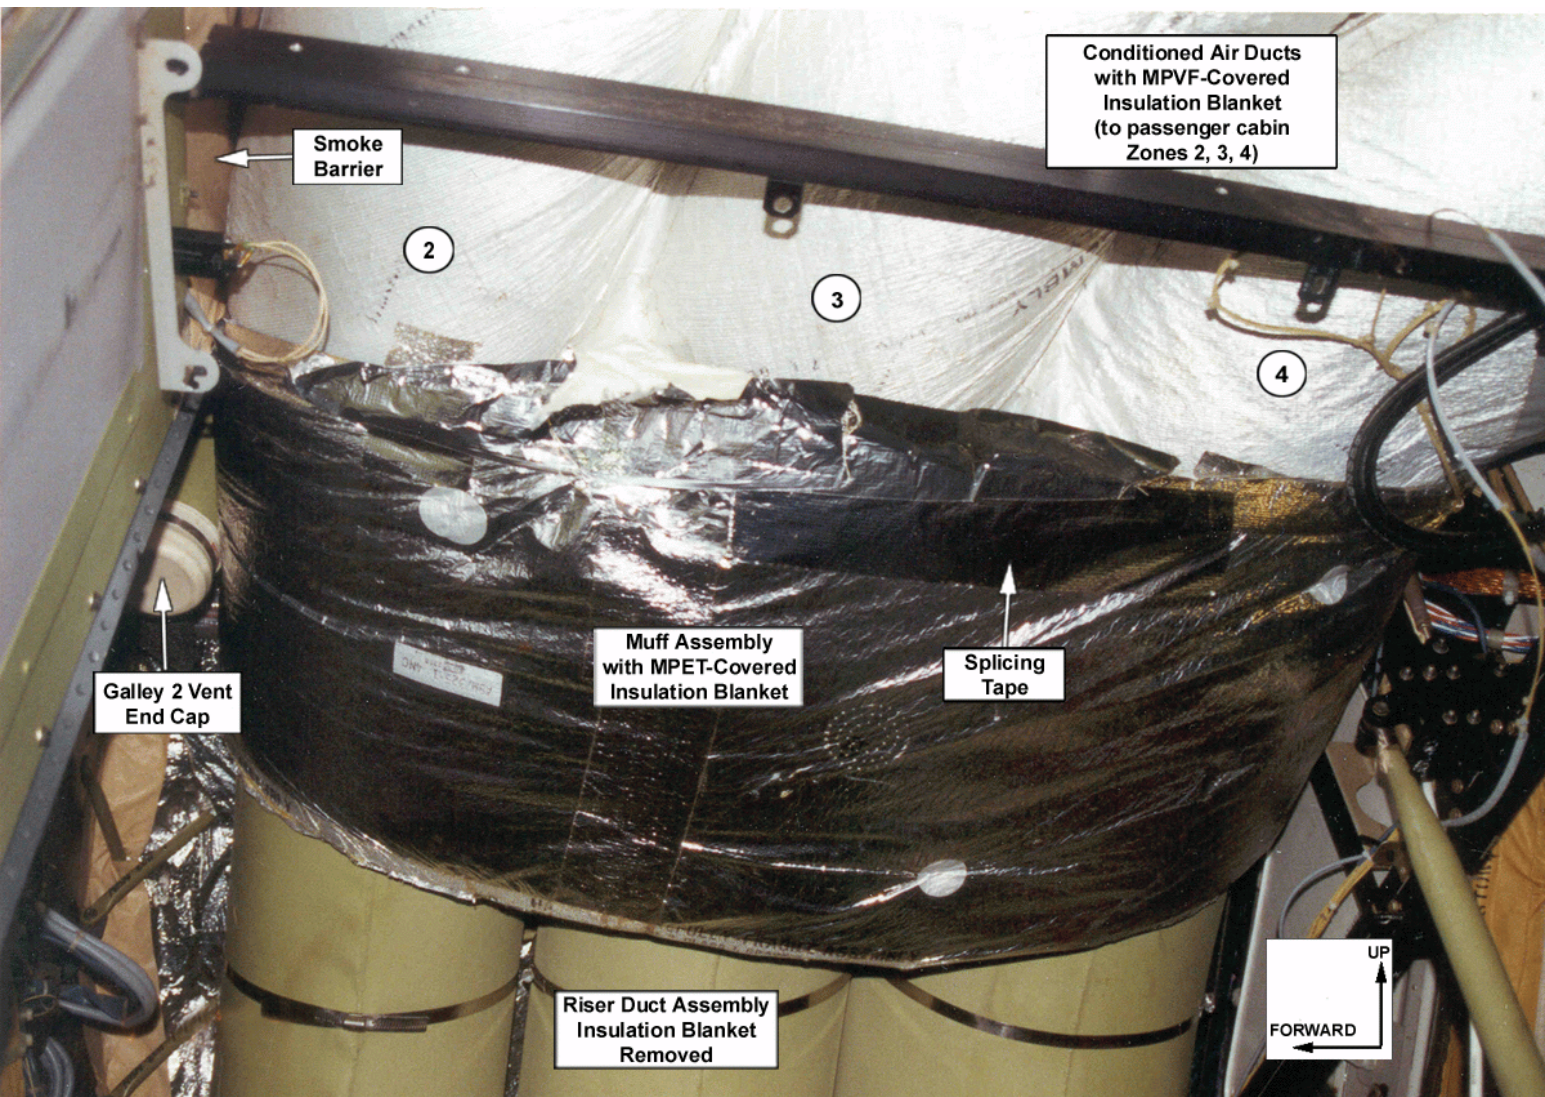
Figure 6: Muff assembly with MPET-covered insulation blanket

Just aft of the right side of the cockpit rear wall, above Galley 2, a sound-suppression muff assembly (muff assembly) was installed around a splice junction of the conditioned air riser duct assembly (see Figure 6). The muff assembly uses an MPET-covered insulation blanket secured at both ends by hook-and-loop fasteners.

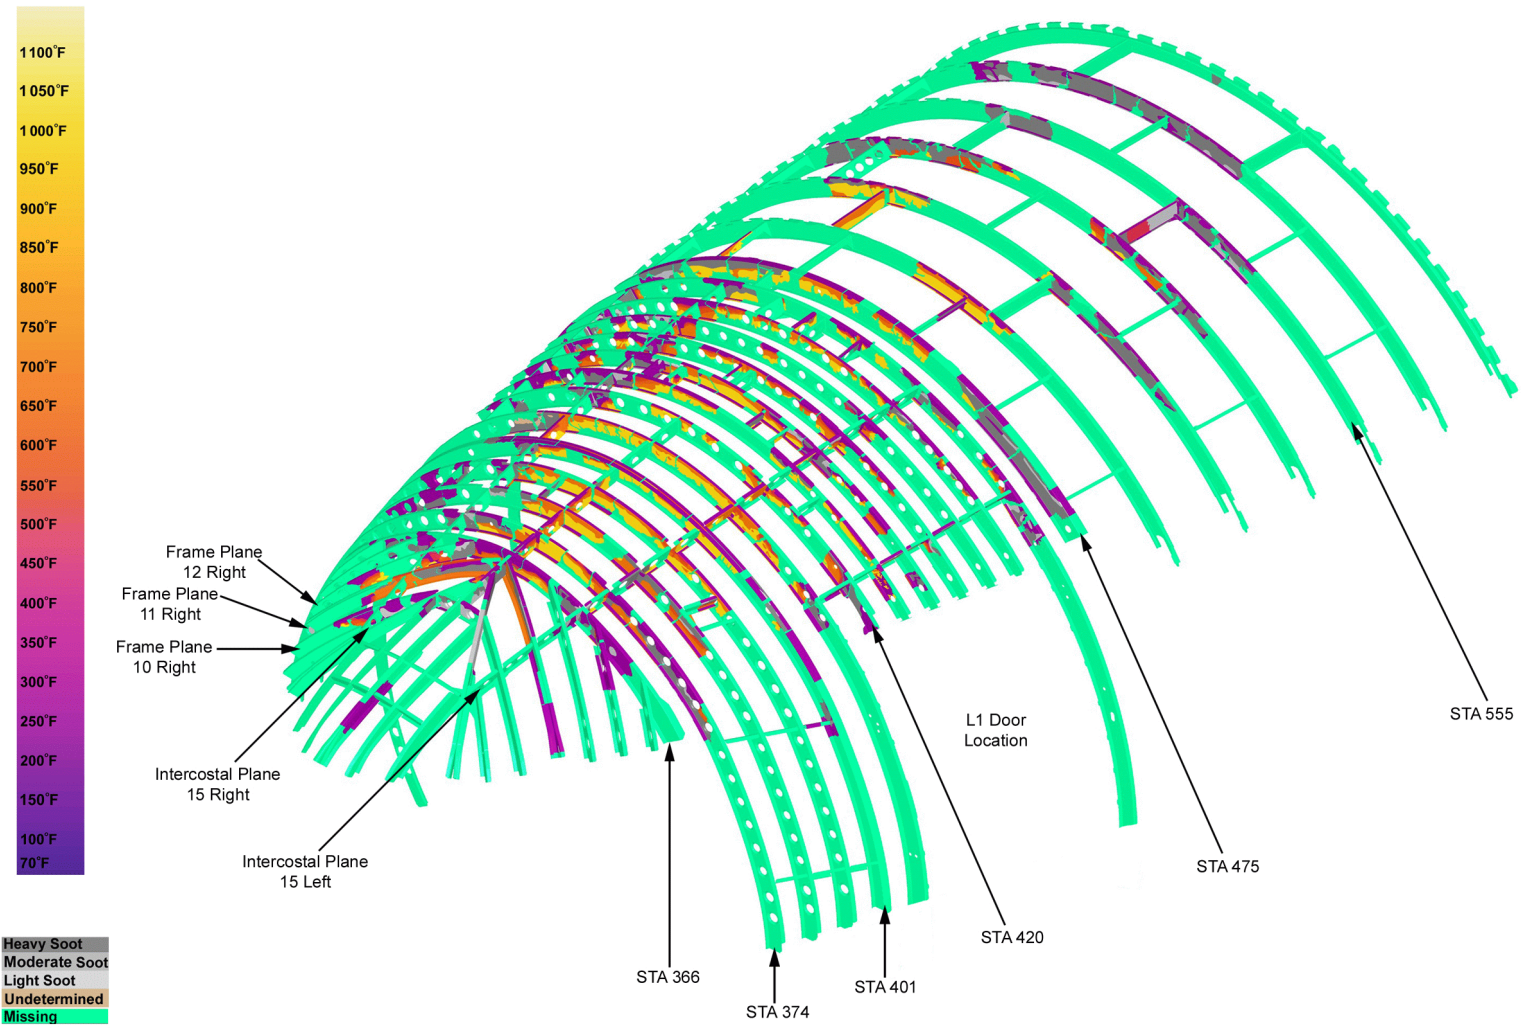
Figure 24: Airframe structure and air distribution system

Between approximately STA 480 and STA 545, the main conditioned air ducts for zones 2, 3, and 4 transitioned from running near the top of the forward cabin drop-ceiling, upward to run near the crown of the aircraft. In this area there was bare-metal heat damage at places along the top of the ducts. The primer on the underside of these ducts was not damaged by heat. The recovered portions of two individual air ducts from approximately STA 555 to STA 595 at $X = 70$ and $X = -70$ had areas of light to moderate soot accumulation.

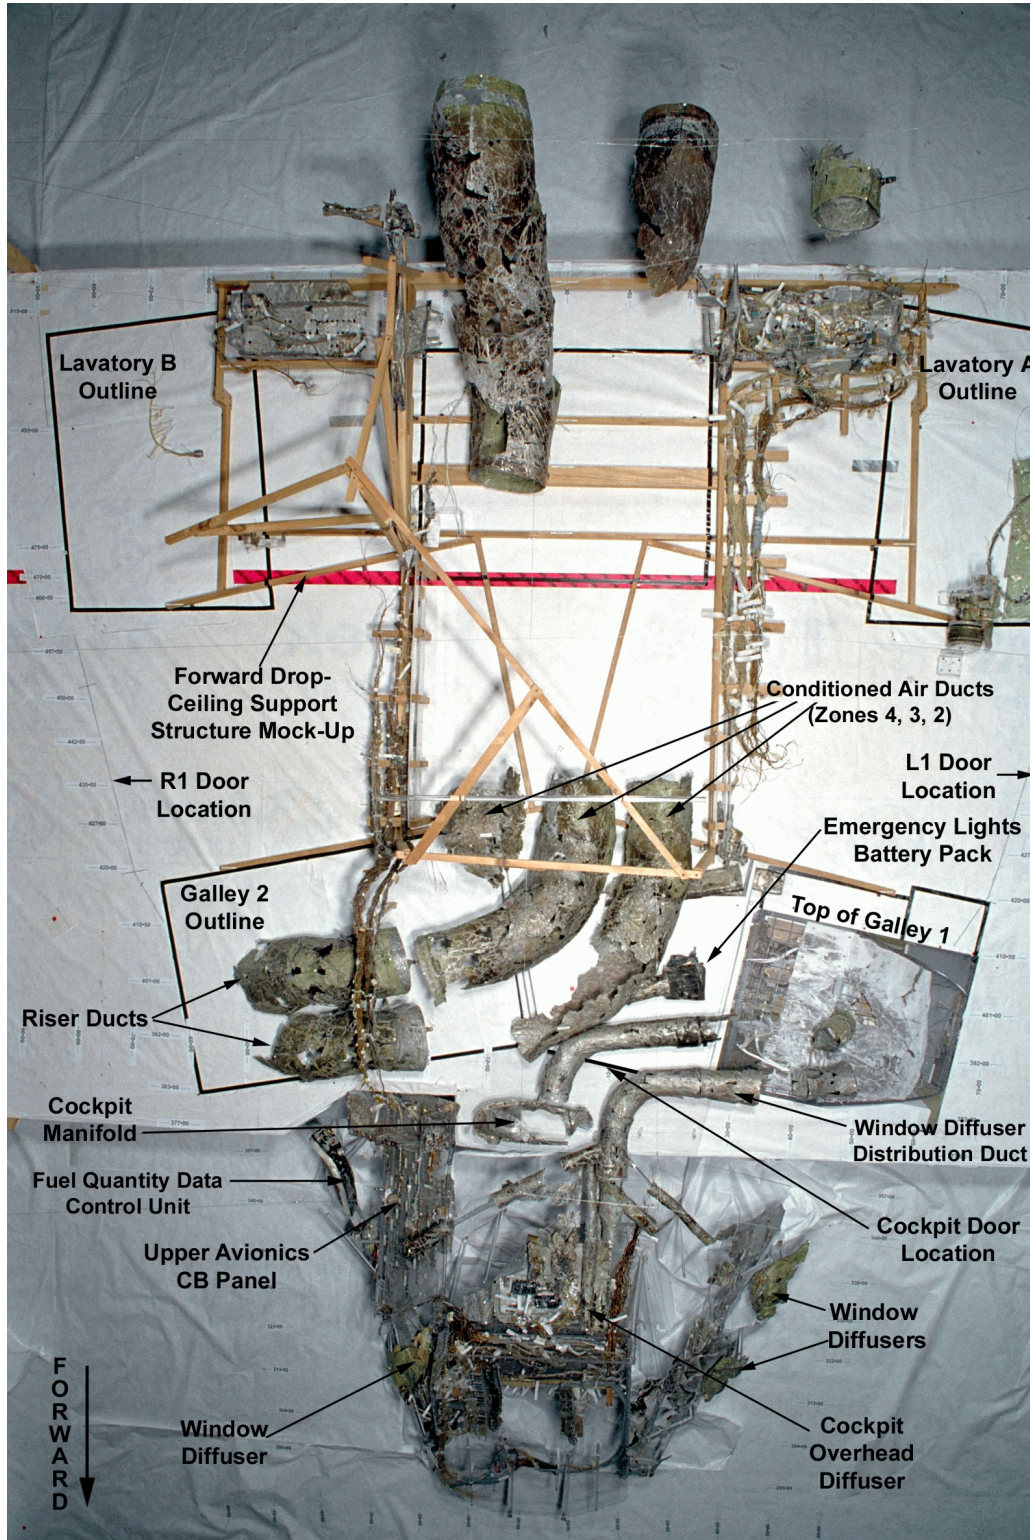
Figure 27: Cockpit attic and forward cabin drop-ceiling areas mock-up

About 75 per cent of the upper and lower CB panels were identified, reconstructed, and placed in the reconstruction mock-up (see Figures 27 and 28). The most forward sections of the upper and lower CB panels were not recovered. The upper avionics CB panel had been exposed to heat coming from both the front and back sides. The lower CB panel did not show any heat damage. The heat damage pattern on the front face of the upper CB panel was shown by the change in colour of the paint. Parts of the panel displayed damage consistent with temperature reference exemplar coupons exposed to temperatures from 430°C to 620°C (800°F to 1 150°F) for 10 minutes.⁶⁷ Discolouration and heat damage was present on the back side of this panel on some electrical components and on some bare-metal surfaces. Although there were similarities at some locations, the damage pattern on the back side was less than on the front

side, particularly on those pieces near the forward end of the panel where the front side of the panel showed considerably more heat damage than the back side. Individual CBs showed soot on the white indicator ring; soot could only have been deposited if the CB had tripped and subsequently been exposed to combustion by-products. Details concerning the CBs on the avionics CB panel and wiring in the vicinity are included in separate sections of this report.

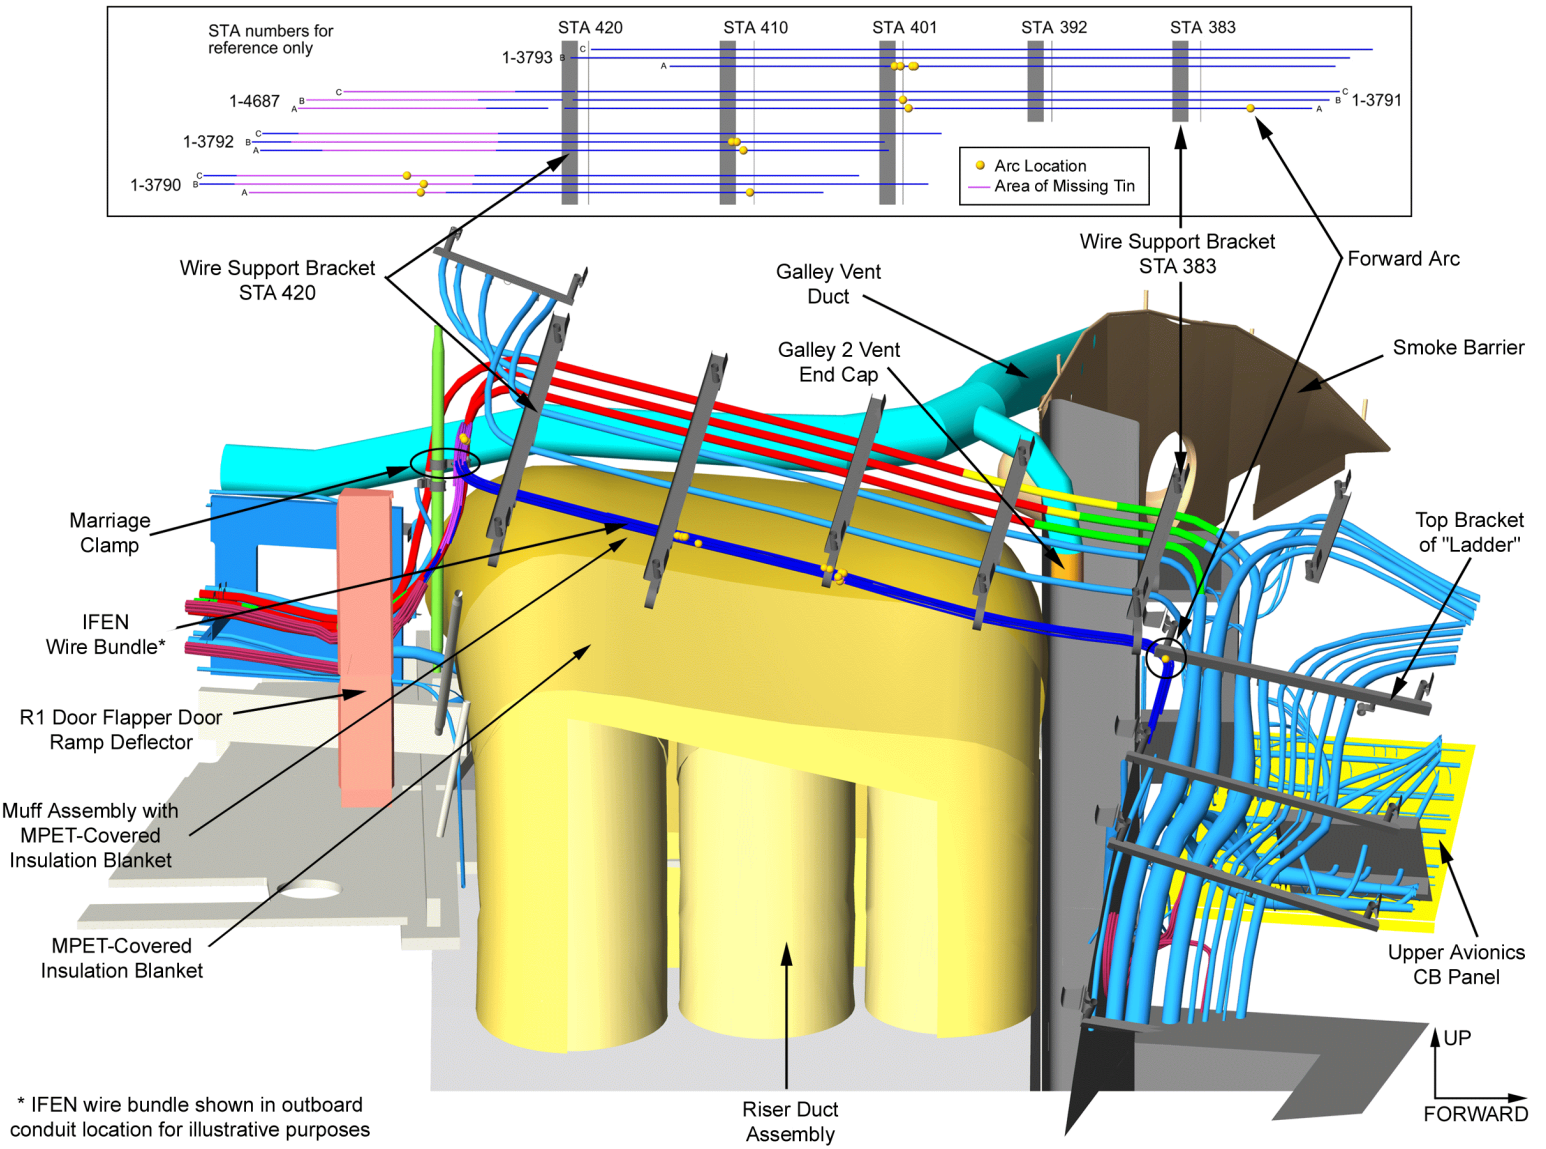
Figure 30: Position of recovered IFEN wires – outboard conduit

Aligning the cables in the outboard conduit using the same criteria as above for placing the region of missing tin placed the single arc on 1-3790 near STA 410 and the remaining (aft) melted copper locations on all three wires from Exhibit 1-3790 approximately 25 cm (10 inches) along the wires aft of STA 420. This placed the copper melts on two of the wires from Exhibit 1-3791 adjacent to the copper melts on the single wire of Exhibit 1-3793 near STA 401. This also located the single copper melt on the forward end of Exhibit 1-3791 approximately 8 cm (3 inches) along the wire forward of the bracket at STA 383. This configuration is shown in Figure 30.

As indicated above, based on the layout of the cables and wires, it is possible to assess the direction of fire propagation based on the sequence of the arcing events. The aft arcs on exhibits 1-3790 and 1-3791 would most likely have tripped their associated CBs; therefore, the forward arcs must have occurred first, and not tripped their associated CBs. This strongly suggests that the fire was moving forward to aft.

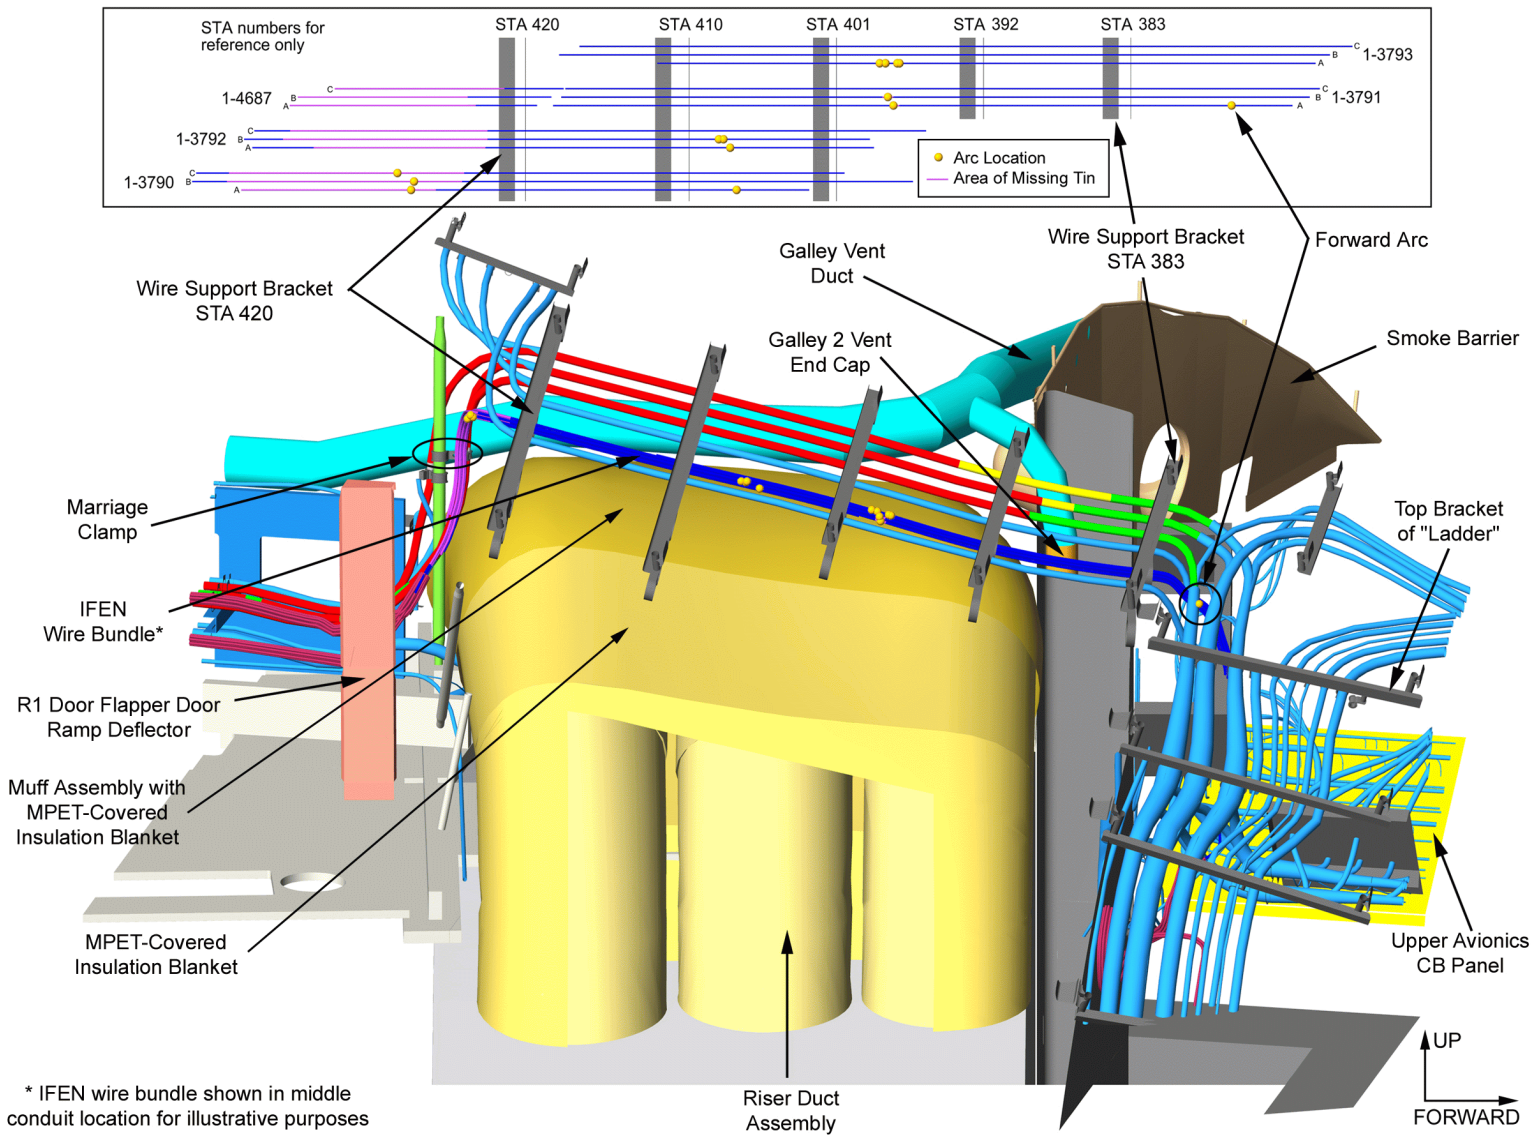
Figure 31: Position of recovered IFEN wires – middle conduit

Aligning the cables in the middle conduit, the single (forward) melted copper on Exhibit 1-3790 was located near STA 407 inside the conduit, and the remaining (aft) melted copper locations on all three wires from Exhibit 1-3790 were about 7.5 cm (3 inches) outside the aft end of the conduit. In this configuration, the remaining areas of melted copper on Exhibit 1-3792 were in the conduit between STA 407 and STA 408. In this alignment, it placed the forward end of the 1-3791/1-3793 cables approximately 25 cm (10 inches) along the wire path past the bracket at STA 383. This placed the copper melts on two of the wires from Exhibit 1-3791 adjacent to the copper melts on the single wire of Exhibit 1-3793 near STA 398. This also located the single copper melt on the forward end of Exhibit 1-3791 approximately 15 cm (6 inches) along the wire path outside of the forward end of the conduit. This configuration is shown in Figure 31.

The region of missing tin represented an area of higher heat. If this had been an earlier event, it is strongly suspected that all three cables would exhibit similar arcing events in the vicinity of 1-3790 outside the aft end of the conduit. With the cables and control wire laid out as described above, all of the regions of melted copper could be attributed to arcing events between phases on the same cable, between the cables and the control wire except for the arc event that took place at the forward end of 1-3791, or both. There was no matching arc damage on cable 1-3793 in this area. However, the continuation of exhibits 1-3790/1-3792 from approximately STA 401, along with the 16 AWG control wire forward, were not identified. Therefore, no determination could be made with respect to exactly what the single wire from 1-3791 had come in contact with at the forward end.
