## Oily fumes on approach producing sickness, BAe 146-200, G-JEAK

# **BAe 146-200, G-JEAK**

| <b>Aircraft Accident Report No: 1/2004 (EW/C2000/11/4)</b> ..... | <b>2</b> |

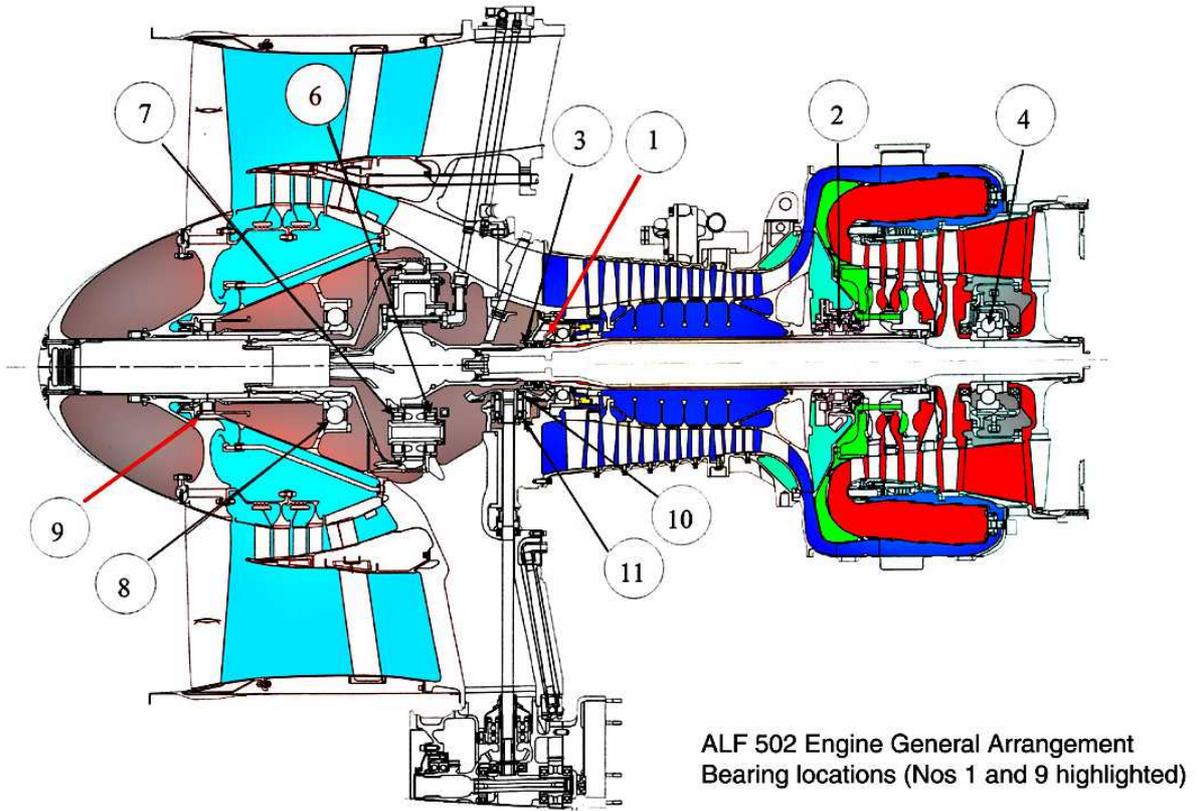
**Figure 1: Cross Section of the Honey well ALF 502 Engine, showing Gas Flow and Bearing Locations**

The engine design does not use labyrinth seal technology to contain oil and control internal airflow. Currently, hydopad seal technology is being introduced but, at the time of the incident, the seals were of an earlier design of carbon face seal that were lubricated and cooled by the oil within the various bearing compartments. Any oil escaping from such a seal, particularly at the No 1 bearing position, is likely to find its way into the main engine gas stream, Figure 2.
