Engine failure on takeoff, Boeing 747-436, G-BNLG

Investigative Body: Aircraft Accident Investigation Board (AAIB), United Kingdom

INCIDENT

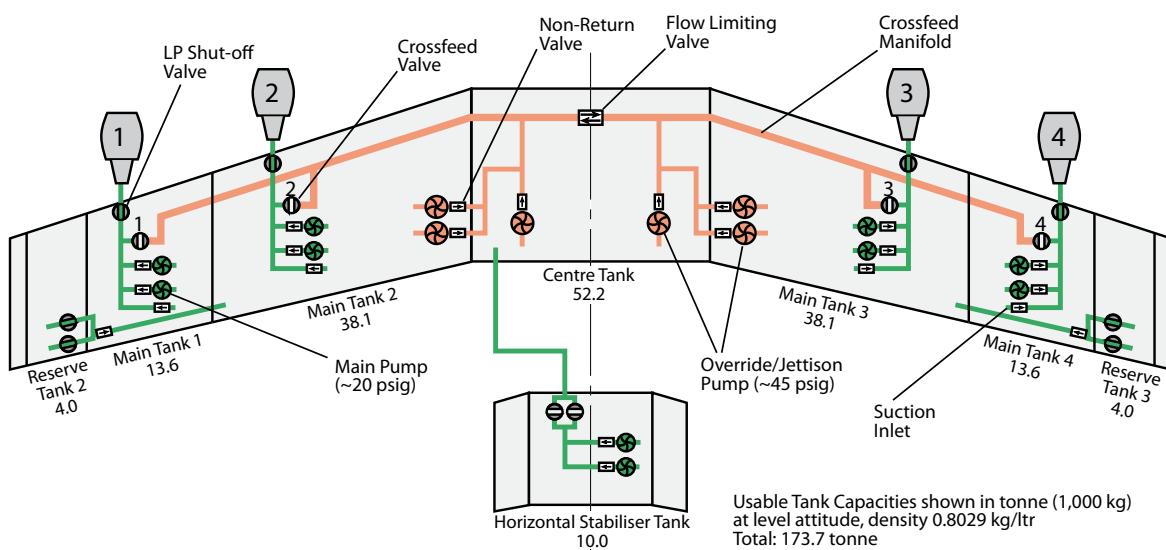
Figure 2
B747-400 Engine Fuel Feed System Schematic

The B747-400 has two main fuel tanks and a reserve tank in each wing, plus a wing centre section tank (referred to as the ‘centre wing tank’) and a horizontal stabiliser tank (Figure 2). Fuel volumes and density are sensed by a fuel quantity indication system (FQIS) using capacitance probes in the tanks. Indications of the fuel quantities, in tonnes in individual tanks and for the whole aircraft, are displayed on a fuel system synoptic diagram on a crew-selectable page of the EICAS. The total fuel on board is always displayed on the EICAS. The tanks are also fitted with a magnetic dip-stick system to allow ground calibration of fuel quantities.

Fuel can be fed from each main tank via two main pumps, operating in parallel, or from a suction inlet in the tank. This feed can be directed to the respective engine, via a low pressure shut-off valve, and/or into a crossfeed manifold, via a crossfeed valve. In addition, each inboard main tank (Nos 2 & 3), with almost three times the capacity of each outboard main tank (Nos 1 & 4), has two override/jettison pumps, feeding into the crossfeed manifold. In order to prevent excessive fuel depletion in a jettison situation these pumps are arranged with standpipe inlets which uncover when the fuel quantity in a tank reduces to around 3.2 tonnes, causing pumping to cease. The centre tank also has two override/jettison pumps, feeding into the crossfeed manifold. The crossfeed manifold incorporates a flow-limiting valve intended to prevent unwanted crossfeed between the left and right sides of the aircraft due to normal variation in pump output pressure.

In order to induce fuel usage from an inboard tank in preference to the adjacent outboard tank when crossfeeding, a considerably higher pump output pressure in the inboard tank is required. This overcomes the

difference in static head between the tanks occasioned by the wing dihedral. A higher pressure is also required for such crossfeeding, because of the longer flow path and the consequent higher pipeline pressure loss when doing so. Pump outlet pressure at typical flow rates is approximately 20 psig for the main pumps and 45 psig for the override/jettison pumps. Thus the override/jettison pumps will automatically deliver the fuel feed in a situation where main pumps and override/jettison pumps are outputting to a common point.

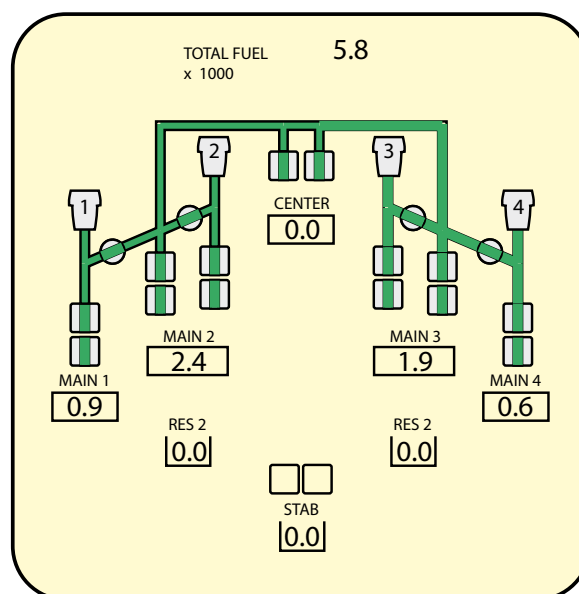
Green line indicates predicted flow.

Fuel quantities shown are approximately those present at G-BNLG's landing.
