Tailstrike on takeoff, Boeing 757-204, G-BYAO

Micro-summary: Following a high rate of rotation, this Boeing 757-204 experienced a tailstrike and diversion.

Investigative Body: Aircraft Accident Investigation Board (AAIB), United Kingdom

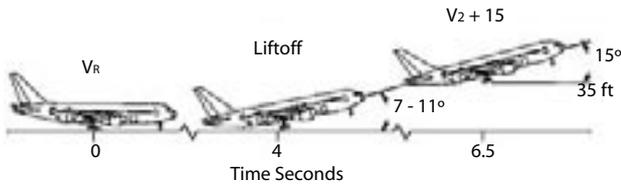
Typical Rotation, All Engines

The following figure shows typical rotation with all engines operating.

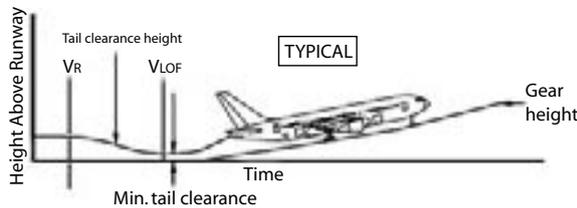
.....Typical Takeoff Tail Clearance

The following diagram and table show the effect of flap position on liftoff pitch attitude and aft fuselage clearance during takeoff. Additionally, the last column shows the pitch attitude for aft fuselage contact with wheels on runway and landing gear struts extended....

Model	Flap	Liftoff Attitude	Minimum Tail Clearance inches (cm)	Tail Strike Pitch Attitude degrees)
757-200	1	10.3	30 (76)	12.3
	5	10.0	33 (84)	
	15	9.5	38 (97)	
	20	8.5	47 (119)	
757-300	5, 15, 20	7.5	26 (66)	9.5
