# Uncontained Engine Failure, Aircraft Incident Report, Japan Airlines Flight JL726, B747-300 JA8178, Tangerang, West Java, Indonesia, 5 September 2000

**AIRCRAFT INCIDENT REPORT**

Japan Airlines Flight JL726

B747-300 JA8178

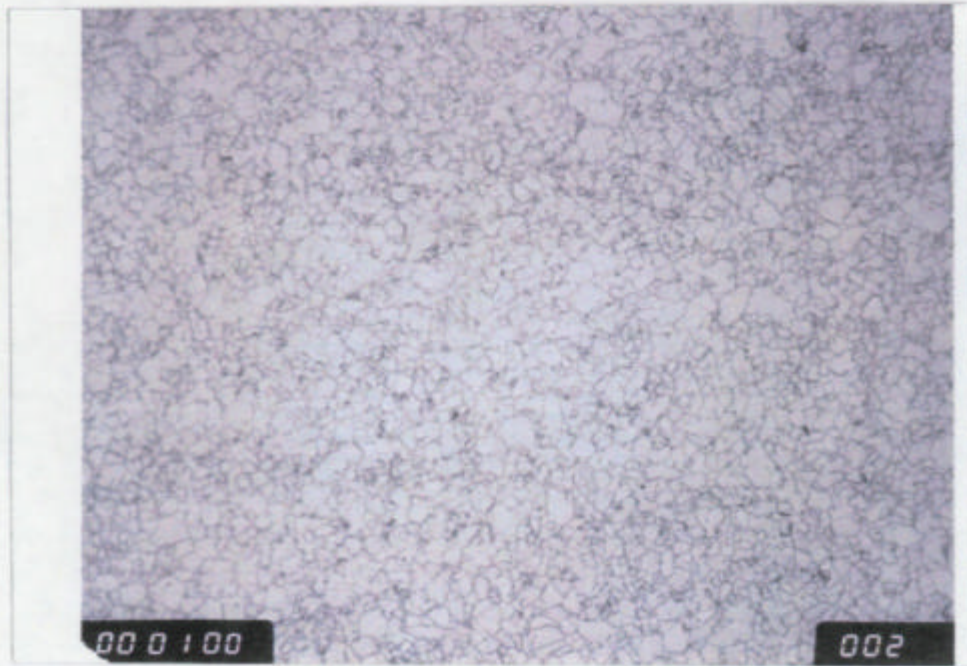
titled "Alloy Bars, Forgings, and Rings, Corrosion and Heat Resistant, (Inconel 718)", indicated that the grain size should be "6 or finer, with occasional grains as large as 5 permissible." Examination of section "Y-Y" in figure 1 revealed that the grain size in the web portion at the fracture origin area was predominantly 5 with several grains that were 4. This grain size is larger than permissible. All areas within the bore, the inboard portion of the web, and the inboard portion of the rim contained equiaxed grains whose size was within the specified range. The outboard portion of the web contained equiaxed grains that were larger than permissible. The mid and outboard portion of the blade retention post contained equiaxed grains; however, these areas also contained several elongated grains that were larger than permissible. The result of the grain size evaluation is summarized in Table 1. Figures 13 through 20 contain typical photomicrographs at various areas of the disk.

Figure 13. Photomicrograph of section "Y-Y" (see figure 1 for location) at the inboard portion of the bore showing typical grain size. Etched with Tucker's reagent. (100X)

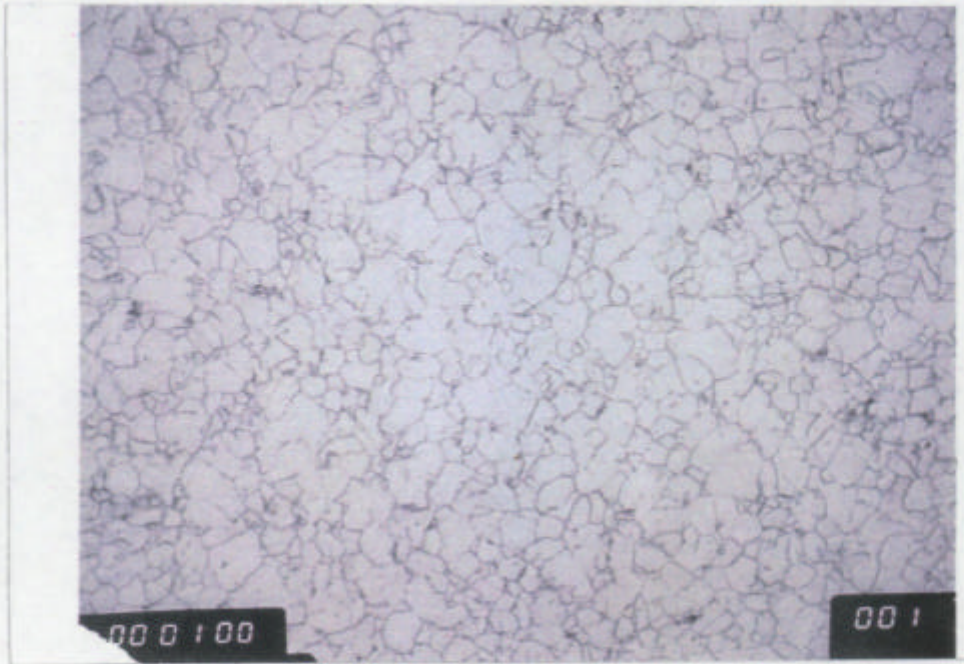
Figure 14. Photomicrograph of section "Y-Y" at the outboard portion of the bore showing typical grain size. Etched with Tucker's reagent. (100X)

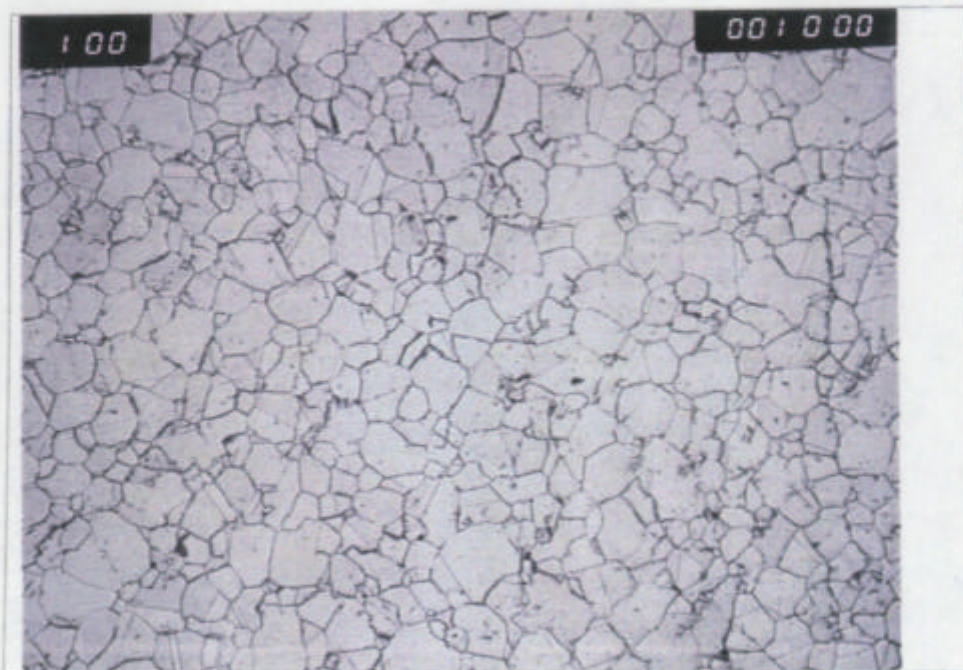
Figure 15. Photomicrograph of section "Y-Y" at the inboard portion of the web showing typical grain size. Etched with Tucker's reagent. (100X)

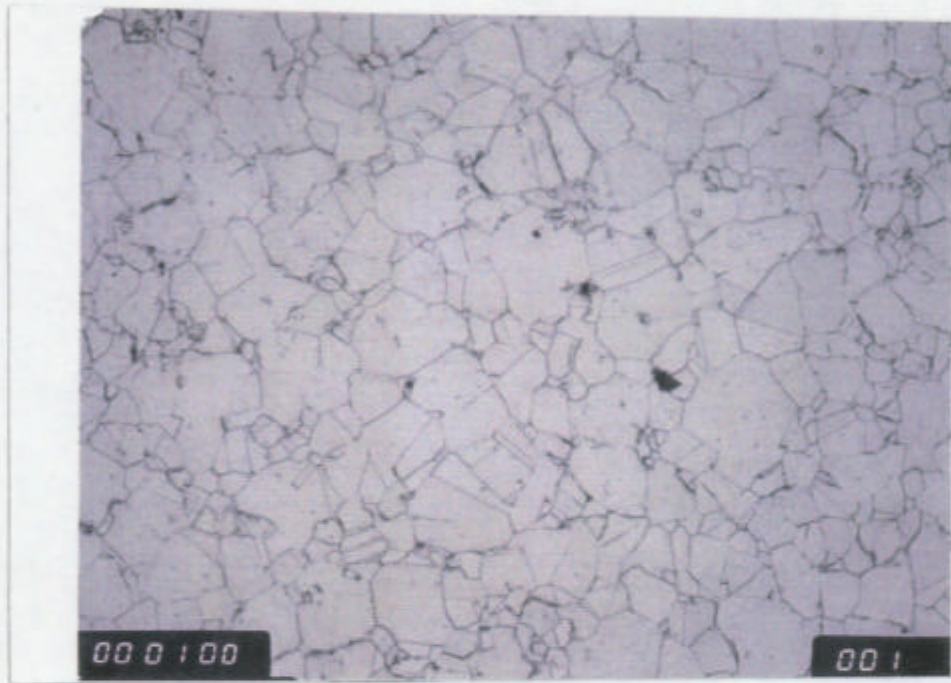
Figure 16. Section "Y-Y" at the web and in the area below the fracture origin area showing typical grain size. Etched with Tucker's reagent. (100X)

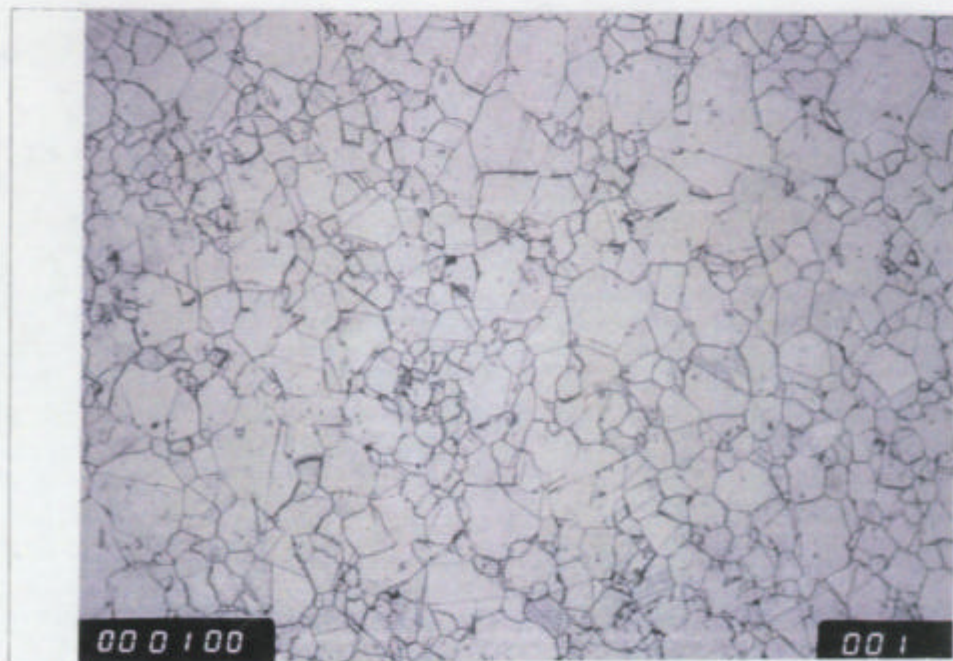
Figure 17. Section "Y-Y" at the outboard portion of the web showing typical grain size. Etched with Tucker's reagent. (100X)

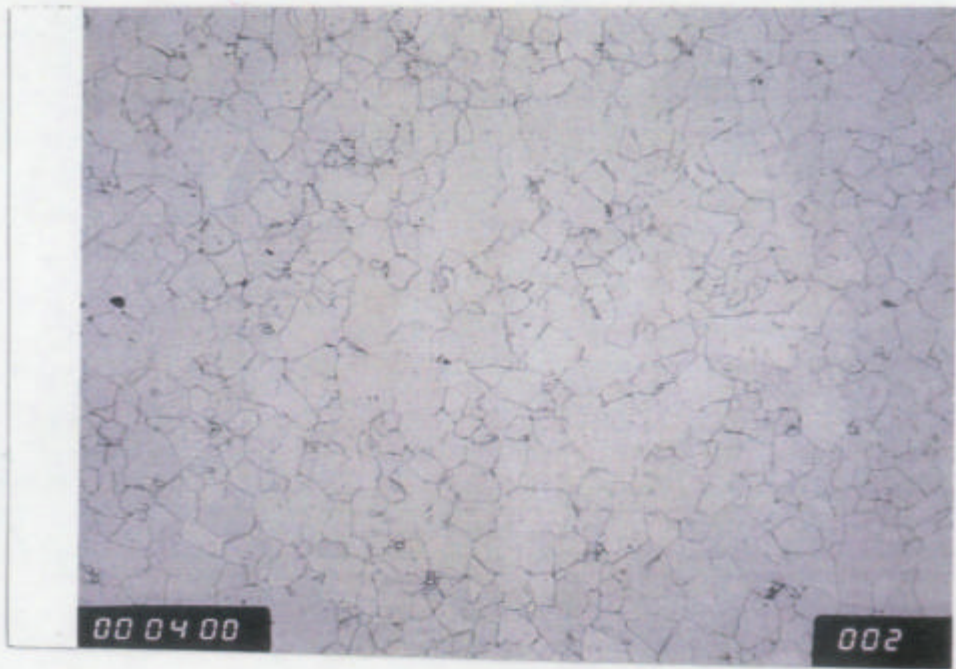
Figure 18. Section "Y-Y" at the inboard portion of the rim showing typical grain size. Etched with Tucker's reagent. (100X)

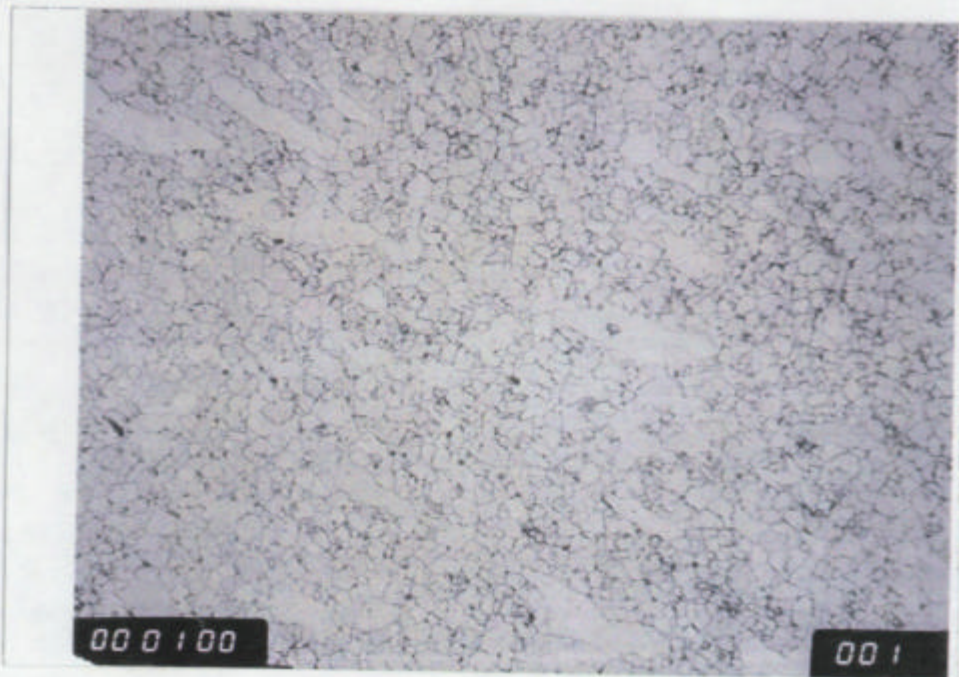
Figure 19. Section "Y-Y" at the mid portion of the rim showing typical grain size. Etched with Tucker's reagent. (100X)

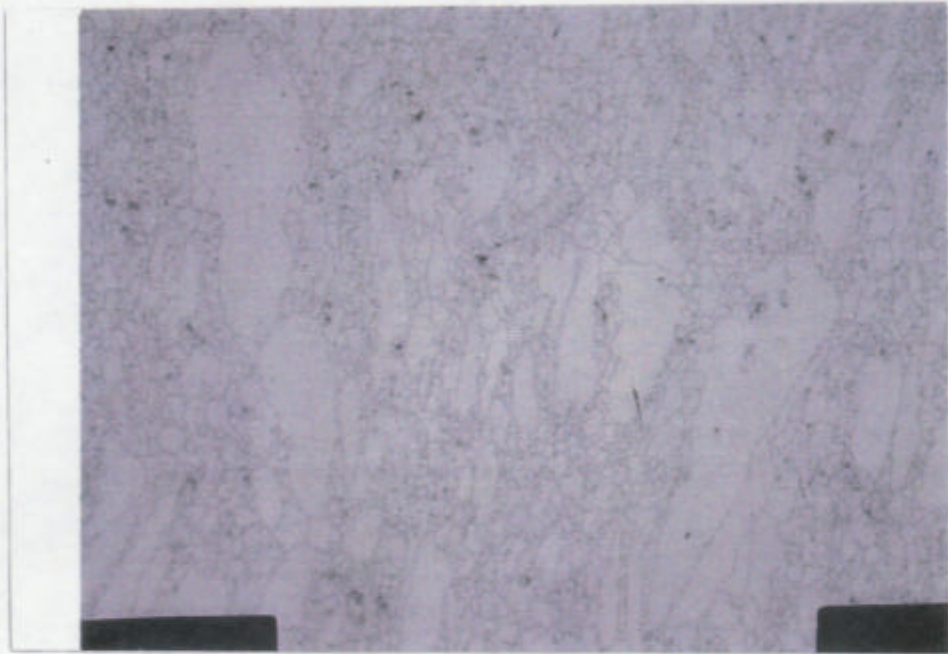
Figure 20. Section "Y-Y" at the most outboard portion of the blade retention post showing typical grain size. Etched with Tucker's reagent. (100X)

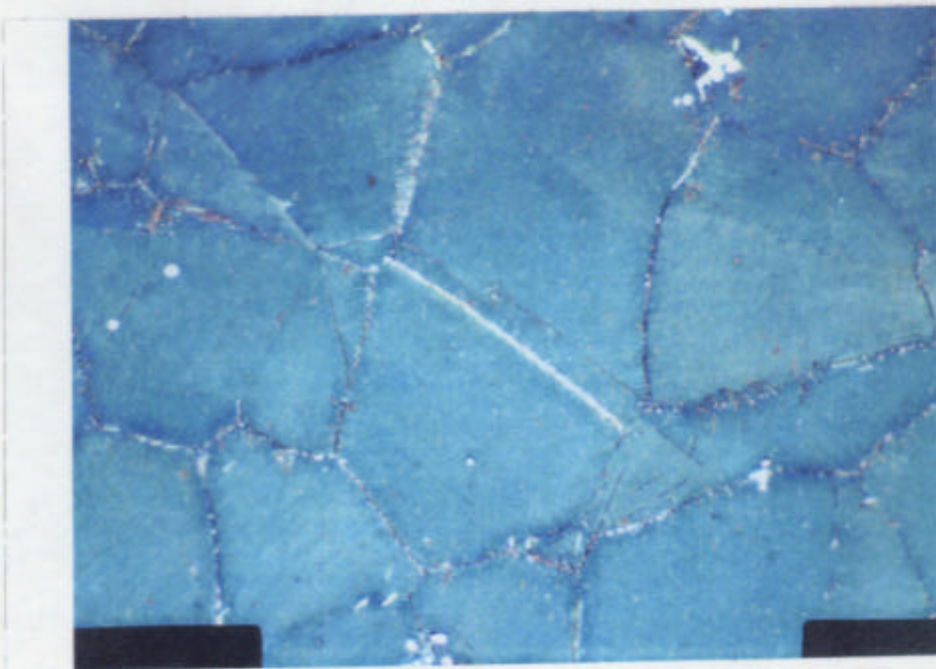
elongated particles of what appeared to be delta phase at the grain boundaries. The delta phase at the grain boundaries reportedly is used to control grain size in wrought materials. The typical microstructure of the sections is shown in figures 21 through 29.

Figure 21. Section "Y-Y" at the web in the area below the fracture origin area showing typical microstructure. Etched with Tucker's reagent and followed by electrolytic etch with a phosphoric acid reagent. (500X)

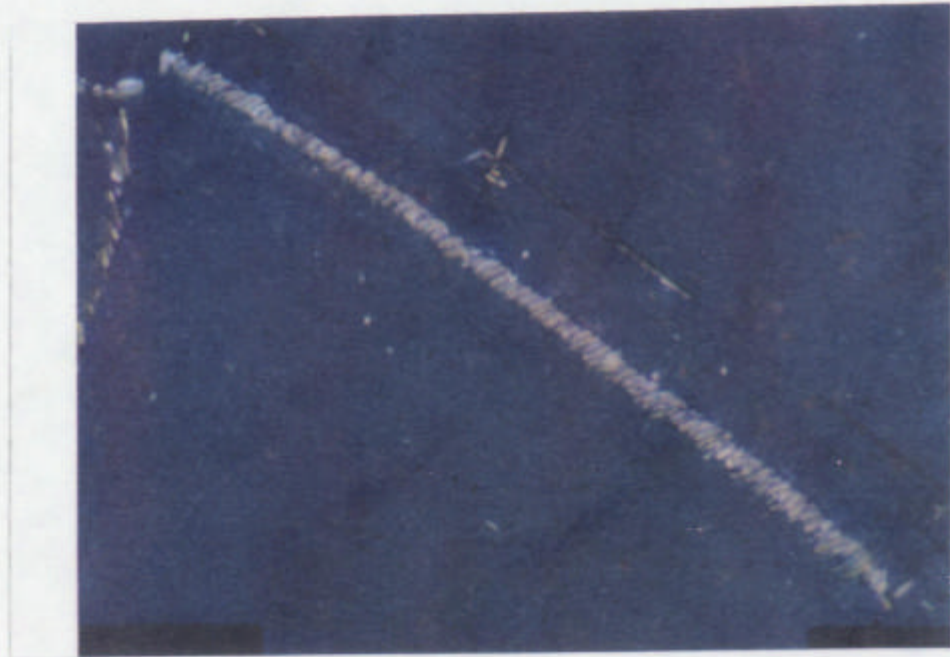
Figure 22. Higher magnification photomicrograph of the area in the center of figure 21. (1,500X)

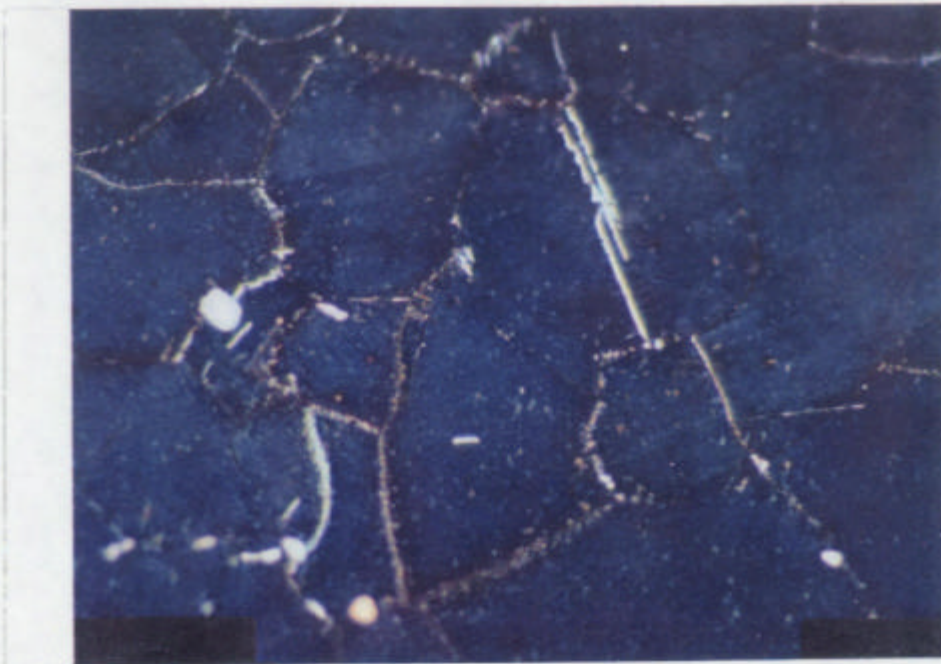
Figure 23. Section "Y-Y" at the web in the area below the fracture origin area showing typical microstructure. Etched with Tucker's reagent and followed by electrolytic etch with a phosphoric acid reagent. (500X)

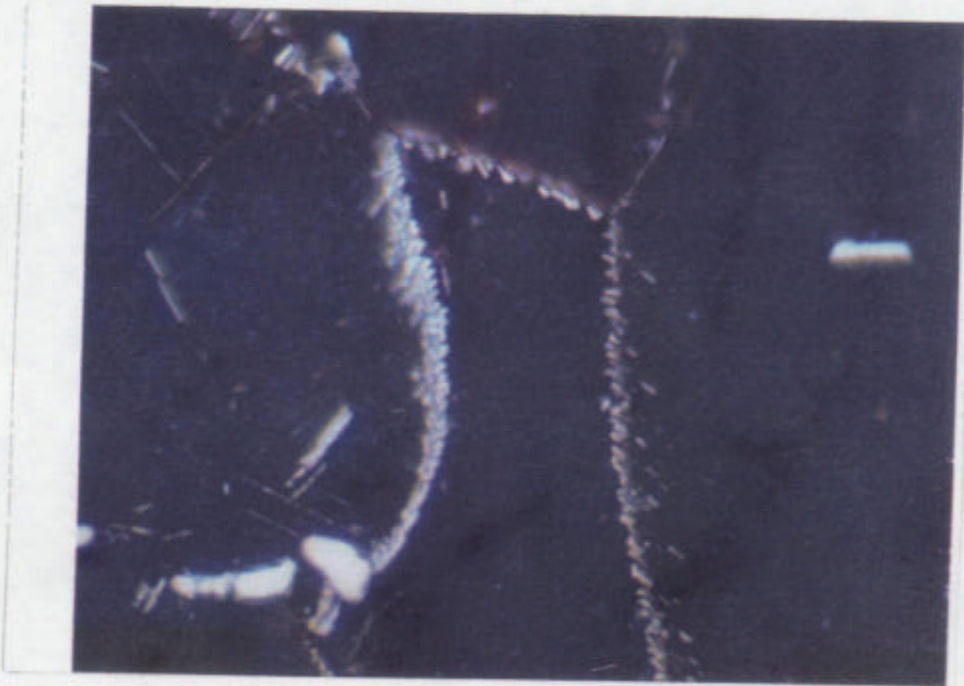
Figure 24. Higher magnification photomicrograph of an area located at the left lower corner in figure 23. (1,500X)

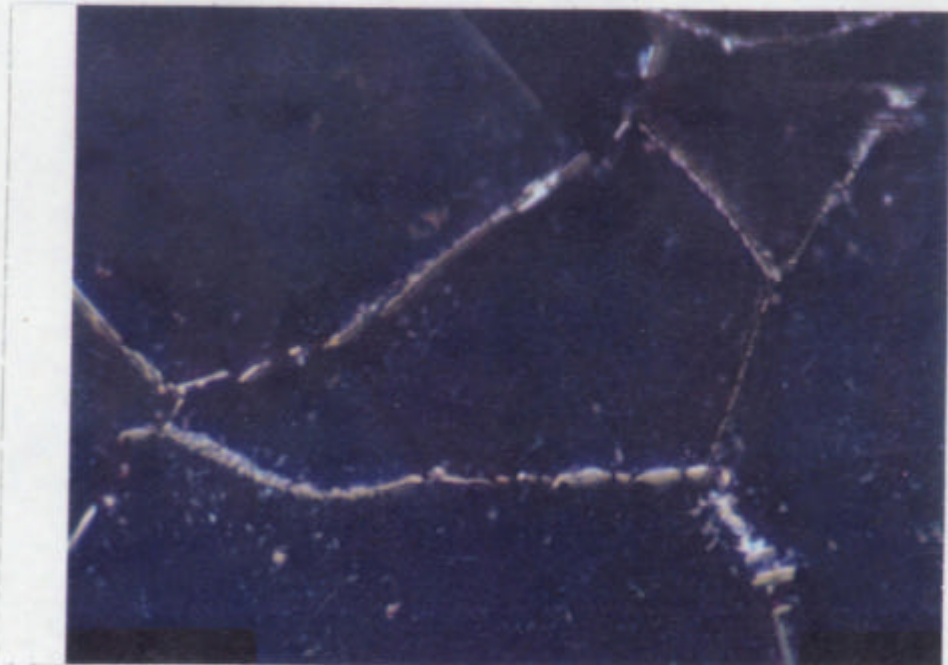
Figure 25. Higher magnification photomicrograph of an area located at the left upper corner in figure 23. (1,500X)

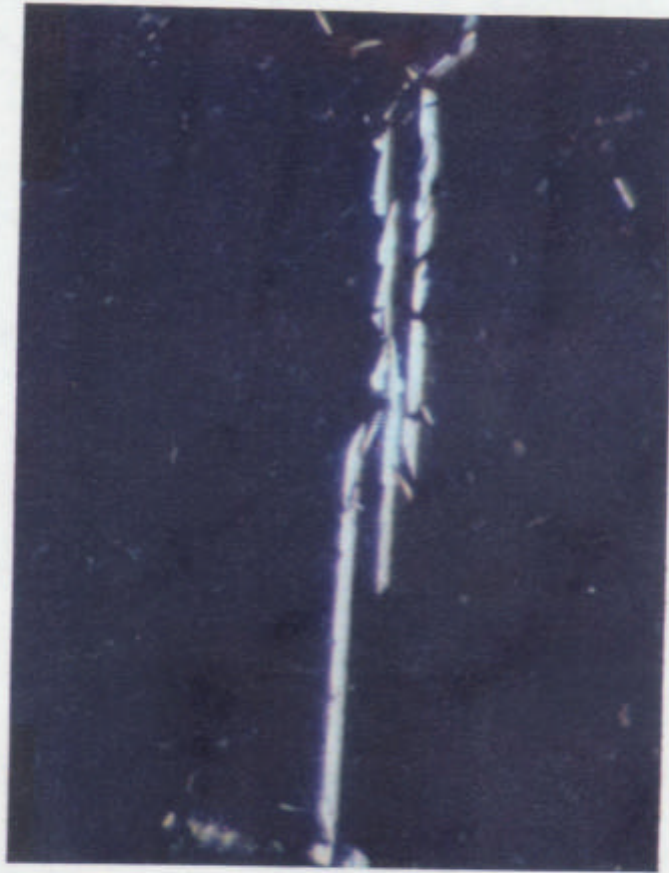
Figure 26. Higher magnification photomicrograph of an area located at the mid upper edge in figure 23. (1,500X)

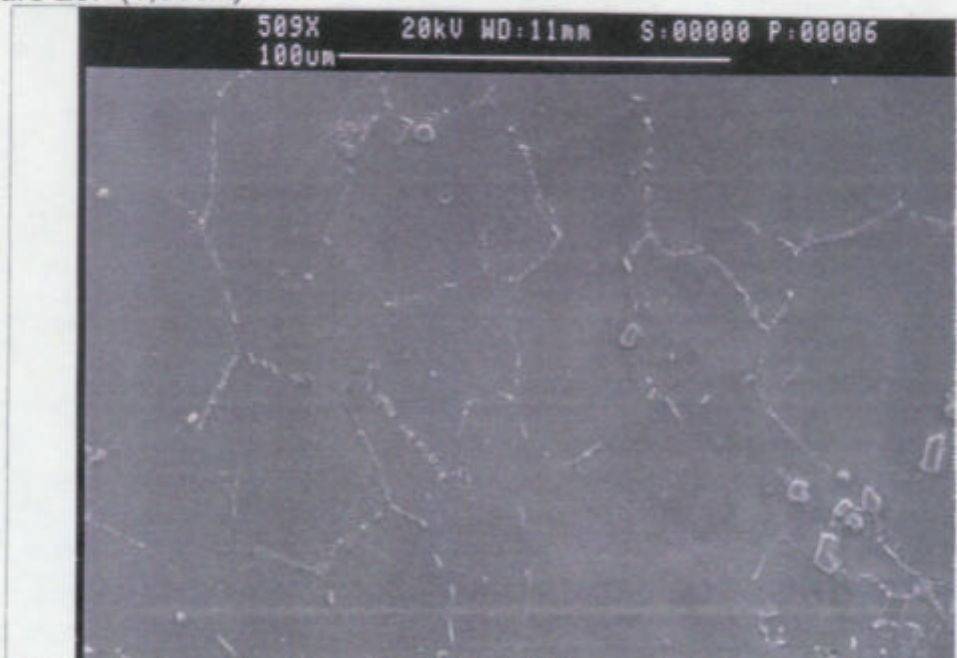
Figure 27. SEM photograph of section "Y-Y" at the web in the area below the fracture origin area. The section was etched with Tucker's reagent, followed by electrolytic etch with a phosphoric acid reagent, and sputter coated with gold-palladium. (509X)

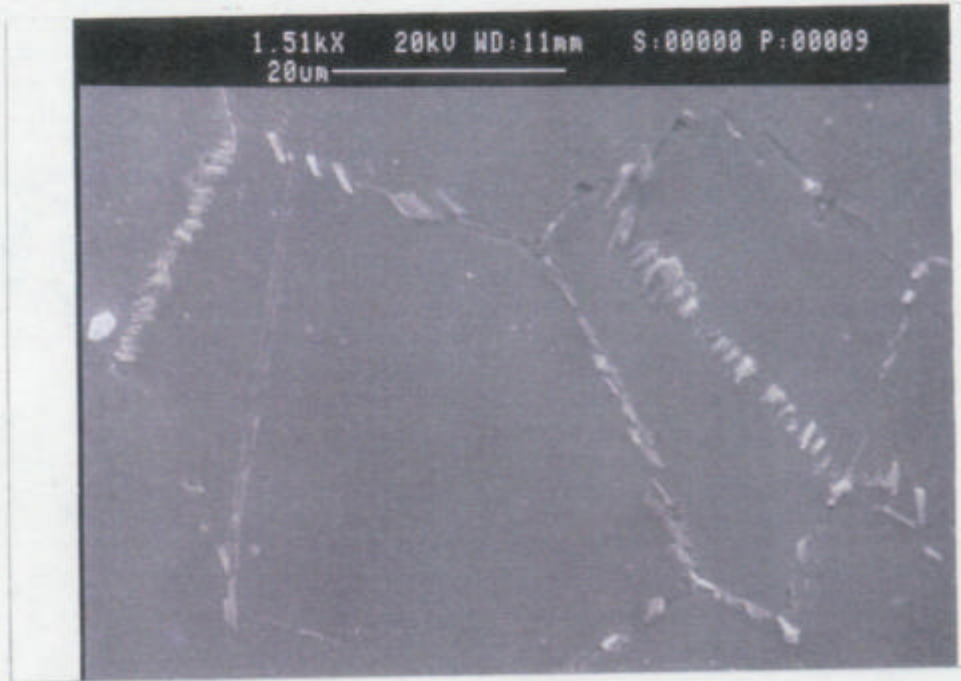
Figure 28. Higher magnification SEM photograph of an area located at the left lower corner in figure 27. (1,501X)

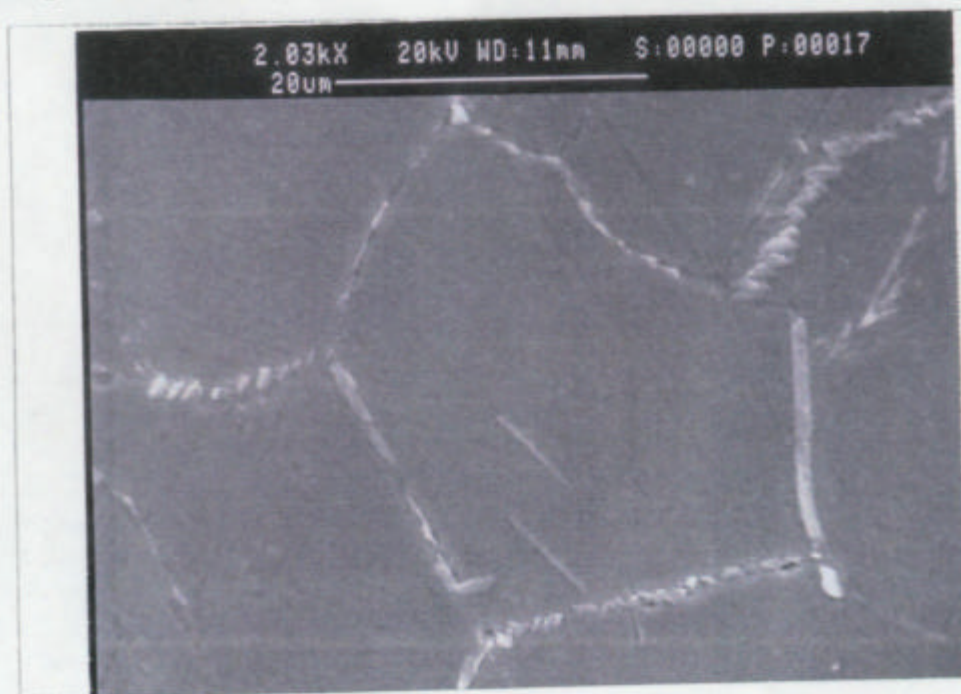
Figure 29. SEM photograph of section "Y-Y" located at the web and below the fracture origin area showing a typical microstructure. (2,030X)

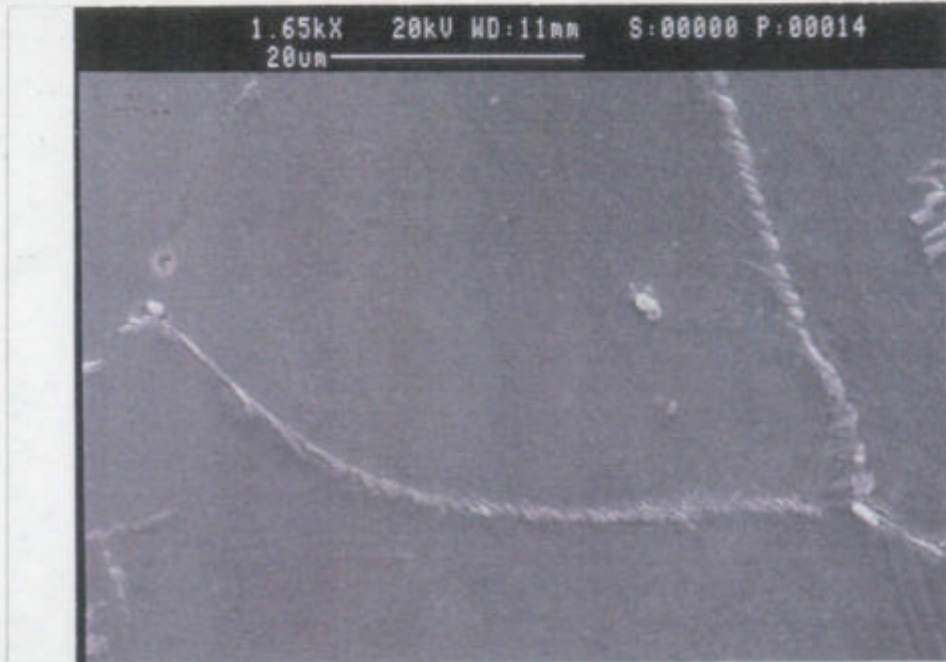
Figure 30. SEM photograph of section "Y-Y" located at the web and below the fracture origin area showing typical microstructure. (1,650X)

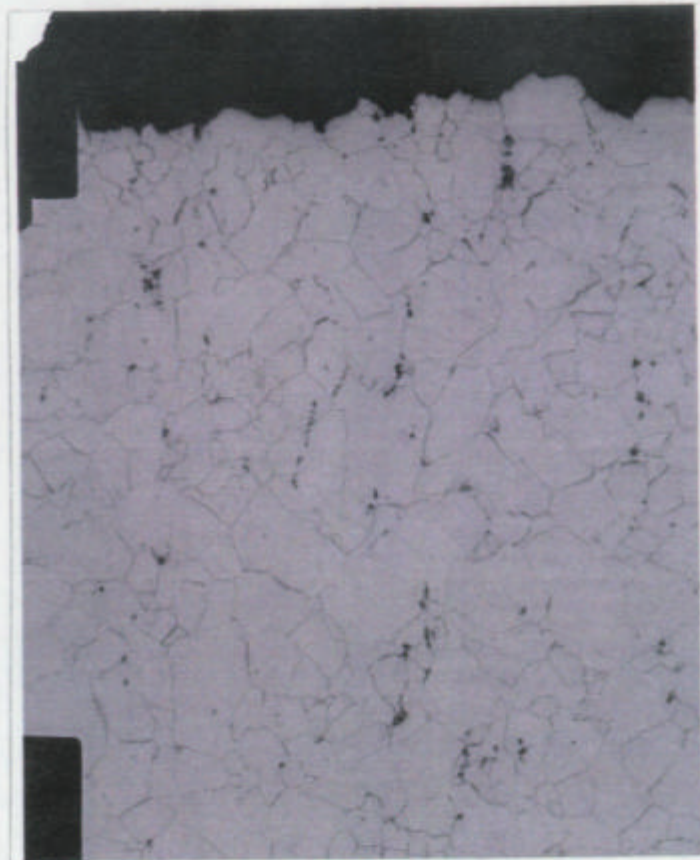
A section was made through the approximate center of the fracture origin area, in the location indicated by line "T-T" in figure 3. The section was encased in a metallurgical mount, polished and etched with Tucker's reagent. Examination of the section revealed intergranular cracking at the fracture surface. The cracking extended between grains and typically did not exceed the thickness of two grains. The cracking at the grain boundaries generally was oriented nearly perpendicular to the fracture surface, with no evidence that these intergranular cracks extended parallel to the fracture surface. The grain boundaries contained no voids. The microstructural constituents in the section through the fracture origin area appeared similar to those found in the metallographic sections from the bore and rim portions of the disk. Figures 32 through 34 show photographs of typical microstructure of the section through the fracture origin.

Figure 31. Section through the approximate center of the fracture origin area at the location indicated by section line "T-T" in figure 3, showing typical grain size in the area adjacent to the fracture surface (top of photograph). Etched with Tucker's reagent. (100X)

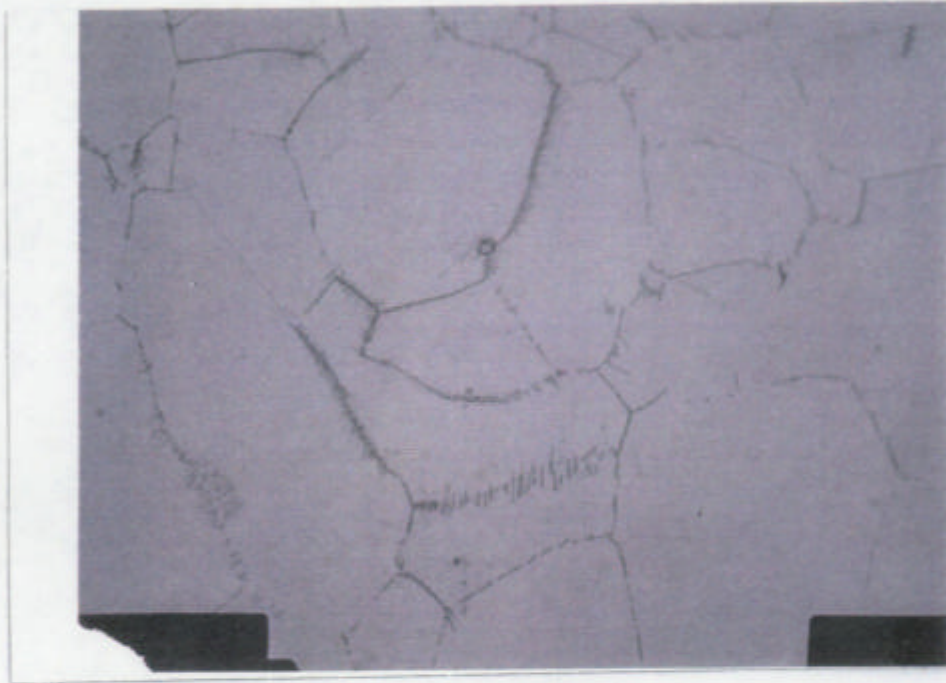
Figure 32. Typical microstructure near the fracture origin area. Etched with Tucker's reagent. (500X)

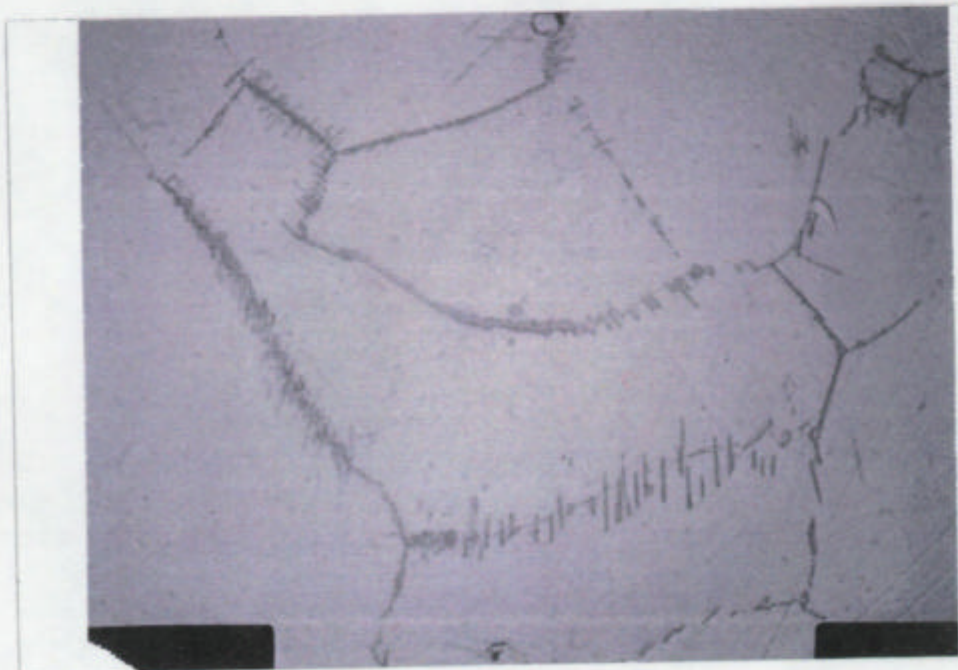
Figure 33. Higher magnification photomicrograph of typical microstructure near the fracture origin area. Etched with Tucker's reagent. (1,000X)

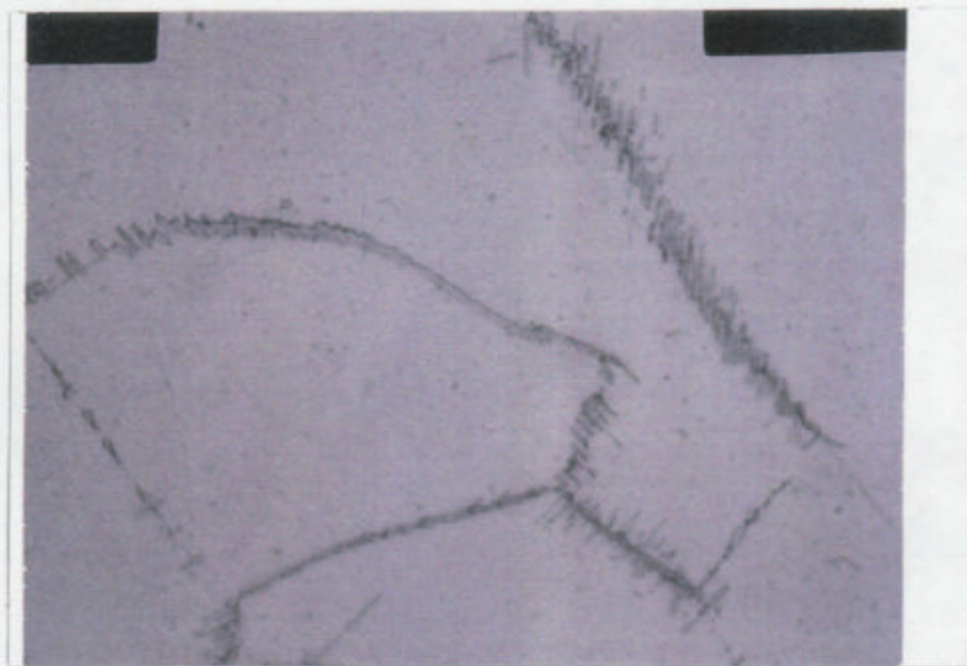
Figure 34. Higher magnification photomicrograph of typical microstructure near the fracture origin area. Etched with Tucker's reagent. (1,500X)

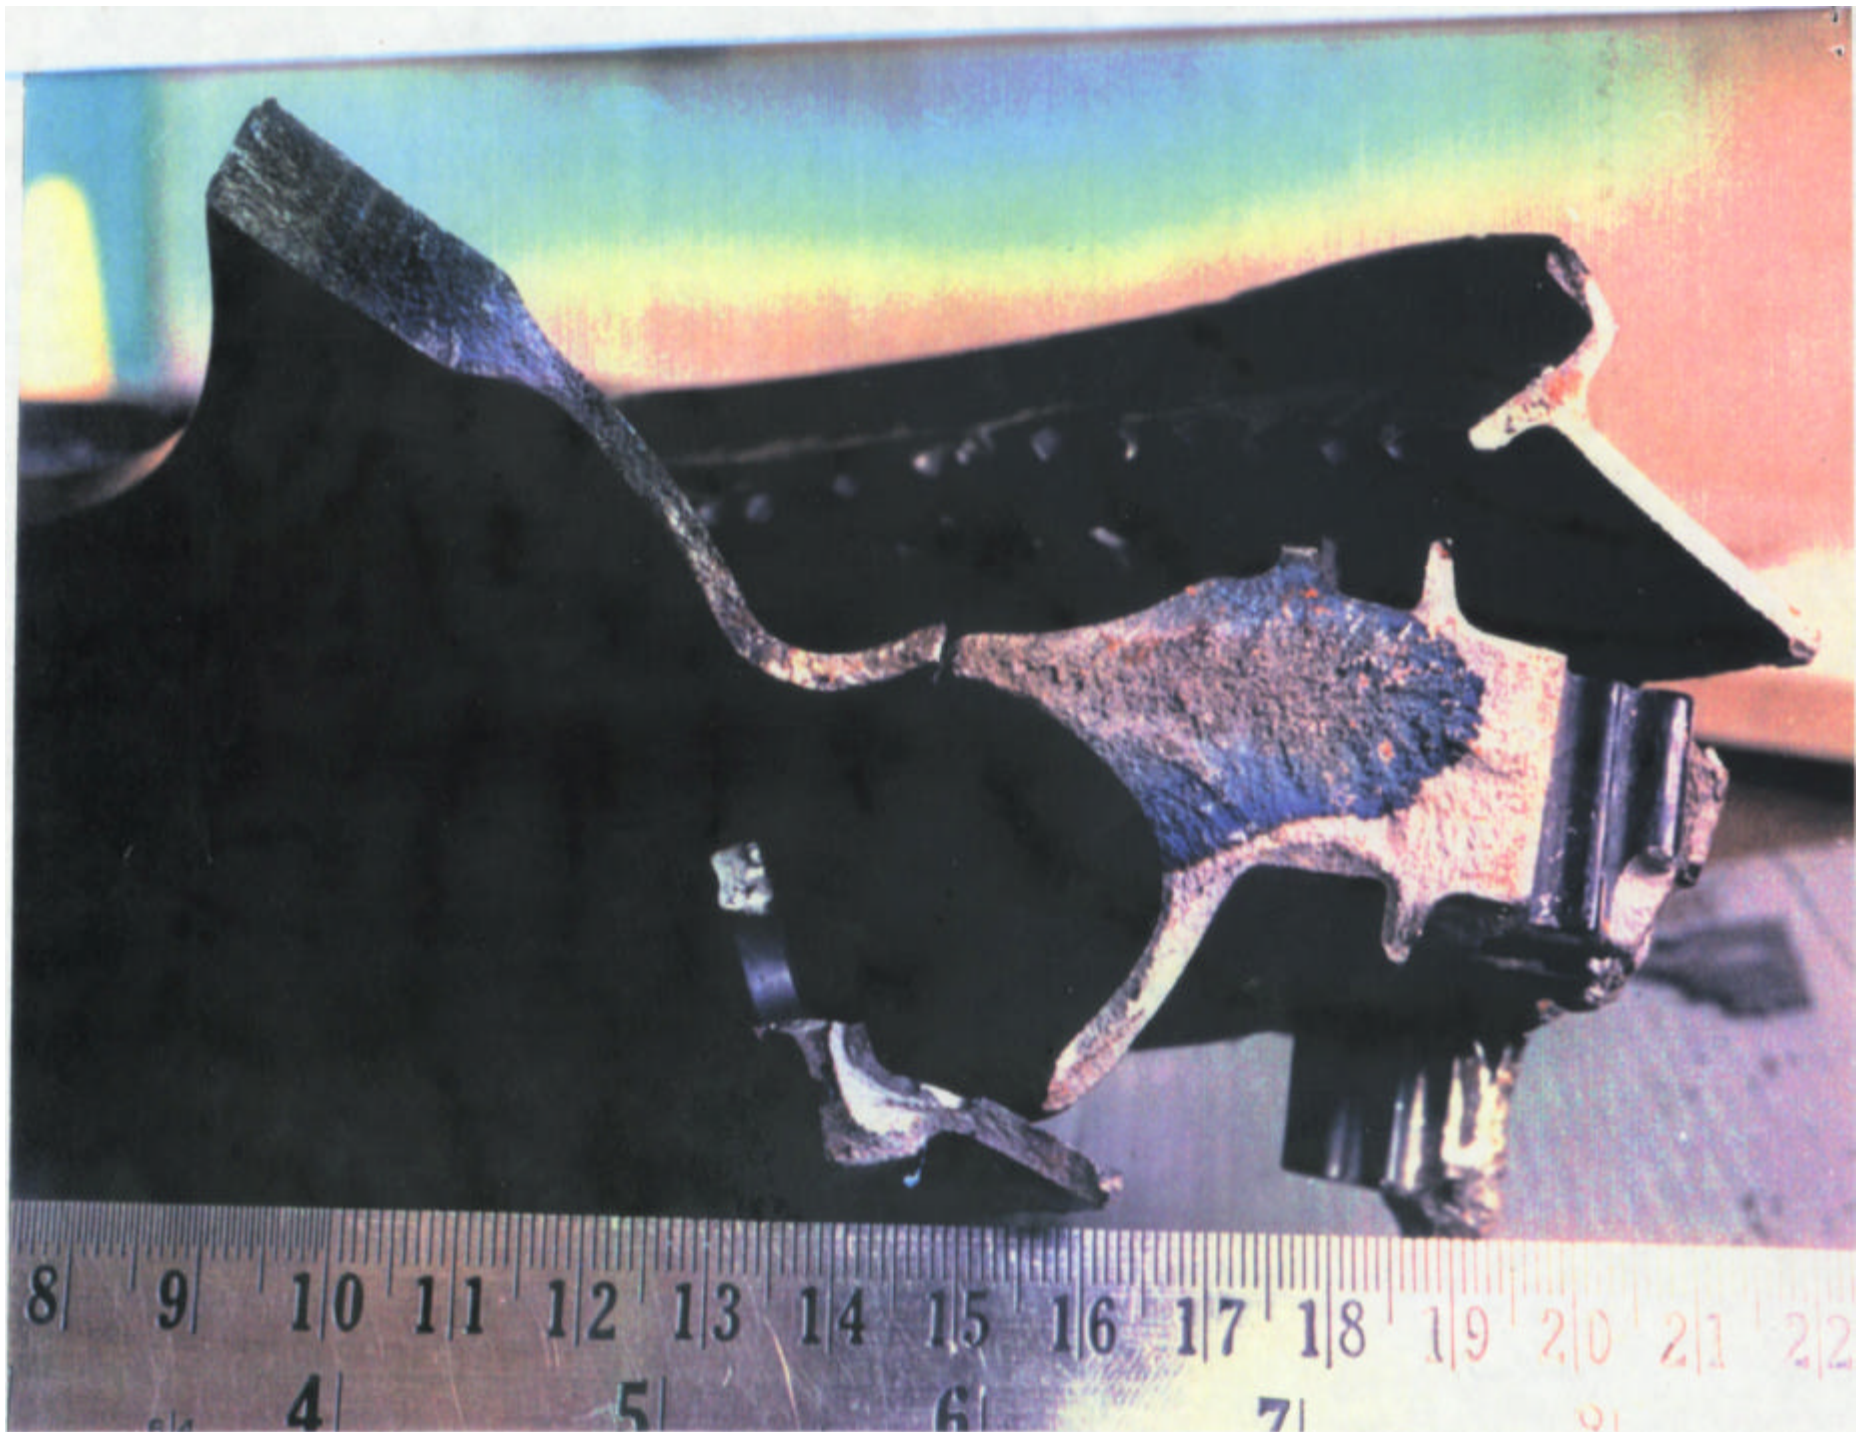
The fatigue mode of failure was indicated by the dark colored fracture surface. The final stage of fracture occurred at the lighter fracture surface. [Fig.1]
