Flight into terrain, Air New Zealand McDonnell-Douglas DC-10-30 ZK-NZP, Ross Island, Antarctica, November 28, 1979

AIRCRAFT ACCIDENT

REPORT No. 79-139

McDONNELL-DOUGLAS DC10-30 ZK-NZP

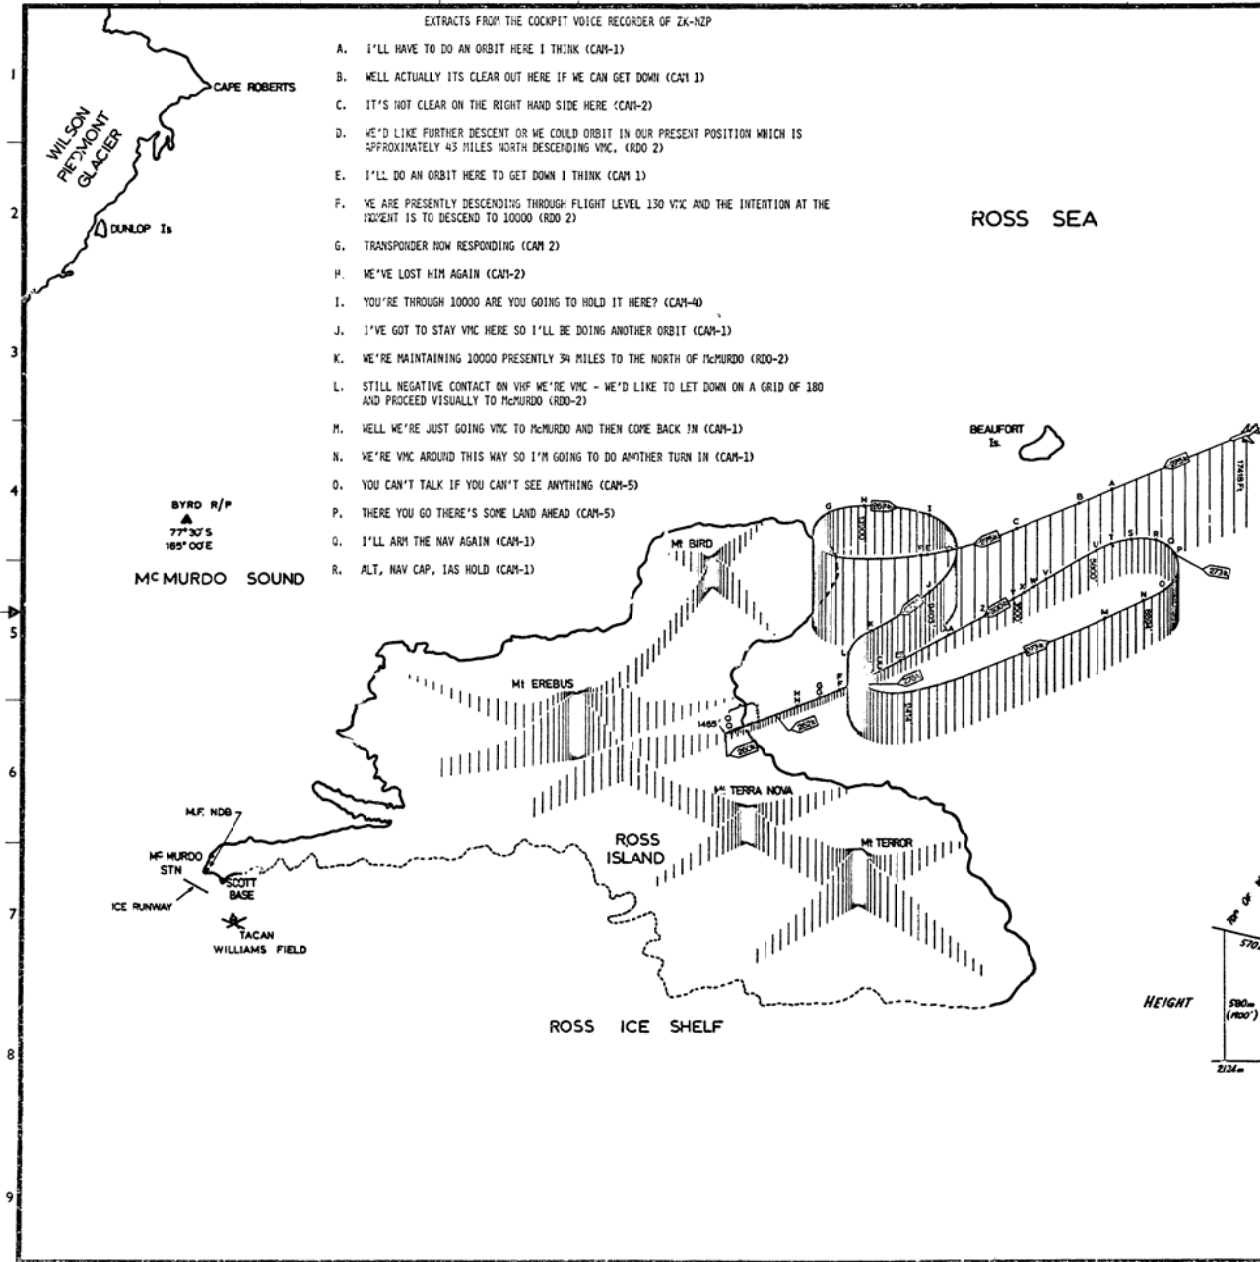
- S. WE ARE NOW AT 6000 DESCENDING TO 2000 AND WE'RE VMC (RDO-2)
- T. WE HAD A MESSAGE FROM THE WRIGHT VALLEY AND THEY'RE CLEAR OVER THERE (CAM-1)
- U. THE TAYLOR OR THE WRIGHT NOW OR DO YA? (CAM-5) NO - I PREFER HERE FIRST (CAM-1)

- V. I STILL CAN'T SEE VERY MUCH AT THE MOMENT - AS SOON AS I SEE SOMETHING THAT GIVES ME A CLUE AS TO WHERE WE ARE I'LL LET YOU KNOW (CAM-5)
- W. ALTIMETERS (CAM-5)
