## Runway excursion, Incident involving aircraft SE-DNU at Ängelholm Airport, M county, Sweden, on 15 April 2004

## **Report RL 2005:14e**

**Incident involving aircraft SE-DNU  
at Ängelholm Airport, M county, Sweden,  
on 15 April 2004**

Case L-06/04

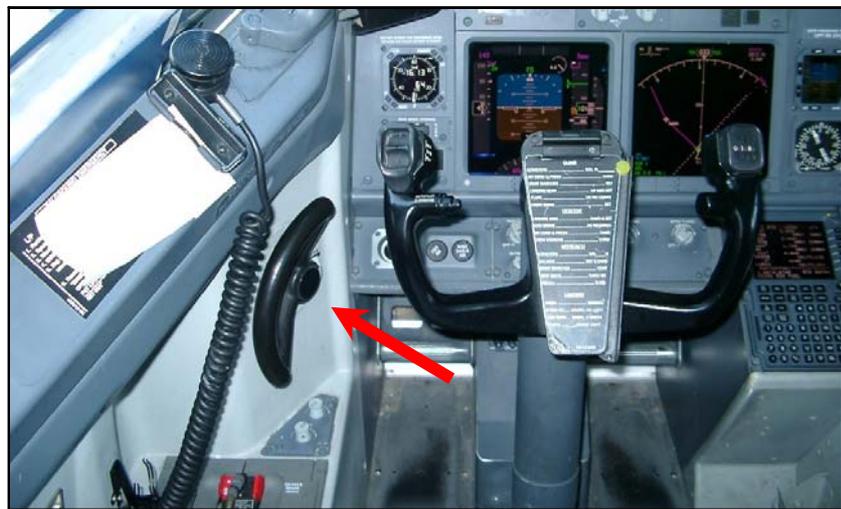
*Tiller handle*

This aircraft type is equipped with nose wheel steering, which is normally used for all operation on the ground. The nose wheel steering can be operated using the rudder pedals and a steering control, the Tiller handle, to the captain's left.

During takeoff and landing, when the speed is high, steering is effected with the rudder pedals, which give both nose wheel steering and aerodynamic steering via the rudder. Nose wheel travel is then limited to  $\pm 7$  degrees.
