Runway excursion after landing, involving a Boeing 747SP, B-18253, at Chiang Kai-shek International Airport on September 2, 1999

Aircraft Incident Report

Number: ASC/AIR-2000/01

Occurrence: Runway excursion after landing

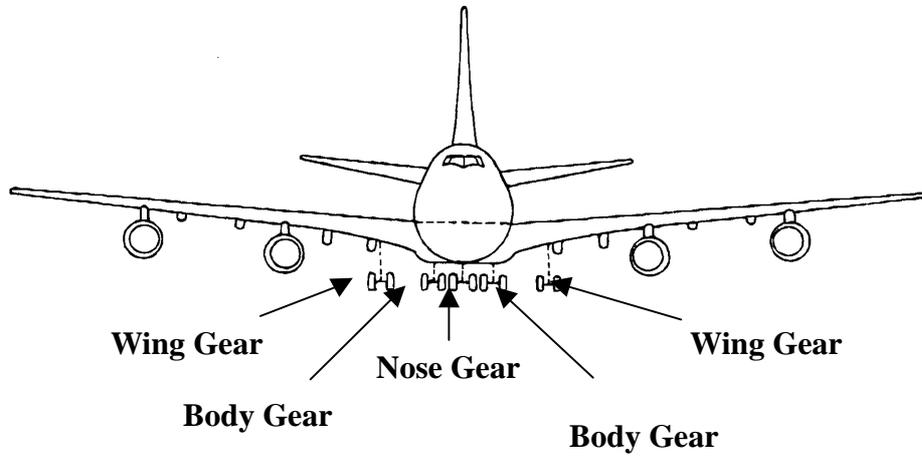
Fig. 1-5 Aircraft Outlook and Gear Locations

A 26ft x 10ft lower fuselage skin immediately adjacent to the left body gear, including the hydraulic lines, were damaged (Fig. 1-1). Some parts of the nose gear assembly and both nose tires were damaged (Fig. 1-2). The axles of the front and rear trucks of the left body gear were snapped (Fig. 1-3 & 1-4). Scrubbed marks were found at the bottom of #1 engine cowling. Please refer to Fig. 1-5 & 1-6 for the outlook of the aircraft and gear locations.

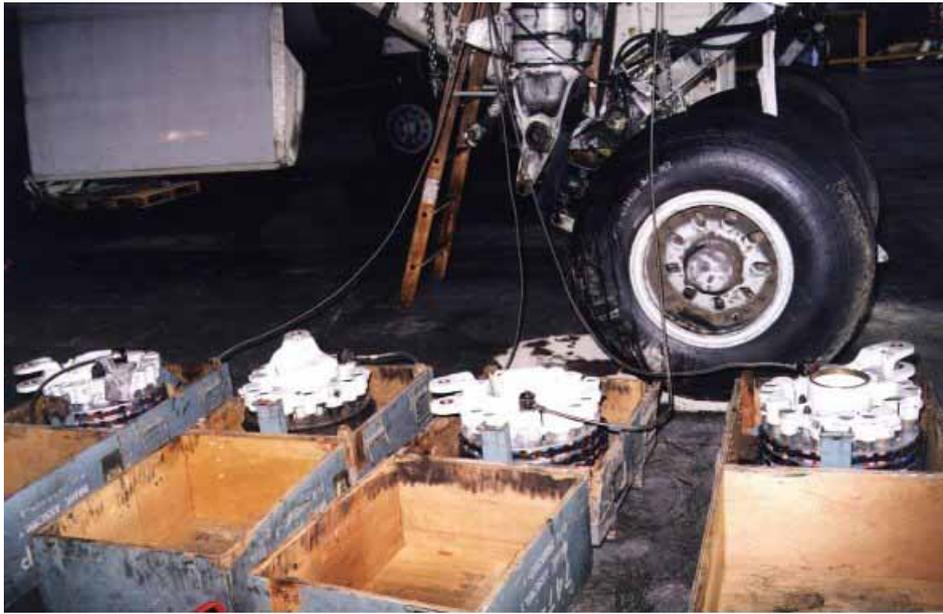
The test was conducted in accordance with Boeing Maintenance Manual AMM 32-41-00 (p.501). The damaged hydraulic lines to #5, 6 and 7 wheels were temporarily connected via soft high pressure hoses to the brakes' serviceable parts, while those to #8 wheel were externally connected to a pressure gauge (Fig. 1-27). The aircraft's electrical power system was then turned on to pressurize, and the gauge indicated 3000PSI when braking paddles were applied (Fig. 1-28). All wheel braking functioned normally. The brakes for #6, 7 and 8 wheels also functioned normally when tested with manual hydraulic pumps. The brakes for #5 wheel were not tested due to damage upon impact.

Fig. 1-27 Soft High Pressure Tubes Connected to Useable Parts

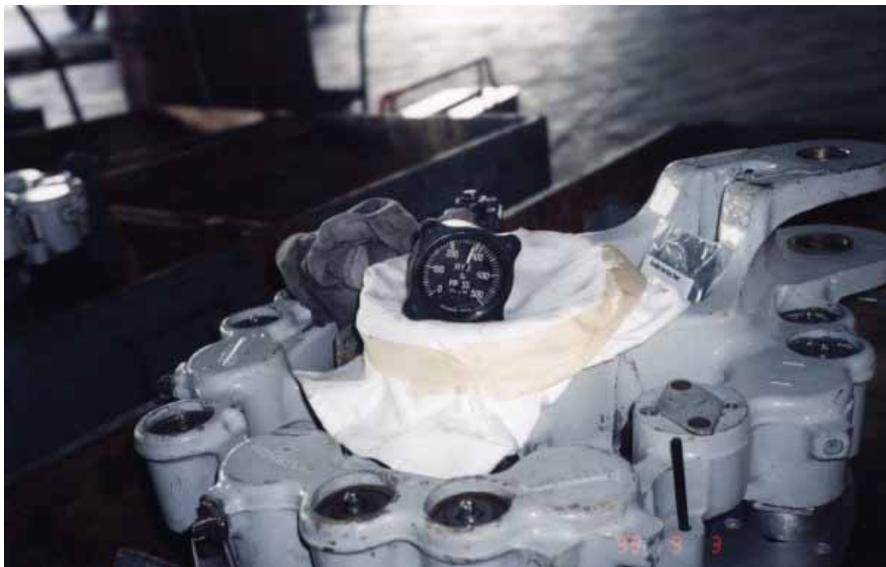
Fig. 1-28 External Pressure Gauge Indicated 3000PSI

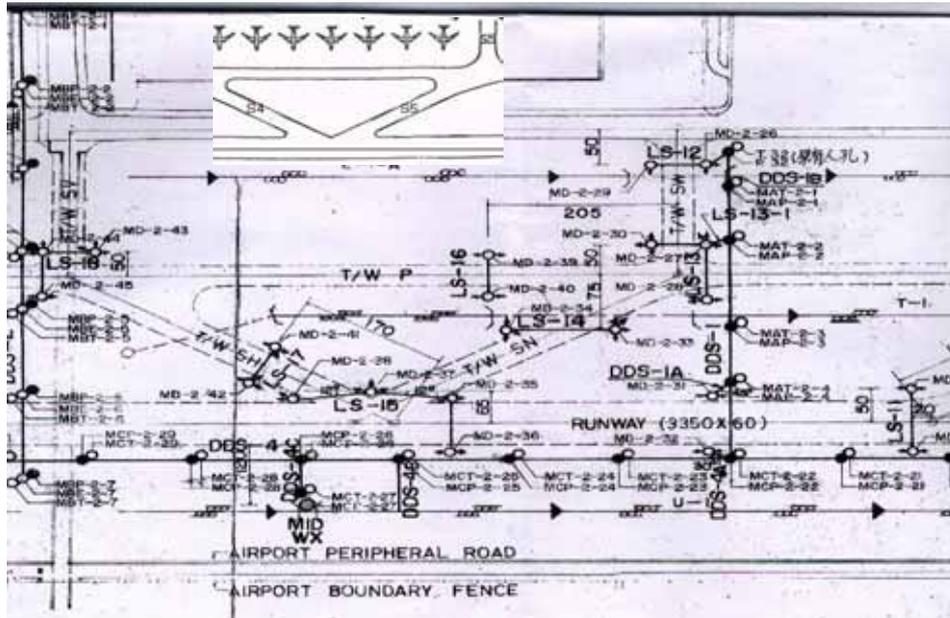
Fig. 1-32 Manhole Locations

As part of the navigation lighting system, the protruding concrete manhole (Fig. 1-30) struck by DT2's nose gear is located 11 meters to the side of the runway between Runway 06 and Taxiway S5.

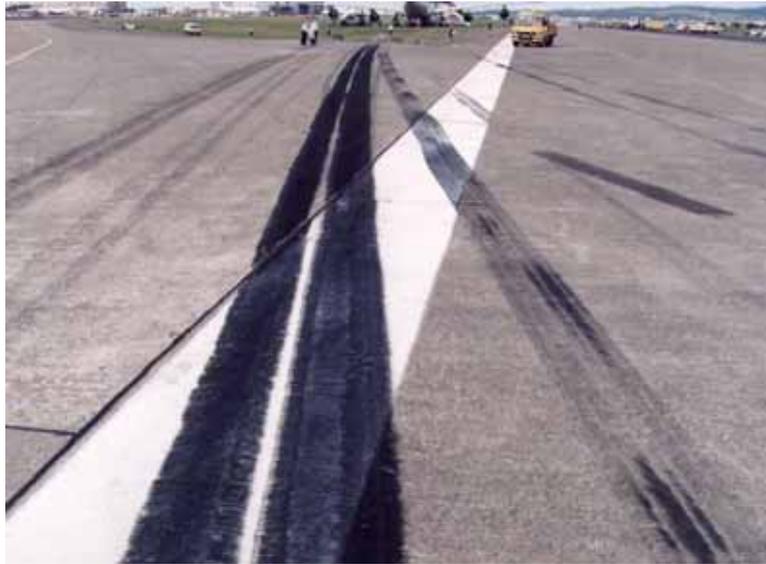
- Nosewheel: The left and right tire marks had slippery traces of liquid, especially on the edge of the white line on the runway, where there were traces of liquid being run over and spread to the sides.
- Mainwheel:
 - Right Body Gear: The four tracks were wider than before, with alternating dark and light strips in the tracks. Starting from the outer edge, the gaps between the first and second, as well as that between the third and fourth tracks, widened.
 - Right Wing Gear: The two strips of wheel tracks were overlapped by another two strips of wheel tracks, their colors visible, and had alternating dark and light strips in the tracks.
 - Left Body Gear: The four strips of wheel tracks were visible. Starting from the outer edge, the gaps between the first and second, as well as that between the third and fourth tracks, continued to widen.

Left Wing Gear: Two tracks started to become visible.

Fig. 1-37 Ground track between 325-400 meters.

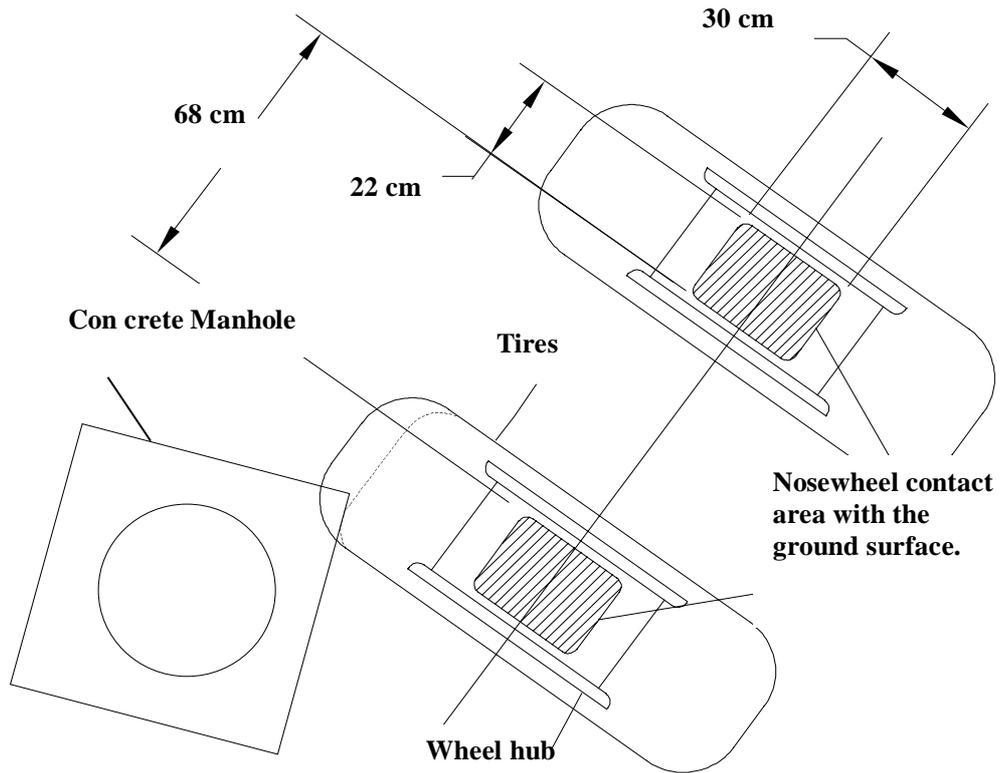
While a B-747SP was parked in a hangar, the aircraft's nosewheel contact area with the ground surface was measured as shown in Fig. 1-39.

Fig.1-39 Nosewheel Contact area with the ground surface.

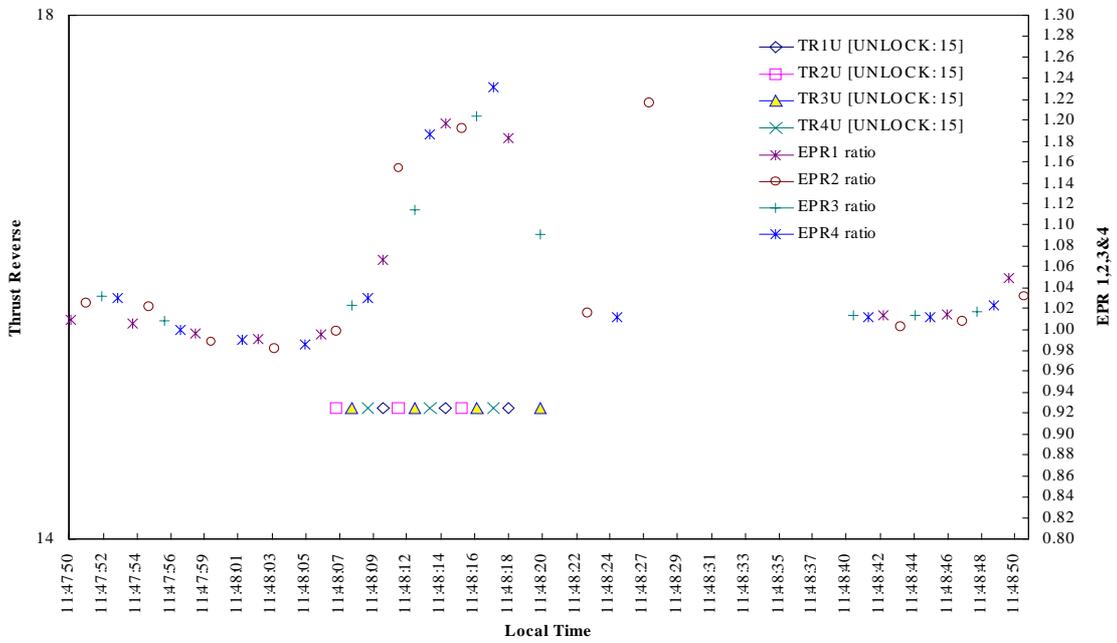
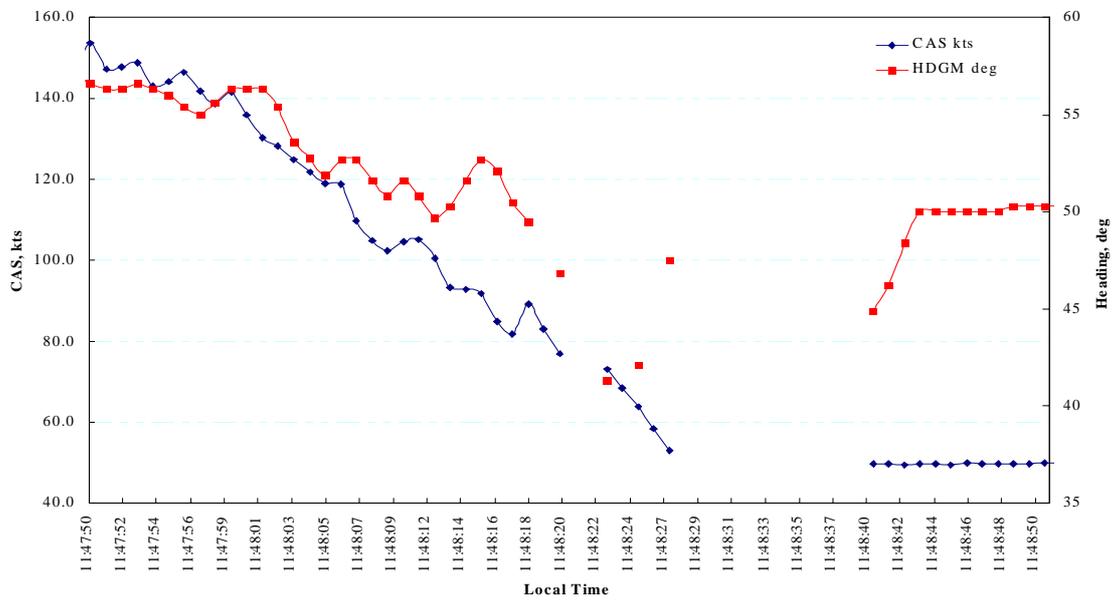
Fig. 2-1 CVR and FDR records.

The flight data recorder indicated that the path of the DT2 during its landing roll was approximately 052 degrees, but shifted to 047 degrees 16 seconds after touchdown (for a duration of approximately four seconds). Two seconds thereafter, the path shifted rapidly to 041 degrees, and information on the flight data recorder disappeared in these two seconds. The shift in direction during this period, verified by the uneven dark nosewheel tracks and the bodywheel tracks indicated that the pilot-in-command had started using the tiller to steer the aircraft toward Taxiway S5. Before the drastic change in the aircraft direction, the FDR recorded the air speed as 76.8 Kts, and the reverse

thrust was not stowed. The relevant records are shown in Fig. 2-1.

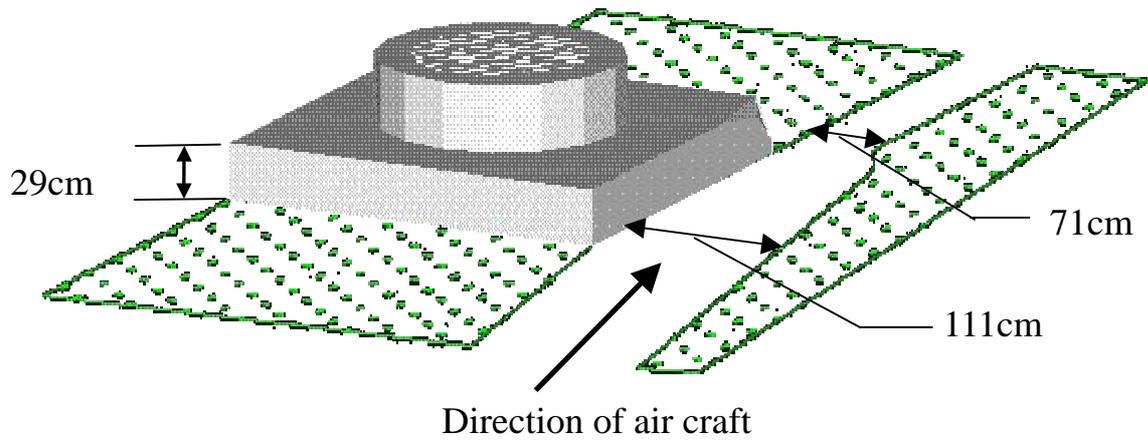
The data measured on site were as follows (Fig. 2-2):

Fig. 2-2 Tracks on the grass area.

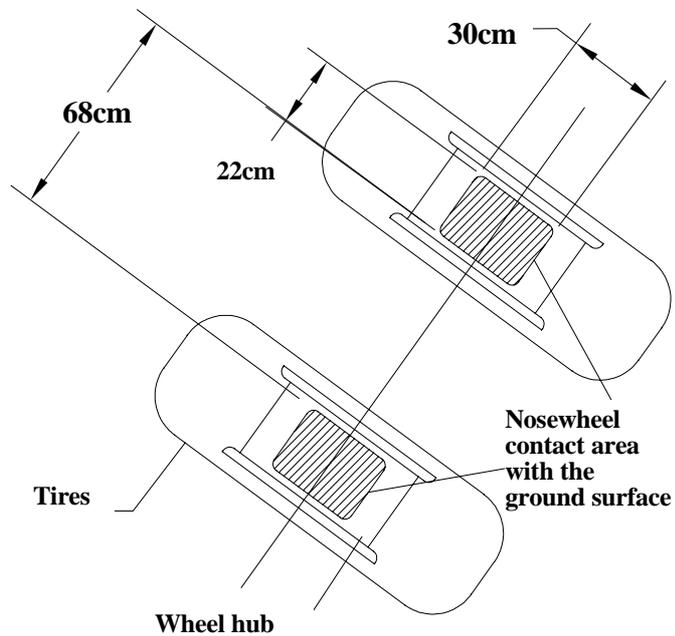
The data obtained at the China Airlines hanger were as follows (Fig. 2-3):

Fig. 2-3 Contact area with the ground surface.

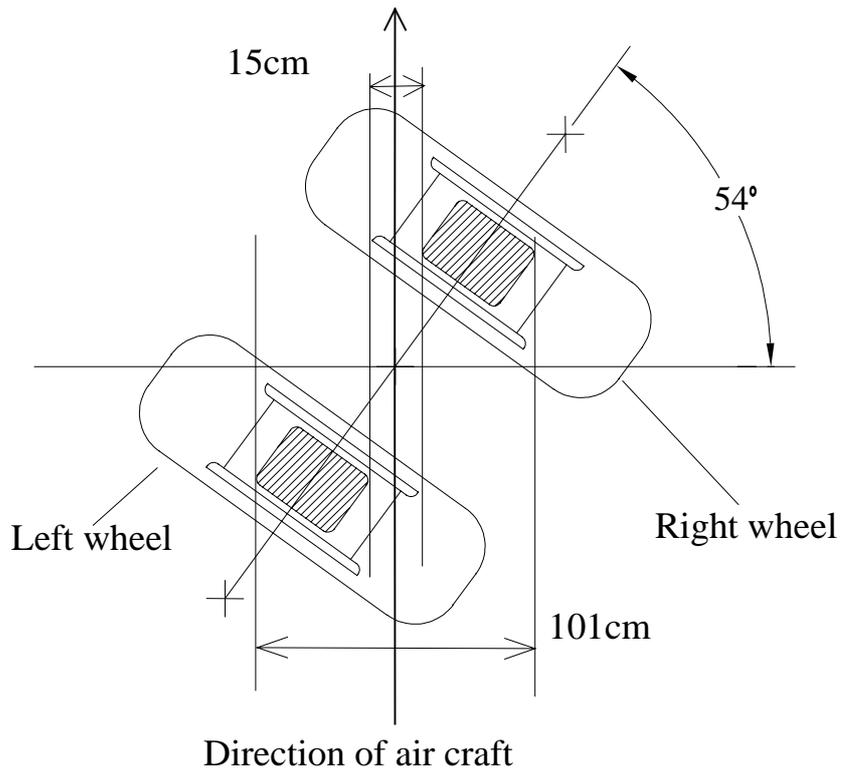
From the steering angle at that time, the track width was calculated to be 101 centimeters.

The steering angle of the nosewheel prior to entering the grass area is as shown in Fig. 2-4. The method of calculation is shown in Fig. 2-5.

Fig. 2-4 The steering angle of the nosewheel prior to entering the grass area.

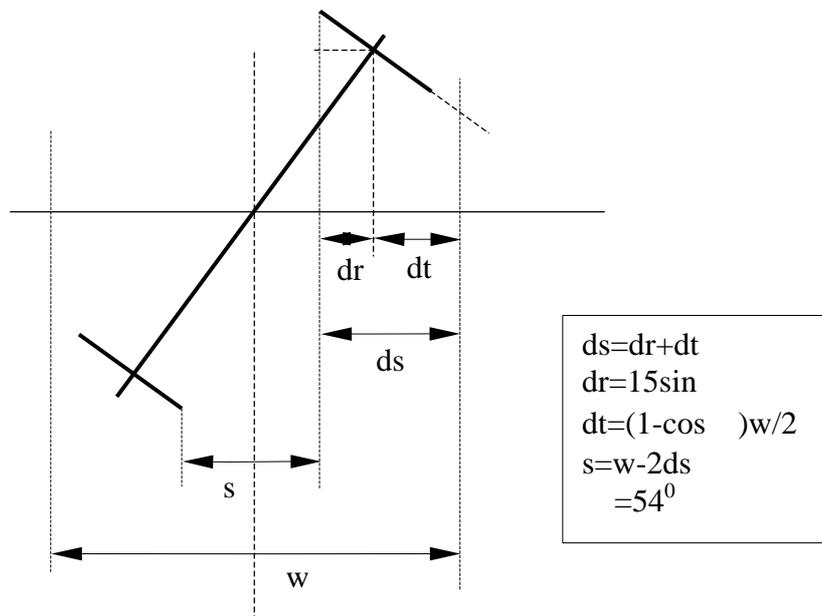
Fig. 2-5 Calculation of the steering angle of the nosewheel prior to entering the grass area.

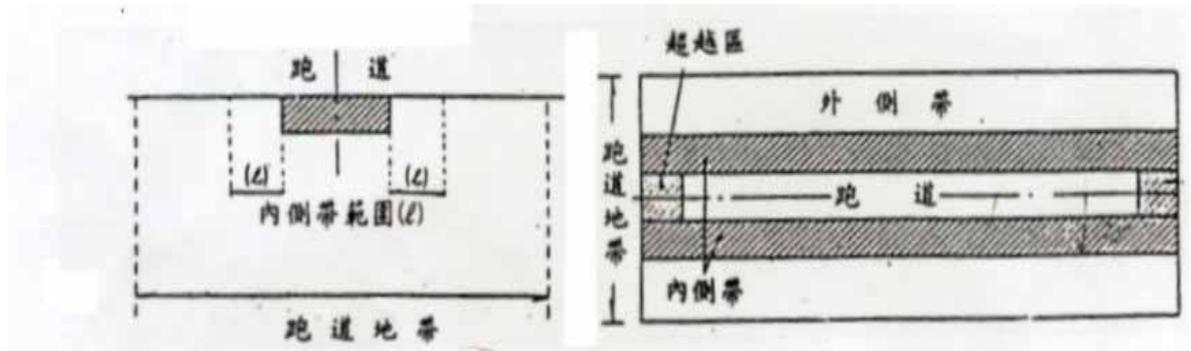
3.3.3.2 The width of the instrument landing runway strip shall be further divided into inner and outer strip areas. The inner strip width shall be the same that the width of the non-instrument runway strips of corresponding reference runways; the remaining width shall belong to the outer strip area, as shown in Fig. 2-12.

Fig. 2-12 Definition of the different areas of the runway strip.

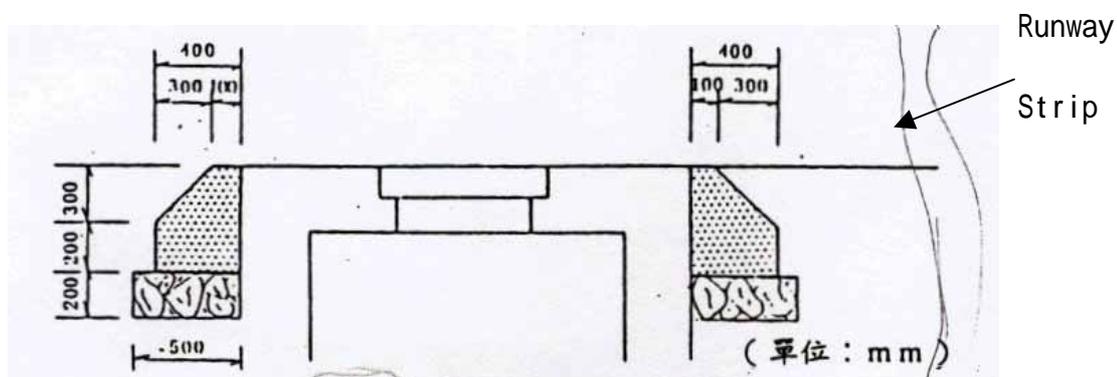
“Within the non-instrument and instrument landing runway strips, structures should be buried at least 30 centimeters under the ground surface as much as possible to ensure uniform strength along the entire runway strip. If it becomes necessary to locate a structure such as manhole above ground surface, the structure can be constructed in accordance with Fig. 2-13. The structure surrounding should be protected by concrete, with a 30 centimeter tapering leading to top of the structure.”

Fig. 2-13 Design of the manhole protective structure.

The essence of the guideline is that when a aircraft runs over a soft ground surface, the aircraft wheel will still be protected by the tapered surface when it sags to the safety limit of 30 centimeters; as such, the tire will not break off or rupture due to forceful collision.

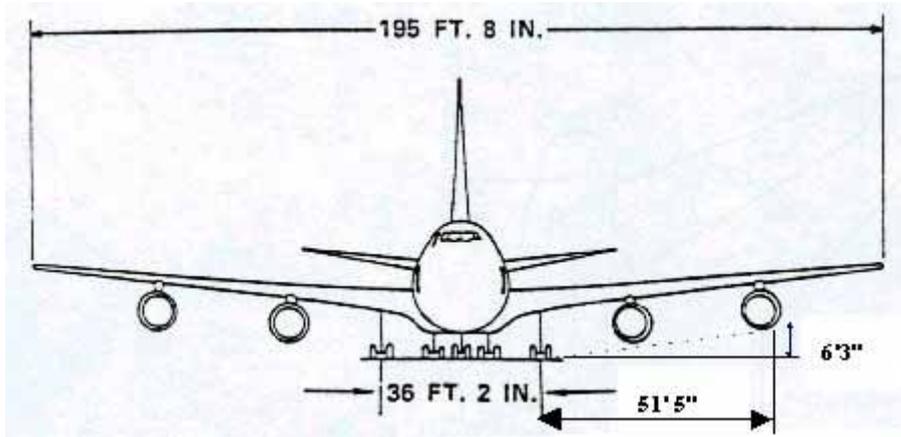
The cowl of #1 engine of China Airlines B18253 came into contact with the grass surface after the aircraft ran off the runway. Thus from the physical appearance of the aircraft (Fig. 2-15) and assuming that the left wing gear ran into a grass area with the same slope, the angle of elevation of the runway's inner strip exceeded 6.9 degrees, that is, the grass areas ran over by the left and right wing gear had a difference in elevation of 134 centimeters. The traverse slope exceeded 12.1%, which does not comply with the above guideline.

Analyzing the breakage of the left body gear, and assuming that the left wing gear ran into a grass area with a different slope, the angle of elevation of the runway's inner strip exceeded 5.13 degrees based on calculation using the aircraft's centerline. The traverse slope exceeded 8.99%, which does not comply with the above guideline.

Fig. 2-15 Physical dimension of the Boeing 747SP.

Therefore, due to safety concerns, the traverse slopes of the runway strips at the CKS airport should be appropriately modified.
