Accident Investigation Report

ASC-AAR-00-11-001

MD-90-30 cabin explosion and fire

during landing roll Hua-Lien, Taiwan

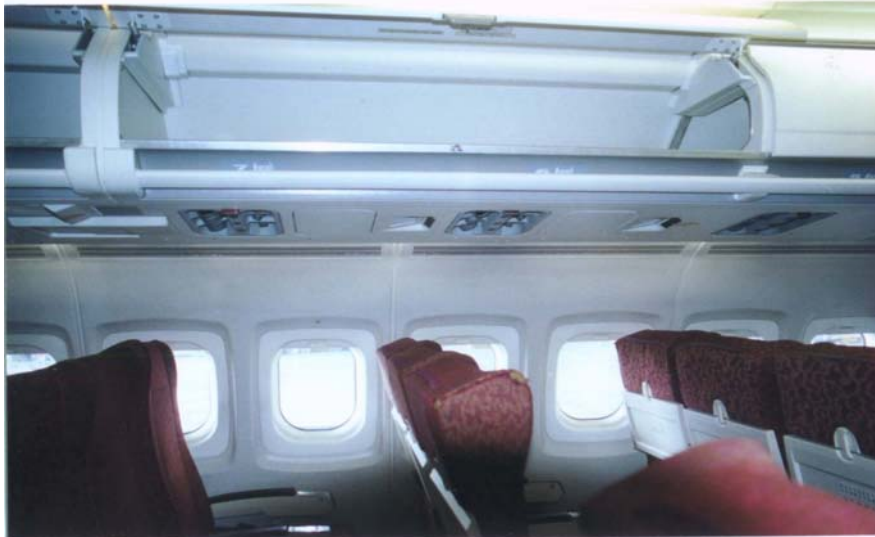
Fig. 1.12-6 Picture of the passenger cabin and stowage bin of an aircraft of identical model.

By comparing a picture of the damaged aircraft to an image of an undamaged aircraft of the exact same type (Fig. 1.12-6), we can deduce that the rupture is located in the stowage bin above rows 3~7 (there is no row 4). The stowage bin is constructed of reinforced fiberglass and measures 577.2cm in length, 57.4cm in width and 37.0cm in height. Its lugs are attached in suspension to the rack that stretches along the fuselage. Above it are electric wire clusters. The larger wires are for carrying a larger load for the galley. Two environmental control tubes can be seen along side the wires. The one of larger diameter is an air duct that provides exhaustion from the wall of the fuselage. The thinner one is for cold and feeds air from the gasper in the Passenger Service Unit (PSU), contained inside the bottom wall of the stowage bin. The entire stowage bin and its suspension system were destroyed by the explosion. Fig.

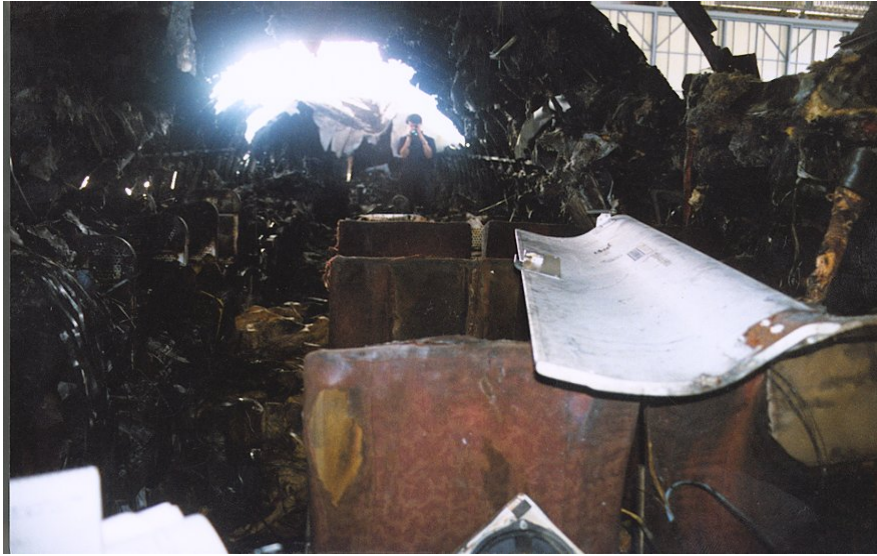
Fig. 1.12-12 FS253~FS1156

The effect of the fire on the condition of interior of the aircraft
Right side of the aircraft [from FS253 (behind Galley 2) to FS1156 (in front of Galley 3)]

consumed the interior material, from the sidewall through the air return in the lower part of the seats. After having been consumed by flames, the cabin partition panel was found on top of the doghouse. Aside from the carbon-fiber wire clusters on the back of the stowage bin, most of this area is now just ashes.

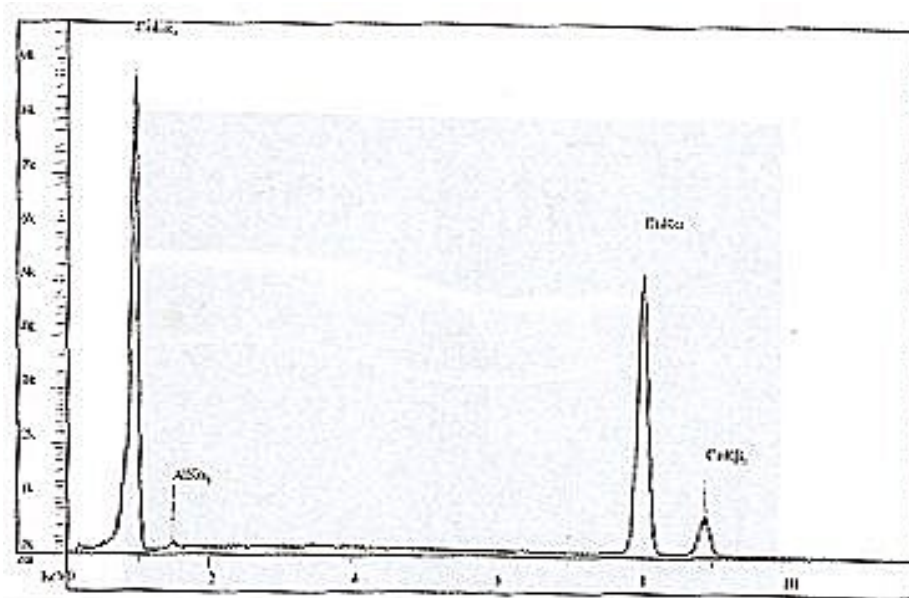
Figure 3. EDS spectrum of C in figure 2. It shows the #1 wire substrate of copper with aluminum coming from the environment reactant.

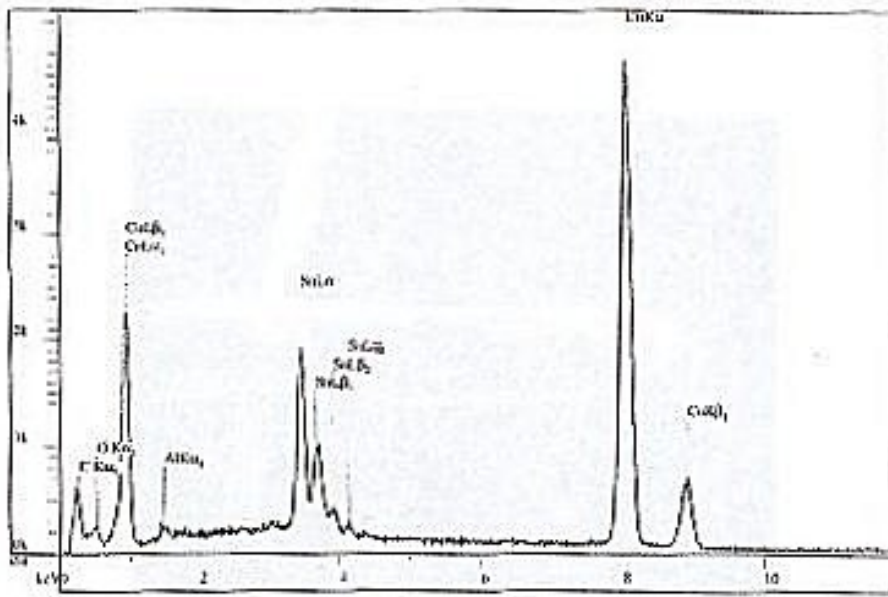
Figure 4. EDS spectrum of D in figure 2. It shows that except the #1 wire substrate of copper and tin-plated surface, the other elements come from the environment reactant.

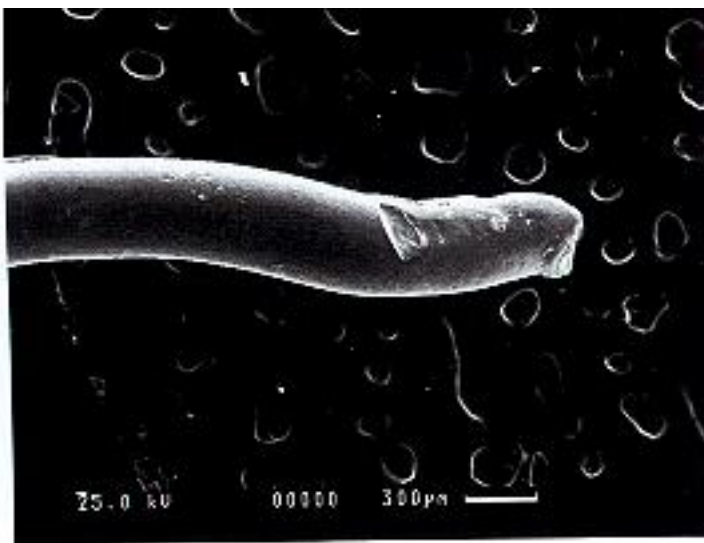
The SEM images show the A, B, P and N end lateral view of the three wire segments. As shown in figure 5, reveal that the #1 wire A end has the remarkable necking and the scratches on surface. As shown in figure 6, reveal that the #1 wire B end has necking and the surface discolored with scratches. Figure 7 shows the lateral aspect of the positive wire with the P end showing necking. Broken plating appears on the surface (dark brown color by visual) 1.7 mm from the fracture. The uneven substrate at 1.7 mm-2.2 mm from the fracture shows peeled plating also. The N end of the negative wire shows necking and squeezing shown as figure 8. When we compare the lateral aspect of the A, B, P and N ends of the wires, we should realize that there is much difference between the positive wire P fracture surface and the fracture surface of the negative wire N and the #1 wire A and B.

Figure 5. The SEM image of A of the #1 wire. The lead has visible necking and the surface shows scratches.

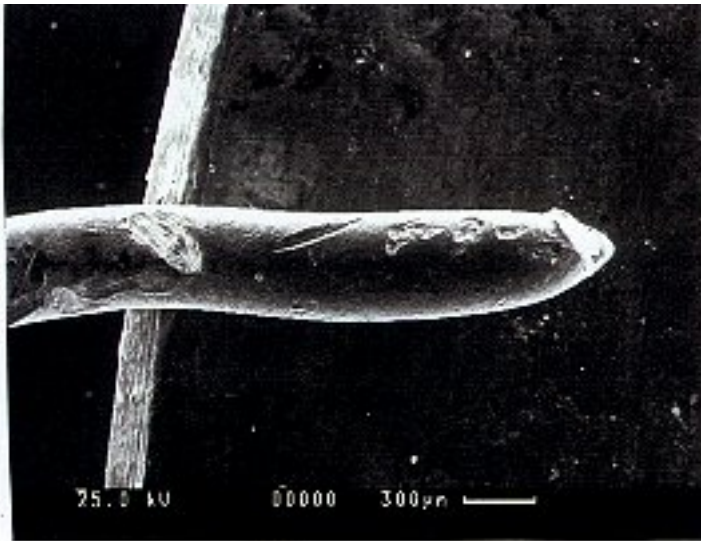
Figure 6 The SEM image shows B of the #1 wire. The lead has visible necking and the surface is faded with scratches.

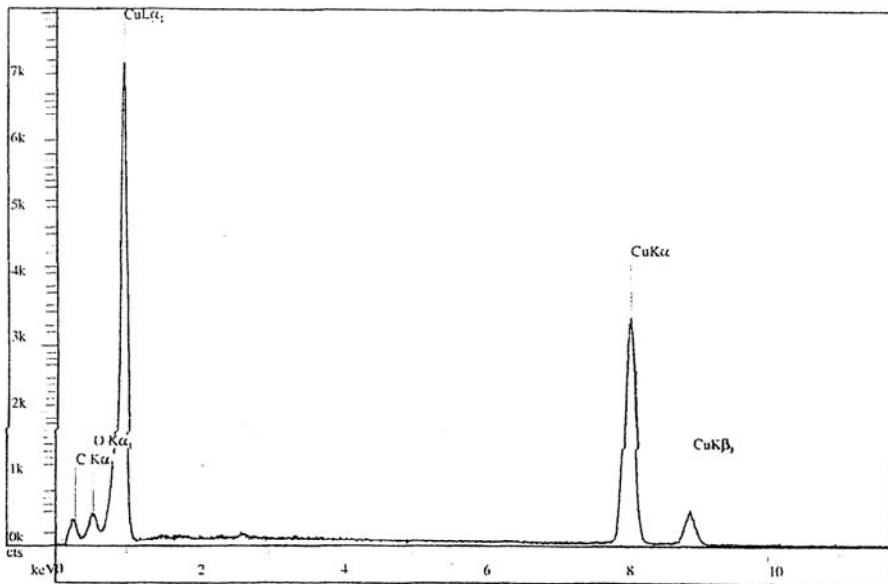
fracture surface of figure 10 using EDS, we would realize that there is copper, carbon, and oxygen in minimal amount, as shown in figure 11. We shall then presume that copper is the key element of the substrate of the #1 wire and carbon and oxygen have resulted from the environment reactant.

Figure 11. EDS spectrum of the fracture surface in Figure 10. The primary element of the #1 wire substrate is copper, with carbon and oxygen resulted from the environment reactants.

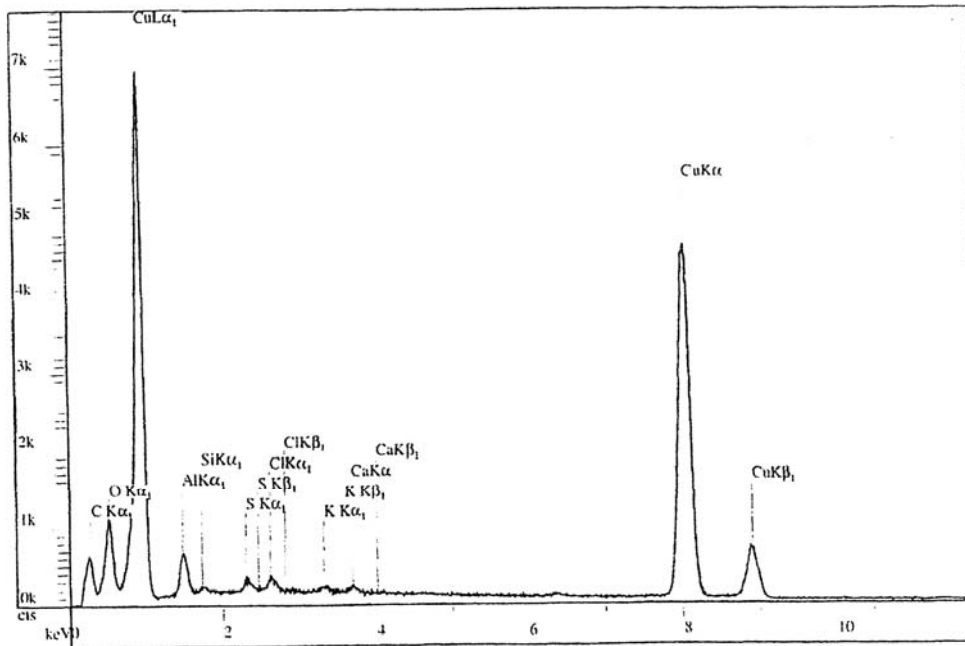
Figure 14. The EDS spectrum of the fracture surface in figure 13. The copper is the substrate of #1 wire. Aluminum, silicon, chlorine, potassium, calcium, sulfur, carbon and oxygen resulted from the environment reactants.

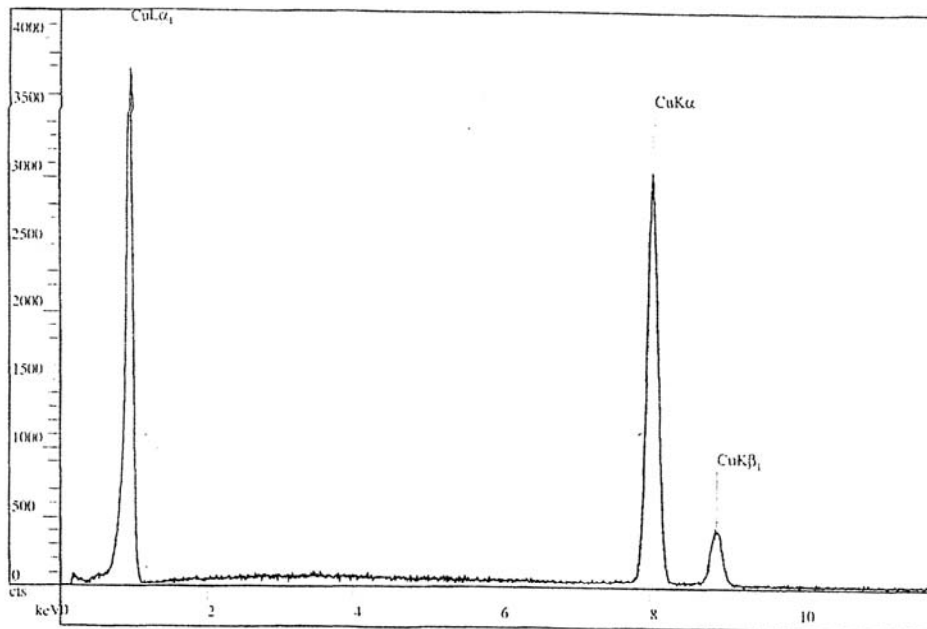
EDS analysis of the composition of the scrapped surface in figure 15 reveals only copper, shown as figure 17, and therefore copper must be the substrate element of the positive wire. EDS analysis of P2 (shown in figure 15), the spectrum shows the primary element of copper and tin, and the minor elements of oxygen, carbon, aluminum, silicon, lead and iron in minimal

Figure 17. The EDS spectrum of fracture surface of P1 in Figure 15, demonstrating that the substrate is copper.

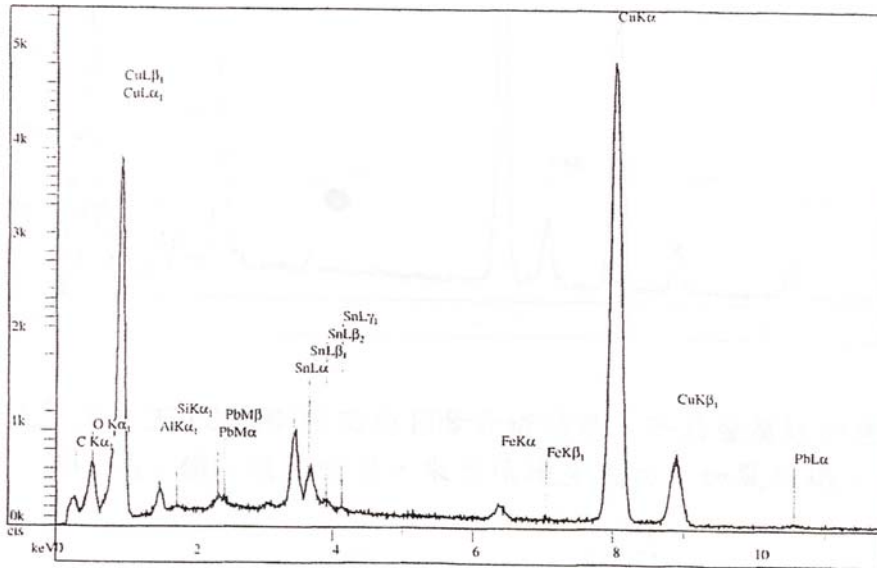
amount shown as figure 18. The copper is the substrate element of the positive wire and the tin is plating. The lead and iron were resulted from the polarity components. The oxygen, carbon, aluminum and silicon probably were resulted from the environment reactants. The EDS analysis given in P1, P2 indicate that the positive wire was copper wire with tin-plating, which is the same as the #1 wire. EDS analysis of the P3 dimpled surface (shown in figure 15), the spectrum shows the elements of iron, copper, oxygen and lead, plus trace amounts of carbon, aluminum, silicon and calcium shown as figure19. The copper is the substrate element of the positive wire. The iron, aluminum, silicon, lead, calcium and oxygen probably resulted from the oxides and carbides, which were come from the environment reactant and the deposited contaminant. The dimpled surface at P3 may be resulted from the high temperature, above 1083°C (the melting points of tin and copper are 232°C and 1083°C, respectively), generated by the arc of the short circuit. The completely burned pure copper substrate formed the crater and later deposited the contaminant (oxides and carbon buildup).

Figure 18. The EDS spectrum of fracture surface of P2 in Figure 15, revealed that the substrate is copper with tin-plating, and aluminum, silicon, chlorine, potassium, calcium, sulfur, carbon and oxygen resulted from the environment reactant.

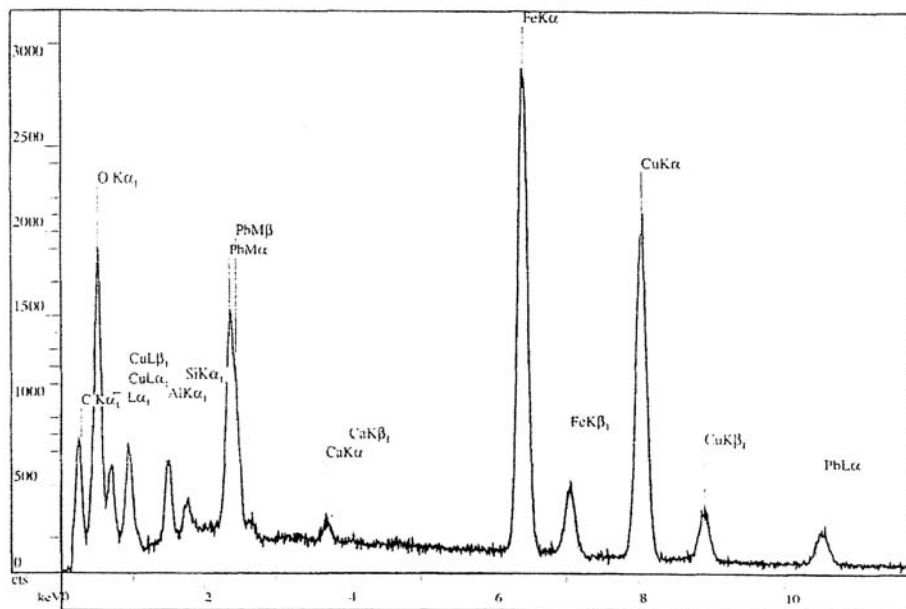
Figure 19. The EDS spectrum of fracture surface of P3 in Figure 15, showing that the substrate is copper, and aluminum, calcium, iron, oxygen and carbon come from the environment reactant.

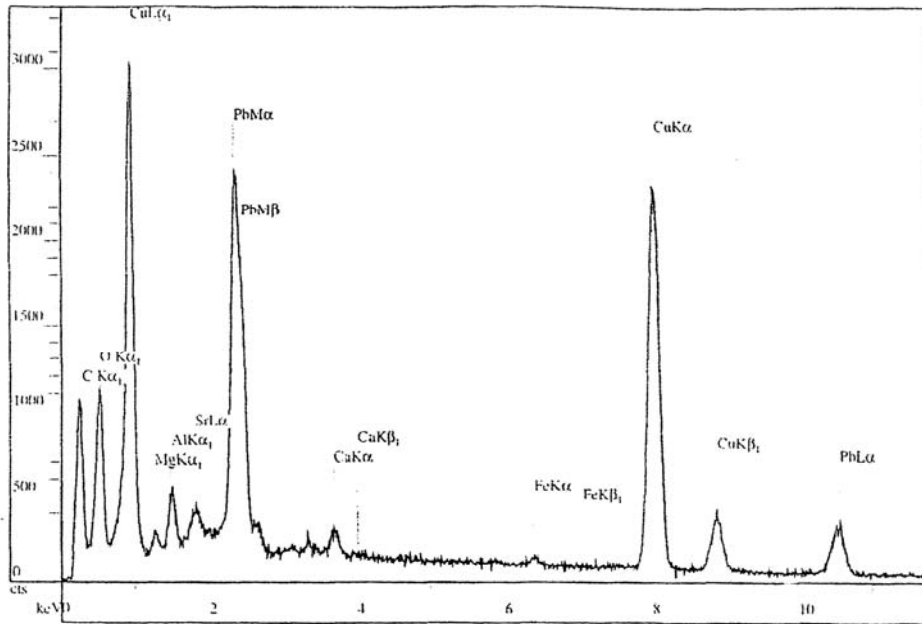
The SEM image shows that the fracture N of the negative wire was squeezed to form a triangle of 200 μm (0.2 mm) in height and 100 μm (0.1 mm) in width shown as figure 20. A magnified image of the N1 fracture surface (shown in figure 20) shows a large number of dimples of 5~10 μm in size shown as figure 21. The N1 fracture surface is resulted by overstress destruction. EDS analysis of the fracture surface (shown in figure 21) that the spectrum reveals the primary elements of copper and lead, the minor element of oxygen, and the magnesium, aluminum, silicon, calcium and iron in

minimal amount shown as figure 22. The negative wire substrate was copper with lead coming from the lead polarity rod. The magnesium, aluminum, silicon, calcium, iron, oxygen and carbon were resulted from the environment reactant. EDS analysis of the N2 negative wire surface (shown in figure 8) that the spectrum reveals its primary components are copper with tin, oxygen and aluminum in minimal amount shown as figure 23. Copper is the substrate element of the negative wire and with tin-plating. The aluminum and oxygen were probably resulted from the environment reactant.

Figure 22. The EDS spectrum of surface of figure 21, showing that the substrate of the negative wire is copper, with magnesium, aluminum, silicone, calcium, iron, oxygen and carbon coming from the environment reactant.

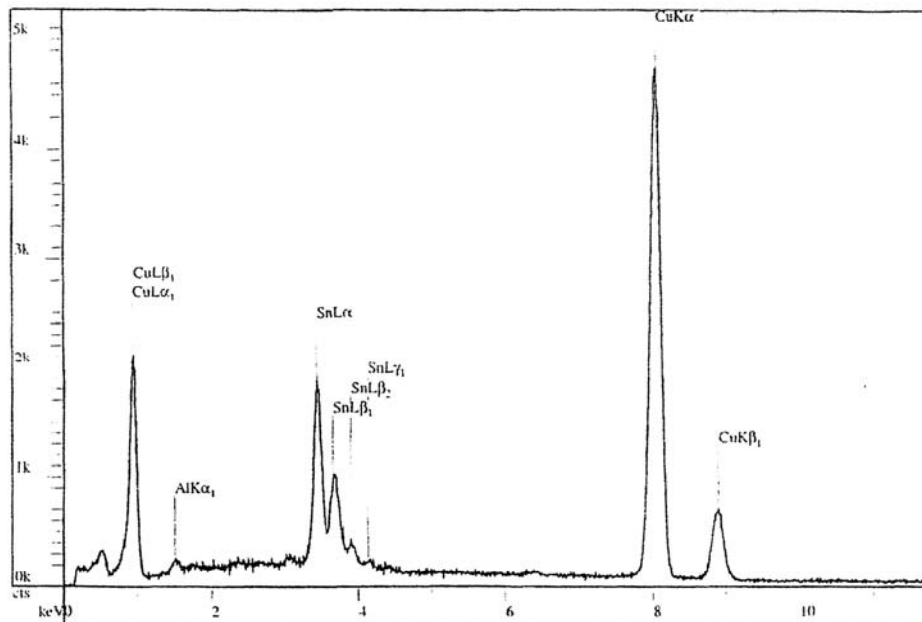
Figure 23. The EDS spectrum of N₂ surface in figure 8, showing that the substrate of the negative wire is copper with tin plating, while aluminum and oxygen came from the environment reactant.
