**Landed short, Boeing 747, N732PA, Renton Airport, Renton, Washington,
December 13, 1969**

AIRCRAFT INCIDENT REPORT

BOEING 747, N732PA

RENTON AIRPORT

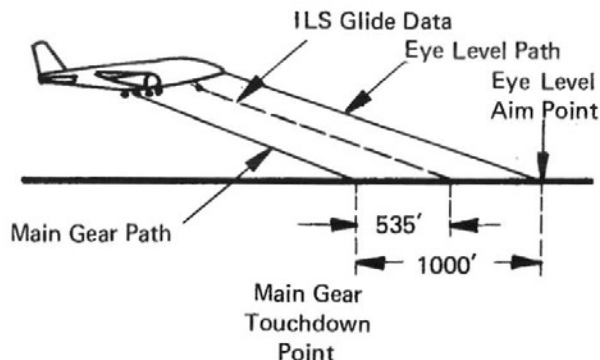
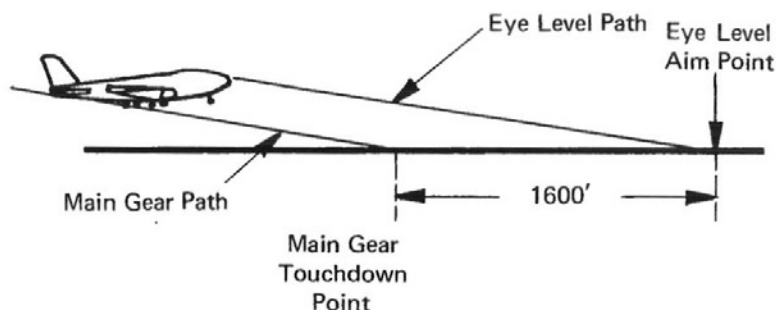
2.5° GLIDE PATH
(MINIMUM GLIDE PATH ANGLE)

1.5° GLIDE PATH
(NOT RECOMMENDED)

RUNWAY THRESHOLD HEIGHT DATA

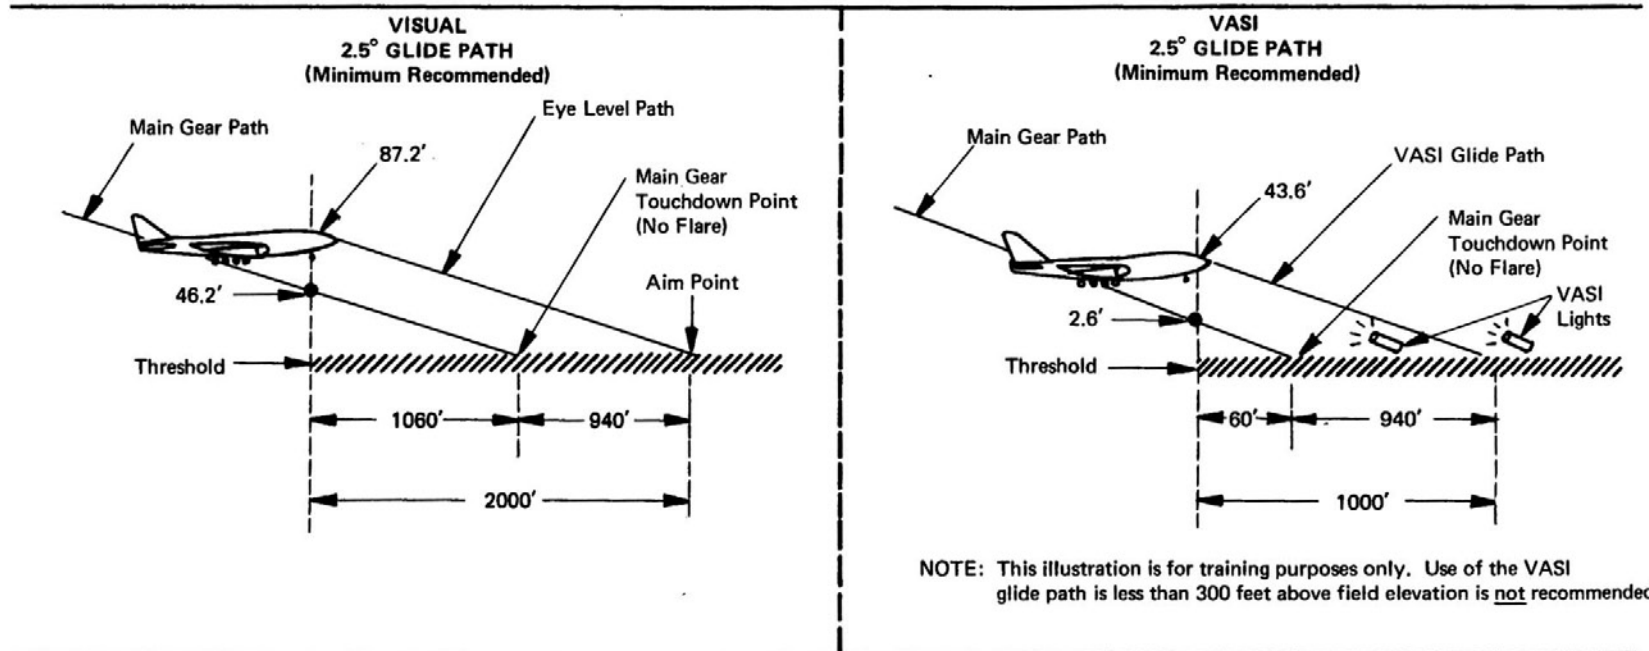
FINAL APPROACH AND LANDING GEOMETRY

The Safety Board believes that the pilot did not select an aiming point sufficiently distant (in keeping with his glide slope) to assure a landing on the runway. Also, no modification of the glide slope was performed which was sufficient and timely, in order to overcome the deficiency in the glide slope. In all other aspects the approach was flown with good procedures and control.

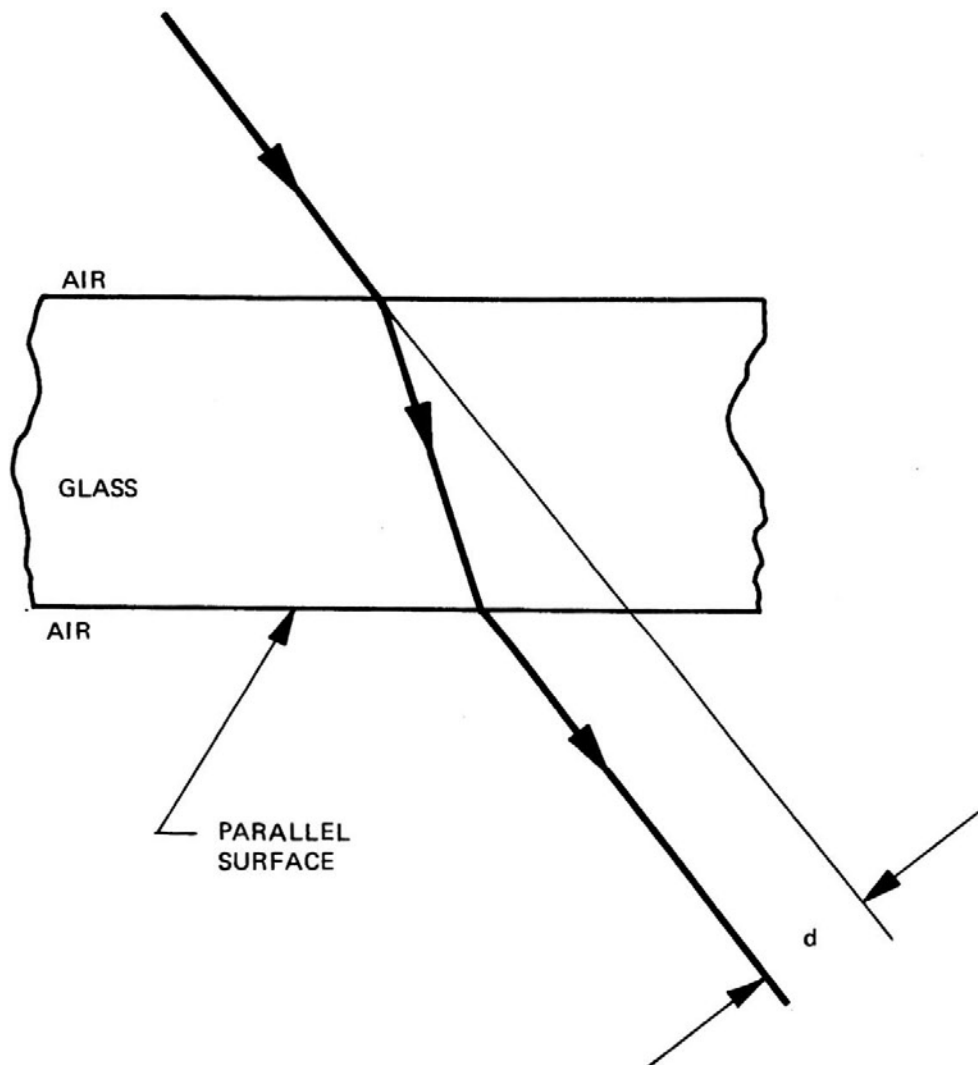
ATTACHMENT 4.

The Board considered the possibility that the curved windshield may have produced distortion or deviation sufficient to have caused the pilot to think that he was higher than he was. A Boeing study reveals that the total displacement is 9.6 feet in 1,000 feet, an amount which would be hardly discernible.

WHEN A LIGHT BEAM STRIKES AT AN ANGLE THE INTERFACE BETWEEN TWO MATERIALS HAVING DIFFERENT INDICES OF REFRACTION, THE LIGHT BEAM IS BENT.

WHEN THE LIGHT BEAM LEAVES A SURFACE PARALLEL TO THE FIRST, IT IS PARALLEL TO THE ENTERING BEAM. THE BEAM IS DISPLACED A DISTANCE "d" FROM ITS ORIGINAL PATH. DISPLACEMENT IS RELATIVELY SMALL.

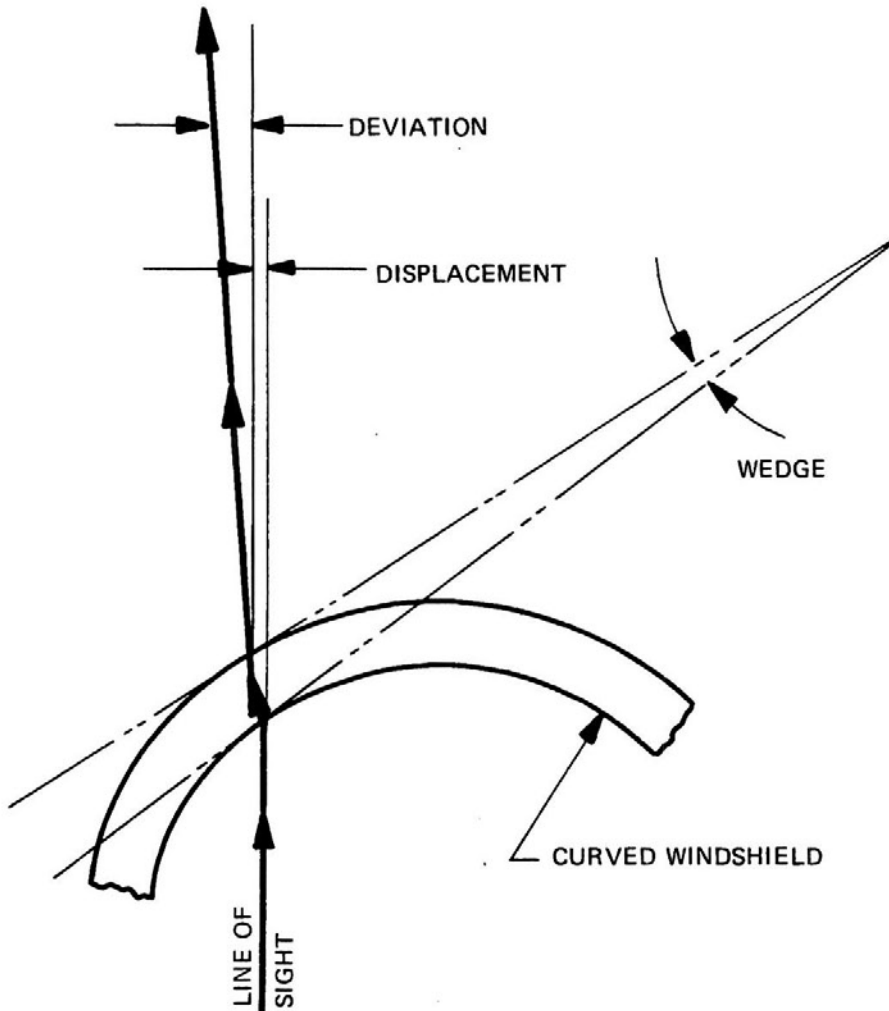
ATTACHMENT 5.

WHEN THE SURFACE THE LIGHT ENTERS IS NOT PARALLEL TO THE SURFACE FROM WHICH IT LEAVES, THE DIRECTION OF THE LIGHT IS CHANGED. THIS IS CALLED THE "WEDGE EFFECT."
