Hard landing, Alitalia Airlines, McDonnell-Douglas DC-8-62, I-DIWZ (Italian Registry), John F. Kennedy International Airport, Jamaica, New York, September 15, 1970

AIRCRAFT ACCIDENT REPORT

MCDONNELL-DOUGLAS DC-8-62, I-DIWZ

REPORT NUMBER: NTSB AAR-71-9

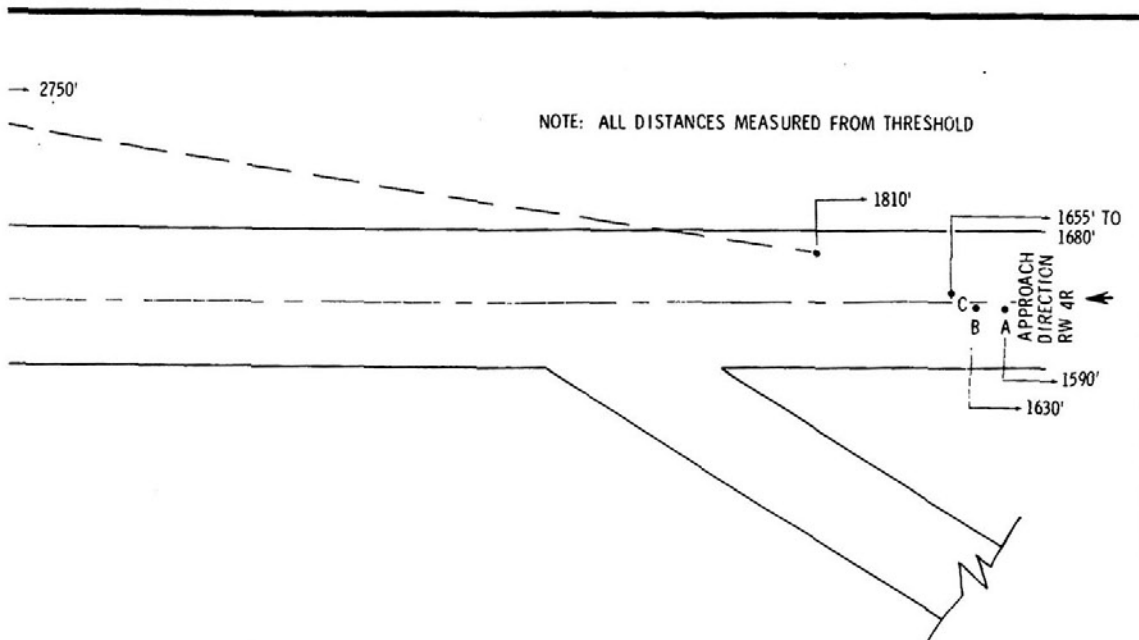
WRECKAGE DISTRIBUTION CHART
ALITALIA DOUGLAS DC-8, I-DIWZ
J.F. KENNEDY INTERNATIONAL AIRPORT, N.Y.
September 15, 1970

11. All mechanical damage sustained was a result of impact with the runway surface.
