**Uncontained engine failure, Overseas National Airways, Inc., Douglas DC-10-30, N1032F, John F. Kennedy International Airport, Jamaica, New York, November 12, 1975**

## **AIRCRAFT ACCIDENT REPORT**

**OVERSEAS NATIONAL AIRWAYS, INC.  
DOUGLAS DC-10-30, N1032F**

**REPORT NUMBER: NTSB-AAR-76-19**

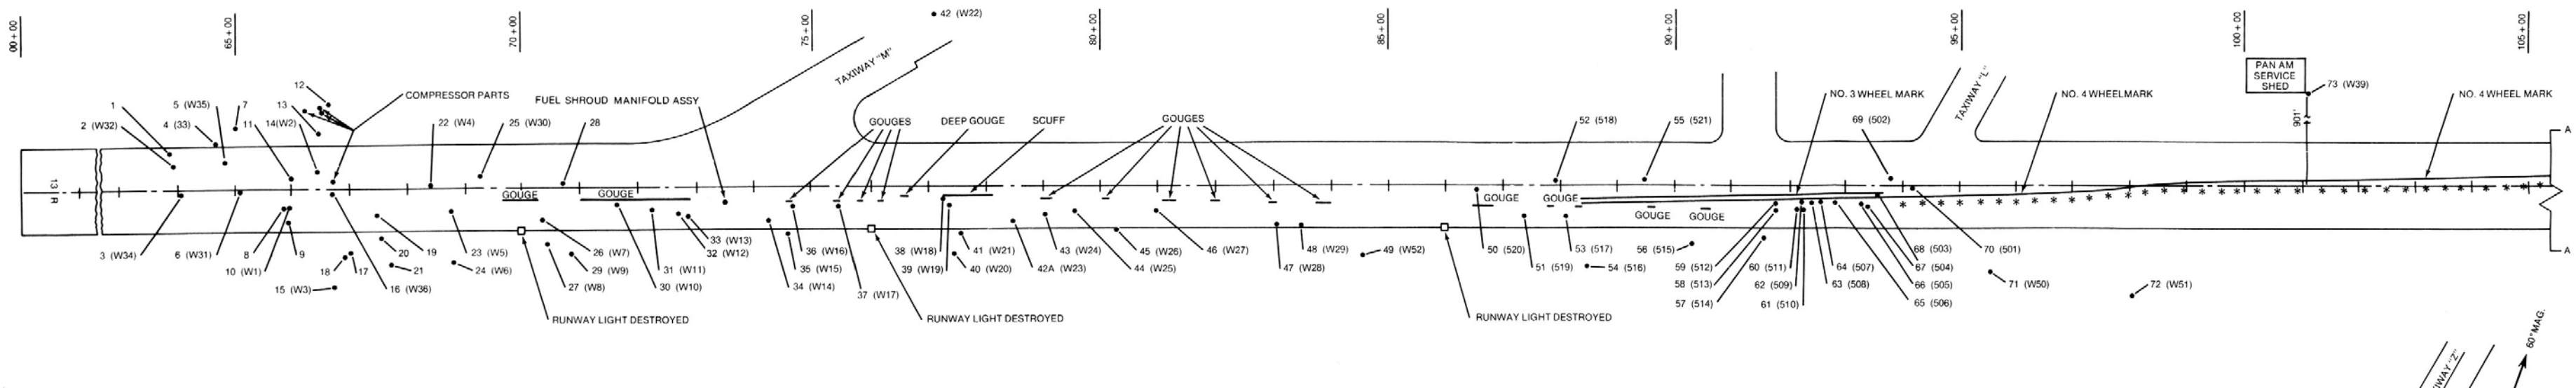
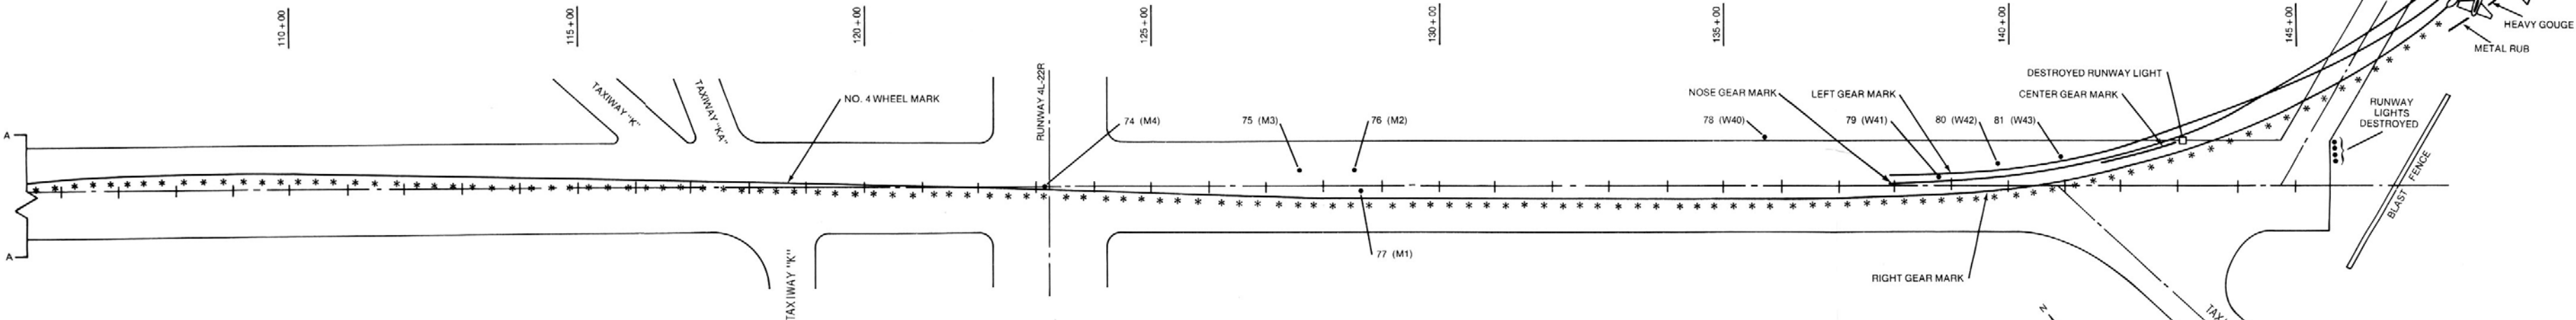
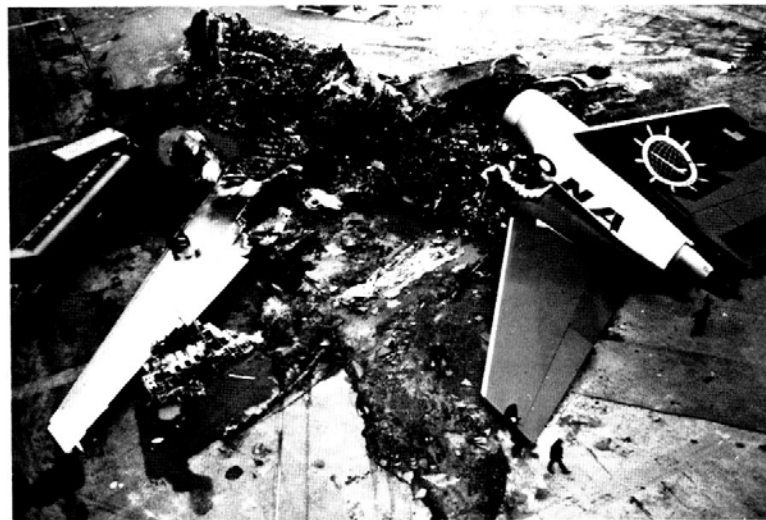
On the south shoulder of taxiway "Z", holes were gouged in the hard surface. A tractor that was parked at the Pan American World Airways tire shop, left of runway 13R, was damaged when struck by the compressor rotor from the No. 3 engine. Several oil drums burned.

Sea gull feathers were found on the runway 6,000 feet from the takeoff end of runway 13R and continued for 400 feet. A vent port recoup duct was found 6,400 feet from the end of runway 13R and to the right of the runway centerline; the bleed duct was from the inner flow path wall of the left-hand fan thrust reverser assembly of the No. 3 engine. A large sea gull was found near the bleed duct, to the left of the runway centerline. High pressure compressor (HPC) blades and vanes were also found near the recoup duct and others were found scattered several hundred feet in the direction of takeoff on both sides of the runway centerline. About 20 sea gulls were found scattered across the runway between 6,400 and 7,100 feet from the takeoff end of the runway. The largest bird weighed 5 lbs., and the average weight of the other birds was between 3 and 4 lbs. Additional engine and cowling parts were located between 6,400 and 9,400 feet from the takeoff end of runway 13R. The largest single piece was the complete fan module located at the 9,400-foot point. A large piece of tire and several smaller pieces were located about 7,000 feet from the takeoff end of runway 13R and to the right of the runway centerline.
