Landing gear collapse, Aircraft Accident Report, New York Airways, Inc. Sikorsky S-61L, N619PA, Pan Am Building Heliport, New York, New York, May 16, 1977

**NEW YORK AIRWAYS, INC.,
SIKORSKY S-61L, N619PA**

PAN AM BUILDING HELIPORT

REPORT NUMBER: NTSB-AAR-77-9

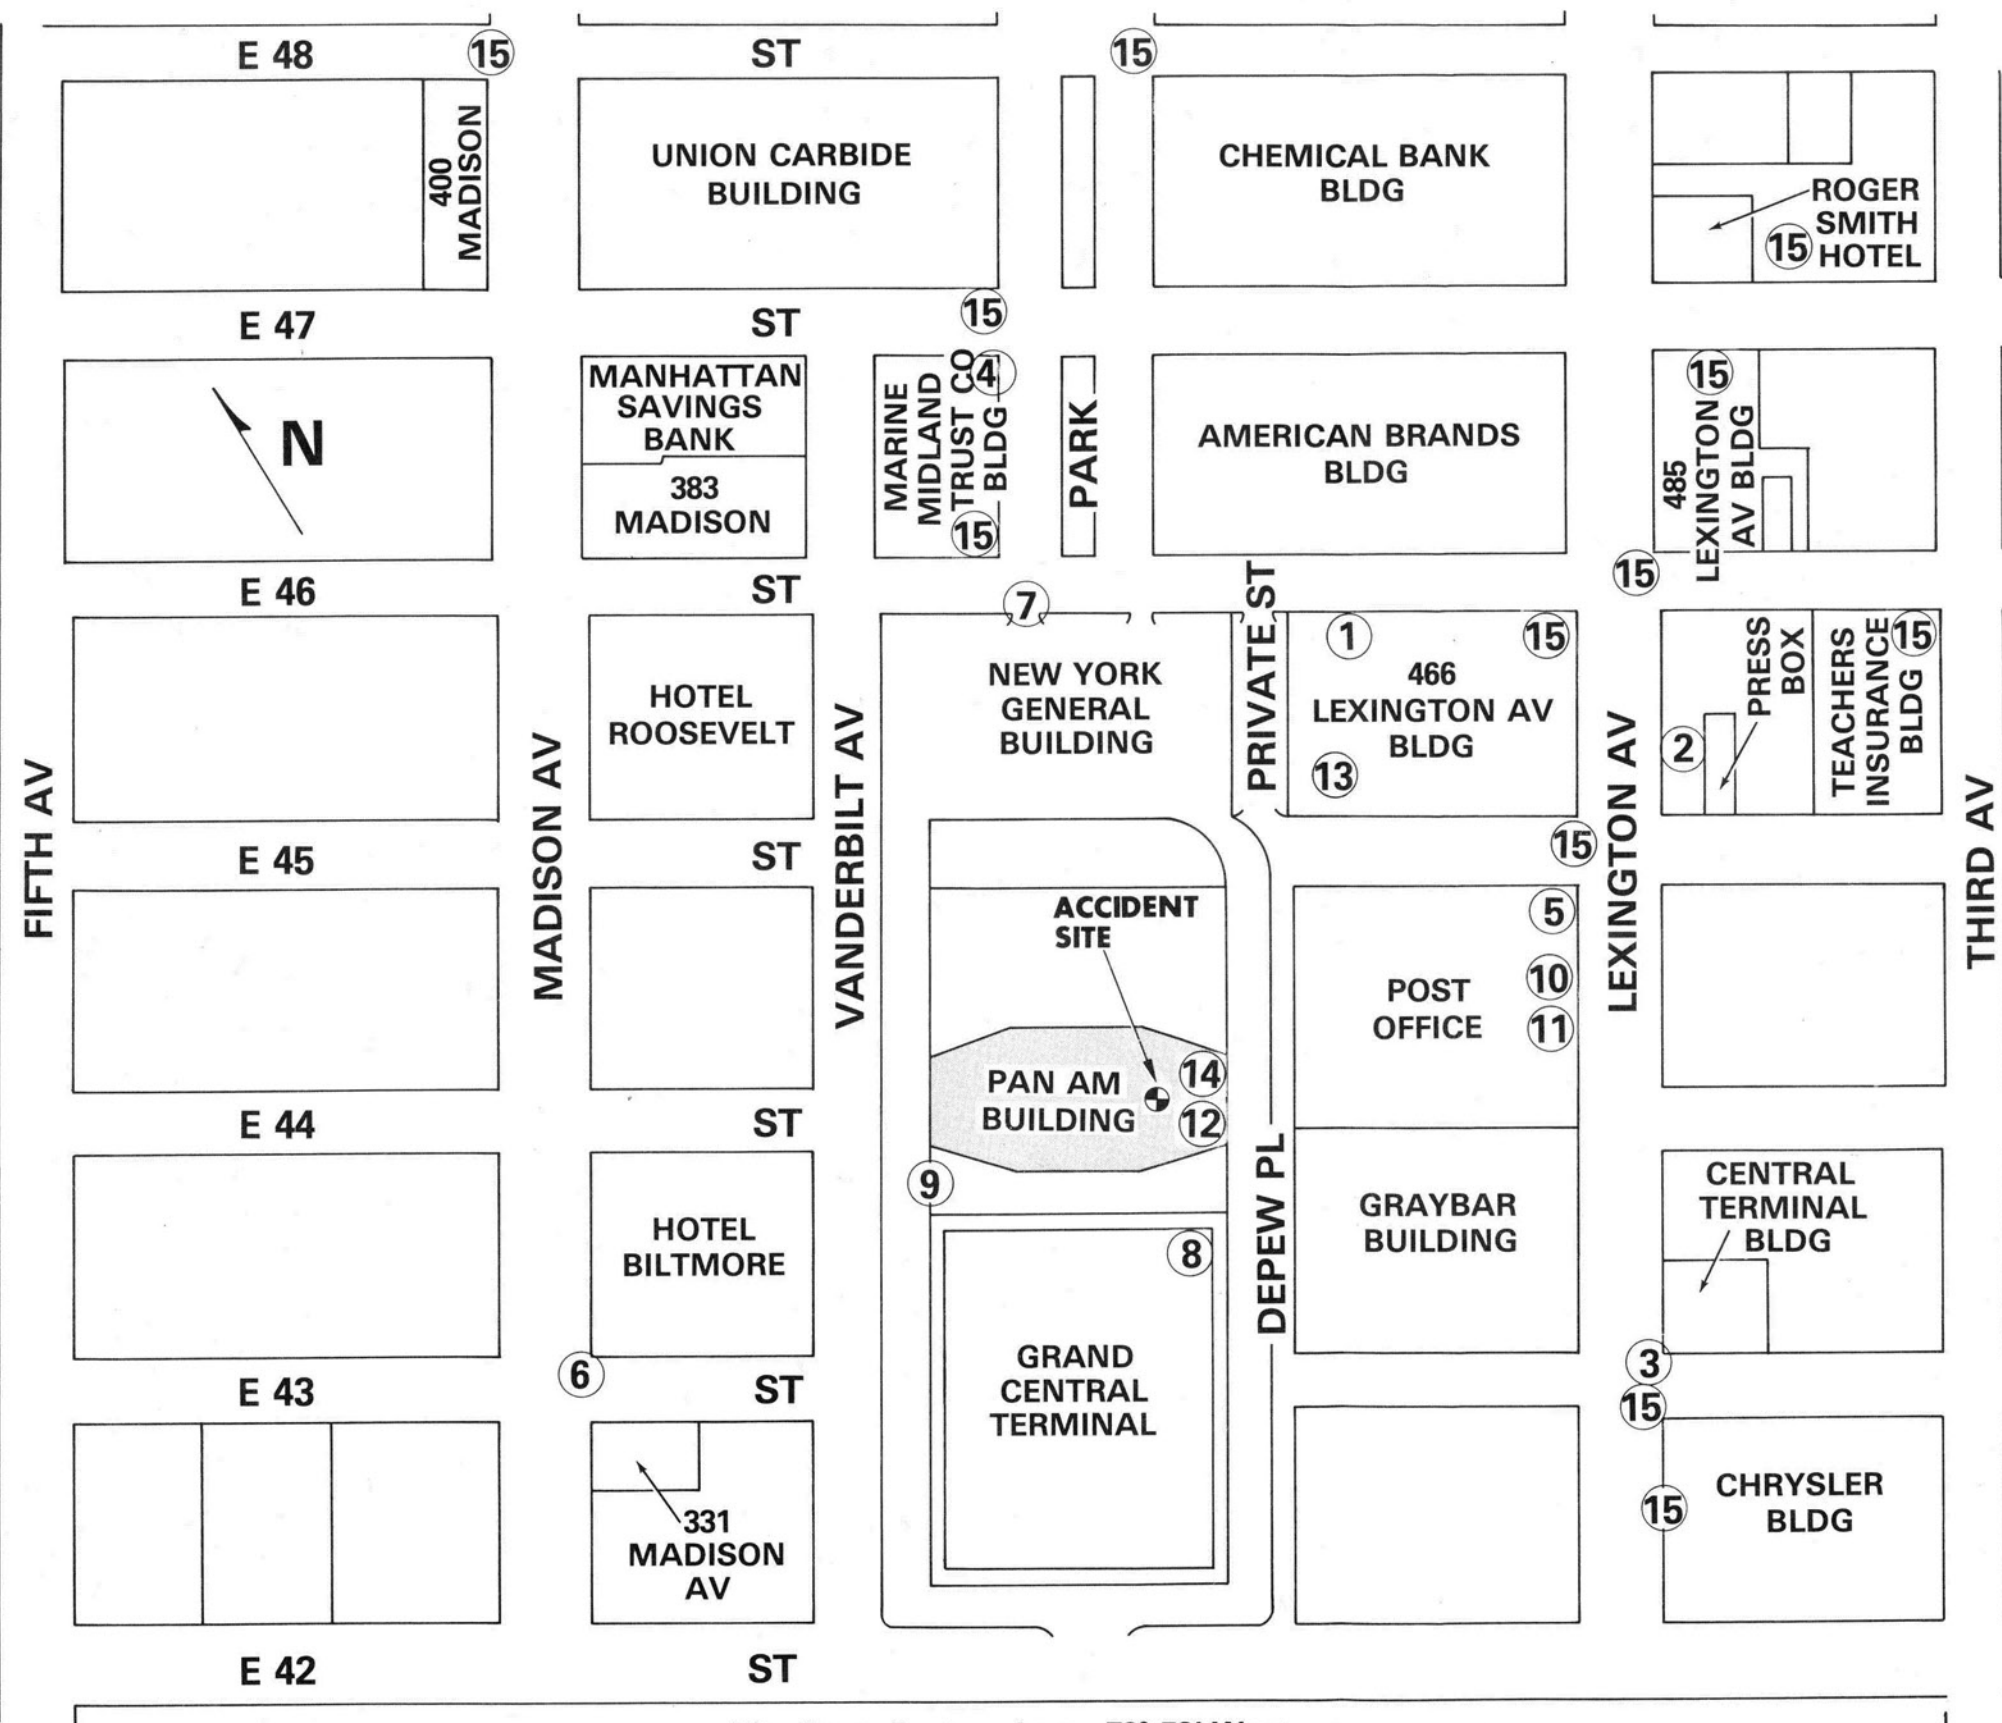
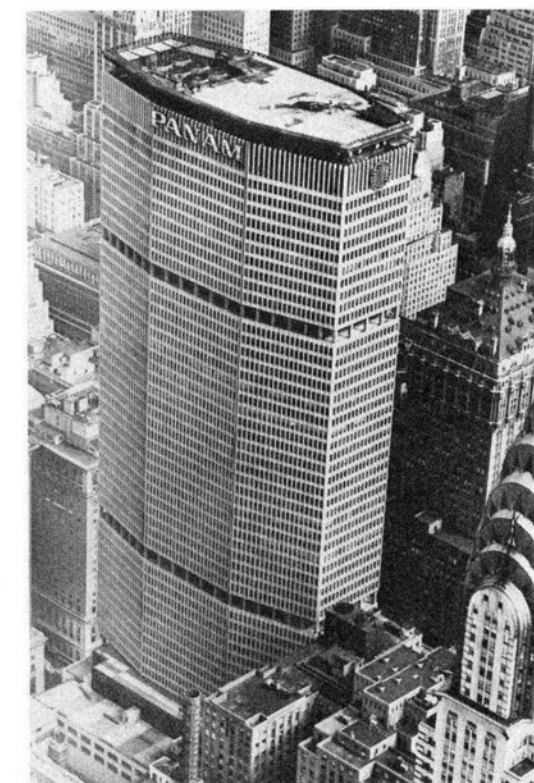
APPENDIX 'D'

1. 4'-5" Outboard Section — Main Blade Spar
2. 4'-6" Spar Section — Outboard End Tip
3. 4'-1" Spar Section — Outboard End Tip
4. 4'-0" Spar Section — Outboard End Tip
5. 0'-11" Spar Section — Outboard End Tip
6. 2'-3" Spar Section — Outboard End Tip
7. 4'-2" Outboard Section — Main Blade Spar
8. 2 Twelve Inch Wide Trailing Edge Pockets
9. 10'-6" Center Section — Main Blade Spar
(Penetrated Window of Office 36th Floor)
10. 2'-4" Outboard Section — Main Blade Spar
11. 1 Twelve Inch Wide Trailing Edge Pocket
12. 3'-6" Outboard Section — Main Blade Spar
(On Heliport)
13. 4'-2" Outboard Section - Main Blade Spar
(Outside Room 369-466 Lexington Ave.)
14. 19'-2" Center Section — Main Blade Spar
(On Heliport Just Forward of Aircraft Nose)
15. Miscellaneous Blade Parts — Pockets,
Leading Edge Counterweights (11 Locations)

Wreckage Distribution Chart
New York Airways Inc.
Sikorsky S-61L N619PA
Pan Am Building Rooftop Heliport
Manhattan, New York
May 16, 1977

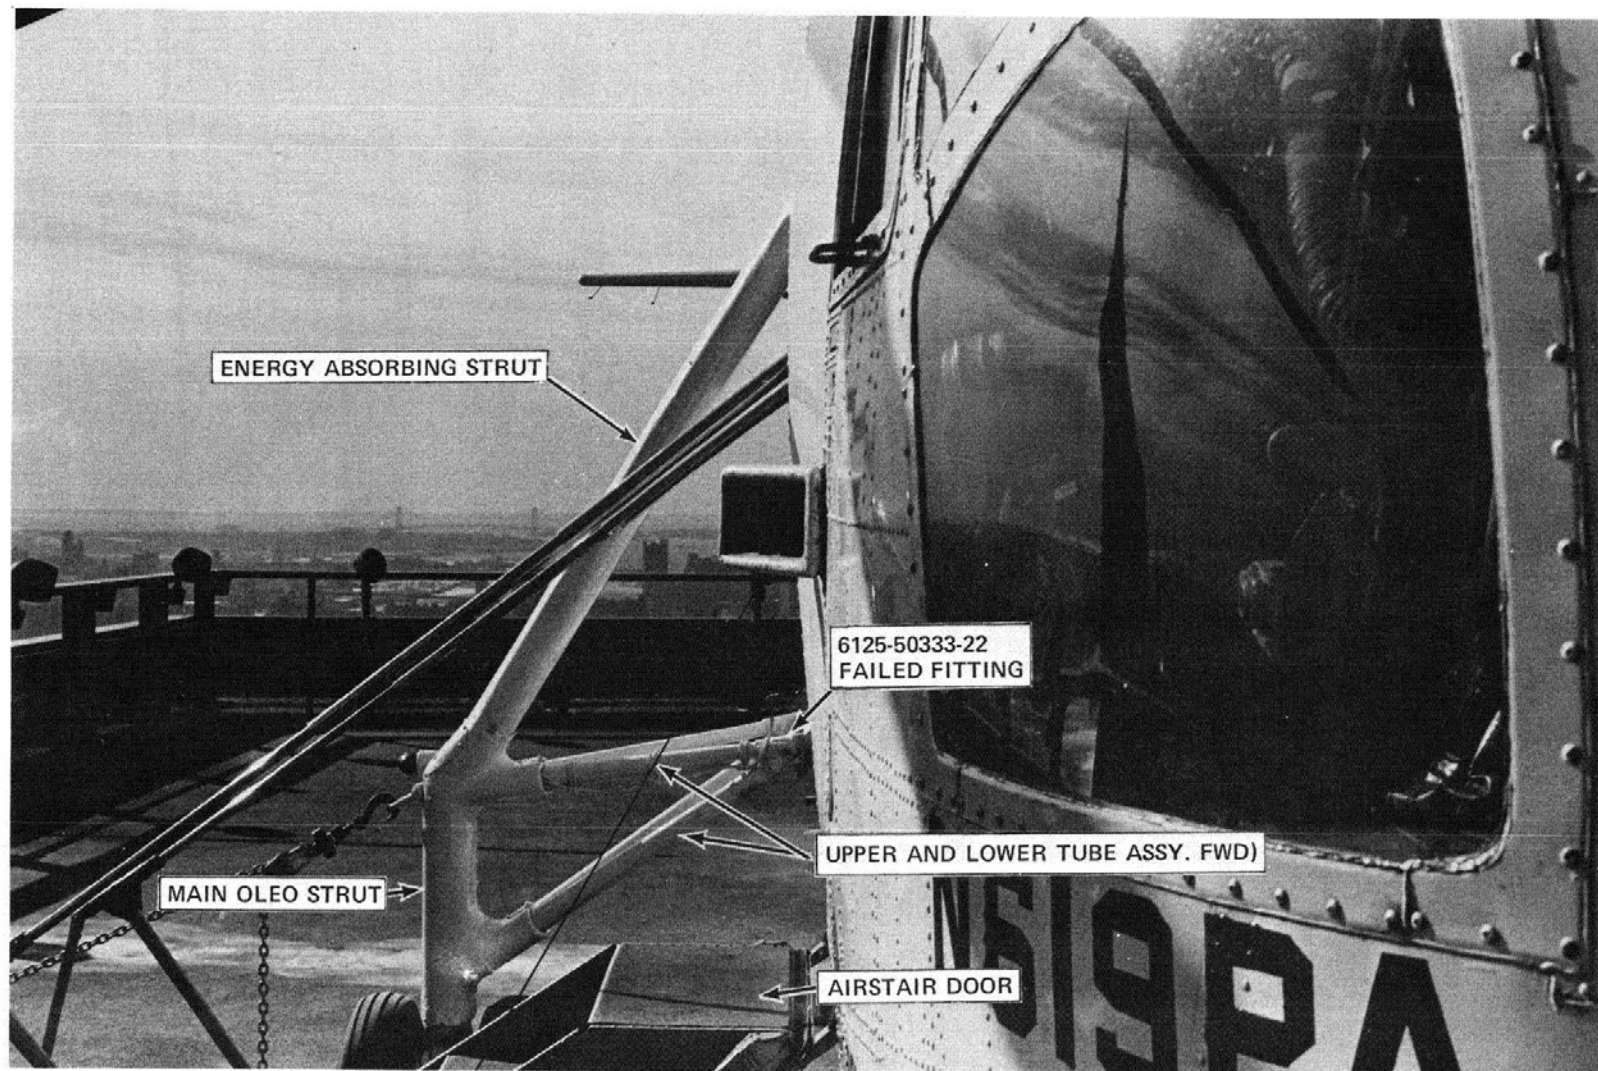
APPENDIX E FIGURE 1

Right main landing gear - S-61L-N619PA photographed on
Pan Am Building rooftop heliport (prior to May 16, 1977 accident date)

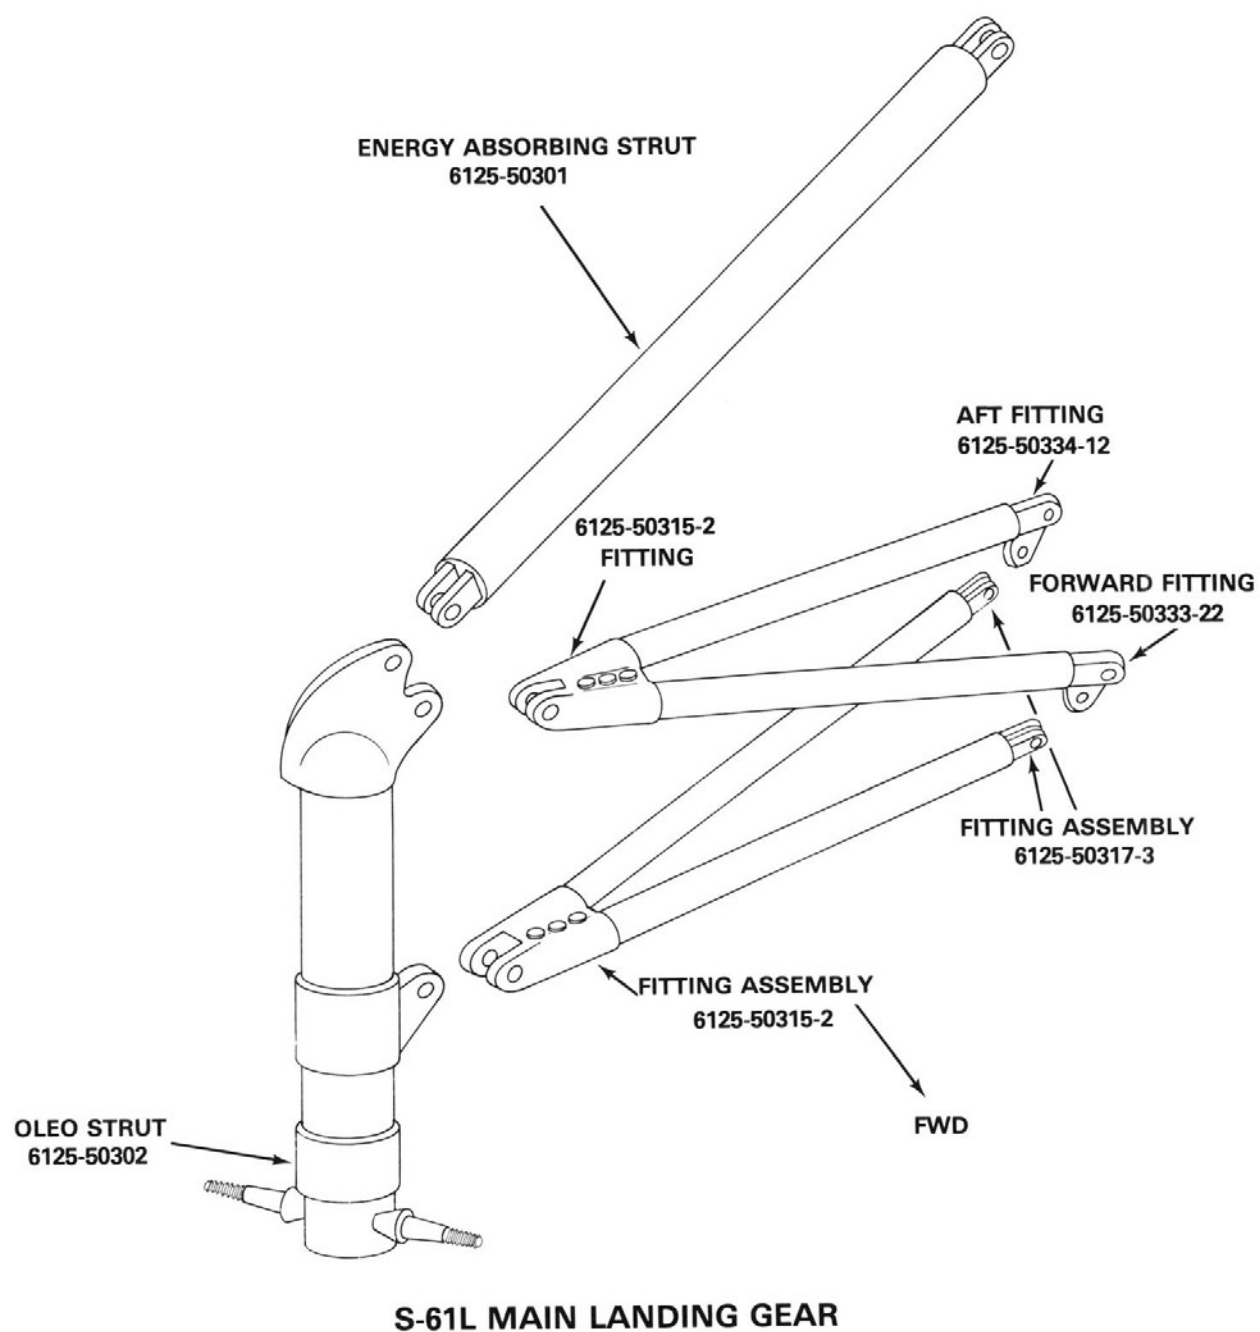
APPENDIX F

Figure 2. Right hand main landing gear fitting (P/N S6125-50333-2) with the fractures (arrows "a" figure 1) placed relative to each other as if intact. Inboard attachment bolt was removed from the hole.
