Runway overrun, Continental Air Lines, Inc., McDonnell-Douglas DC-10-10, N68045, Los Angeles, California, March 1, 1978

AIRCRAFT ACCIDENT REPORT

**CONTINENTAL AIR LINES, INC.,
McDONNELL-DOUGLAS DC-10-10, N68045
LOS ANGELES, CALIFORNIA
MARCH 1, 1978**

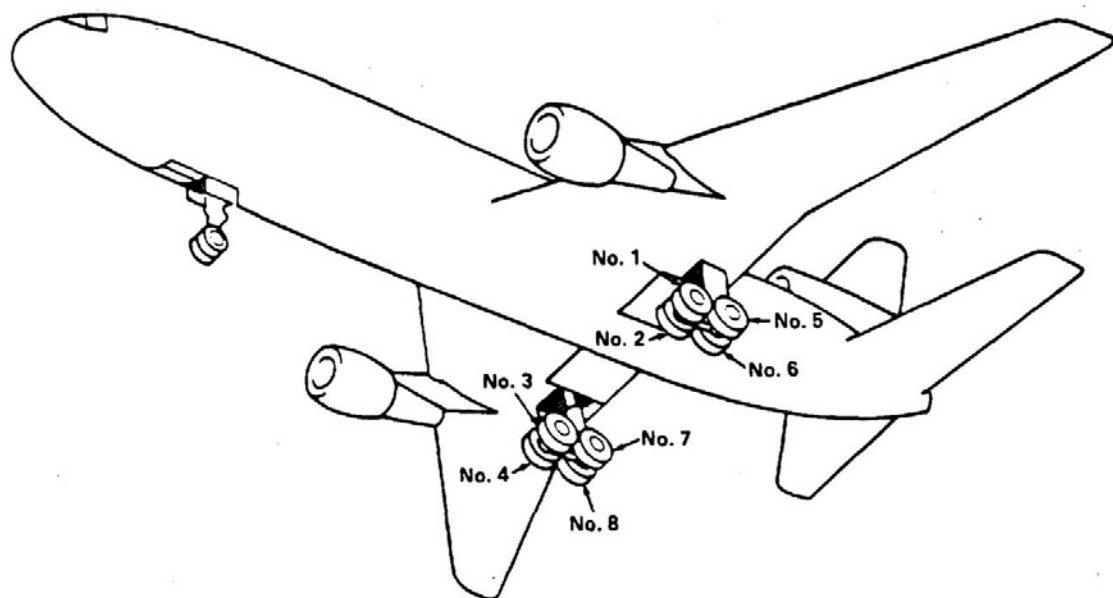
The wheel, brake, and tire positions on the DC-10-10 main landing gear are designated by number, from left to right, beginning with the forward tires. (See figure 1.) Nos. 1 and 2 are the forward positions on the left main gear, Nos. 3 and 4 are the forward positions on the right main gear. Nos. 5 and 6 are the aft positions on the left main gear, and Nos. 7 and 8 are the aft positions on the right main gear. The tires in positions 4, 6, and 8 were on their first retread cycle; those in positions 3 and 5 were on their second retread cycle; and those in positions 1, 2, and 7 were on their third retread cycle. It was the company's policy to replace a tire after its third retread cycle.

Figure 1. DC-10-10 main landing gear tire/wheel assembly positions.
