Midair collision, Pacific Southwest Airlines, Inc., Boeing 727-214, N533PS, Flight 182, Gibbs Flite Center, Inc., Cessna 172, N7711G, San Diego, California, September 25, 1978

AIRCRAFT ACCIDENT REPORT

**PACIFIC SOUTHWEST AIRLINES, INC.,
B-727, N533PS AND**

**GIBBS FLITE CENTER, INC.,
CESSNA 172, N7711G**

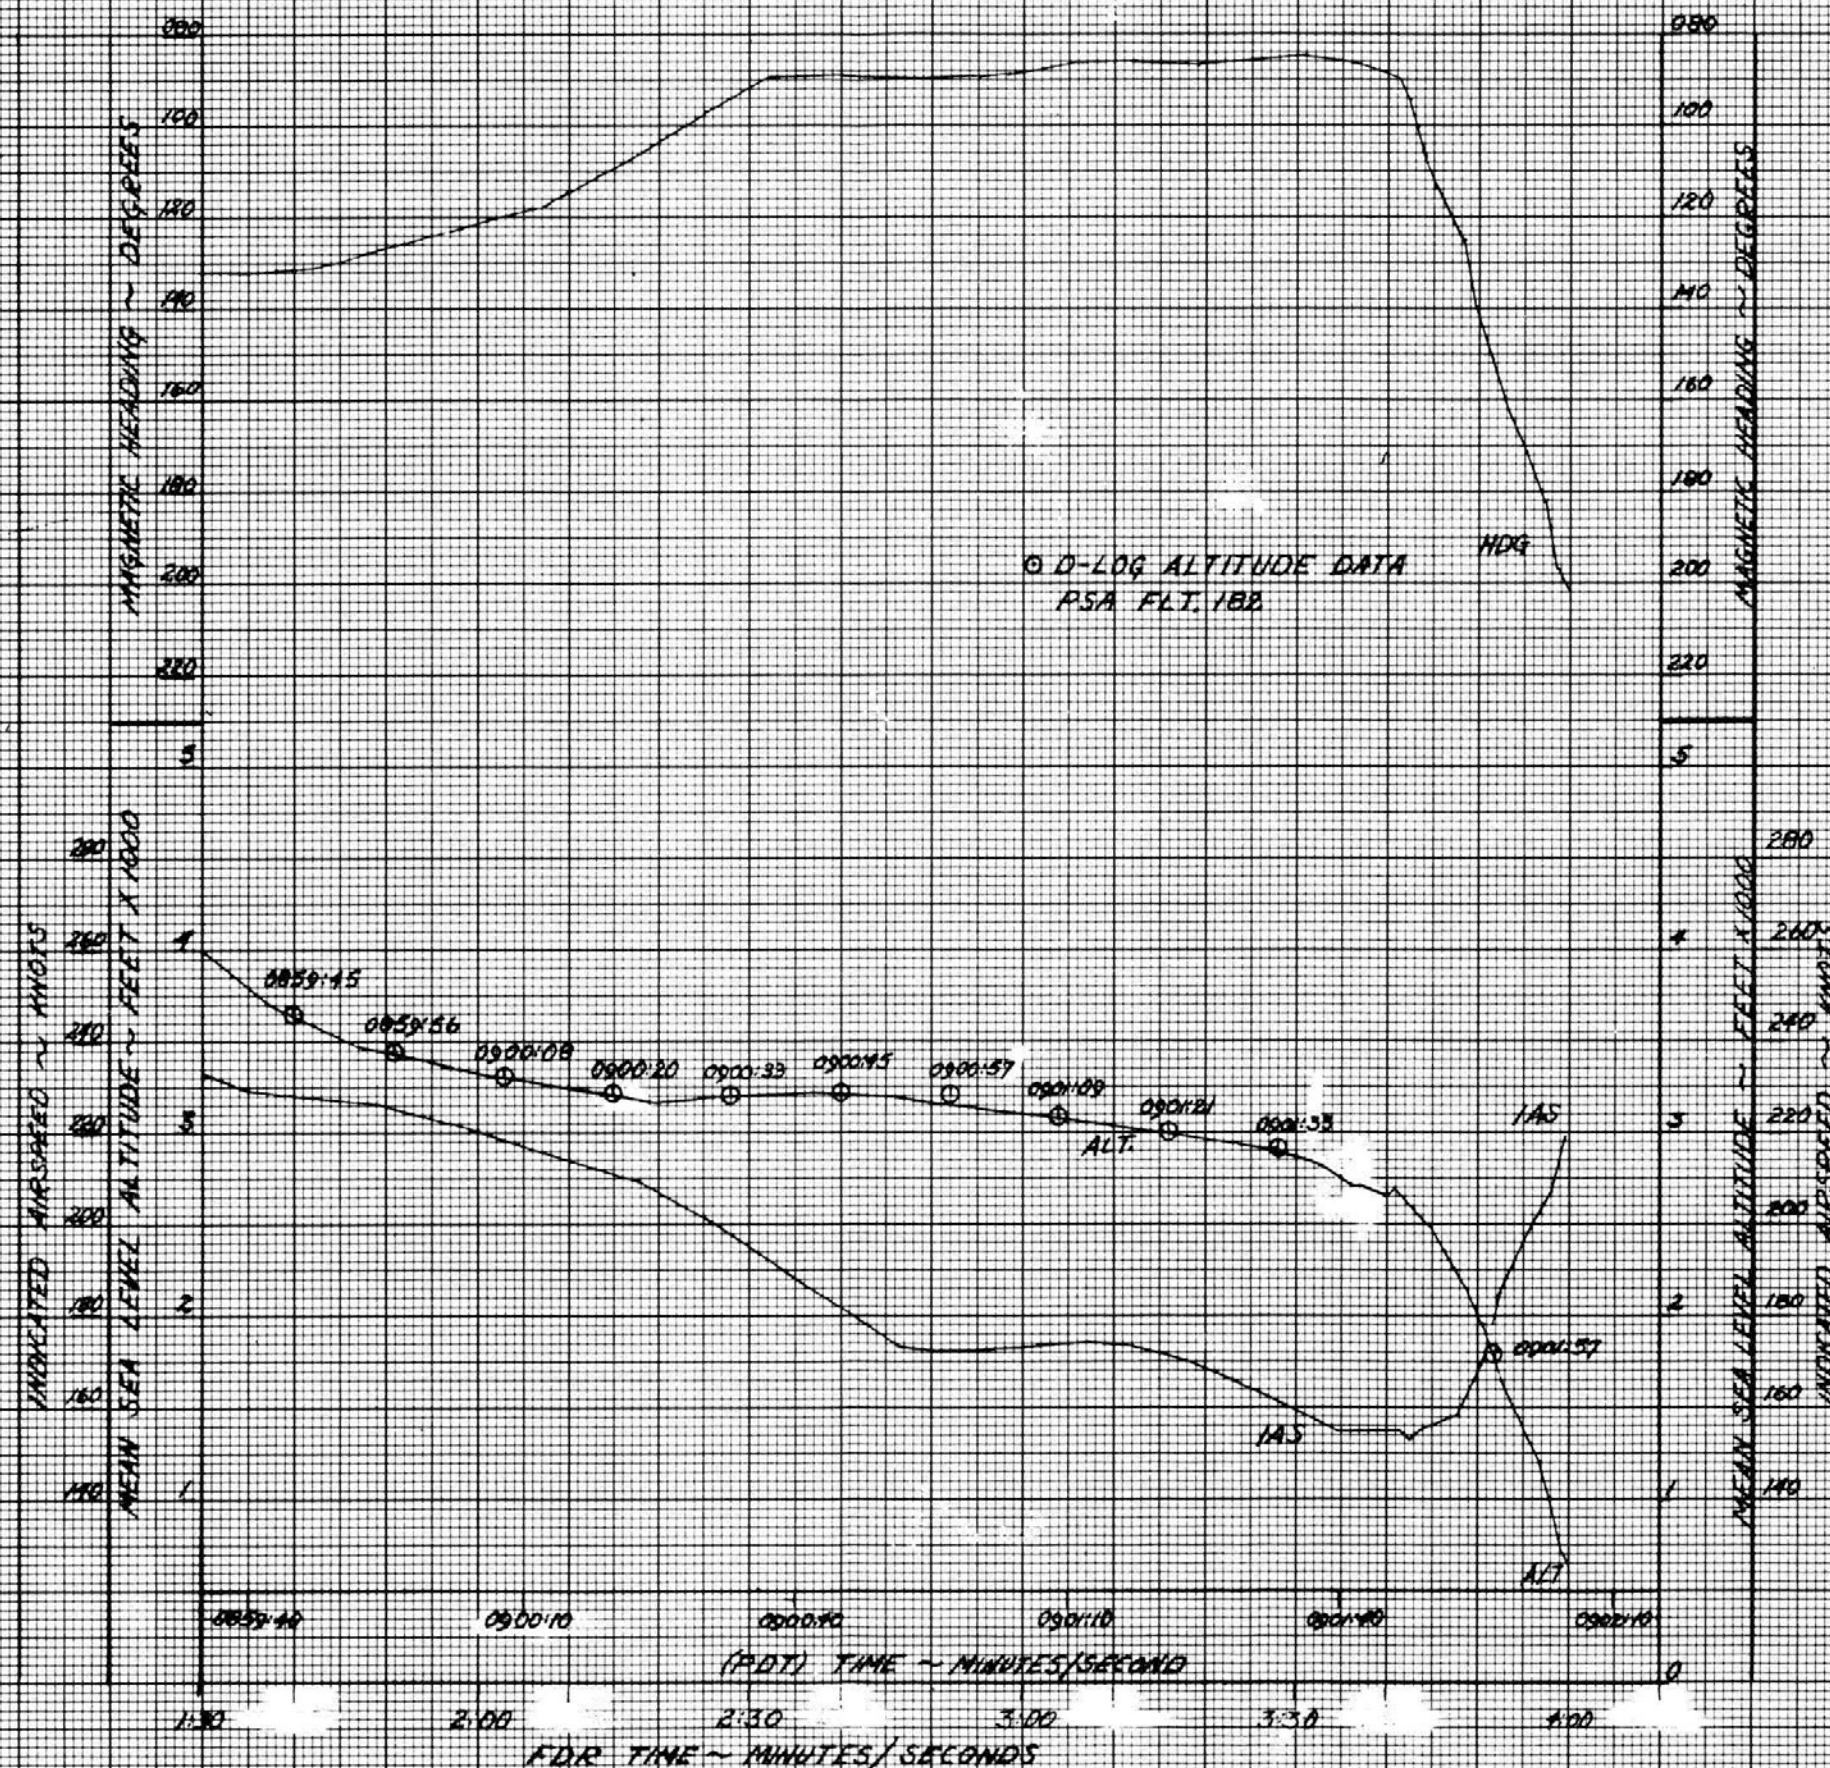
APPENDIX G

PACIFIC SOUTHWEST AIRLINES, BOEING 747
FLT 182, N533PS, SAN DIEGO CALIF., SEPT 25, 1978
MID-AIR COLLISION WITH CESSNA 172
FLIGHT DATA RECORDER GRAPH
NAS STAGE-A D-LOG ALTITUDE DATA

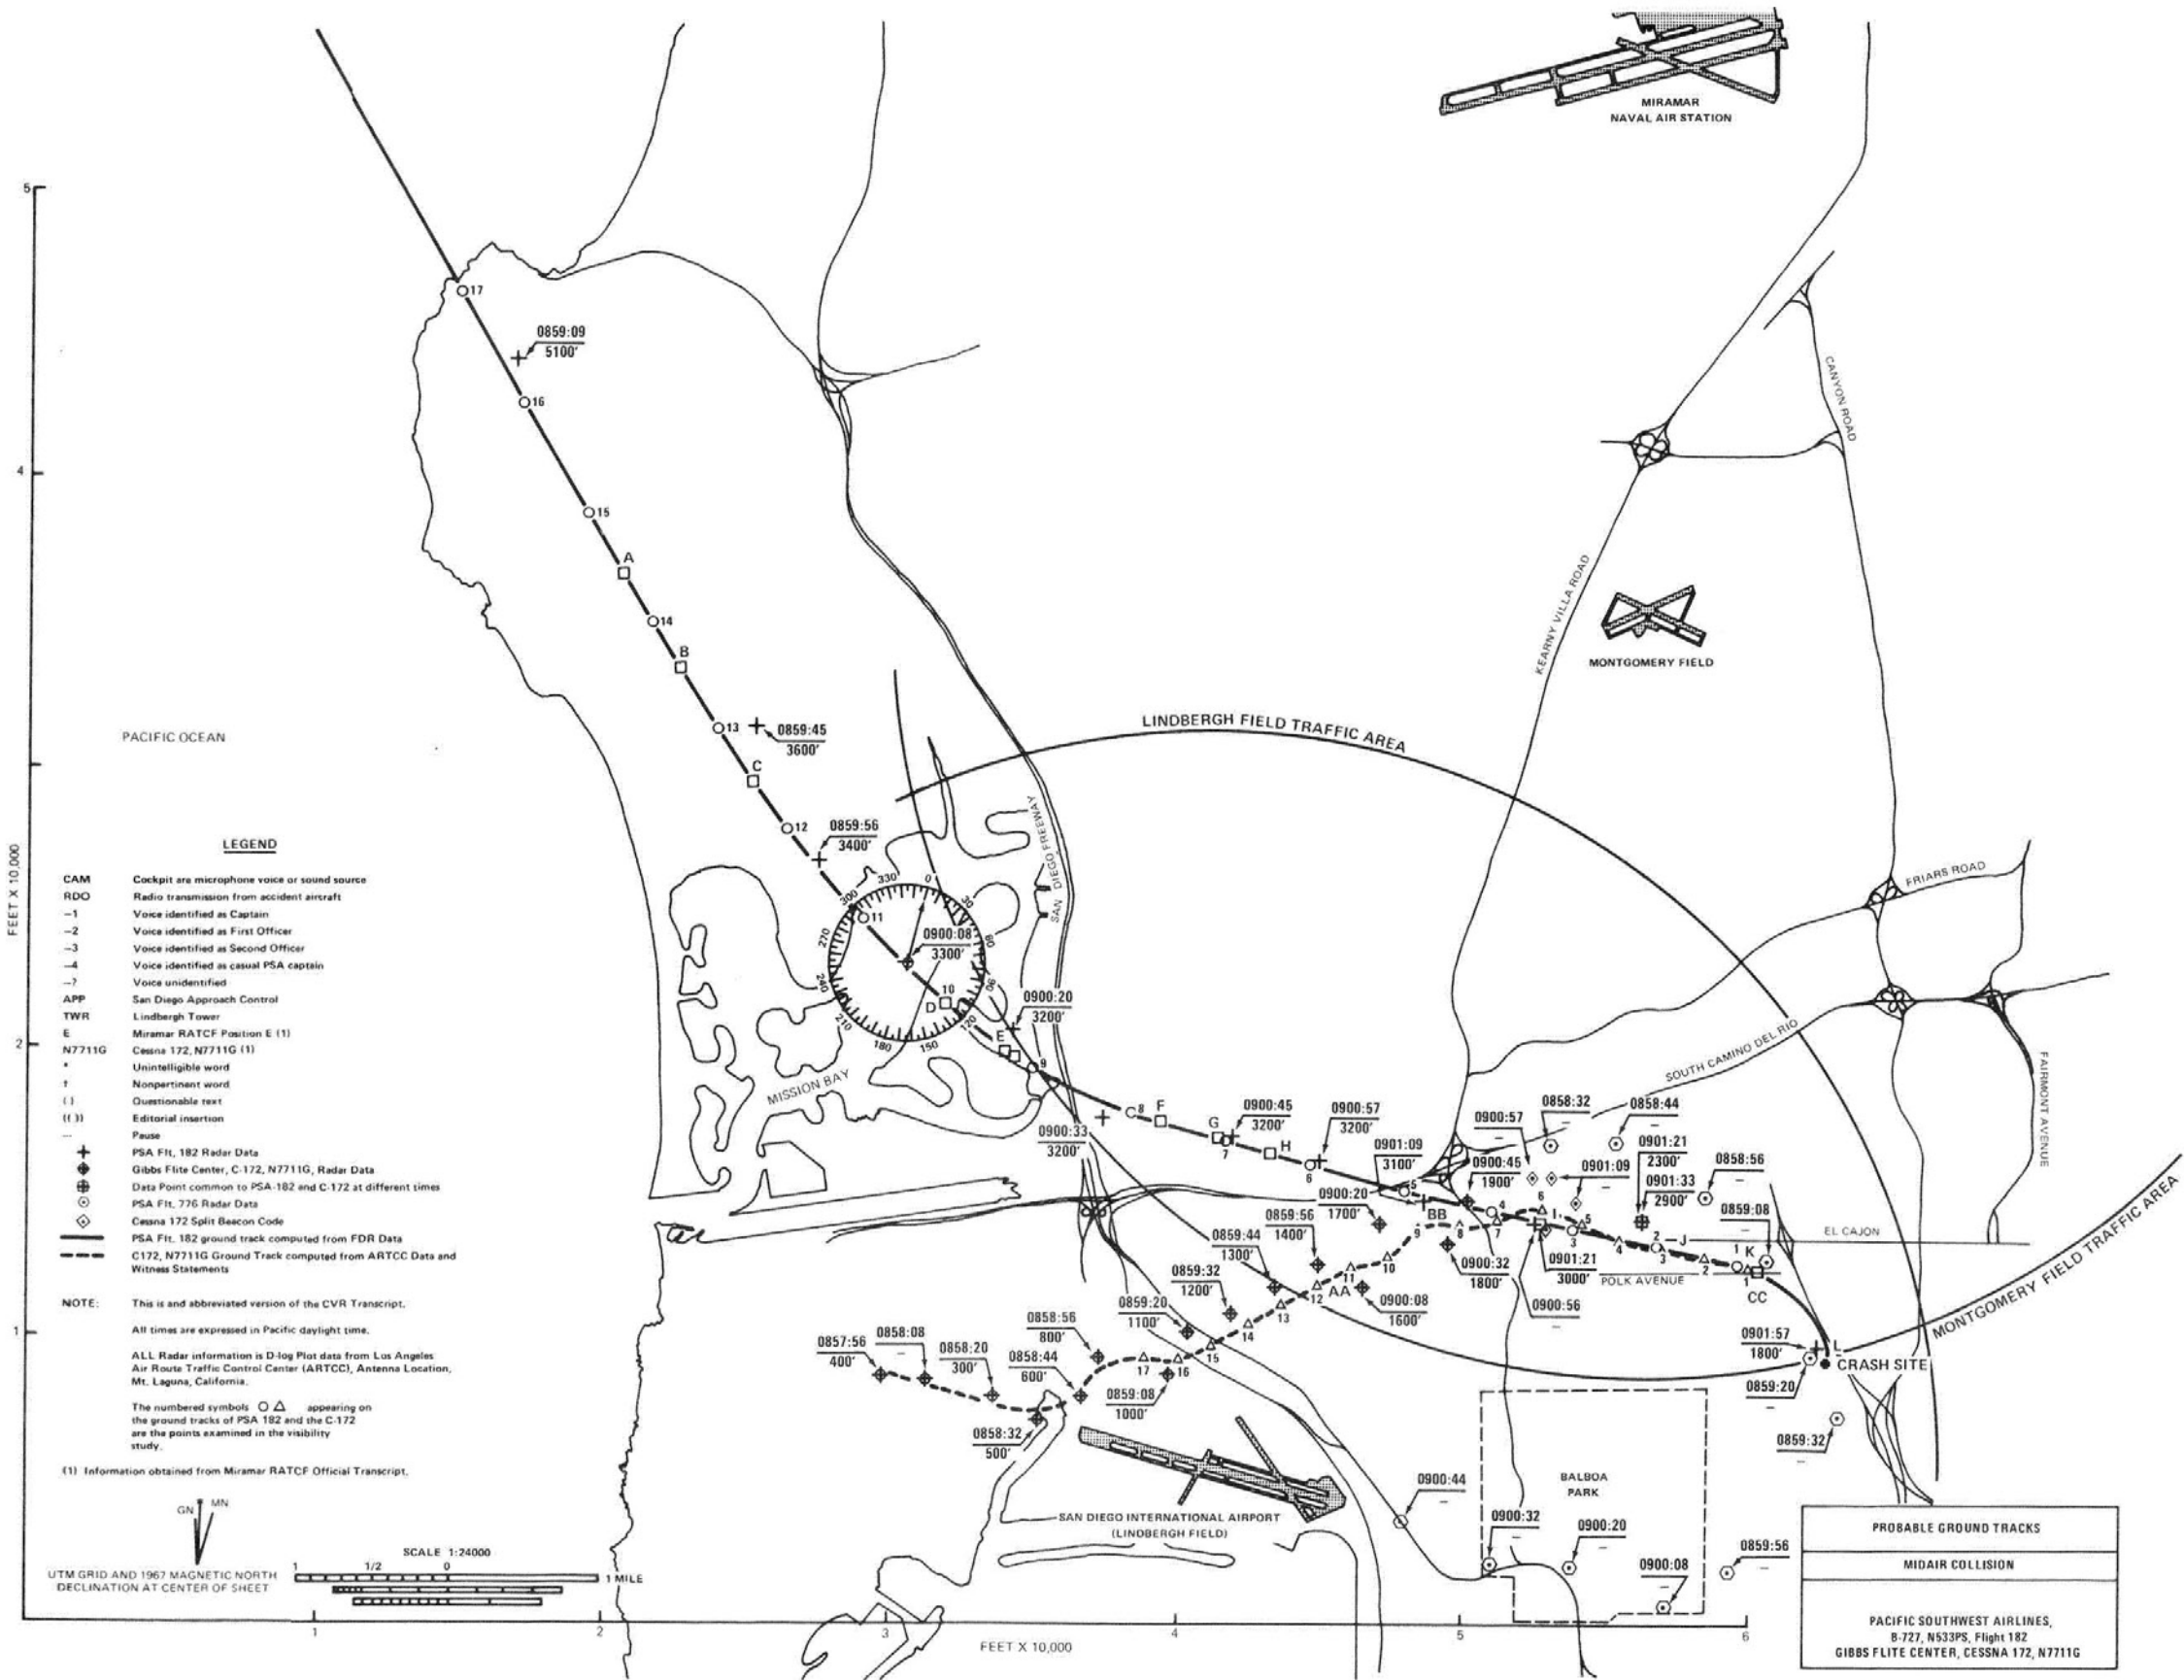
APPENDIX H

0859:30 APP	PSA one eighty-two, traffic twelve o'clock, one mile northbound	0901:11 CAM-2	Are we clear of that Cessna?
0859:35 RDO-1	We're looking	0901:13 CAM-3	Suppose to be
B 0859:39 APP	PSA one eighty-two, additional traffic's, ah, twelve o'clock, three miles just north of the field northeastbound, a Cessna one seventy-two climbing VFR out of one thousand four hundred	0901:14 CAM-1	I guess
C 0859:50 RDO-2	Okay we've got that other twelve	0901:20 CAM-4	I hope
0859:57 APP	Cessna seven seven one one golf, San Diego departure radar contact, maintain VFR conditions at or below three thousand five hundred, fly heading zero seven zero, vector final approach course	I 0901:21 CAM-1	Oh yeah, before we turned downwind, I saw him about one o'clock, probably behind us now
D 0900:15 APP	PSA one eighty-two, traffic's at twelve o'clock, three miles out of one thousand seven hundred	0901:38 CAM-2	There's one underneath

E 0900:21 CAM-2	Got 'em	J 0901:39 CAM-2	I was looking at that inbound there
0900:22 RDO-1	Traffic in sight	0901:45 CAM-1	Whoop!
0900:23 APP	Okay, sir, maintain visual separation, contact Lindbergh tower one three three point three, have a nice day now	0901:46 CAM-2	Aghhh!
0900:28 RDO-1	Okay	K 0901:47 CAM	((Sound of impact))
0900:34 RDO-1	Lindbergh PSA one eighty-two downwind	0901:49 CAM-1	Easy baby, easy baby
F 0900:38 TWR	PSA one eighty-two, Lindbergh tower, ah, traffic twelve o'clock one mile a Cessna	0901:51 CAM	((Sound of electrical system reactivation tone on voice recorder, system off less than 1 second))
0900:41 CAM-2	Flaps five	0901:51 CAM-1	What have we got here?
0900:43 CAM-1	Is that the one we're looking at	0901:52 CAM-2	It's bad
0900:43 CAM-2	Yeah, but I don't see him now	0901:53 CAM-2	We're hit man, we are hit
G 0900:44 RDO-1	Okay, we had it there a minute ago	0901:55 RDO-1	Tower we're going down, this is PSA
