## **In-flight upset, Trans World Airlines, Inc., Boeing 727-31, N840TW, near Saginaw, Michigan, April 4, 1979**

**TRANS WORLD AIRLINES, INC.,  
BOEING 727-31, N840TW  
NEAR SAGINAW, MICHIGAN  
APRIL 4, 1979**

**NTSB-AAR-81-8**

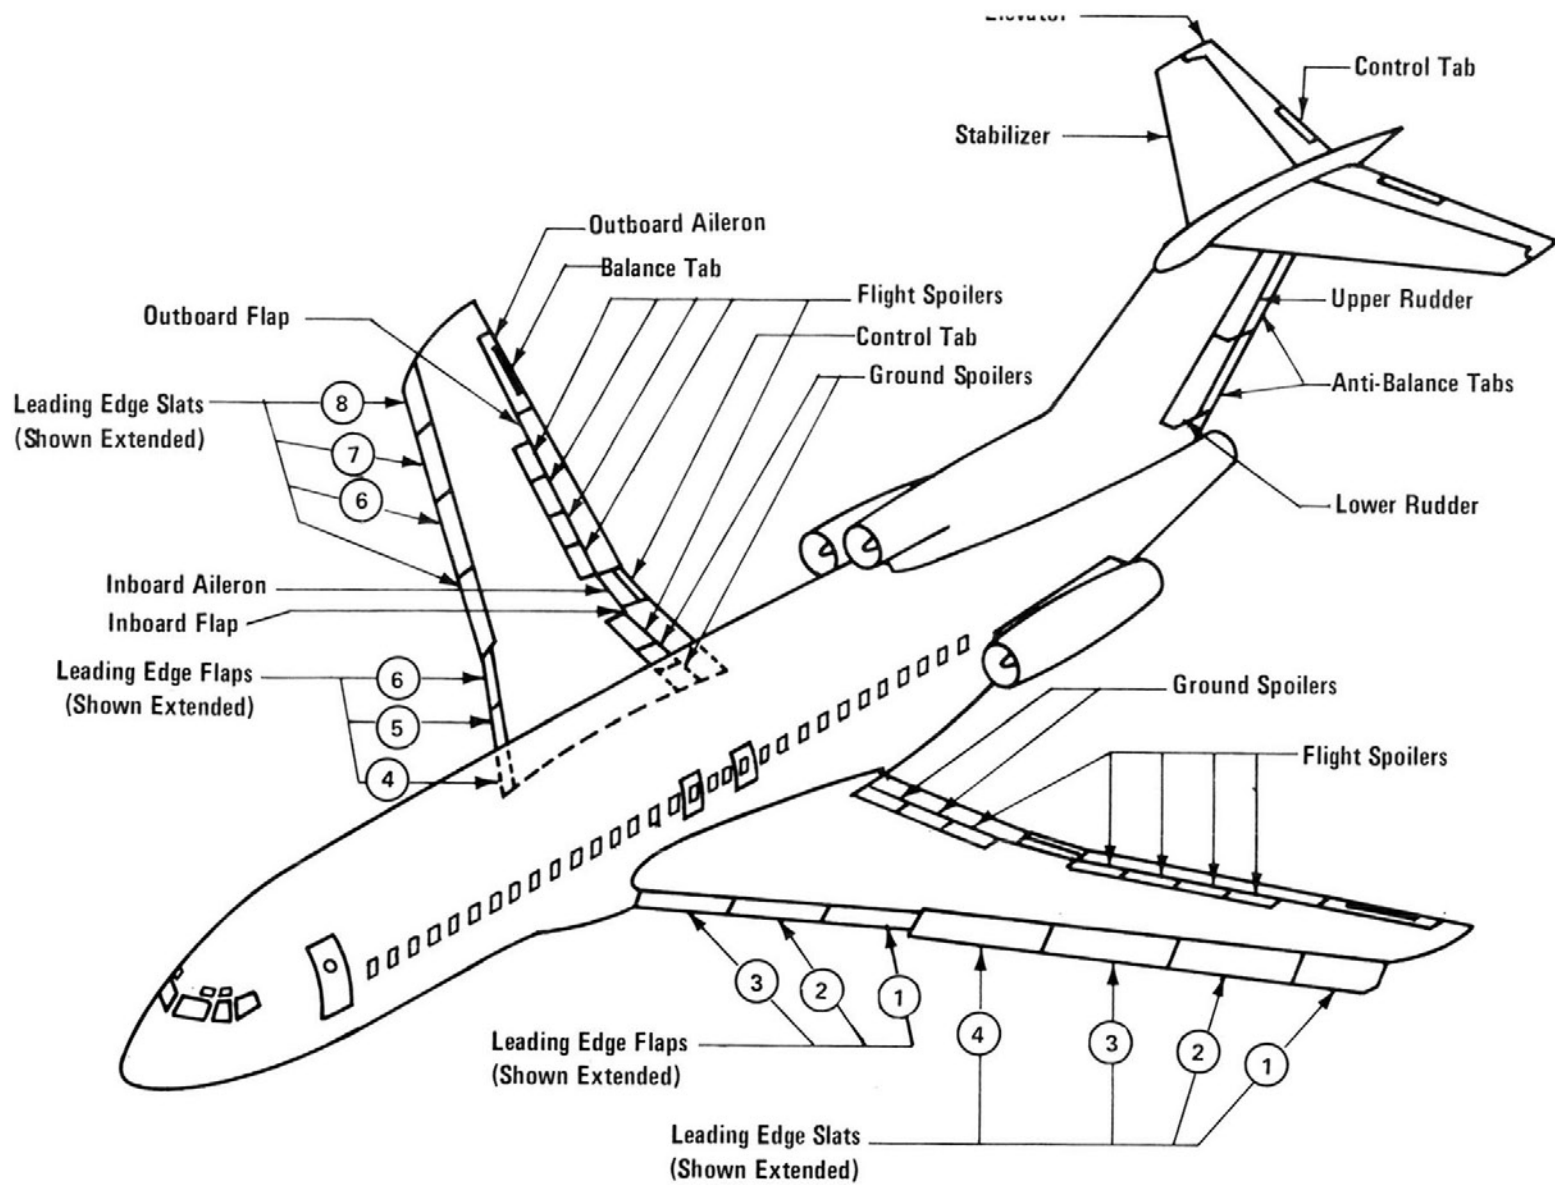
Figure 1.--B-727 flight control system surfaces.

The B-727 has eight individual leading edge slats and four individual leading edge flaps. The slats are mounted on the outboard positions of the wings and are numbered 1 through 4 on the left wing and 5 through 8 on the right wing. The flaps are on the inboard portion of the wings. (See figure 1.) The leading edge slats and flaps are high lift devices that are extended for takeoff and landing. (See figure 2.) According to the TWA Flight Handbook, the maximum speed and altitude with the leading edge devices extended are 240 knots and 25,000 feet, respectively, and the maximum speed for extension and retraction is 230 knots.

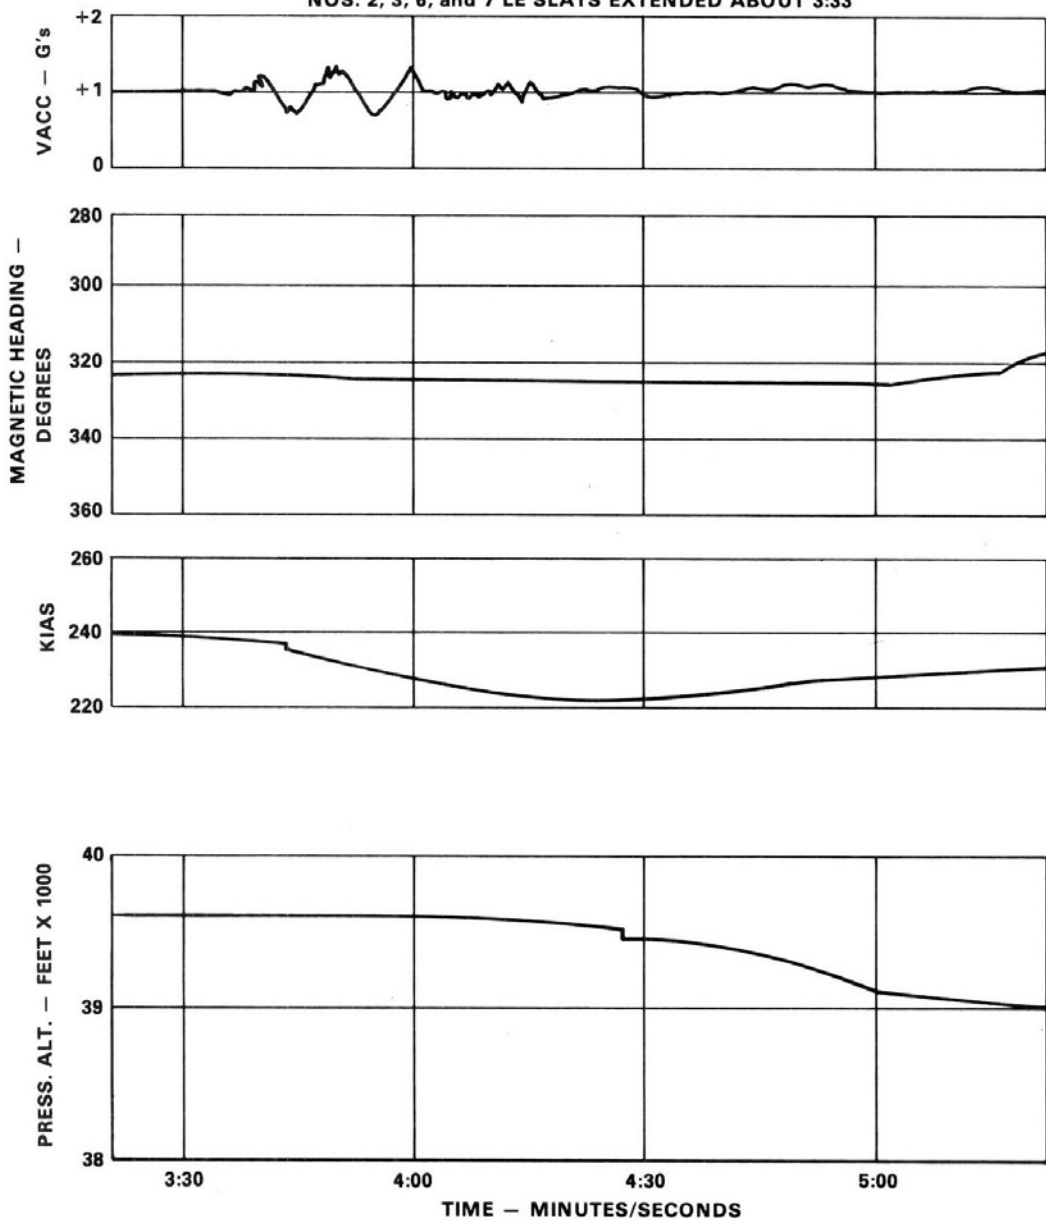
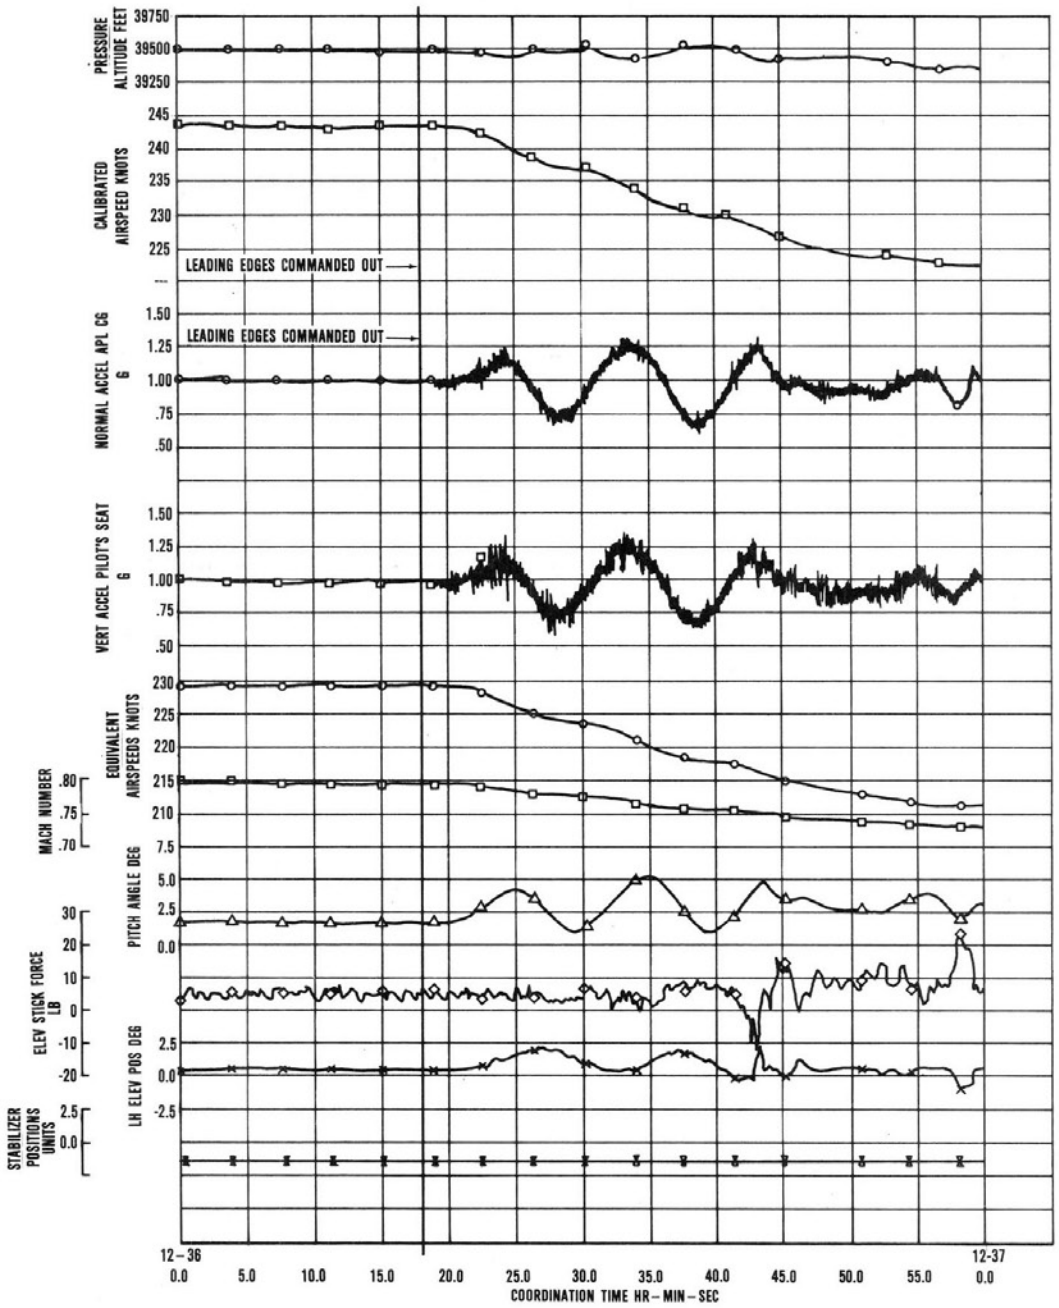
**APPENDIX F**  
**FLIGHT TEST DATA**

**FLIGHT TEST — FDR**  
**AIRCRAFT CONFIGURATION — — — TE FLAPS 2°**  
**NOS. 2, 3, 6, and 7 LE SLATS EXTENDED ABOUT 3:33**
