Midair Collision of Aeronaves De Mexico, S.A., McDonnell Douglas DC-9-32, XA-JED, and Piper PA-28-181, N4891F, Cerritos, California, August 31, 1986

AIRCRAFT ACCIDENT REPORT

**COLLISION OF
AERONAVES DE MEXICO, S.A.
McDONNELL DOUGLAS DC-9-32, XA-JED
AND PIPER PA-28-181, N4891F
CERRITOS, CALIFORNIA
AUGUST 31, 1986**

NTSB/AAR-87/07

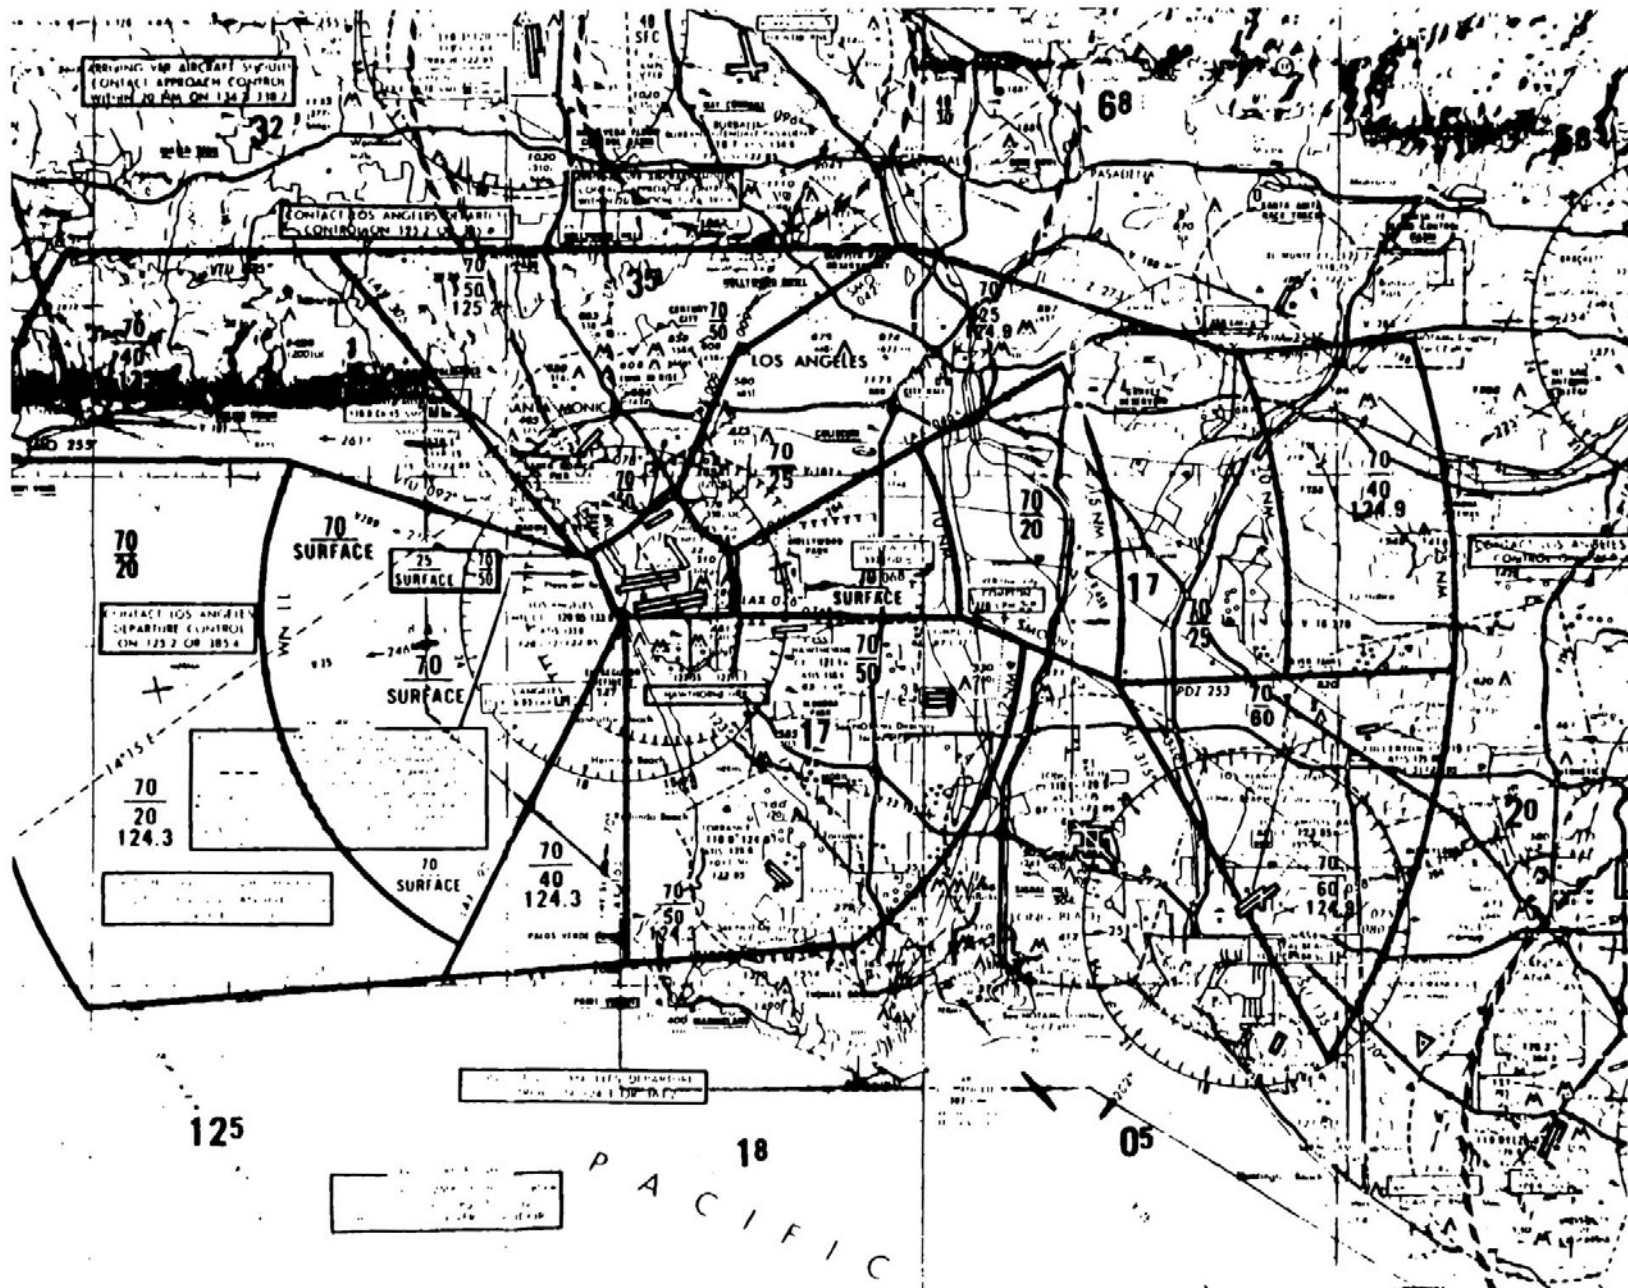
Figure-1.--Los Angeles Terminal Control Area (TCA).

L.A. International is located near the center of its TCA. Except for a triangular segment in the vicinity of Long Beach, California, the apex of which extends northward from its southern boundary, the TCA is essentially a parallelogram. Its western and eastern boundaries are about 20 nmi and 25 nmi, respectively, from the western edge of L.A. International. The TCA's northern and southern boundaries are essentially parallel to the extended centerlines of L.A. International's four runways and are each about 10 nmi from the center of the airport, respectively. (See figure 1.)

Vertically, the TCA resembles an "upside down" wedding cake, beginning at the surface at L.A. International and rising to a ceiling of 7,000 feet. Proceeding westward from the airport and aligned with the extended centerlines of the airport's runways, the floor of the TCA remains at the surface. Between 11 nmi and 20 nmi west of the airport, the floor rises to 2,000 feet. A similar gradient exists along the eastward extensions of the four runway centerlines. To the north and south of the airport and the extended centerlines of the four runways, the floor of the TCA rises sharply. (See figure 1.)

The TCA charts show that Torrance Municipal Airport is under the southern edge of the TCA and that the floor of the TCA above the airport is 5,000 feet. The Piper pilot bought a Los Angeles Sectional Chart and a Los Angeles VFR Terminal Area Chart on the morning of the accident. The Terminal Area Chart, folded to display the combined map and TCA diagram, was found in the Piper's cockpit wreckage; course lines had not been drawn on either side of the chart.

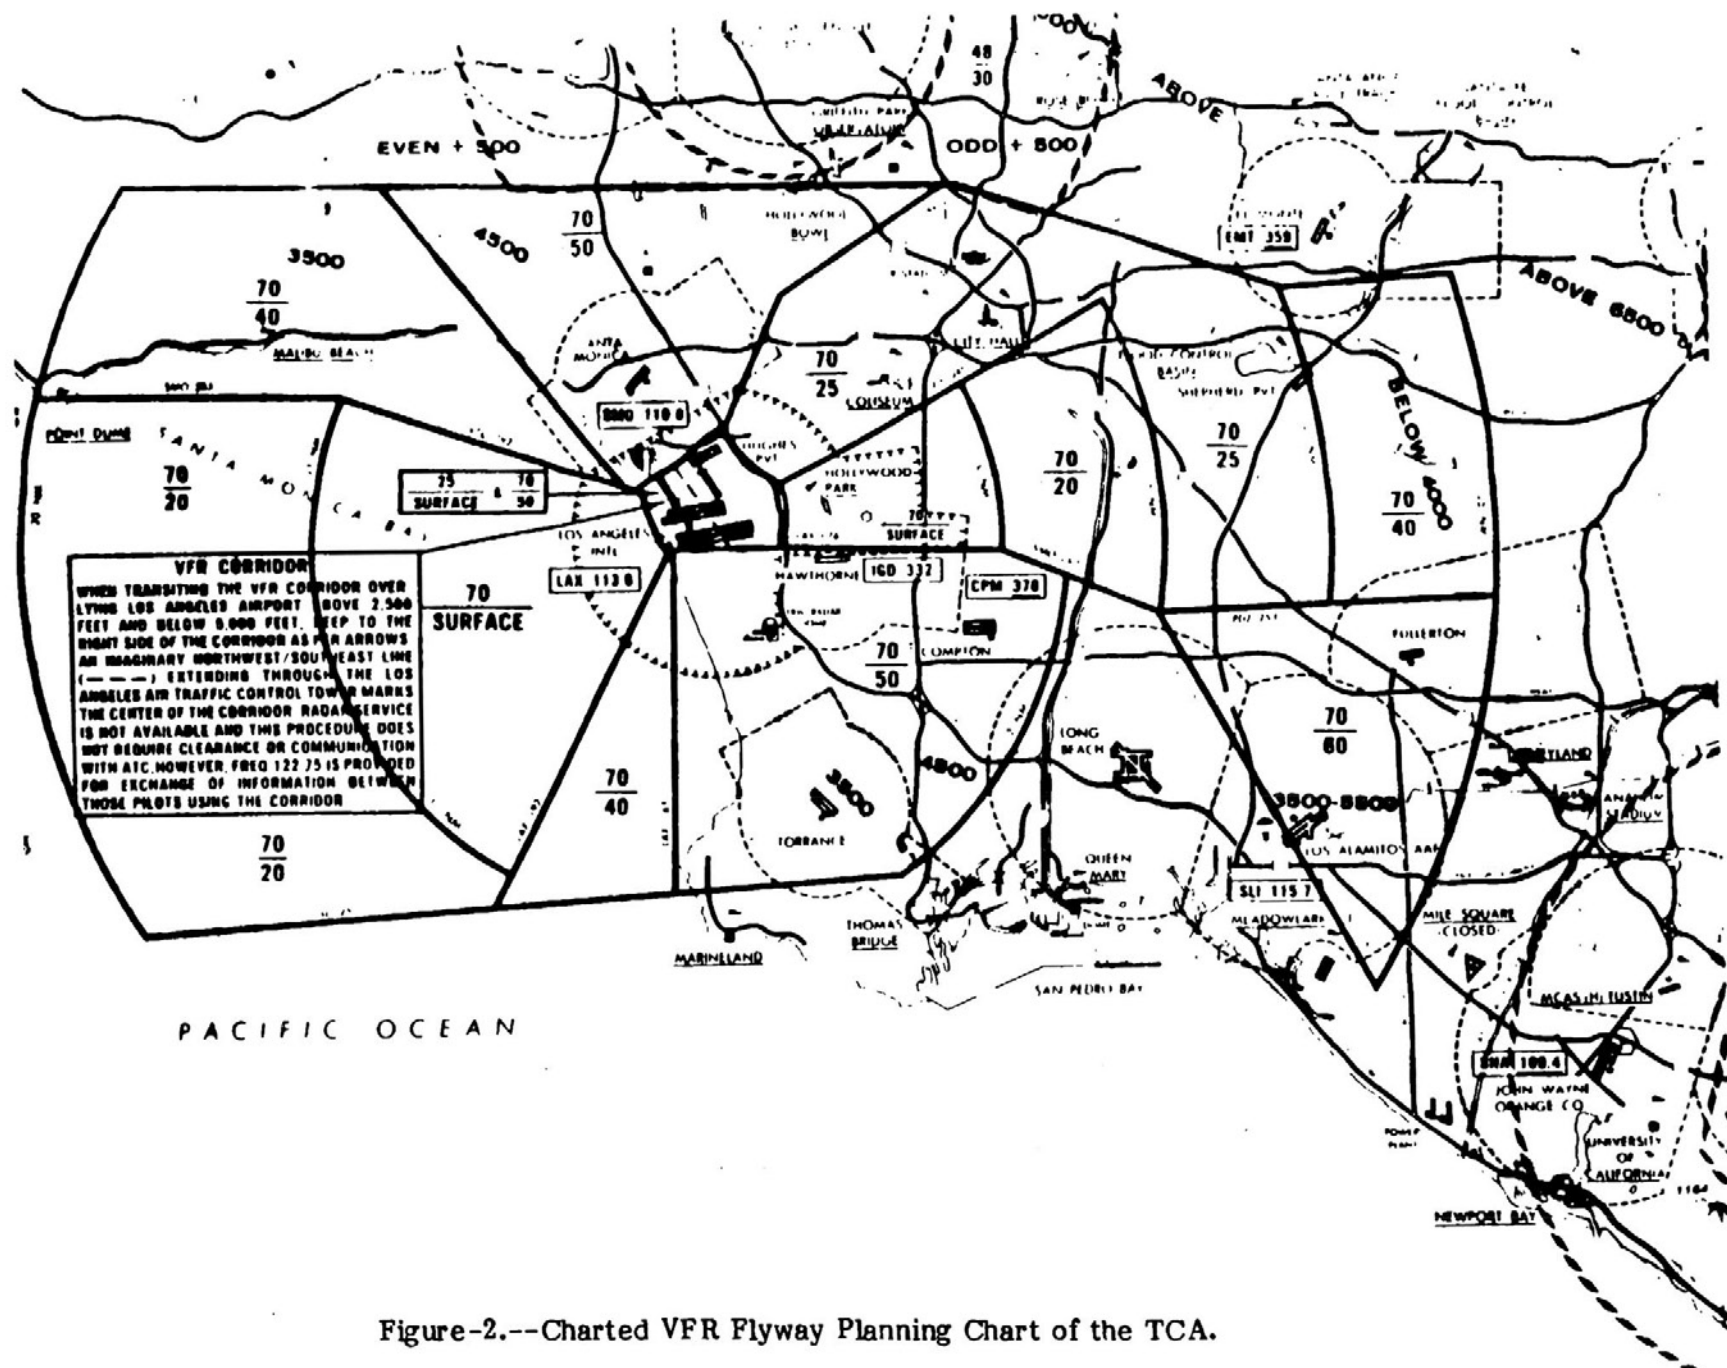
Figure-2.--Charted VFR Flyway Planning Chart of the TCA.

The lateral and vertical dimensions of the Los Angeles TCA are depicted on the Los Angeles VFR Terminal Area Chart. On one side of the chart, the TCA is superimposed on a Lambert Conformal Conic Projection map (figure 1); the chart's overleaf contains a Charted VFR Flyway Planning Chart of the TCA (figure 2). In addition to depicting the numerous airports in the Los Angeles area, the plan view also depicts prominent landmarks within and adjacent to the TCA. For example, the planning chart shows that Disneyland and the Anaheim Stadium are just east of the TCA's eastern boundary. It also depicts and names the freeways located within and around the TCA. Finally, the planning chart depicts the north-south VFR flyway over L.A. International and the altitudes to be flown when using this flyway (figure 2).

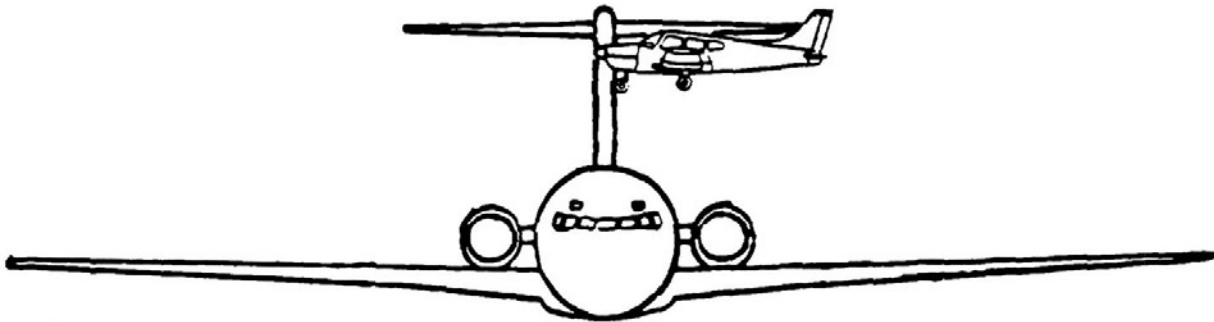
Figure 6.--Collision geometry as viewed from above the DC-9.

The damaged areas on the DC-9 vertical and horizontal stabilizers contained propeller slice marks, paint transfer marks from the nose wheel area and vertical stabilizer of the Piper, and embedded pieces from the cabin roof area of the Piper. The location and angles of these marks and damage on the DC-9, when matched to their respective locations on an intact Piper PA-28, showed that the front of the Piper had struck the left side of the DC-9 vertical stabilizer and that the impact angle was perpendicular to the longitudinal axis of each airplane. (See figure 6.) The impact angle was generally consistent with the flight tracks of the airplanes shown on the radar data plots.

Estimated positions of aircraft at impact, based on the propeller damage and scratch marks on the DC-9 Vertical and Horizontal Stabilizers.
