## Runway Departure Following Landing, American Airlines Flight 102, McDonnell Douglas Dc-10-30, N139AA, Dallas/Fort Worth International Airport, Texas, April 14, 1993

RUNWAY DEPARTURE FOLLOWING LANDING  
AMERICAN AIRLINES FLIGHT 102  
McDONNELL DOUGLAS DC-10-30, N139AA  
DALLAS/FORT WORTH INTERNATIONAL AIRPORT, TEXAS  
APRIL 14, 1993

**Abstract:** This report explains the runway departure of American Airlines flight 102, a DC-10-30, after landing at Dallas/Fort Worth International Airport, Texas, on April 14, 1993. The safety issues discussed in the report include weather conditions affecting the flight, flightcrew and air traffic control training and procedures, airplane emergency evacuation lighting, and runway maintenance. Recommendations concerning these issues were made to the Federal Aviation Administration, Dallas/Fort Worth International Airport, and American Airlines, Inc.

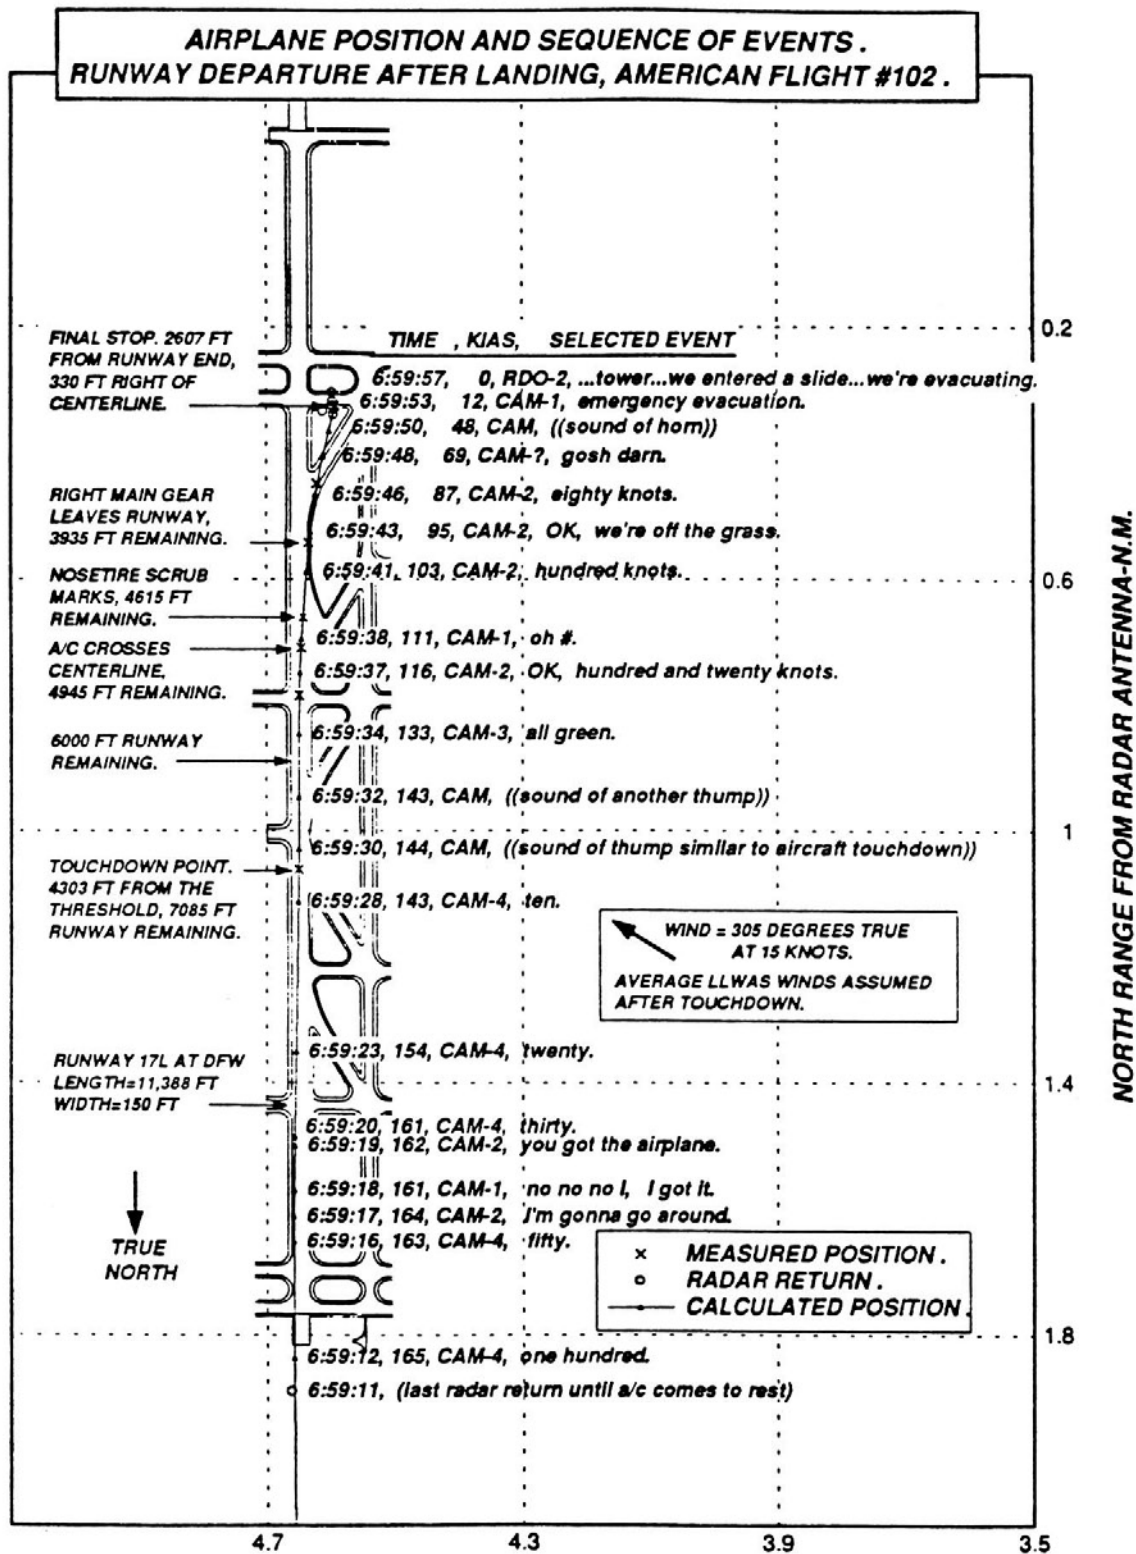
Investigators examined the landing runway after the accident and found three long sets of lightly shaded tire traces that paralleled the centerline but then angled to the right and departed the runway. The tracks from the right main landing gear continued as furrows in the soil.

Then the airplane traveled across high speed taxiway 3S before returning to the soft soil. The airplane came to rest, upright, about 2,607 feet from the departure end of 17L and about 250 feet from the right edge of the runway, with the nose on perpendicular taxiway 31. (See figures 2, 3 and 4).

The first tire marks found on the runway were traced to the left and right main landing gear, and started at 4,303 feet from the beginning of the runway. The tracks approximately paralleled the runway centerline for about 1,700 feet, then turned gradually to the right until they departed the runway.

Figure 2.--Approach and landing.  
History of airplane motion and events.

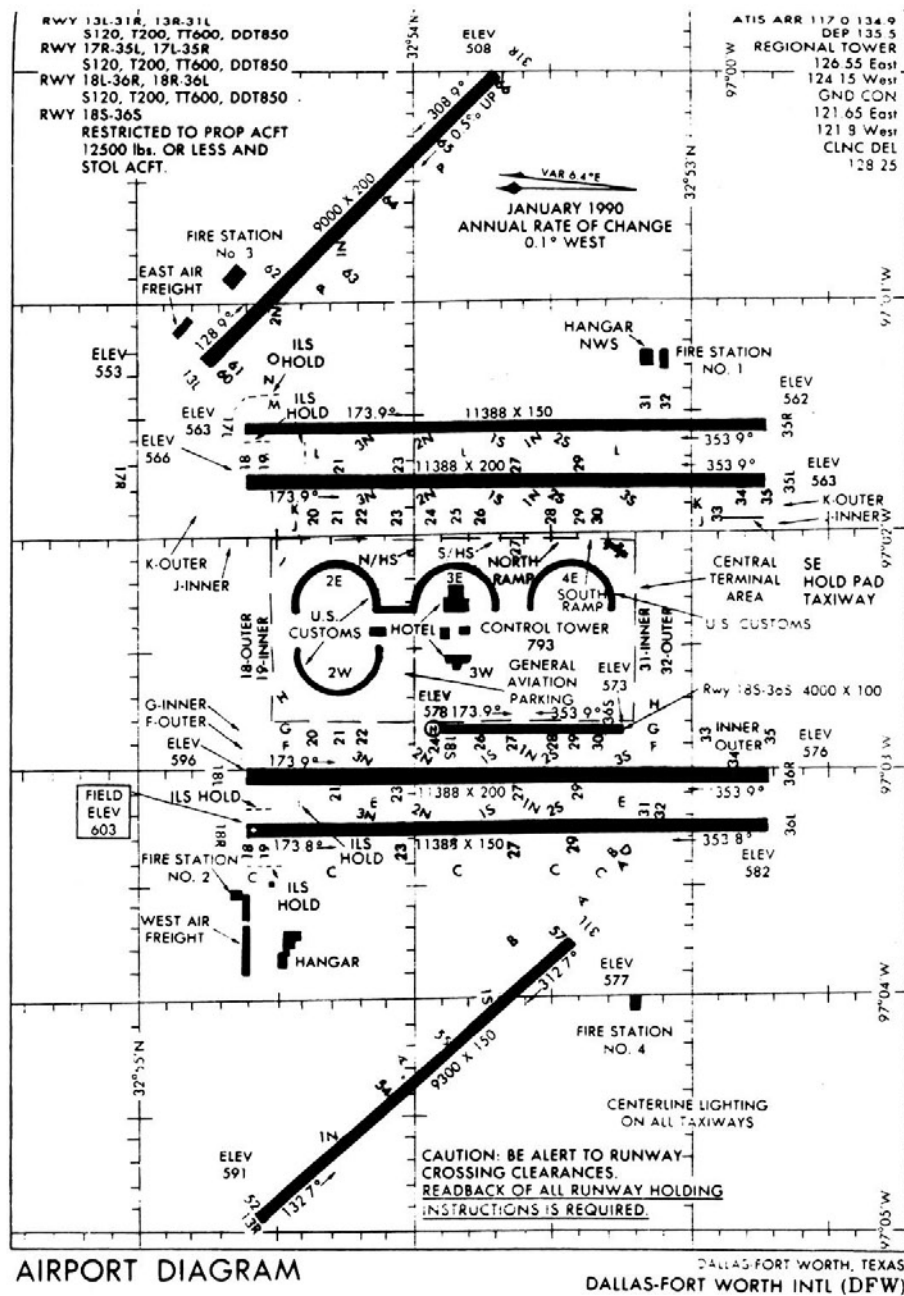
Figure 6.--Airport diagram.

short takeoff and landing (STOL) runway that is superimposed on a taxiway. (See figure 6). The runways are served by eight ILS and nondirectional beacon (NDB) instrument approaches.

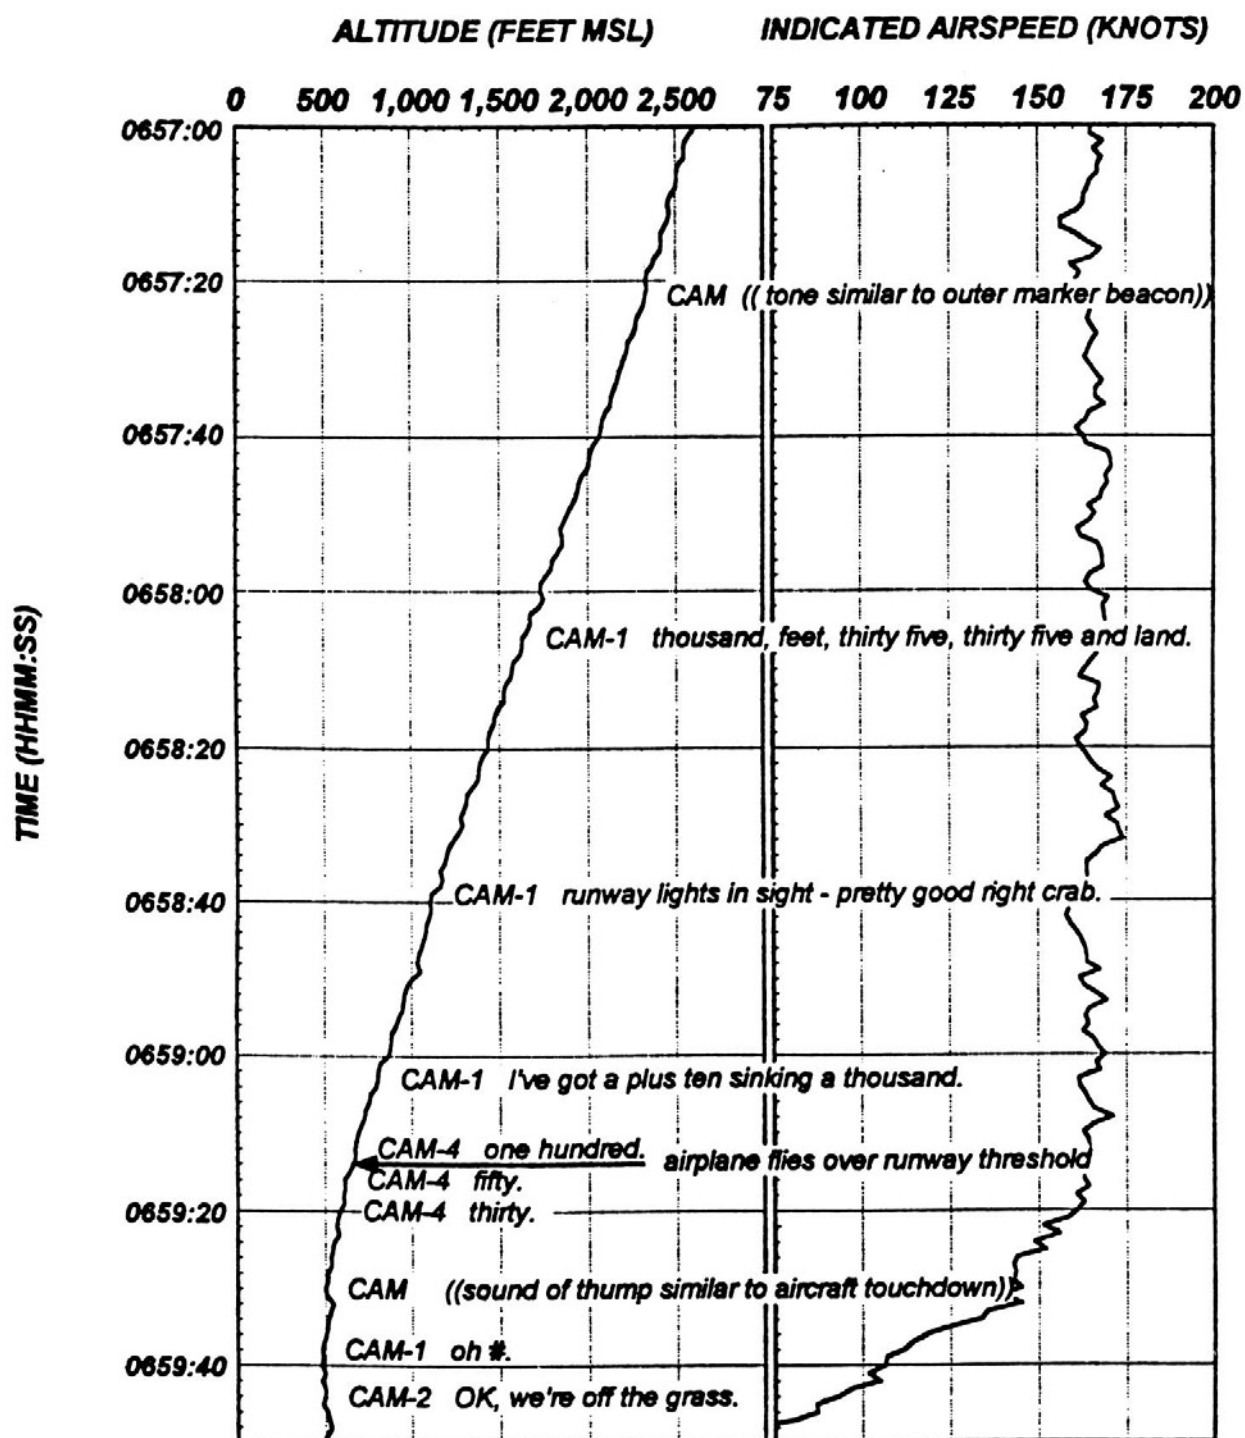
Data from ATC radar, weather, CVR, FDR, and information from the examination of the aircraft wreckage and the accident runway were used to develop a time history of the accident flight's motion during the approach and landing. (See figure 10 for airspeeds and altitudes during the landing sequence). Calculations were made of the crosswind component during the final 2 1/2 minutes before landing. A composite plot was developed that shows, in a graphical format, the flight control positions and airplane headings when key events occurred during the landing sequence. (See figures 11a and 11b).

Figure 10.--Airplane airspeeds and altitudes versus time.

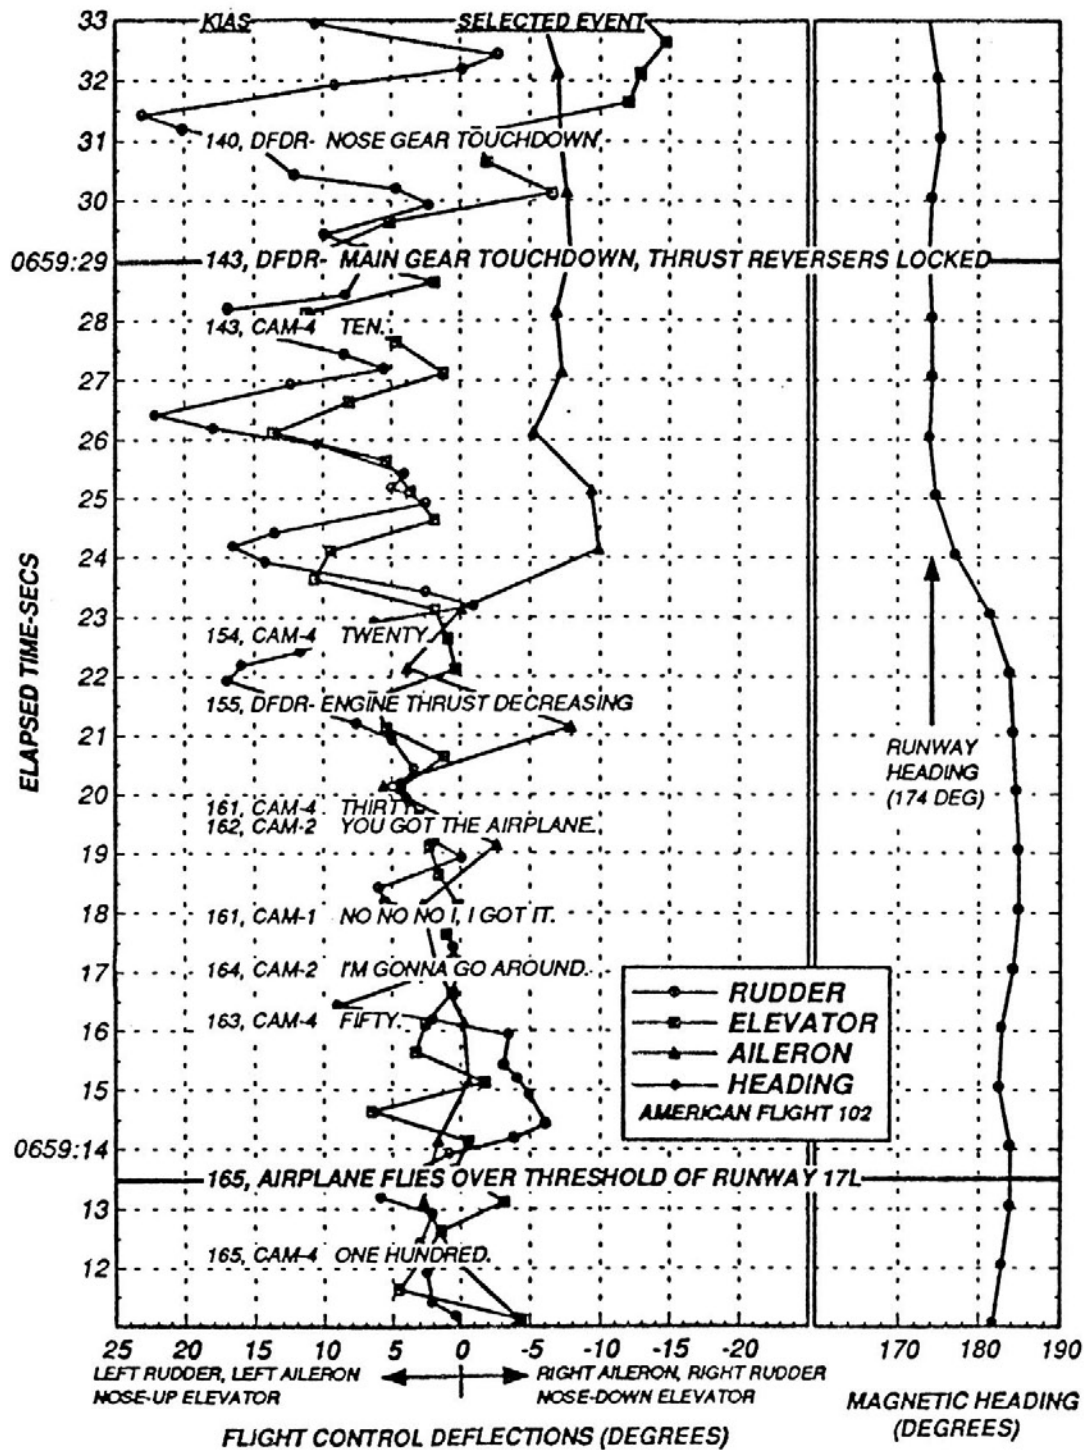
Figure 11a.--Flight control positions and airplane headings during landing sequence.

Prior to touchdown, the airplane transitioned from a 10-degree right crab to a 2-degree right-wing-down (RWD) roll and a 10-degree airplane-nose-left (ANL) rudder deflection. The data show that the airplane touched down at 0659:29 and tracked near the centerline of 17L for about 8 seconds, averaging an 8-degree ANL rudder deflection. During the 8 seconds after touchdown, the airplane decelerated to 116 knots indicated airspeed (KIAS), while the rudder was deflected on average about 8 degrees ANL, the aileron position averaged 5 degree RWD, and the elevator averaged 7 degrees airplane nose down (AND).

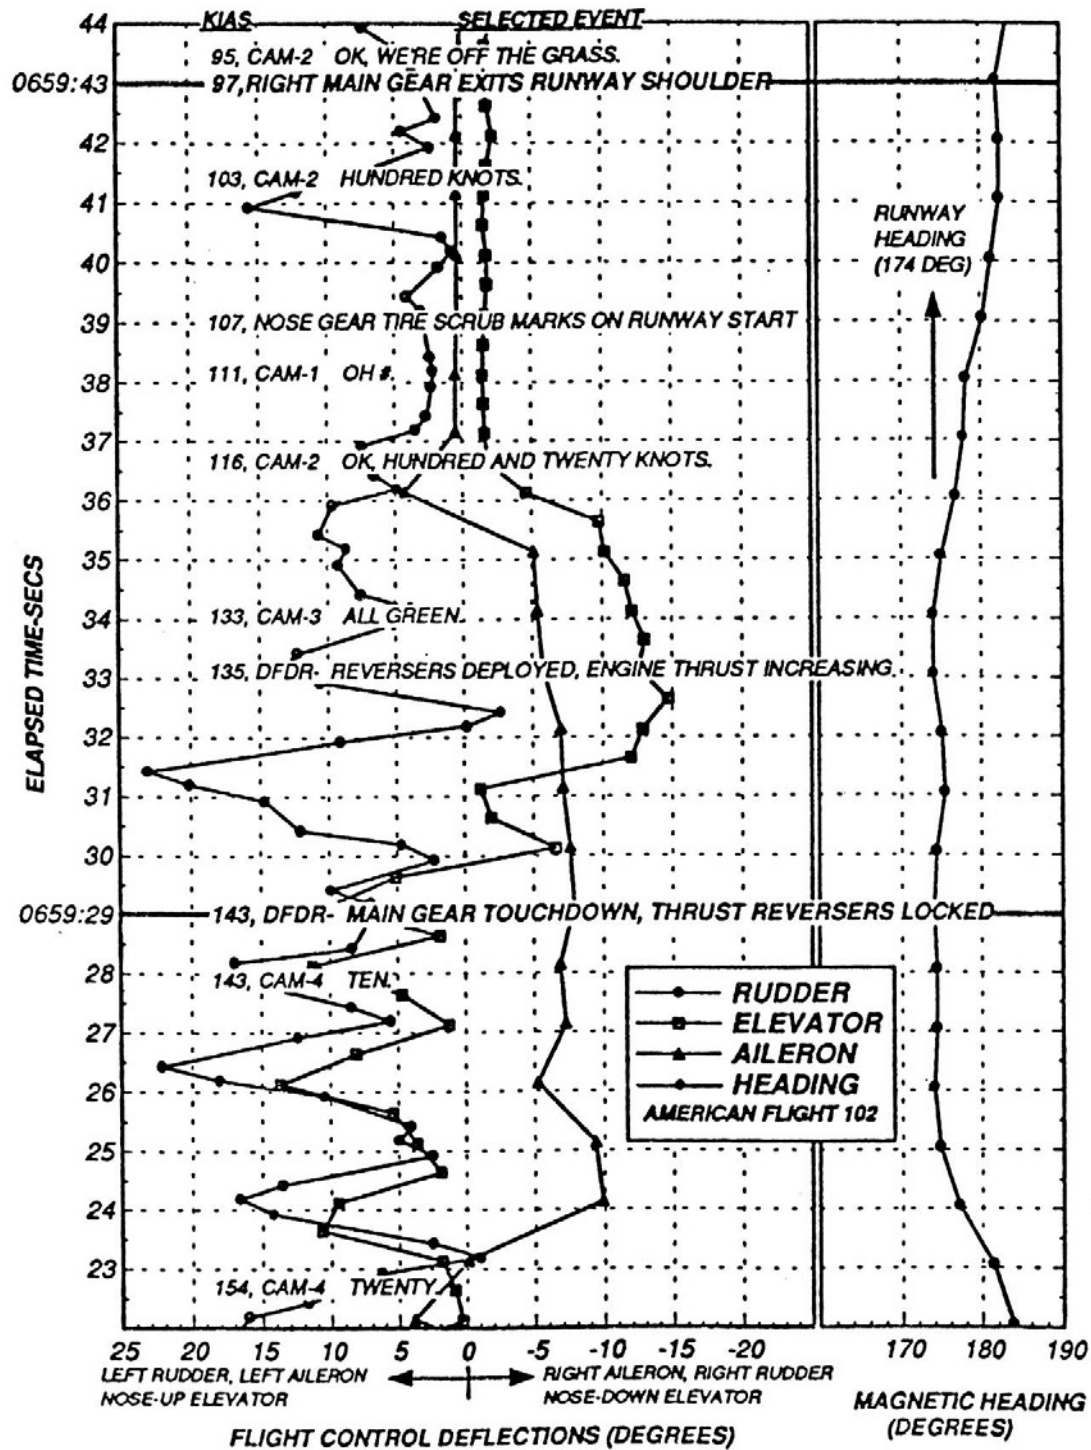
Figure 11b.--Flight control positions and airplane headings during landing sequence.
