## Uncontained Engine Failure, Delta Air Lines Flight 1288, McDonnell Douglas MD-88, N927DA, Pensacola, Florida, July 6, 1996

**Investigative Body:** National Transportation Safety Board (NTSB), USA

UNCONTAINED ENGINE FAILURE  
DELTA AIR LINES FLIGHT 1288  
MCDONNELL DOUGLAS MD-88, N927DA  
PENSACOLA, FLORIDA  
JULY 6, 1996

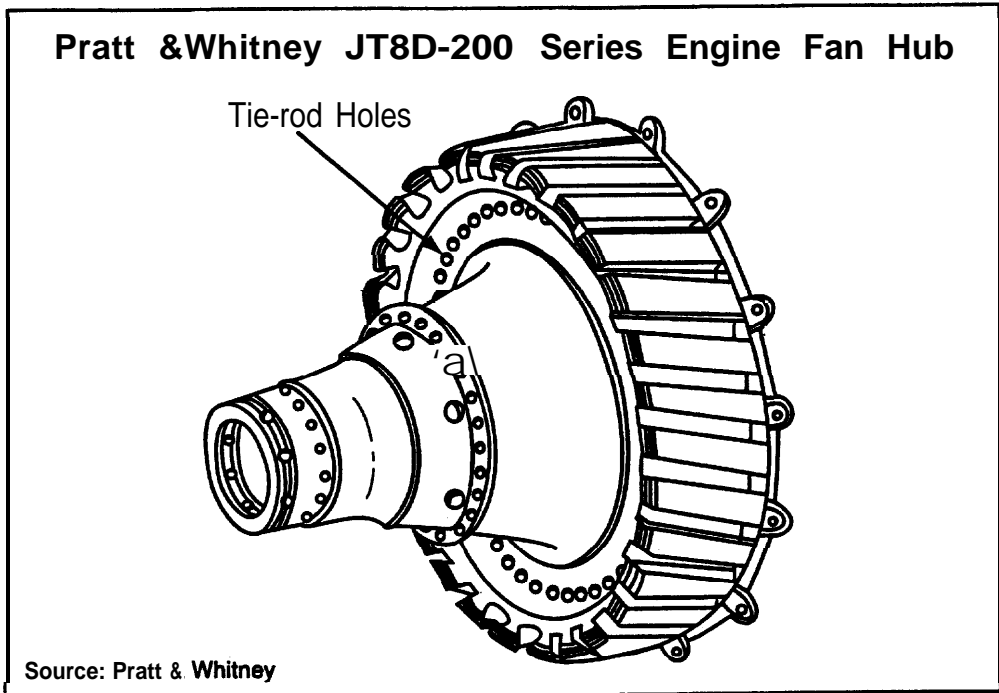
Figure 4.—Pratt & Whitney JT8D-200 series engine fan hub.

dovetail slots. The 2.91-inch deep tierrod holes were located around the circumference of the hub bore and alternated with 24 smaller diameter stress redistribution (SR) holes (see figure 4 ).<sup>21</sup> The fan hub was forged from a titanium-based alloy containing 6 percent aluminum and 4 percent vanadium.
