In-Flight Fire/Emergency Landing, Federal Express Flight 1406 Douglas DC-10-10, N68055, Newburgh, New York September 5, 1996

AIRCRAFT ACCIDENT REPORT

IN-FLIGHT FIRE/EMERGENCY LANDING
FEDERAL EXPRESS FLIGHT 1406
DOUGLAS DC-1 0-10, N68055
NEWBURGH, NEW YORK
SEPTEMBER 5, 1996

The National Transportation Safety Board determines that the probable cause of this accident was an in-flight cargo fire of undetermined origin.

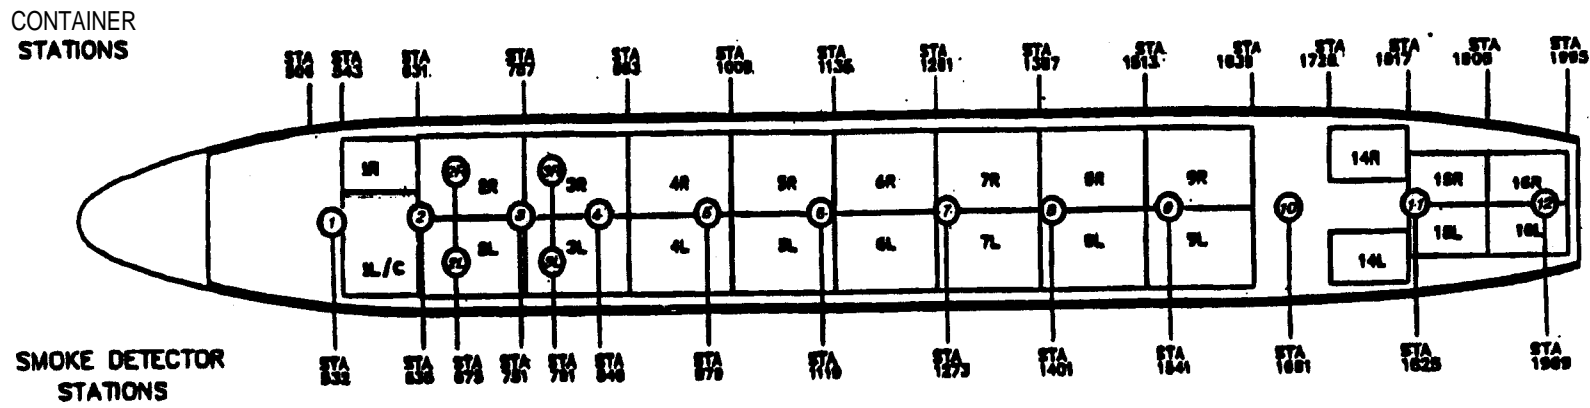
Figure 1.—DC-10-10, N68055, upper cabin cargo container positions and smoke detector locations.

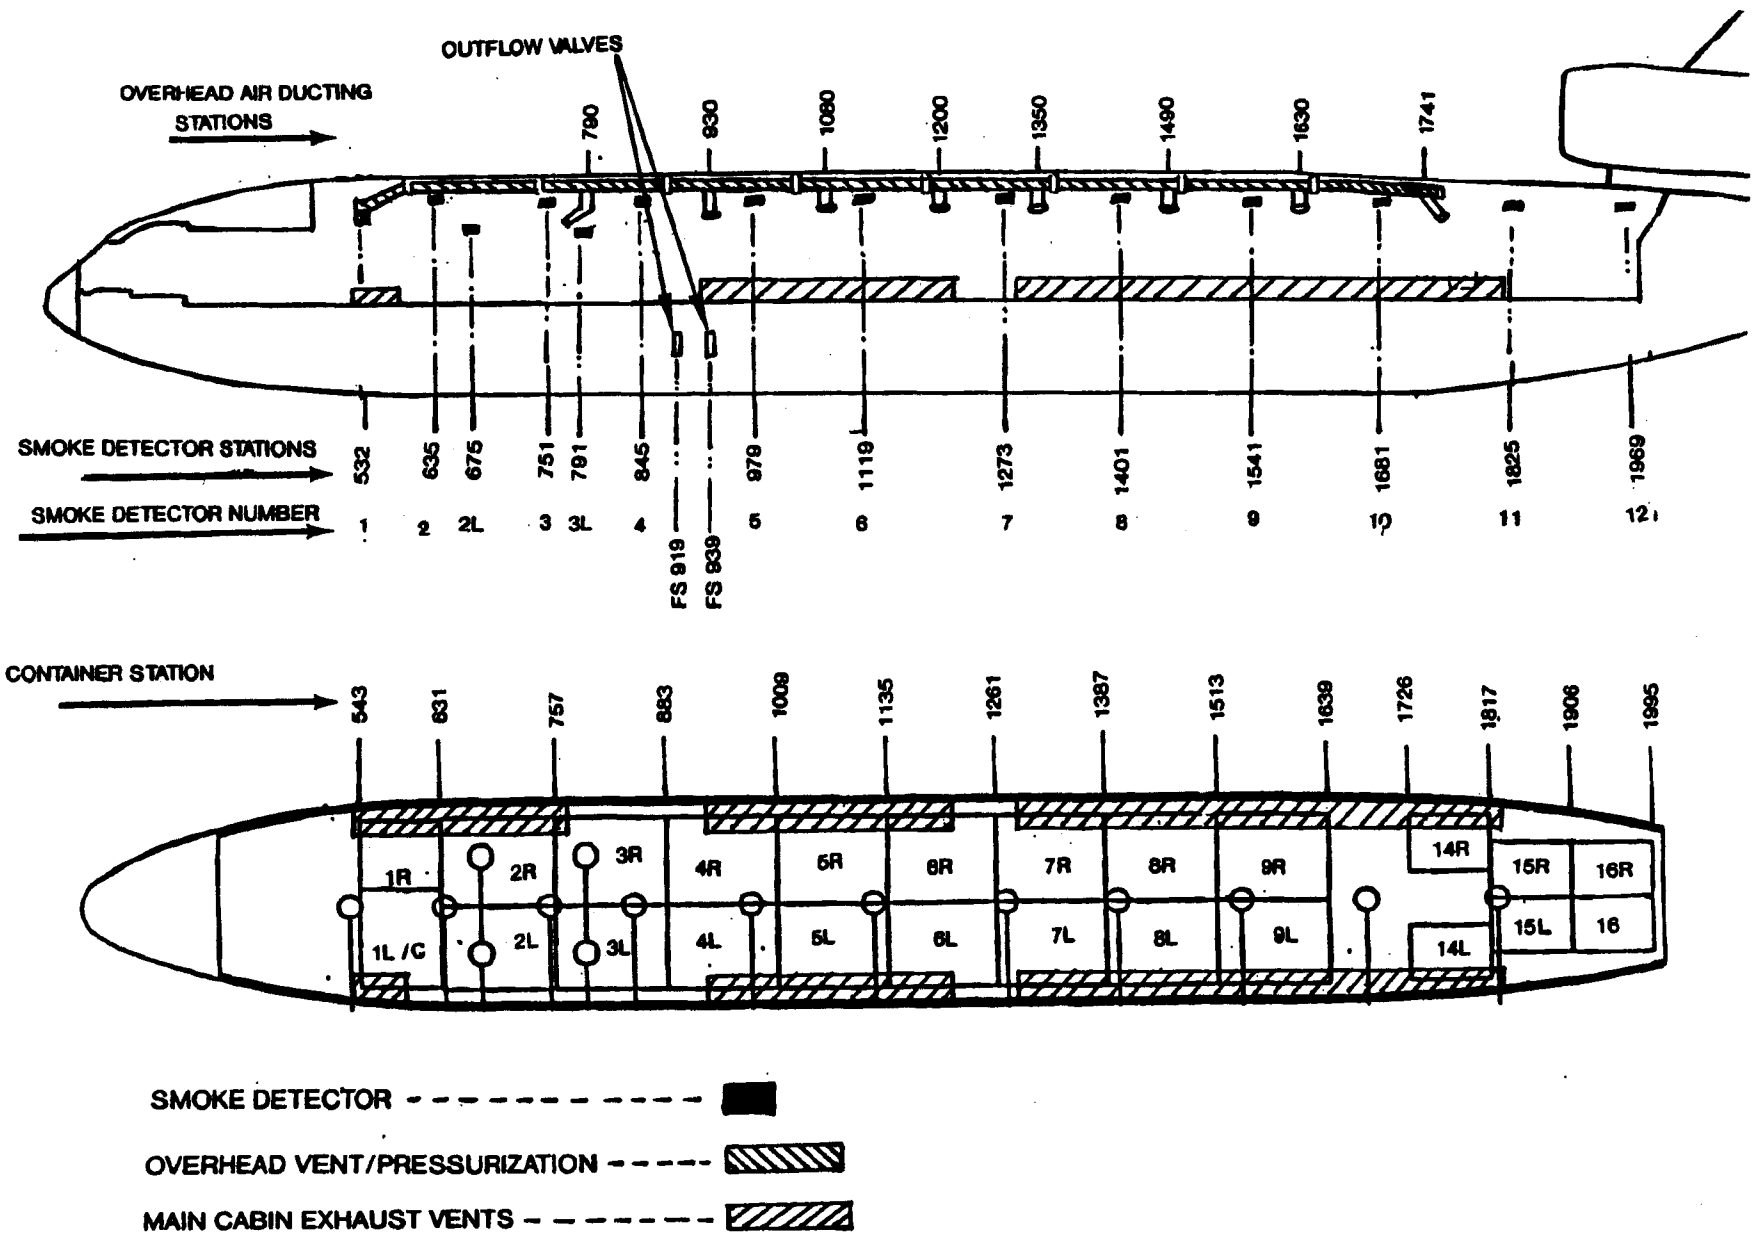
Figure 5.—DC-10-10, N68055, cargo container, smoke detector, and main cabin overhead ducting locations.

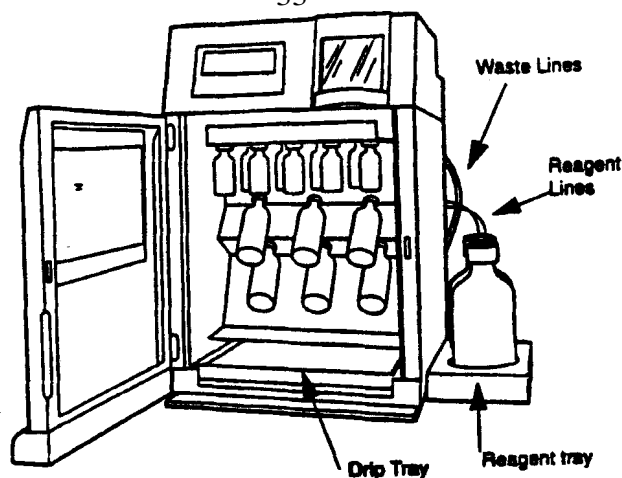
The Expedite Model 8909 DNA synthesizer was found in the center of container 6R lying on its left side with the top facing forward (as viewed from aft looking forward), the front towards the right side of the airplane, and the bottom facing aft (see figure 8 for a diagram of the synthesizer). The unit contained several bottles with labels that included flammability symbols, and some of the bottles contained liquid. One large bottle in the aft row had a very strong odor when it was removed from the unit. Because this unit was found at the lowest point of the "V" burn pattern, the Safety Board investigation evaluated and analyzed the liquids contained in this unit.

Figure 8.—Expedite Model 8909 DNA synthesizer instrument cabinet.

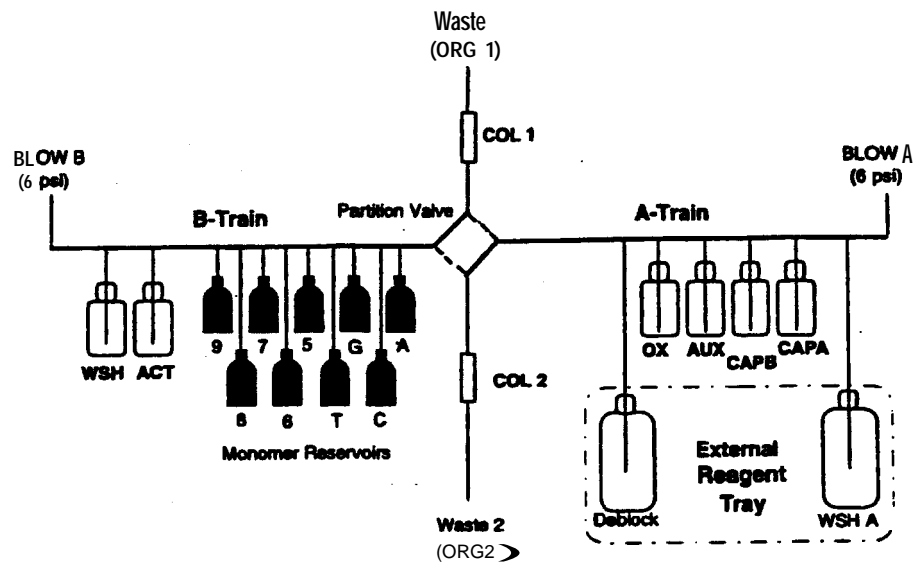
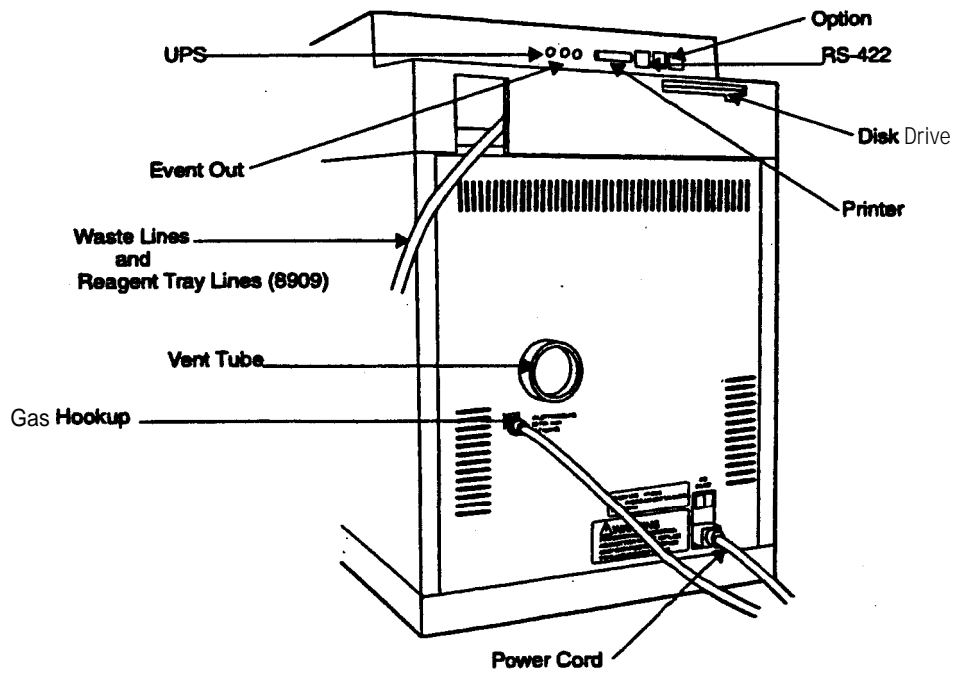
Figure A.—Expedite Model 8909 DNA synthesizer instrument diagram.

A paper diagram of the bottle locations and system schematic taped inside the front door of the synthesizer exhibited slight soot damage. The paint on the inside of the door below the window frame was undamaged but exhibited some sooting. The inside of the door exhibited heavier heat damage above the lower window frame than was observed below the window frame. The stainless steel bottle bracket was heavily sooted behind bottles 4, 5, and 6. The plastic dip tubes were cut off during the on-site accident phase. The upper third of the right side of the stainless steel bottle bracket exhibited some sooting and discoloration. The left side was sooted from the base to the top of the synthesizer. The polyethylene drip tray was melted along the right rear side and was heavily sooted along the left and forward walls. An 8½- by 9½- inch rectangular soot-free area was observed approximately 1 inch from the left side of the drip tray. Pieces of broken glass and a large amount of debris were found in the bottom of the drip tray. The floor of the synthesizer was heavily sooted and also contained pieces of debris. There was some blue discoloration along the right side of the stainless steel bracket where it intersected the mounting for bottles 1, 2, and 3.

Removal of the synthesizer controller top revealed that the controller top's interior exhibited extensive fire damage, and all of the electrical wire insulation was destroyed. The wire conductors were intact and brittle. The inside of the top was heavily sooted. Most of the paint was charred and missing under the controller PC board and around the floppy drive at the rear of the controller top. The resin binder for the controller PC board was destroyed by fire. The
