### In-Flight Engine Failure and Subsequent Ditching, Air Sunshine, Inc., Flight 527, Cessna 402C, N314AB, About 7.35 Nautical Miles West-Northwest of Treasure Cay Airport, Great Abaco Island, Bahamas, July 13, 2003

# Aircraft Accident Report NTSB/AAR-04/03

In-Flight Engine Failure and Subsequent Ditching Air Sunshine, Inc., Flight 527 Cessna 402C, N314AB About 7.35 Nautical Miles West-Northwest of Treasure Cay Airport, Great Abaco Island, Bahamas July 13, 2003

NTSB/AAR-04/03 PB2004-910403 Notation 7671A Adopted October 13, 2004

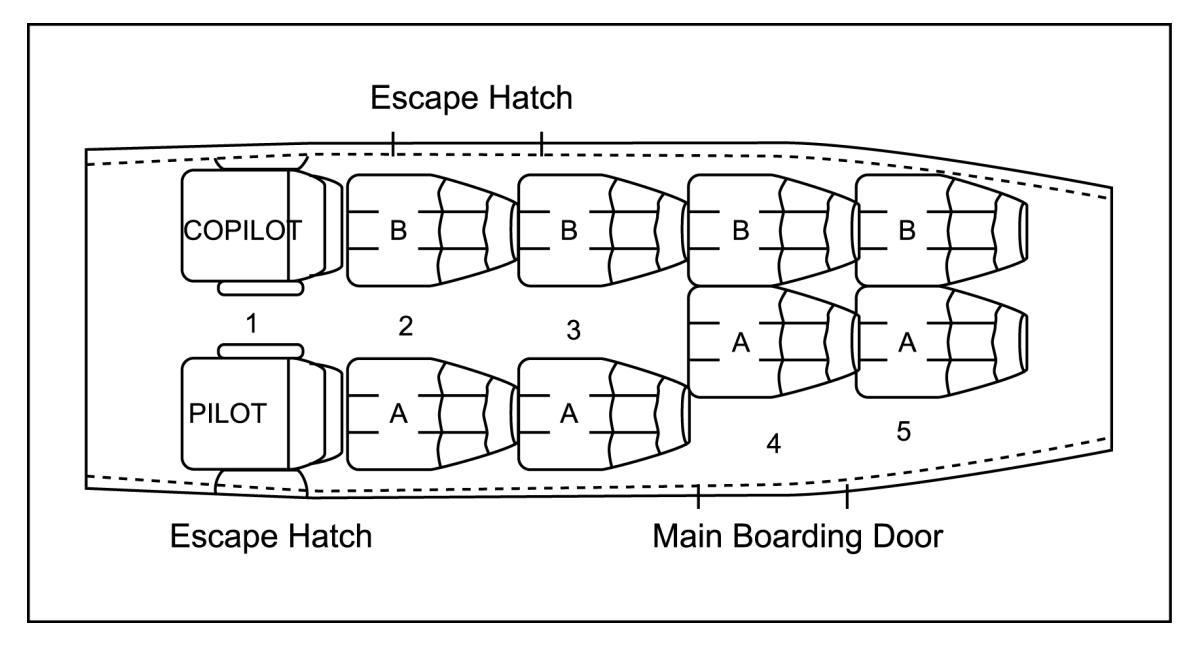
The airplane was configured with a pilot seat (left side), a copilot seat (right side), and eight passenger seats. (See figure 1.) The airplane was equipped with a window escape hatch adjacent to the pilot seat (1A); an emergency escape hatch adjacent to seats 2B and 3B; and a two-section outward opening airstair door (main cabin door) adjacent to seats 4A and 5A, the lower portion of which was equipped with stairs. The pilot and copilot seats were equipped with lapbelts and single-strap shoulder harnesses, and the passenger seats were equipped with lapbelts.

Figure 1. Interior configuration of the accident airplane.
