## Hard Landing, Gear Collapse, Federal Express Flight 647, Boeing MD-10-10F, N364FE, Memphis, Tennessee, December 18, 2003

**NTSB/AAR-05/01**

**National  
Transportation  
Safety Board**

**NTSB/AAR-05/01  
PB2005-910401  
Notation 7632A  
Adopted May 17, 2005**

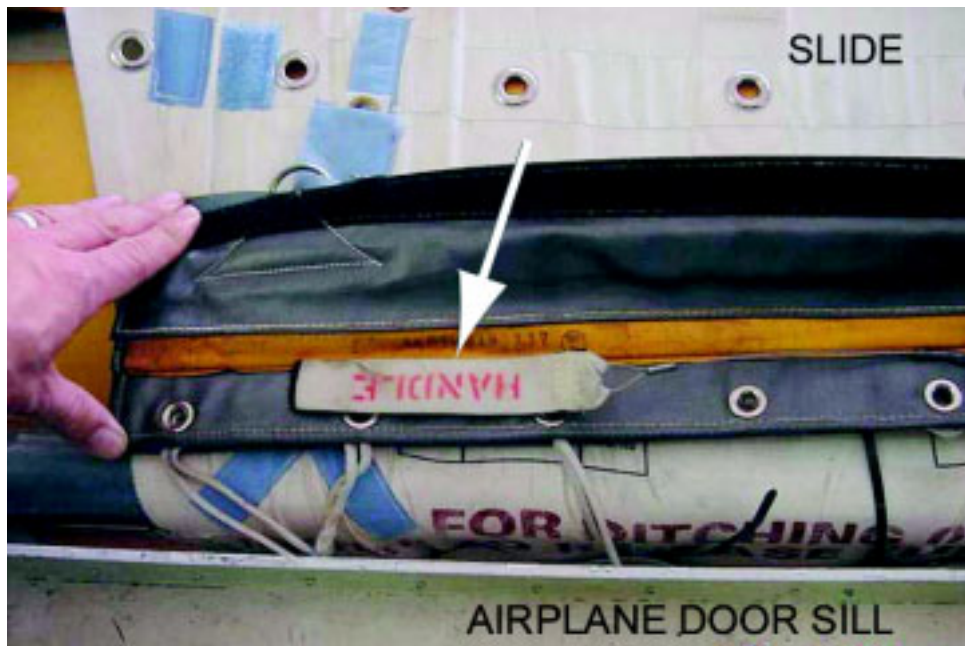
**Figure 4.** FedEx's MD-11/-10 emergency evacuation door trainer, with the girt flap assembly lifted. The arrow indicates the slide/raft disengage handle.
