**Runway overrun, Executive Airlines (doing business as American Eagle)  
Flight 5401, Avions de Transport Regional 72-212, N438AT, San Juan,  
Puerto Rico, May 9, 2004**

**Crash During Landing  
Executive Airlines (doing business as  
American Eagle) Flight 5401  
Avions de Transport Regional 72-212, N438AT  
San Juan, Puerto Rico  
May 9, 2004**

**NTSB/AAR-05/02**

**Abstract:** This report explains the accident involving Executive Airlines (doing business as American Eagle) flight 5401, an Avions de Transport Regional 72-212, which skipped once, bounced hard twice, and then crashed at Luis Muñoz Marin International Airport, San Juan, Puerto Rico. Safety issues discussed in this report focus on flight crew performance, the lack of company bounced landing recovery guidance and training, and malfunctioning flight data recorder potentiometer sensors. Safety recommendations concerning these issues are addressed to the Federal Aviation Administration.

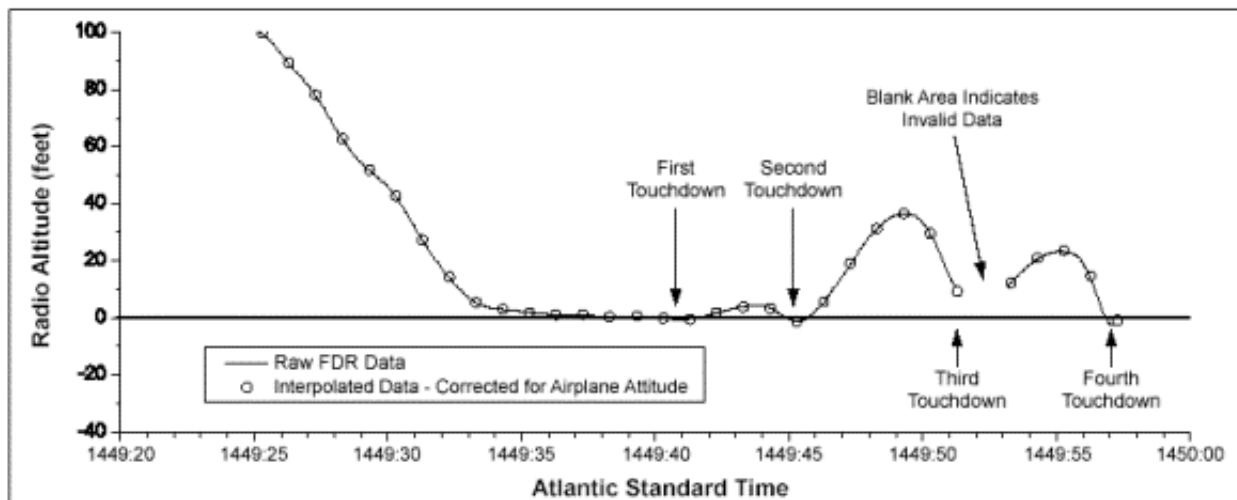
Figure 1a. Altitude profile of the accident flight.

CVR and FDR information indicated that the airplane touched down a fourth time about 1449:56 (about 15 seconds after the initial touchdown) and about 4,000 feet beyond the runway 8 threshold. FDR data indicated that the airplane pitched down to -7° and that it was banked 29° left wing down. The airplane came to a complete stop about 4,317 feet from the runway threshold. Figure 1 shows the ground track of the accident flight, and figure 1a shows the altitude profile of the accident flight.
