Final report of the accident investigation, Flash Airlines Flight 604, Boeing 737-300 SU-ZCF, Red Sea off Sharm El-Sheikh, Egypt, January 3, 2004

FINAL REPORT OF THE ACCIDENT INVESTIGATION

Flash Airlines flight 604

Boeing 737-300 SU-ZCF

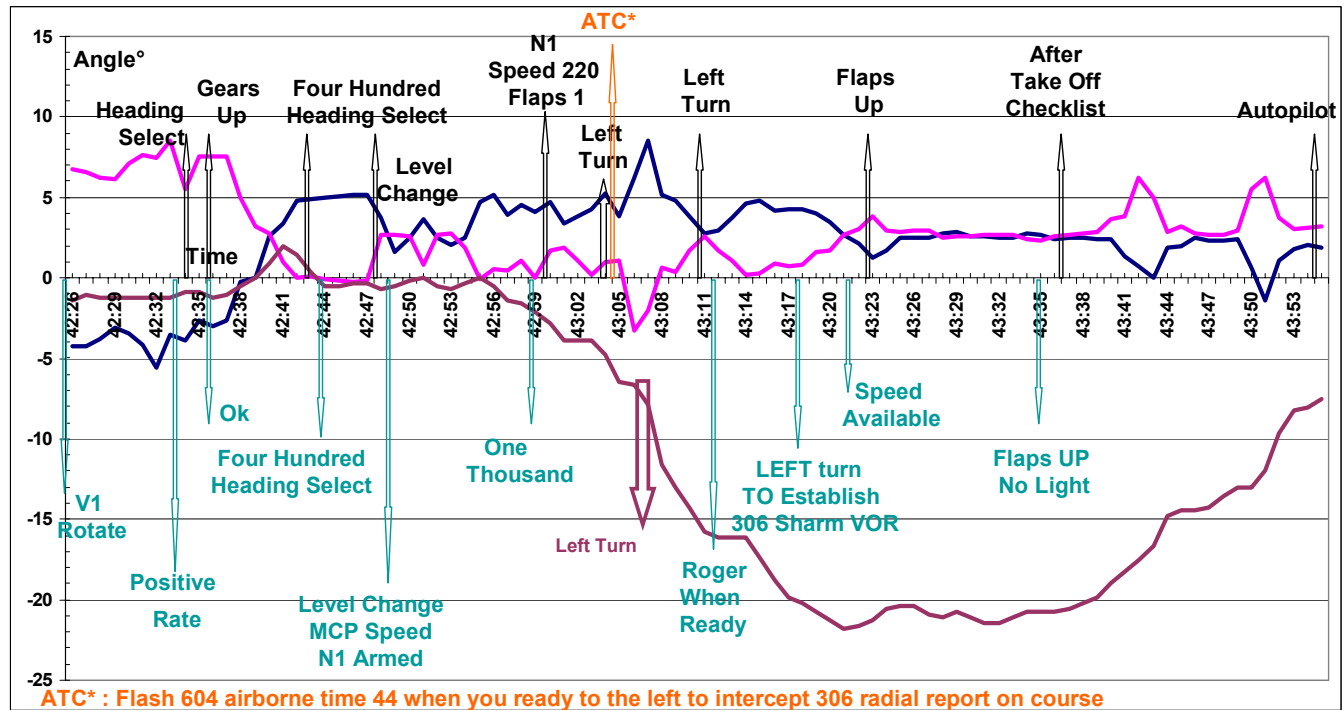
Figure 1.1-1 Correlated FDR- CVR Data

- During this time, an increase in pitch and decay in airspeed were observed
- At time 02:44:05, the Captain requested heading select. (3880 ft, CAS 203 kts, Hdg 139.5°, Pitch 20.5°, Roll 0.0° left)

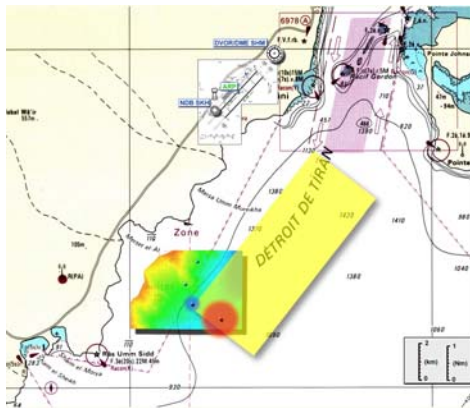
There was no other damage. Most of the wreckage remains on the floor of the Red Sea at a depth of approximately 1000 meters.

Efforts were made to locate human remains by use of deep sea cameras and robots but were also not successful due to the location of the wreckage and the depth of more than 1000 meters.

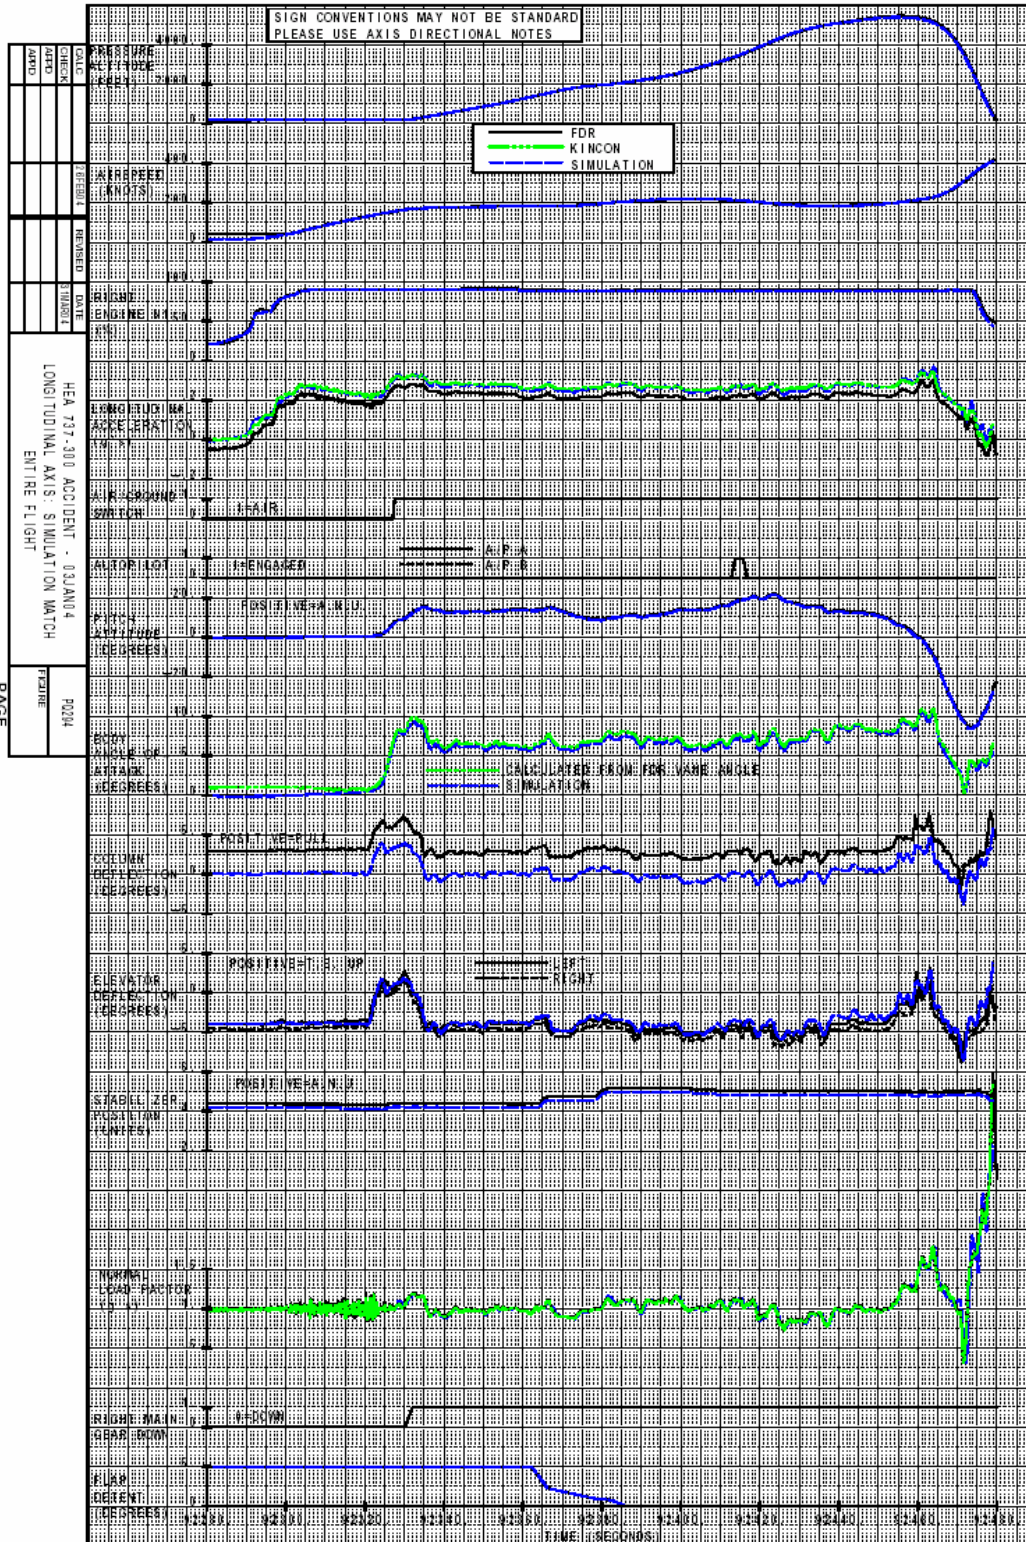
Figure 1.16.2-1 – FDR and Simulation Match Data – Longitudinal Axis

A baseline simulation recreation of the accident flight was started just as the airplane turned onto the runway and the throttles were advanced, and the simulation was stopped at the end of the FDR data. Because the simulation can calculate the response of the airplane to control inputs, a set of control input time histories (column, wheel, and rudder movements) can be determined that results in the simulation following the same path as the accident airplane. It is important to note that this process does not use the control or surface position data recorded on the FDR, only the path information (e.g. accelerations, attitude and altitude).

An examination of the baseline simulation revealed that the path of the accident airplane is consistent with the recorded motion of the control surfaces. Specifically, the extreme bank attitude that occurs towards the end of the flight is consistent with recorded motion of the ailerons.

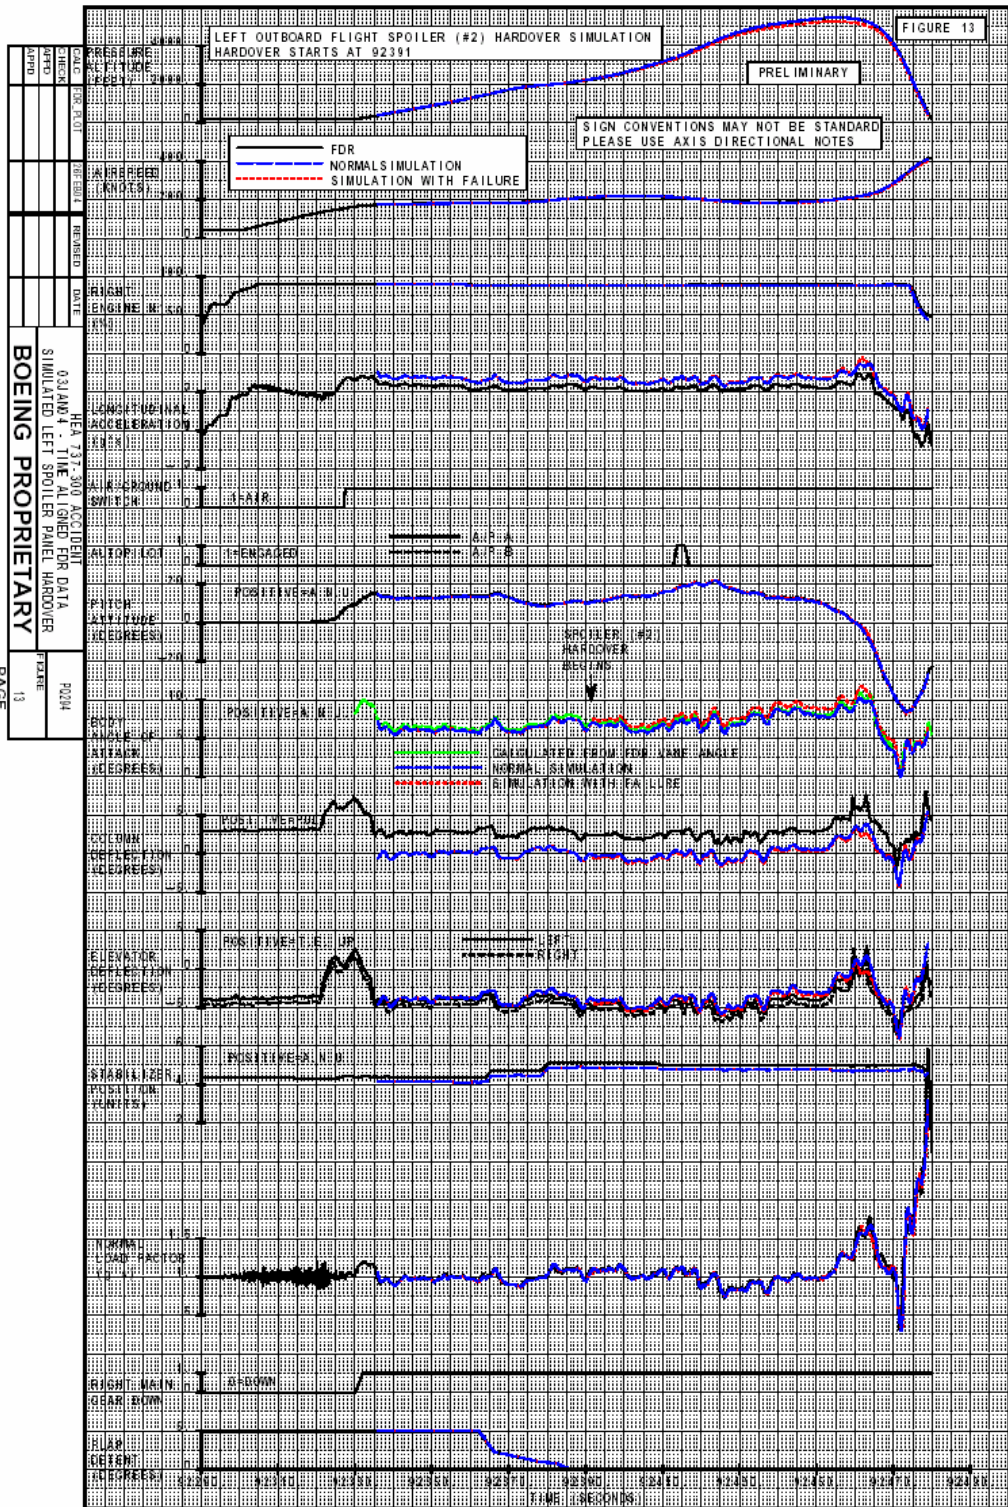
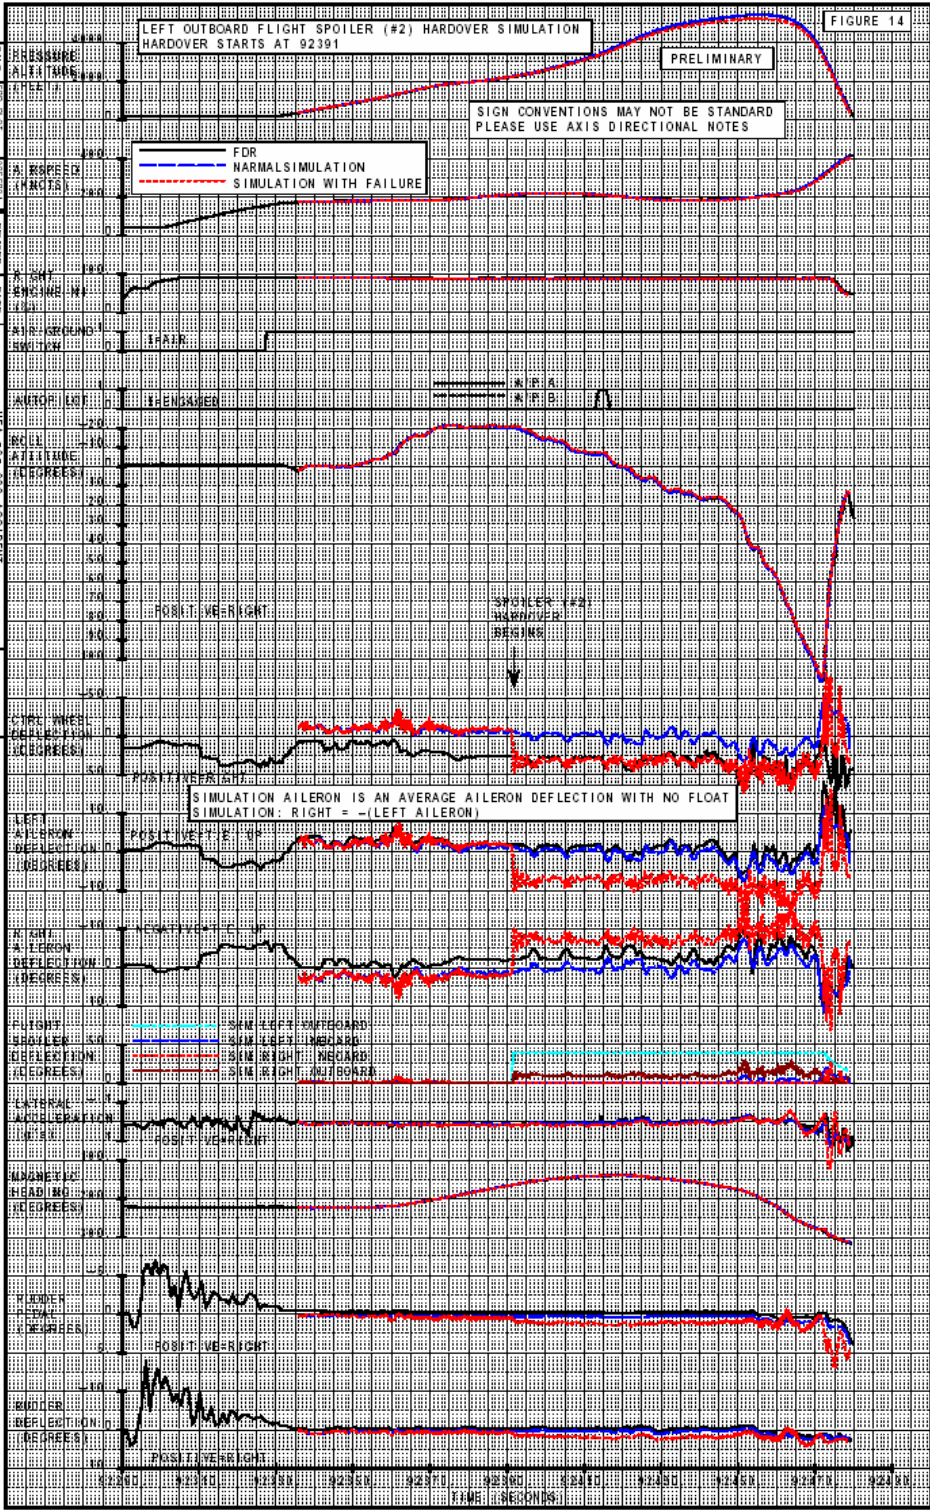
Left outboard flight spoilers (#2) Hardover simulation (hardover starts at 92391)

TITLE: 031 JAN 78 - 300 ACCIDENT
 DATE: 031 JAN 78
 SUBJECT: SIMULATED LEFT SPOILER PANEL HARDOVER
 PAGE: 11

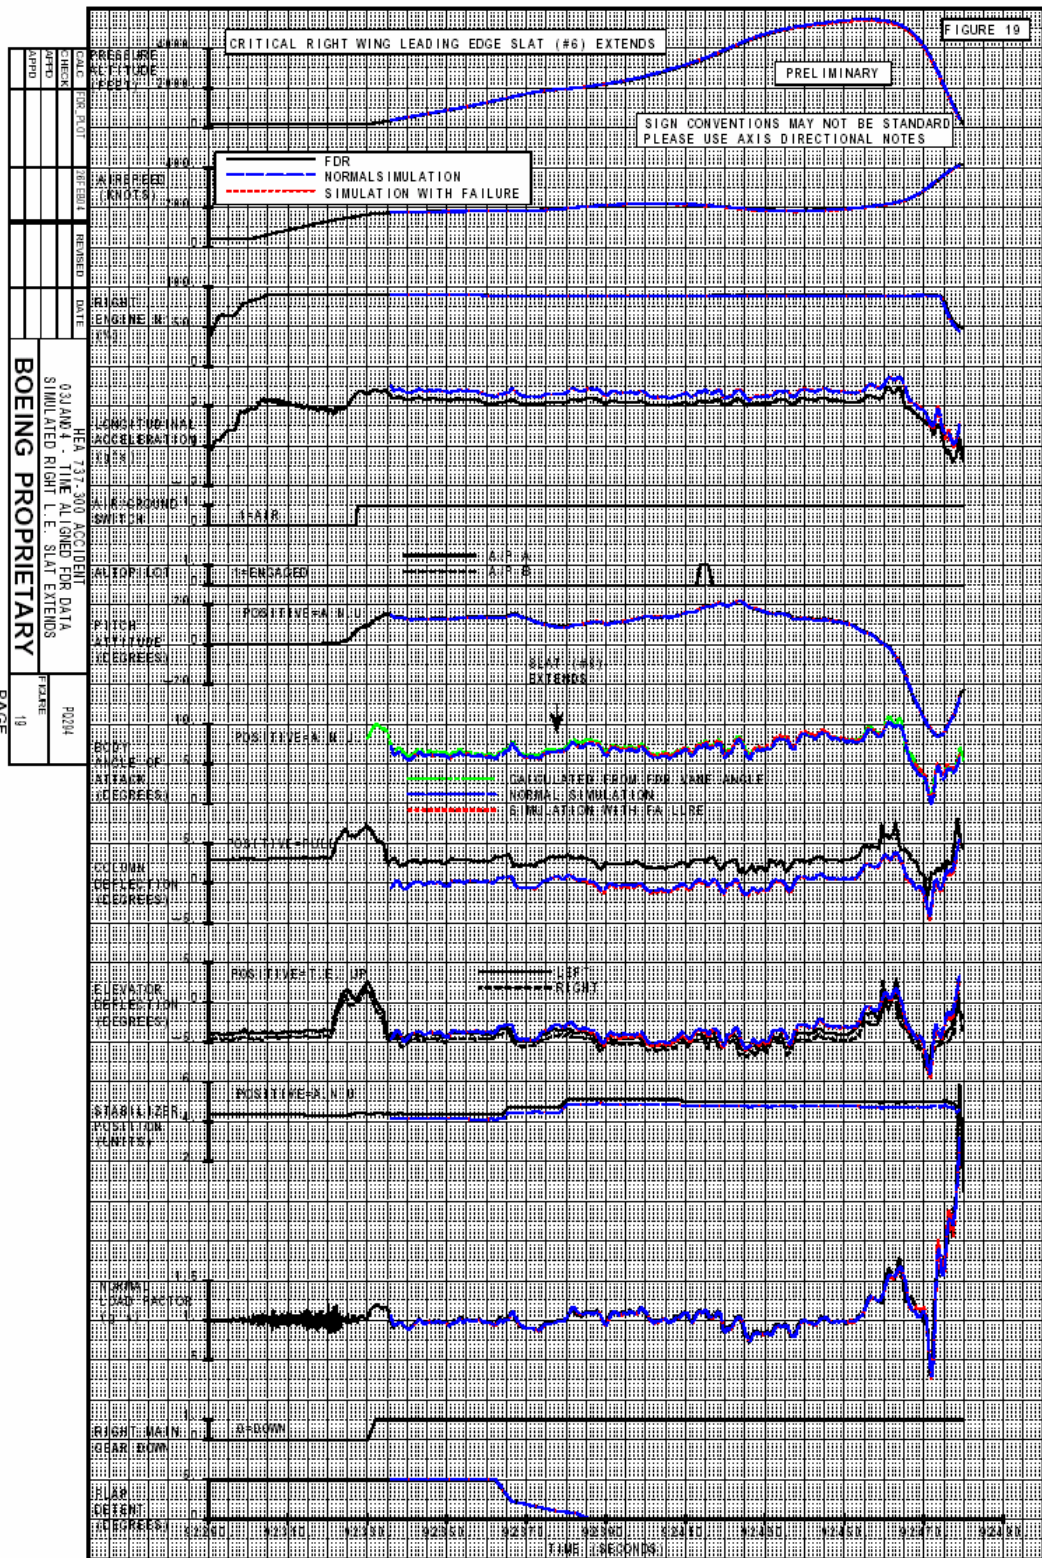
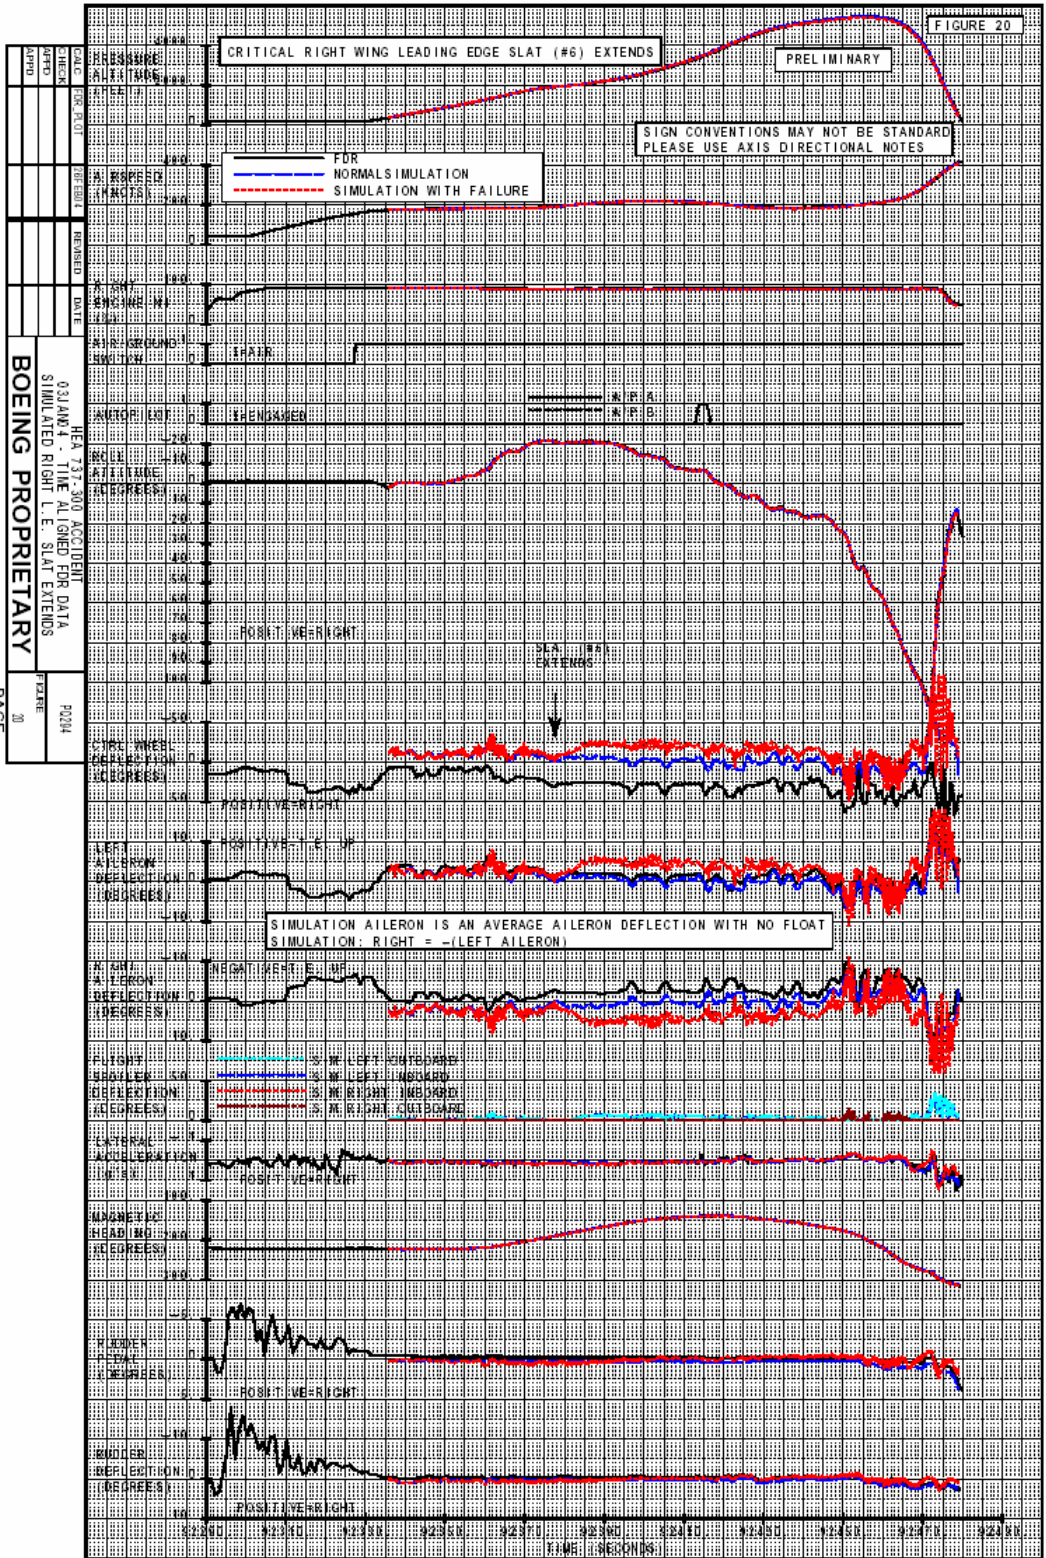
Critical right wing leading edge slat # 6 extends

HEA 737-300 ACCIDENT
 03JAN4 - TIME ALIGNED FOR DATA
 SIMULATED RIGHT LE SLAT EXTENDS

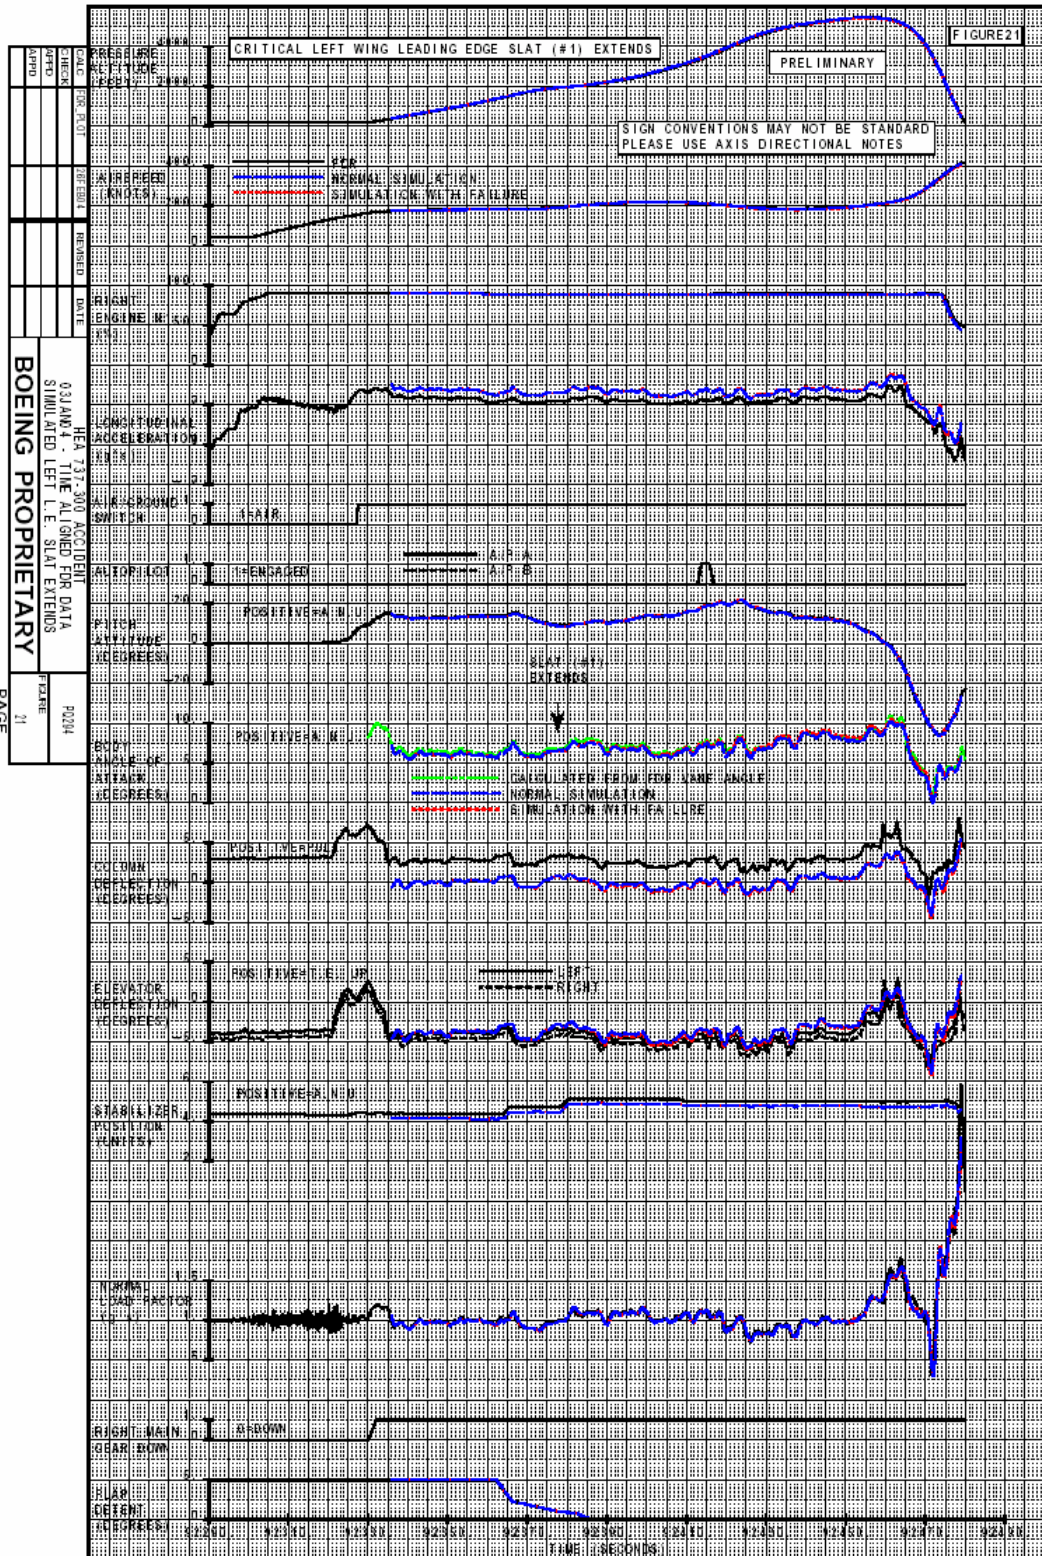
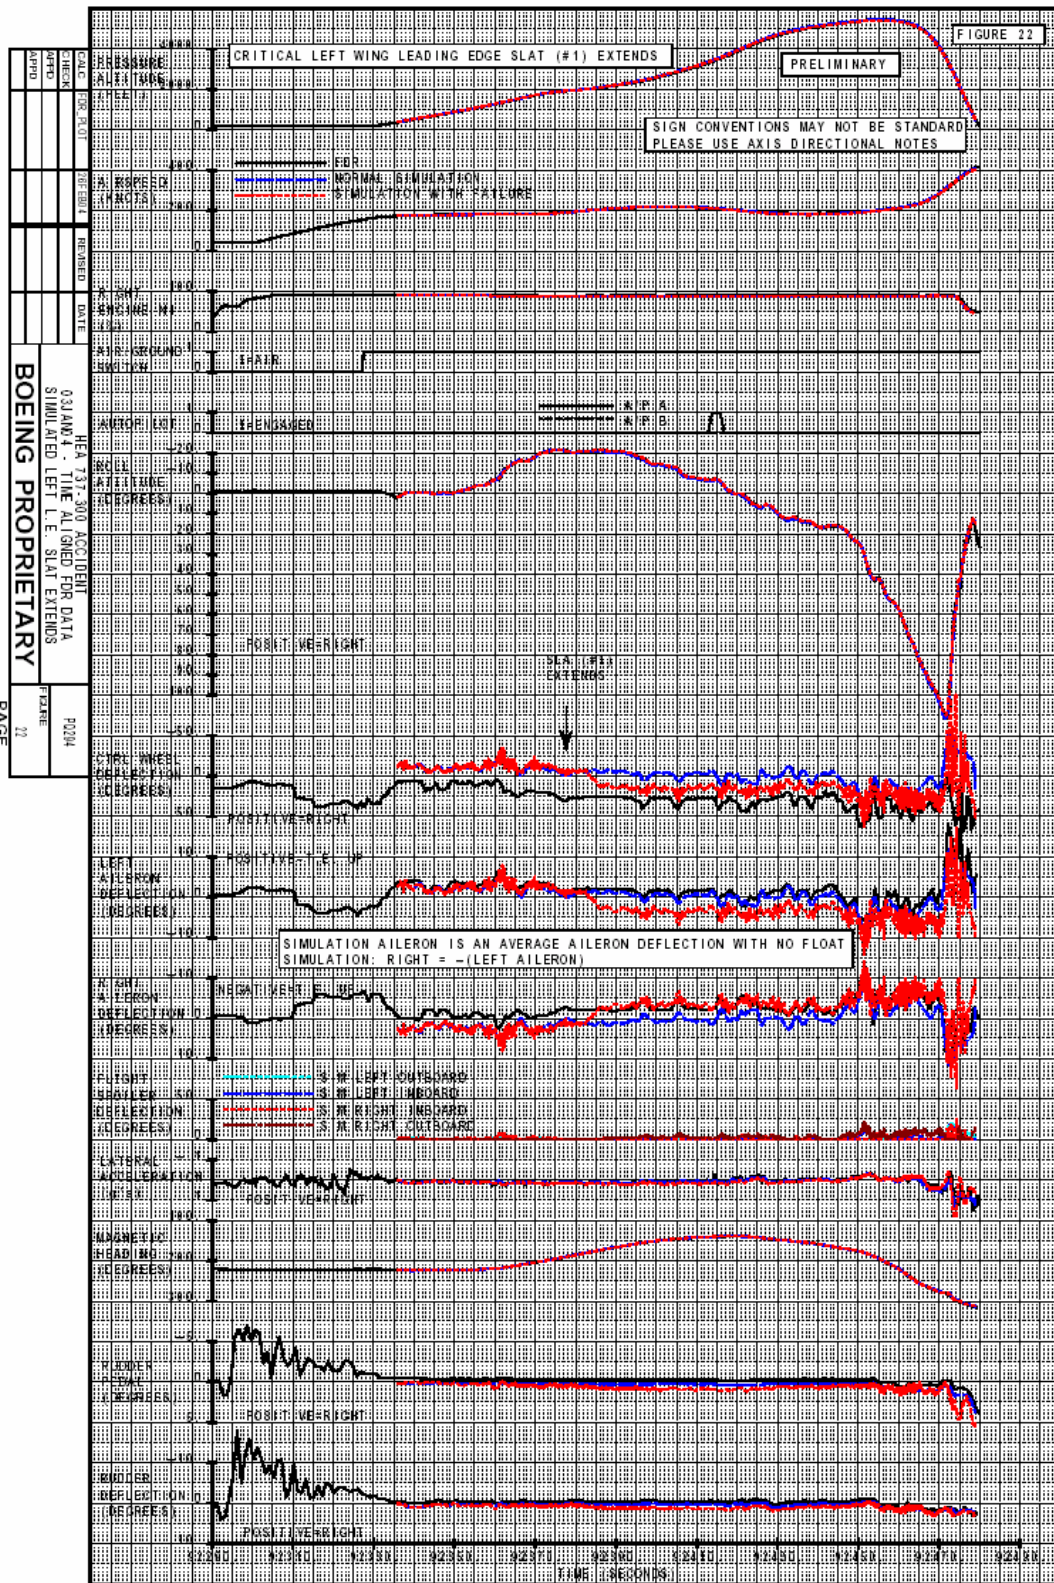
Critical left wing leading edge slat # 1 extends

HEA 737-300 ACCIDENT
03JAN04 - TIME ALIGNED FOR DATA
SIMULATED LEFT L.E. SLAT EXTENDS

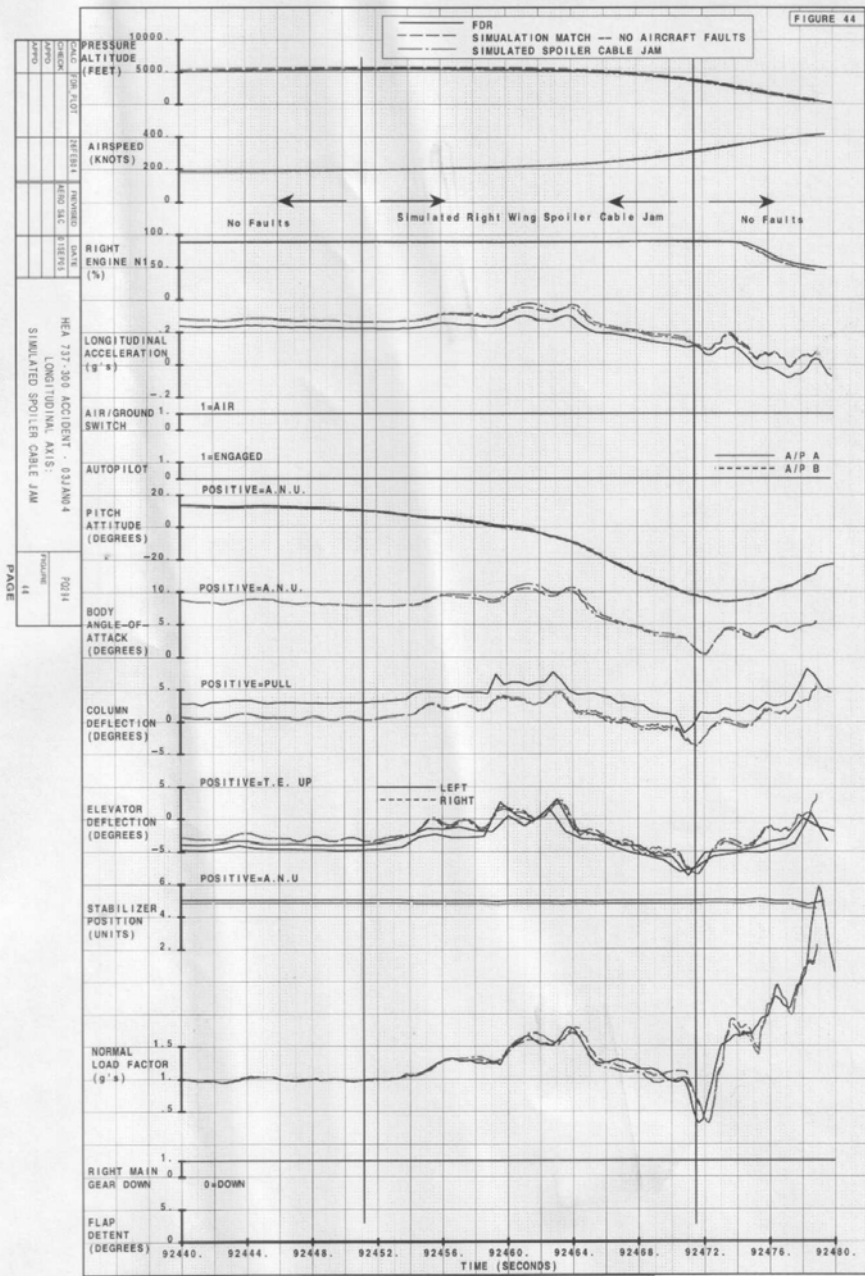
Longitudinal Axis, simulated right wing spoiler cable jam

Scenario 10 - Spoiler wing cable jam (Spoiler wing cable jam) offset of the neutral position at time 92450 (maximum wheel deflection).and clears at 92472

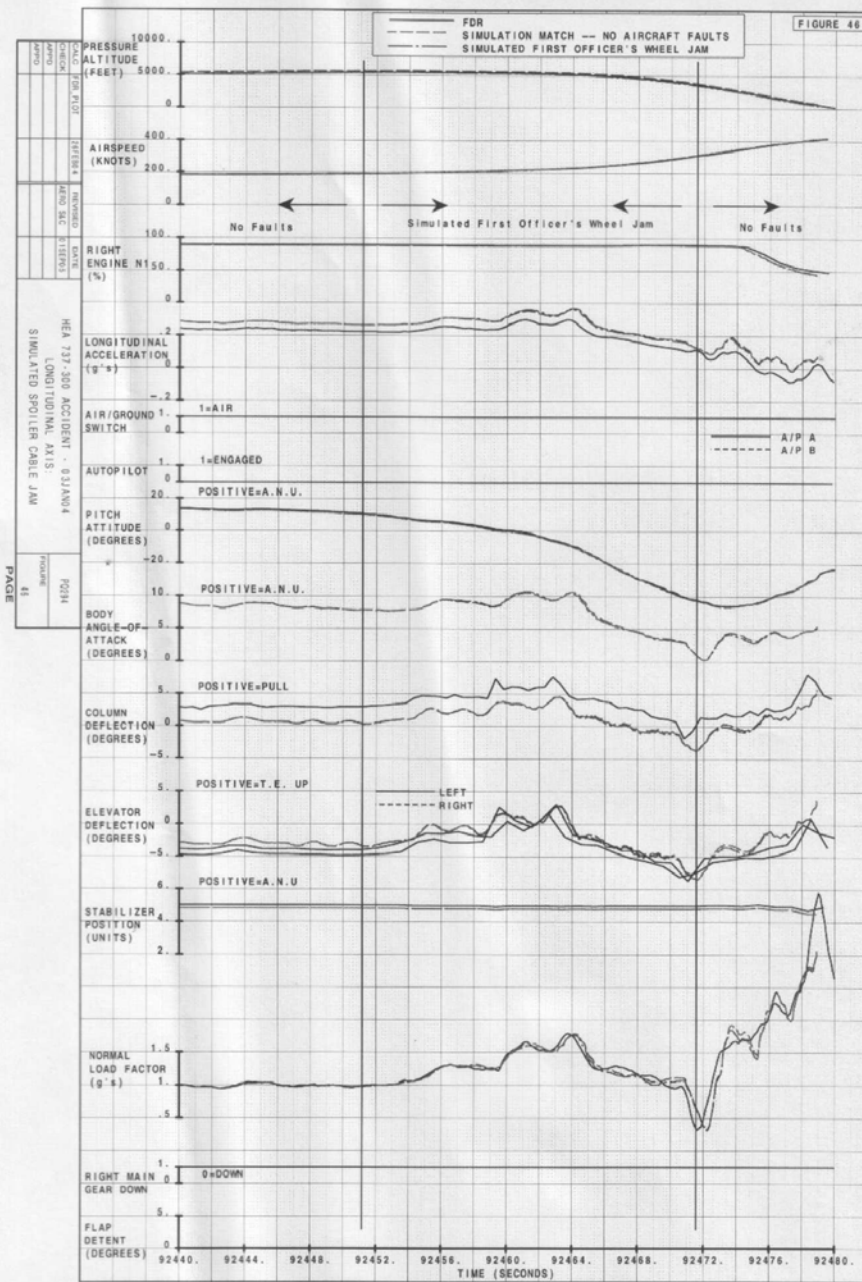
Longitudinal Axis, simulated F/O's wheel jam:

Scenario 10a - F/O wheel jam (F/O wheel jam) offset of the neutral position at time 92450 (maximum wheel deflection).and clears at 92472

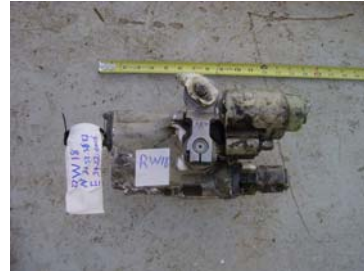
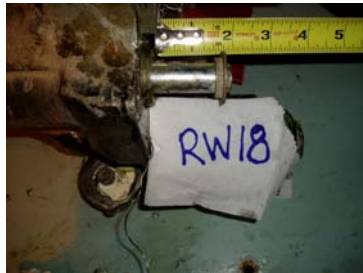
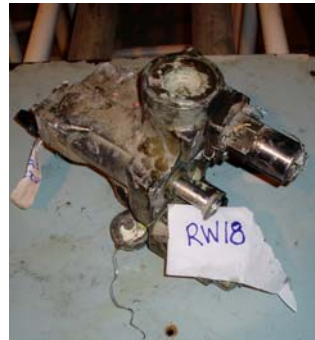
Aileron PCU Field Note Summary

- Recovered 25 Jan 04 (day 23)
- Stored in seawater on board
- Rinsed in freshwater on shore
- Stored at Sharm el-Sheikh airport until shipped to Seattle
- EQA conducted 25-26 Jan 05

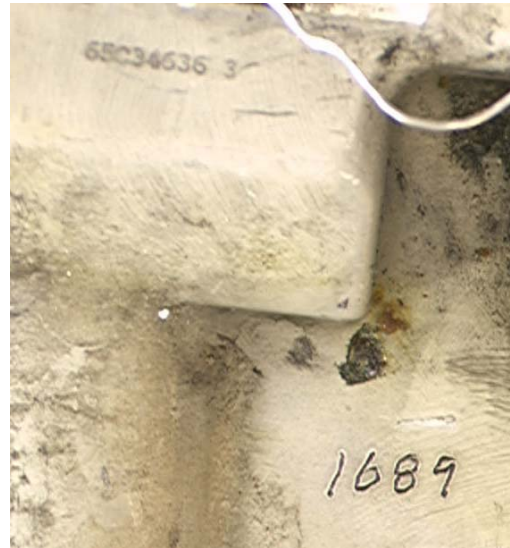
Supplier: Parker Hannifin
Boeing P/N: 65-44761-21*
S/N: 10748A*
Date Built: 1992*

*Data plate missing, information derived from Parker records based on manifold part number, serial number, and servo valve part number and serial number.

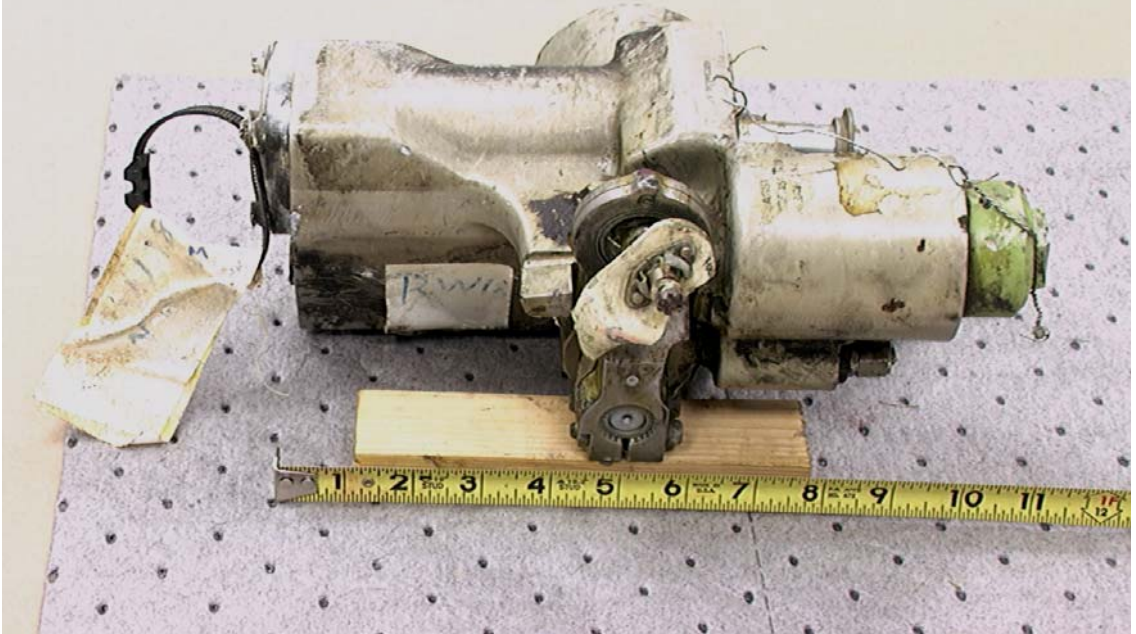
65-44761-21 Aileron PCU

Rod end fitting missing
Main ram fractured

Tailstock
missing

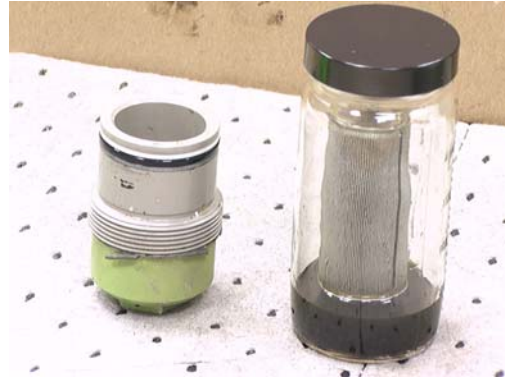
- Filter cap and filter element removed
- Fluid sample and filter retained for chemical analysis

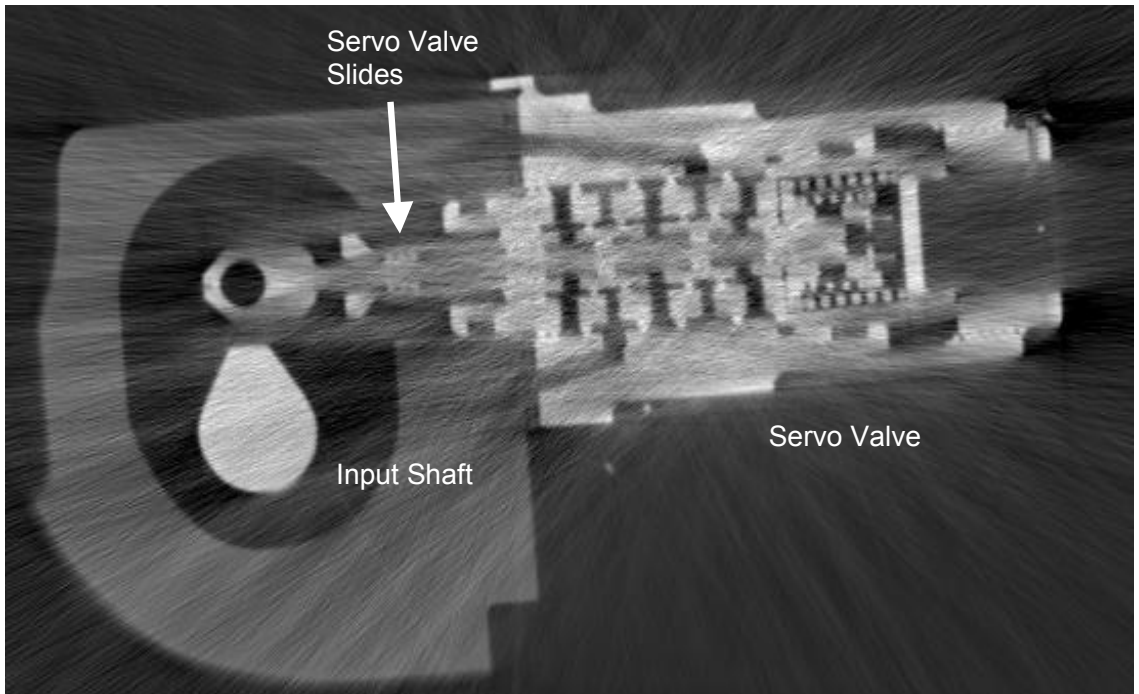
Computed Tomograph Scan

- Decision made to discontinue disassembly of servo valve (driving out slides could cause damage to surfaces)
- If deemed necessary, servo valve can be sectioned by electro-machining discharge (EDM).

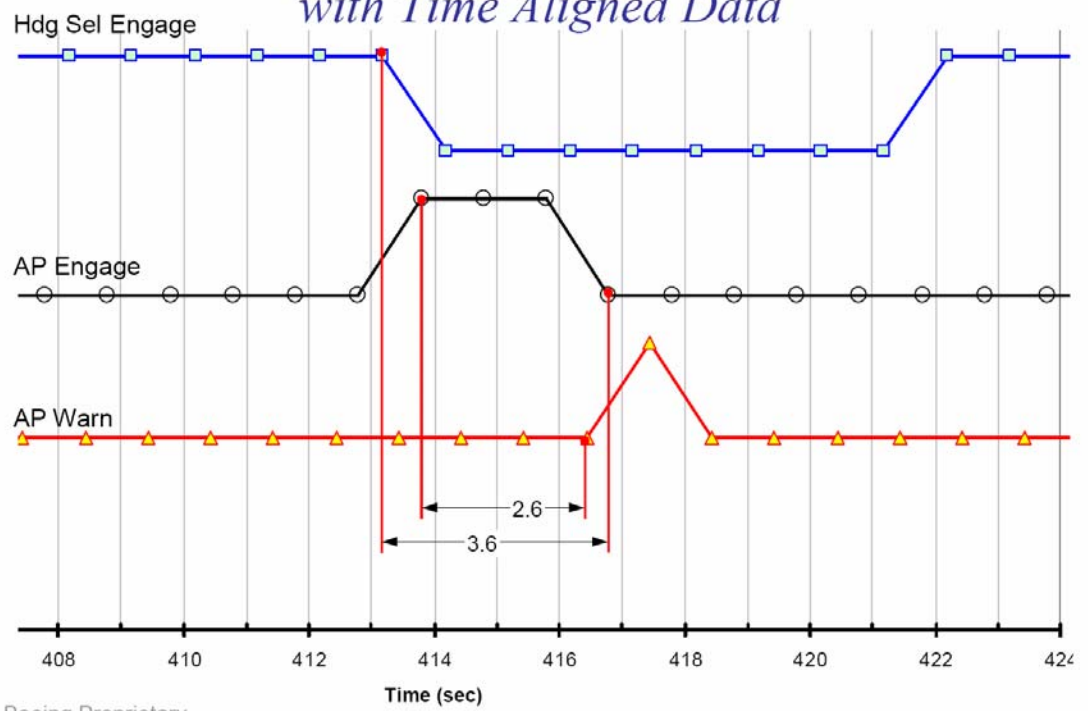
Autopilot Engage Attempt- with Time Aligned Data

Autopilot Engage Attempt *with Time Aligned Data*

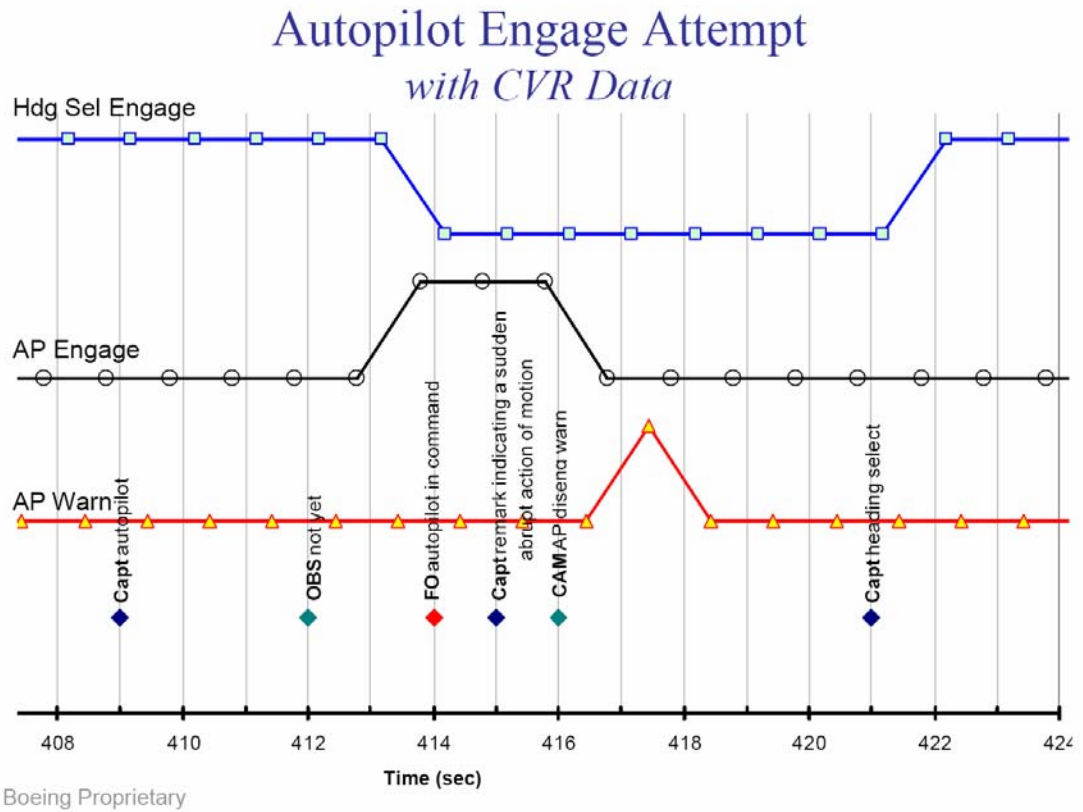
Autopilot Engage Attempt- with CVR Data

Note:
The recording “not yet” at 412 seconds is attributed to the captain and not to the observer.

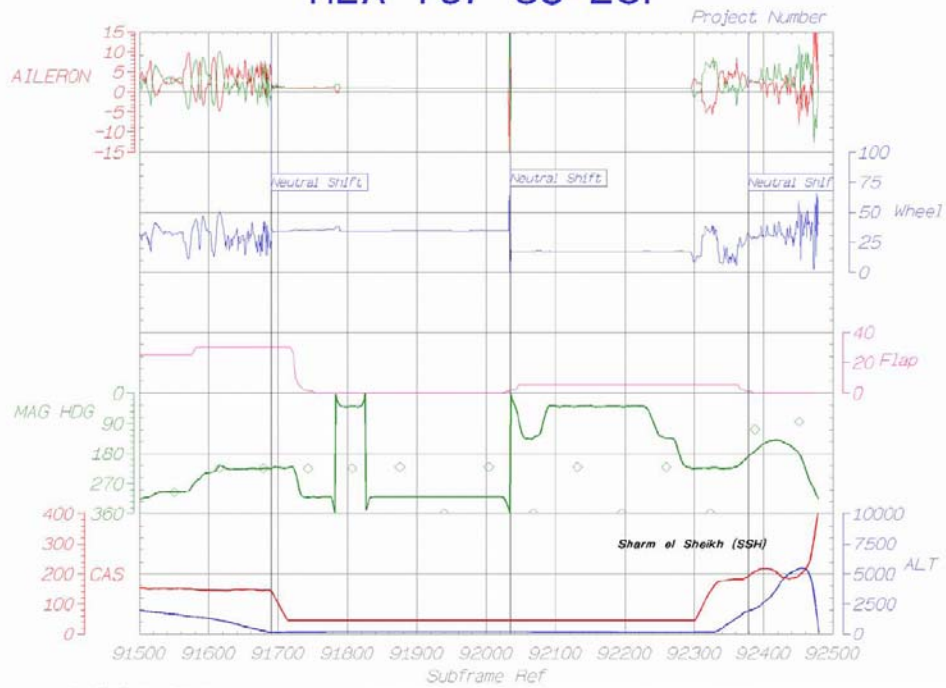
Response: The bias in the recorded control wheel signal appears to change on numerous occasions. As noted in the earlier presentation material, the bias changes during the control wheel sweep prior to every takeoff. In addition, the bias appears to change during every climb out, typically between takeoff and flaps up. Furthermore, the bias also appears to change just prior to landing, either during descent or approach. See attached slides that show the changing wheel bias for the accident flight and the previous flight. Similar behavior is noted in all flights, including the first recorded landing, control sweep and takeoff from Abu Simbel. The behavior of the recorded FDR wheel signal appears consistent with a slipping synchro body.

Wheel bias shifts during landing at SSH, control sweep on ground at SSH, and takeoff on accident flight from SSH.

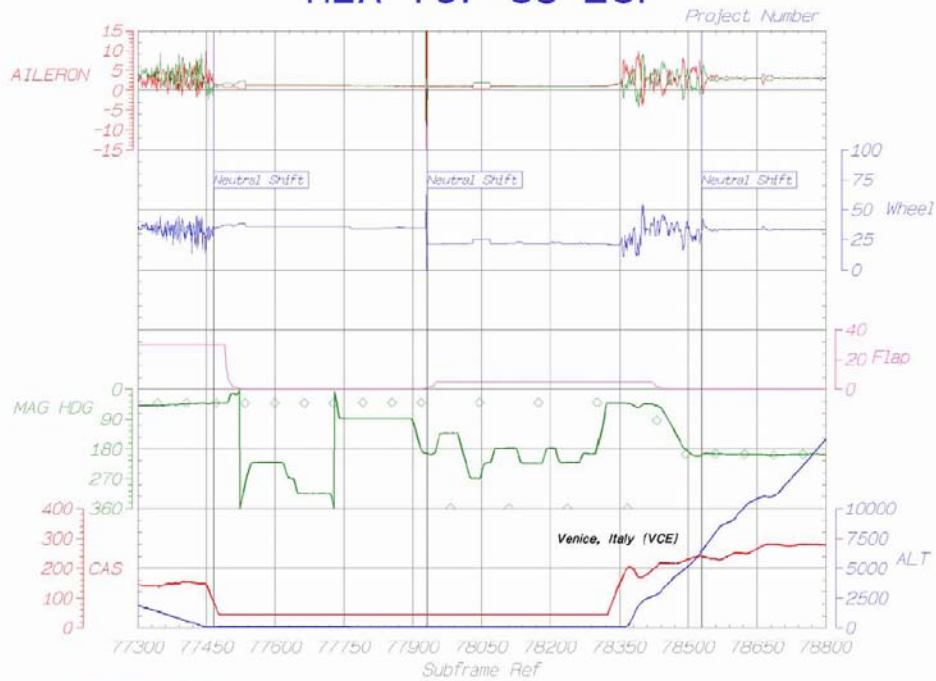
Wheel bias shifts during landing at VCE, control sweep on ground at SSH, and takeoff on previous flight from VCE.

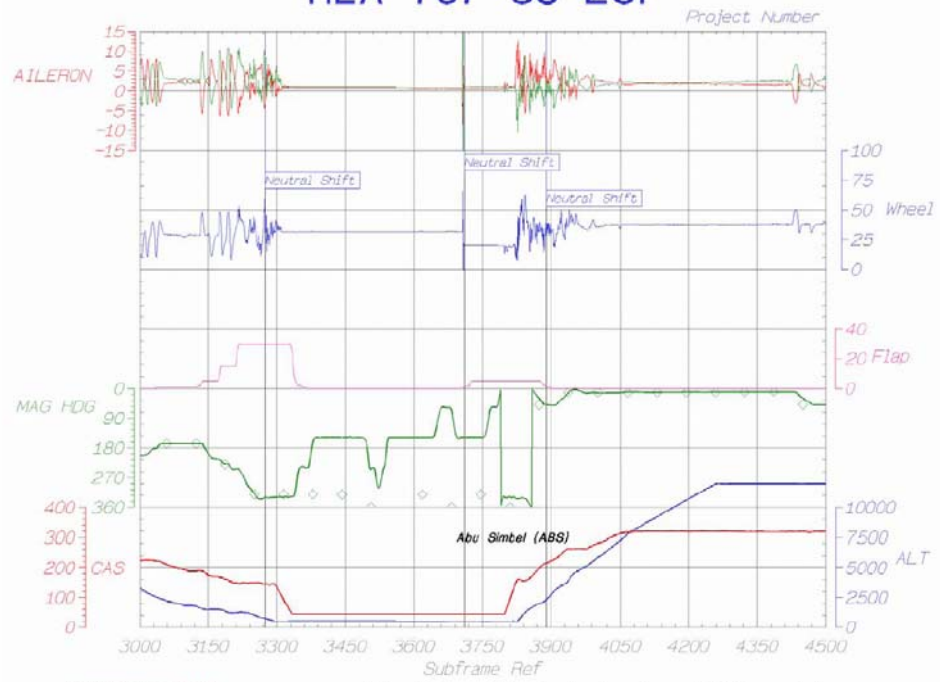
Wheel bias shifts during landing at ABS, control sweep on ground at ABS, and first recorded takeoff from ABS.

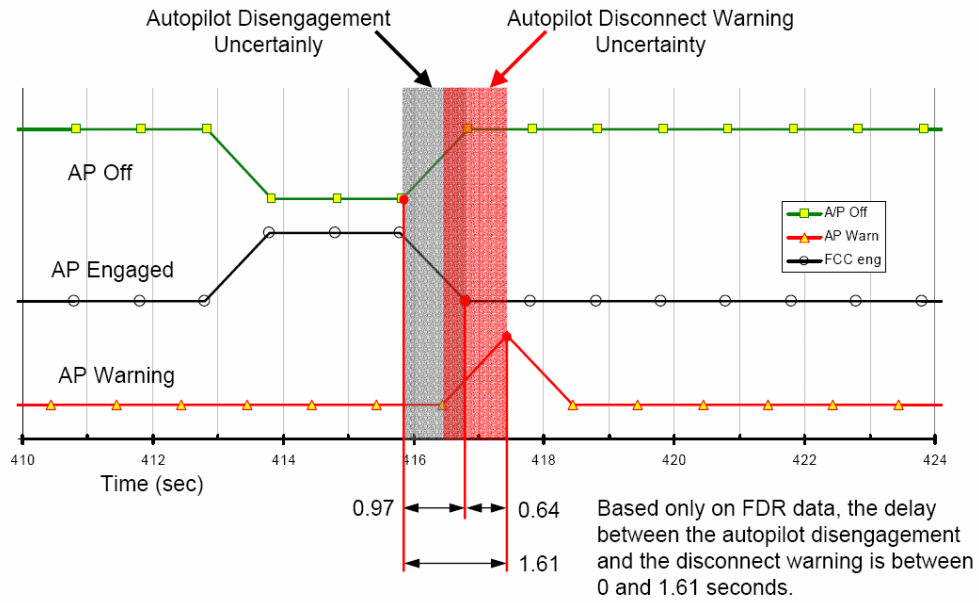
Autopilot Disengagement with Time Aligned Data

Answer: There are three possible reasons why the autopilot disengaged: the engage synchronization (actuator to surface) failed to complete; the engage hold interlocks were not satisfied; or it was manually disconnected. Based on the data recorded on the FDR, we are not able to pinpoint which of these caused the autopilot to disengage. Additional information on the details of the interlocks and their operation are provided in the Airplane Maintenance Manual section 22-11-01 . ①

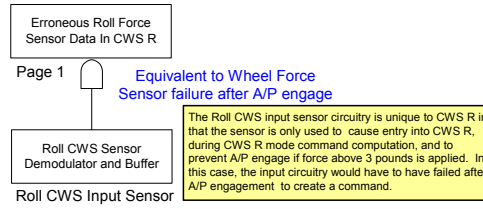
Note :This failure does not inhibit manual disconnect nor does it result in failure to disconnect with erroneous FDR disengaged indication. When this failure occurs, pilot can override erroneous command with normal autopilot override forces.

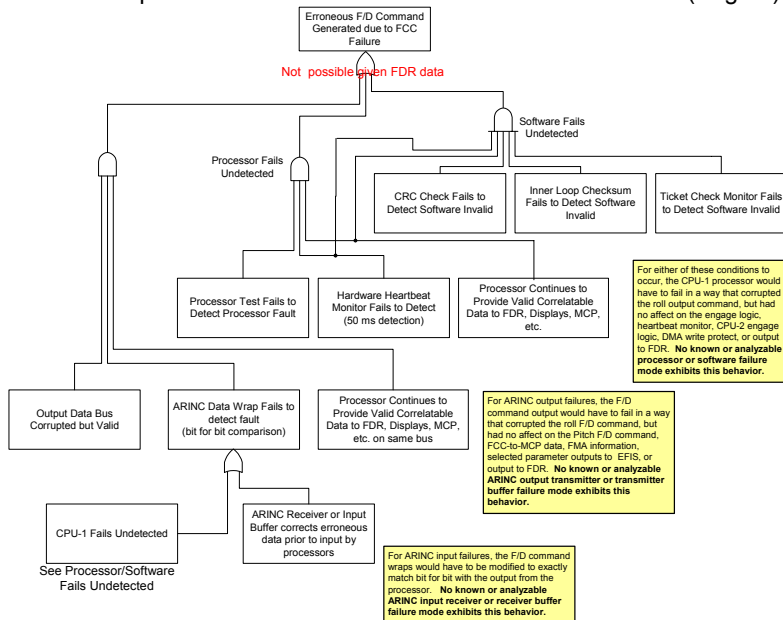
Scenario 5 & 11 – Multiple FCC Failures Cause Erroneous F/D Command (Page 5)
