Final report of the accident investigation, Flash Airlines Flight 604, Boeing 737-300 SU-ZCF, Red Sea off Sharm El-Sheikh, Egypt, January 3, 2004

FINAL REPORT OF THE ACCIDENT INVESTIGATION

Flash Airlines flight 604

Boeing 737-300 SU-ZCF

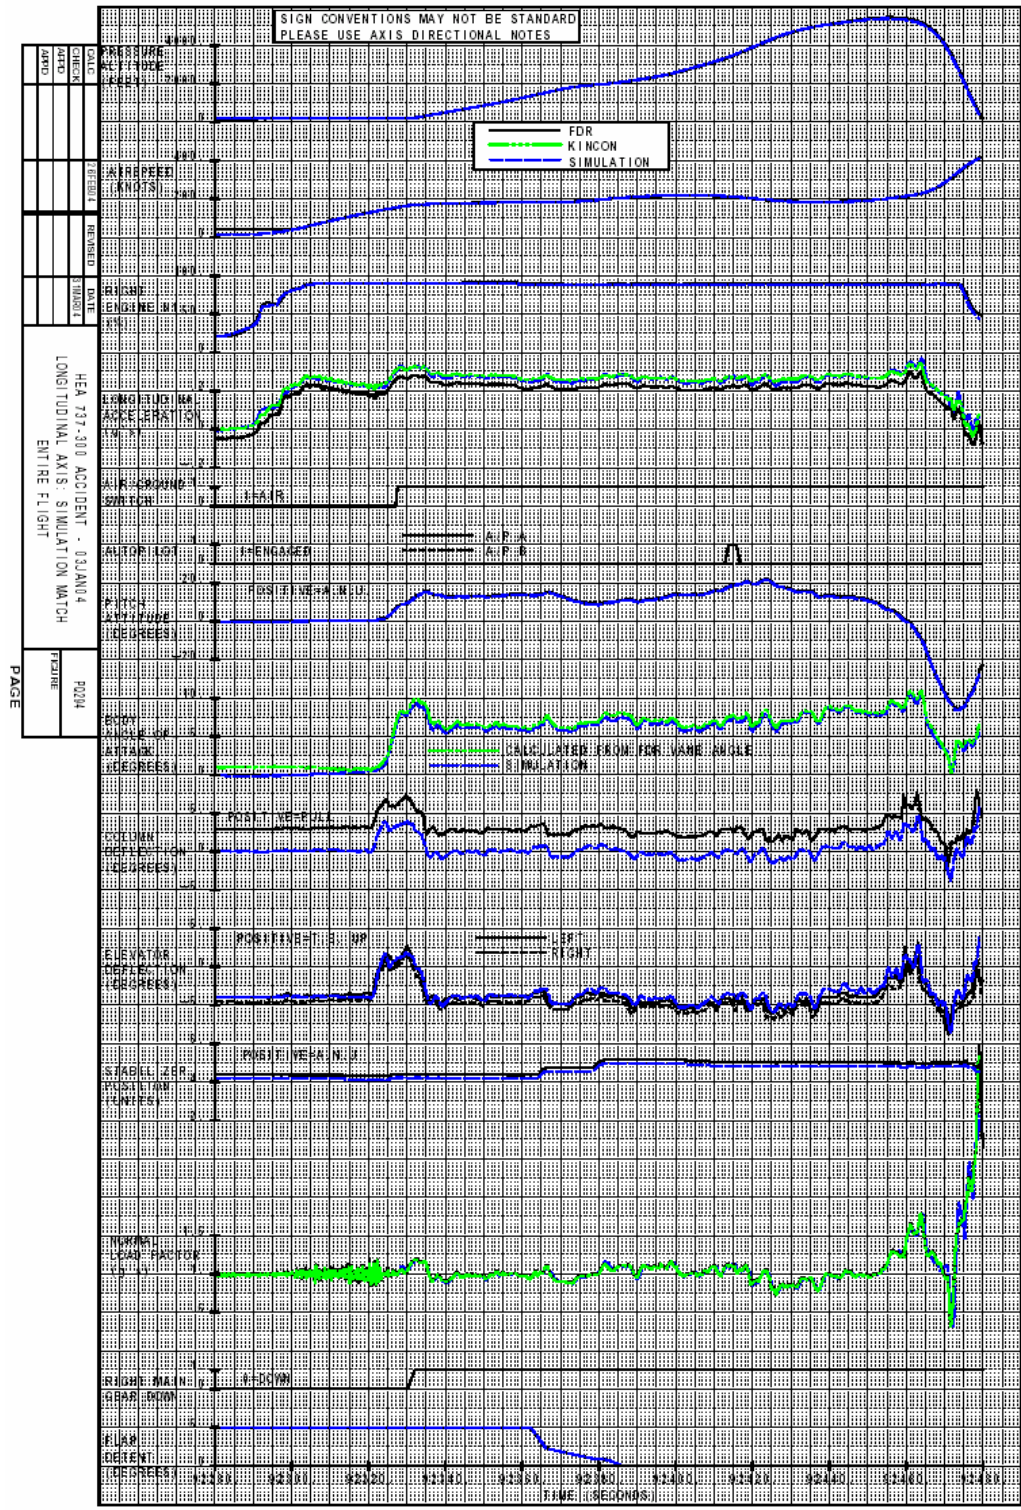
Figure C7-1 – FDR and Simulation Match Data – Longitudinal Axis

Comparisons between the recorded FDR data and the simulation time history data are provided for longitudinal and lateral/directional data in Figures Figure C7-1 and Figure C7-2 respectively.

An examination of the baseline simulation revealed that the path of the accident airplane is consistent with the recorded motion of the control surfaces. Specifically, the extreme bank attitude that occurs towards the end of the flight is consistent with recorded motion of the ailerons.

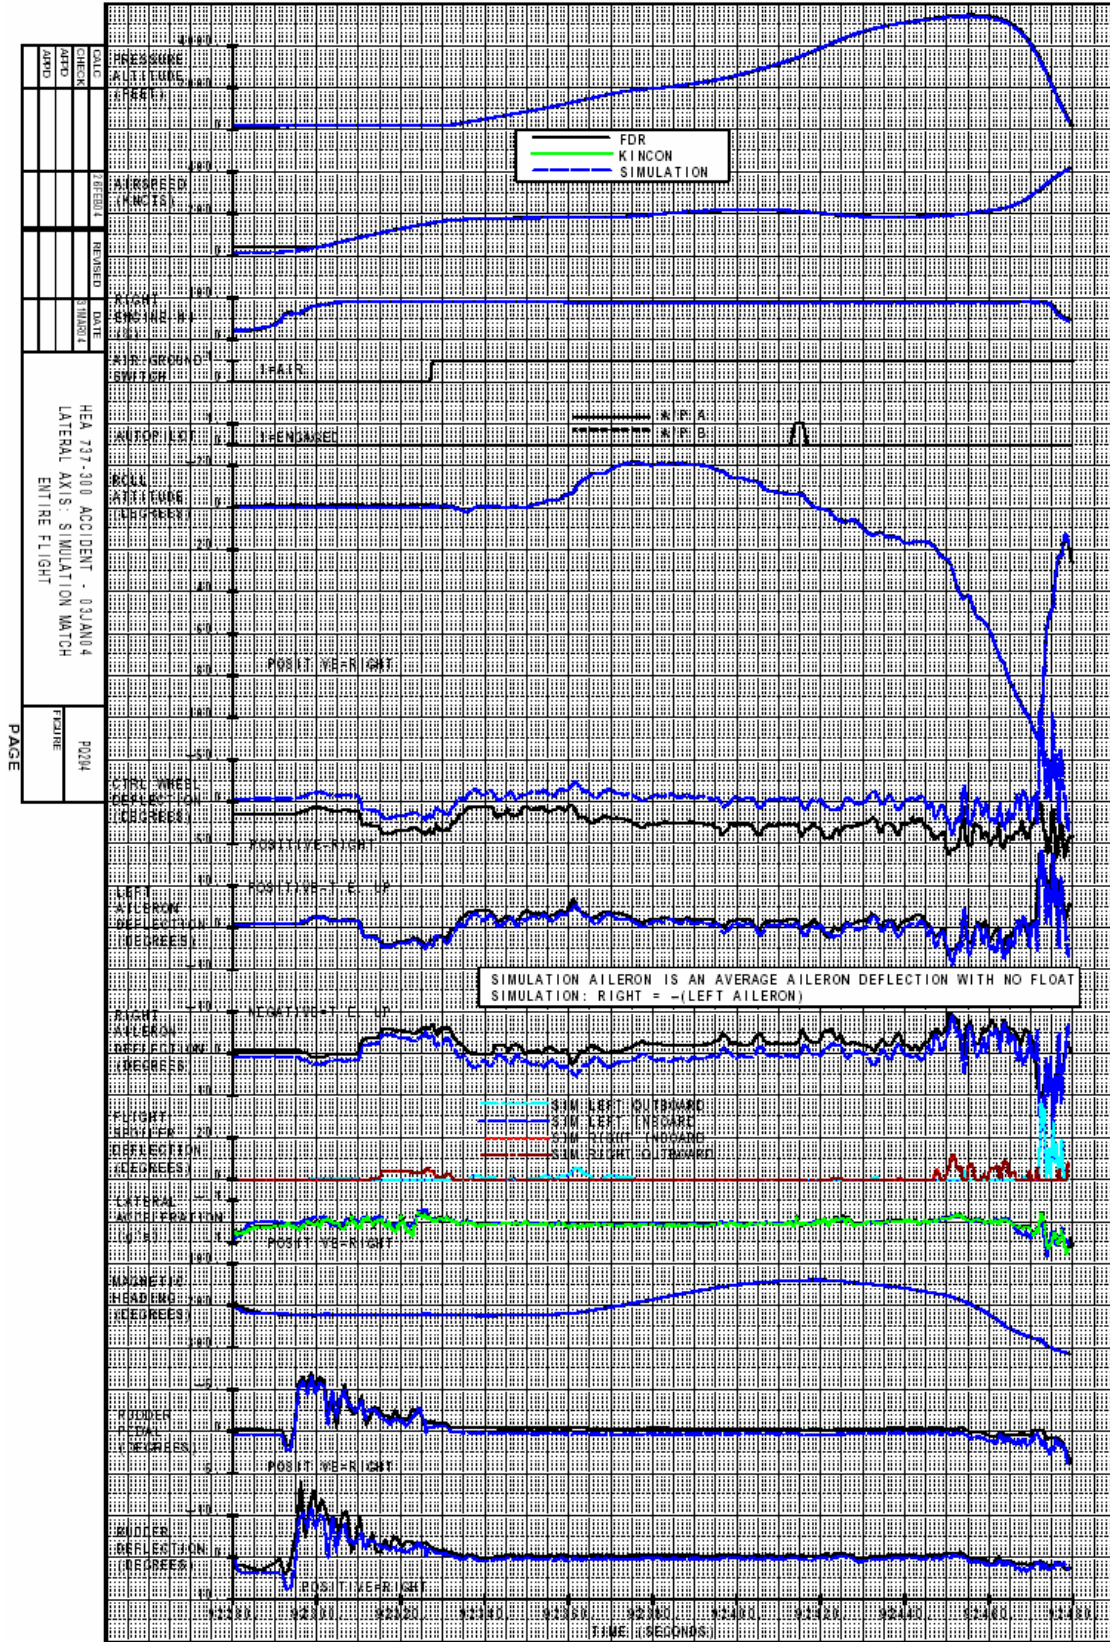
Figure 1.16.2-2 – FDR and Simulation Match Data – Lateral/Directional Axis

An examination of the baseline simulation revealed that the path of the accident airplane is consistent with the recorded motion of the control surfaces. Specifically, the extreme bank attitude that occurs towards the end of the flight is consistent with recorded motion of the ailerons.

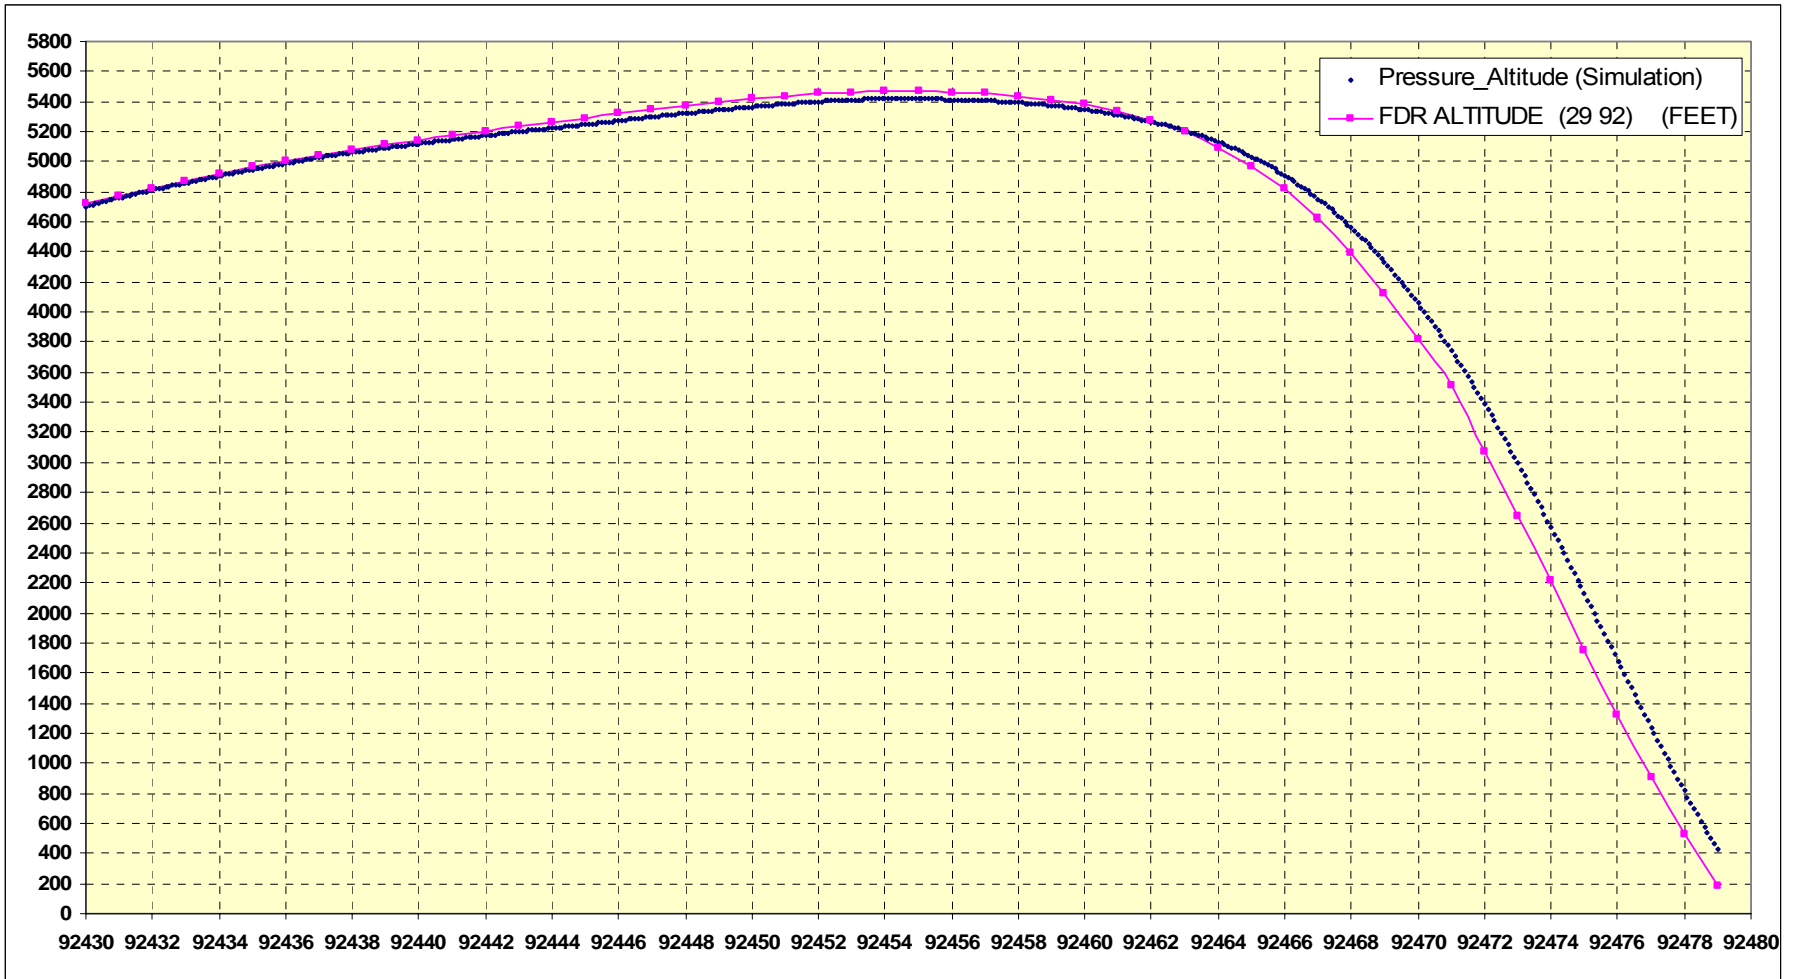
Fig 2.2.3.1 Pressure Altitude vs time frames (FDR and Simulation data)

A 65 lb error in calculated lift will result in an altitude error of 200 ft after 147 seconds.

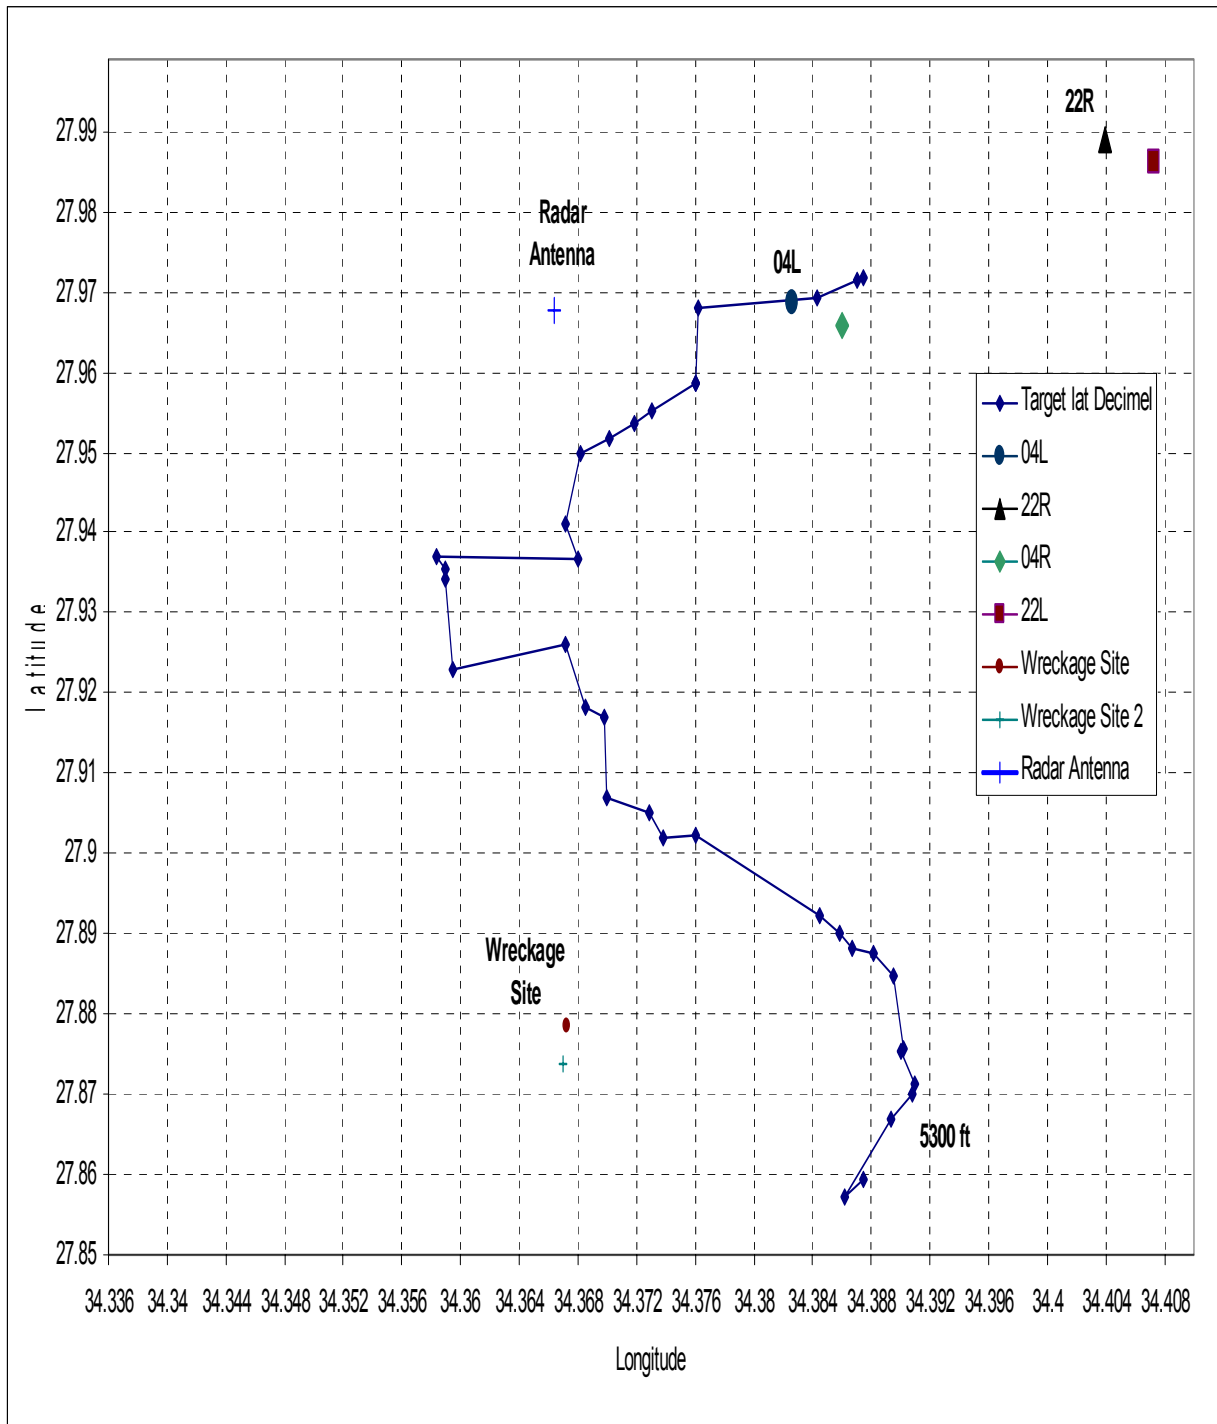
Figure C.2-1 Radar Data Plot, Sharm El Sheikh Radar

It is noted that the time scale of the radar is not exactly in match with the time scale of FDR. Based on the FDR timing, the airplane crashed in the water at 02:45:06 GMT (92480), while the radar indicated airplane disappearance at 02:47:27 GMT (about 141 seconds later). The last radar return from the airplane which can be considered as reliable was at 02:46:39 Radar time (about 92467 second frames on

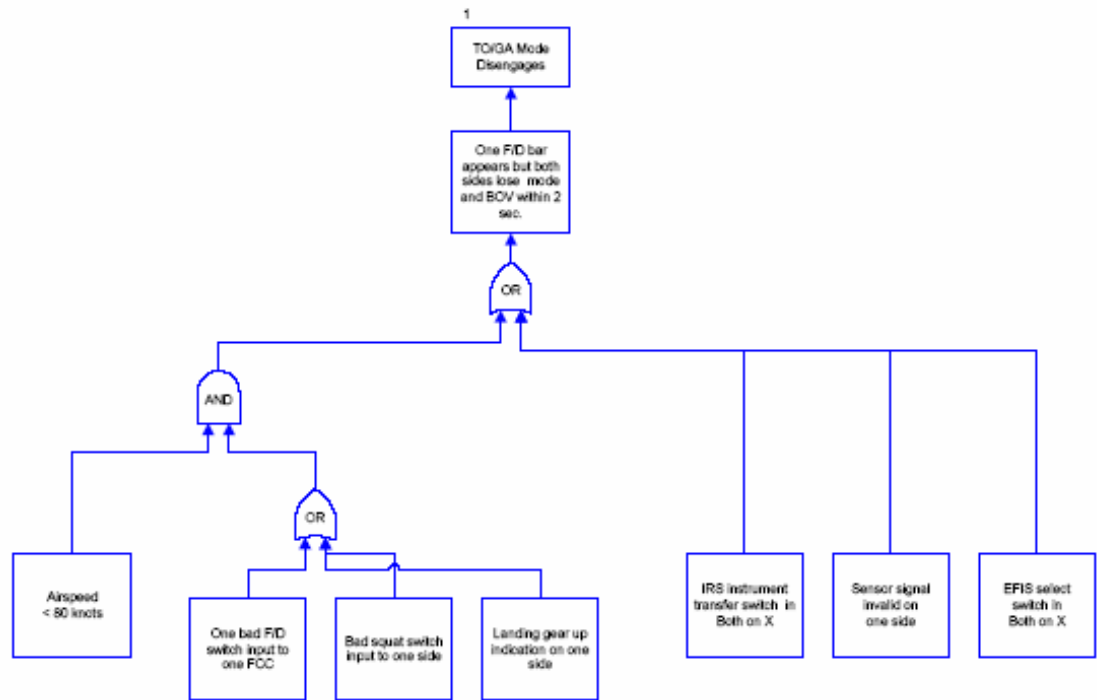
Fig 2.5.1.3 TO/GA Mode Disengage Logic

{(Airspeed < 80 knots). [(One bad F/D switch input to one FCC) + (Bad squat switch input to one side) + (Landing gear up indication on one side)] + {(IRS instrument transfer switch in Both on X) + (Sensor signal invalid on one side) + (EFIS select switch in Both on X)}

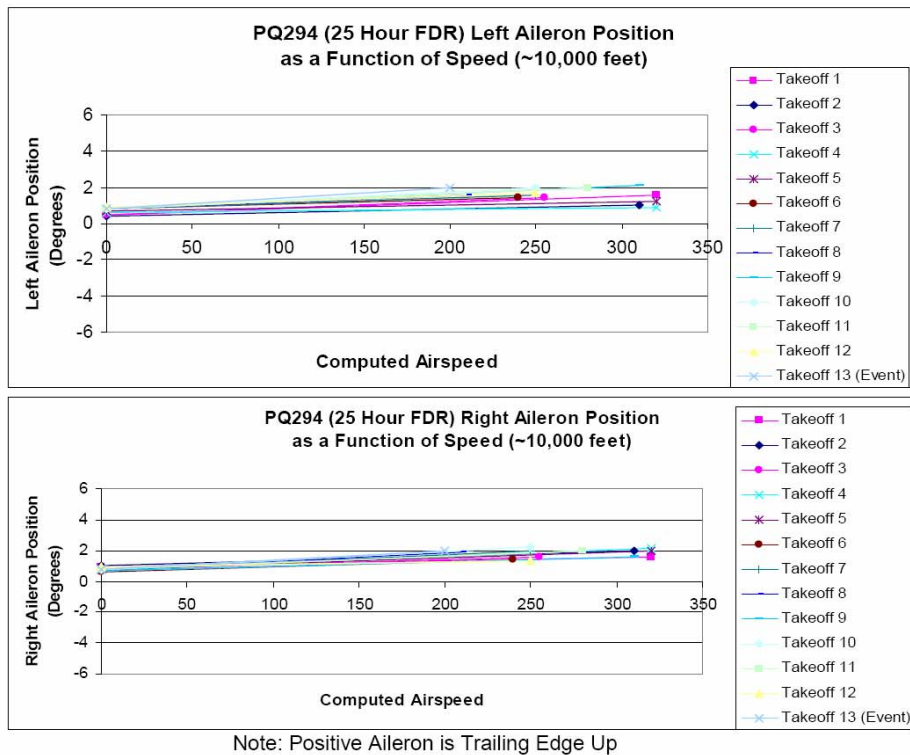
Figure 2.5.2.3a Aileron float from Airload (PQ294)

As shown from the above figures, the ailerons blow up as result of increasing speed is not exactly the same for all Take Off's. The aileron blow up increases with increasing speed.

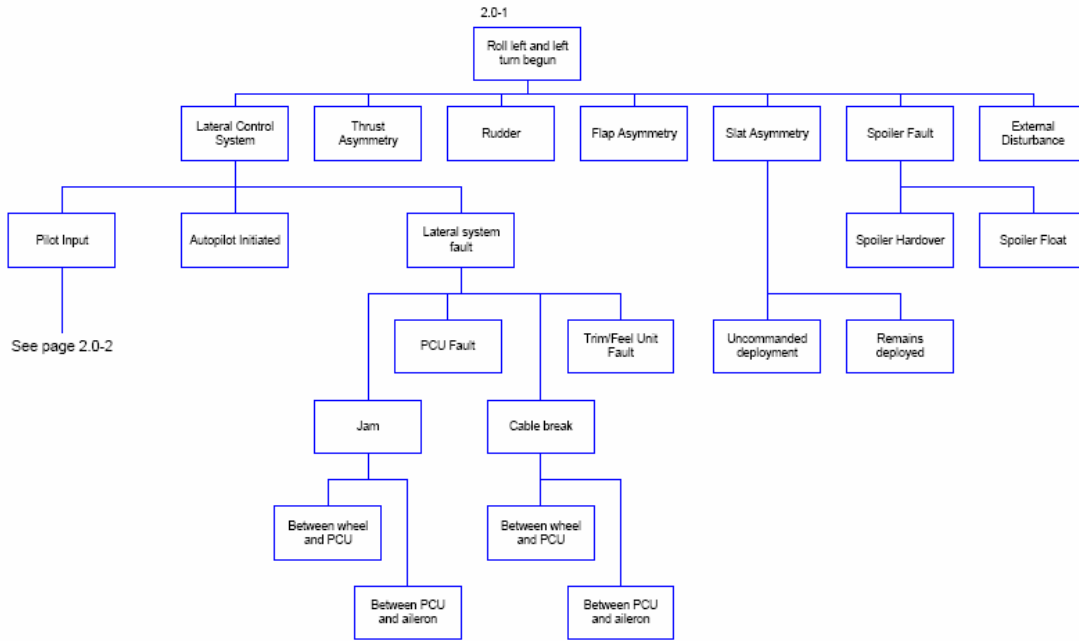
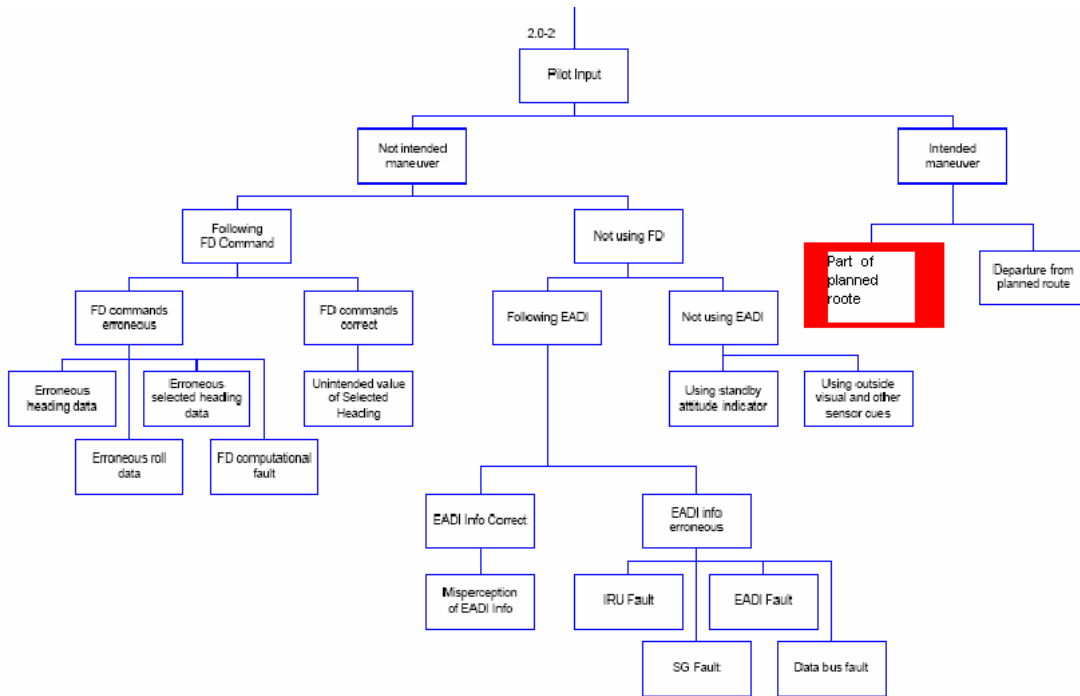
Figure 2.5.4.2 Roll Left and Left Turn Begun analysis

The Roll Left and the beginning of Left Turn are normal and expected to intercept and follow the Radial 306 to Cairo. These movements have no direct relation with the accident.

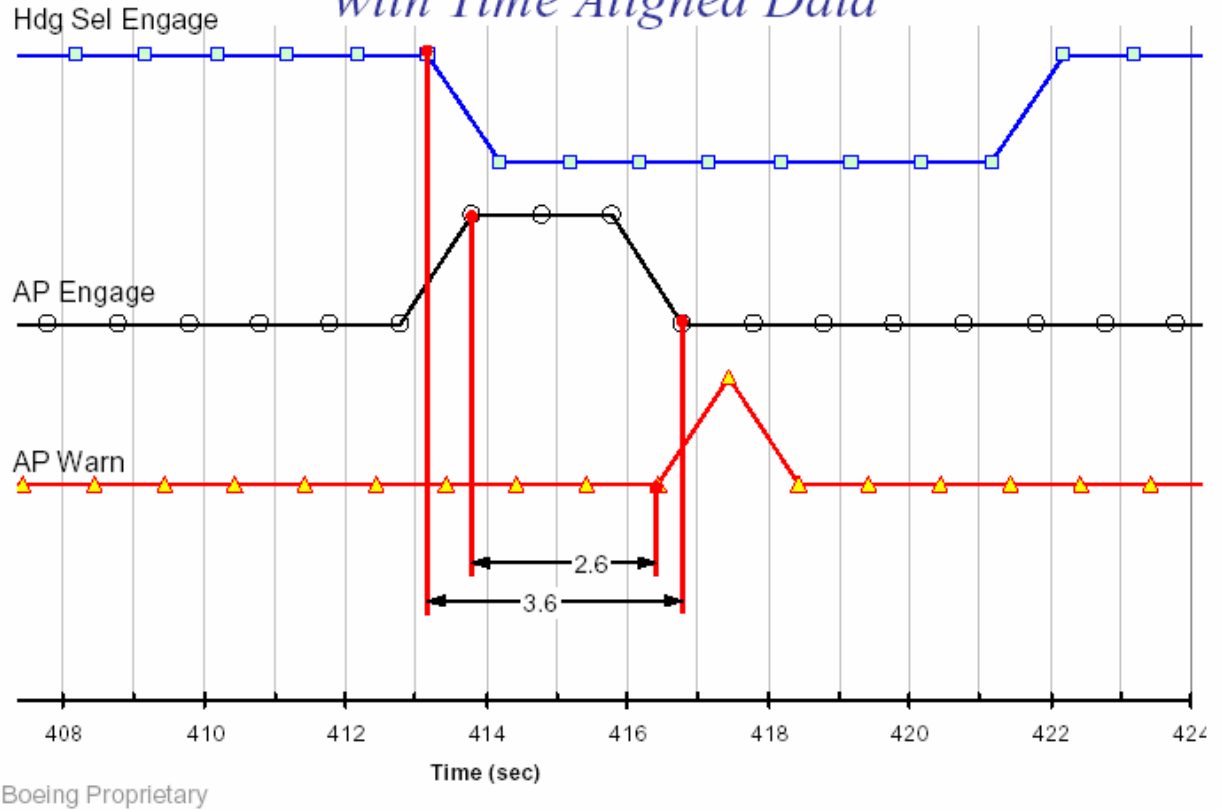
Figure 2.5.7.3 Autopilot Engage Attempt with Time Aligned Data

The investigation could not determine a higher possibility to any of the above findings based on the given data. However, with reference to the CVR/ FDR correlation, this event could have initiated crew distraction.

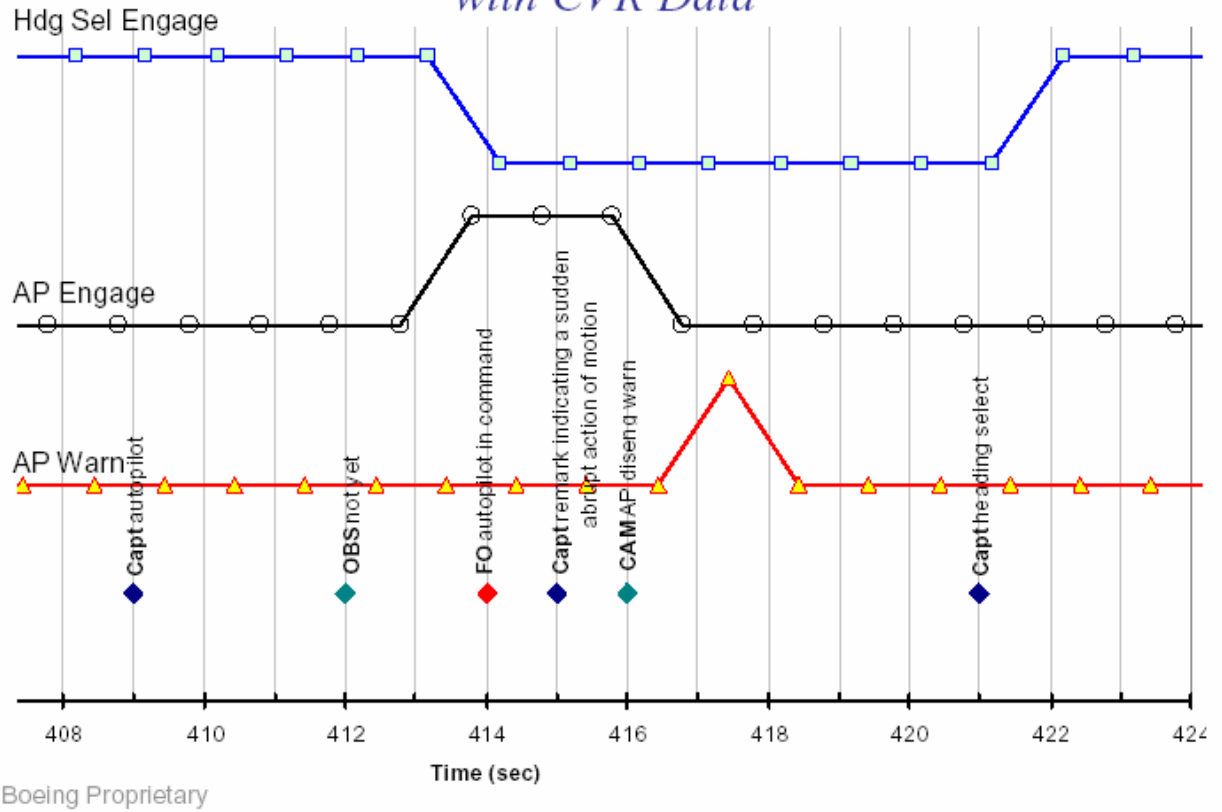
Figure 2.5.7.4 Autopilot Engage Attempt with Time CVR Data

The CVR statement "Not yet" at 412 is attributed to Captain instead of the Observer

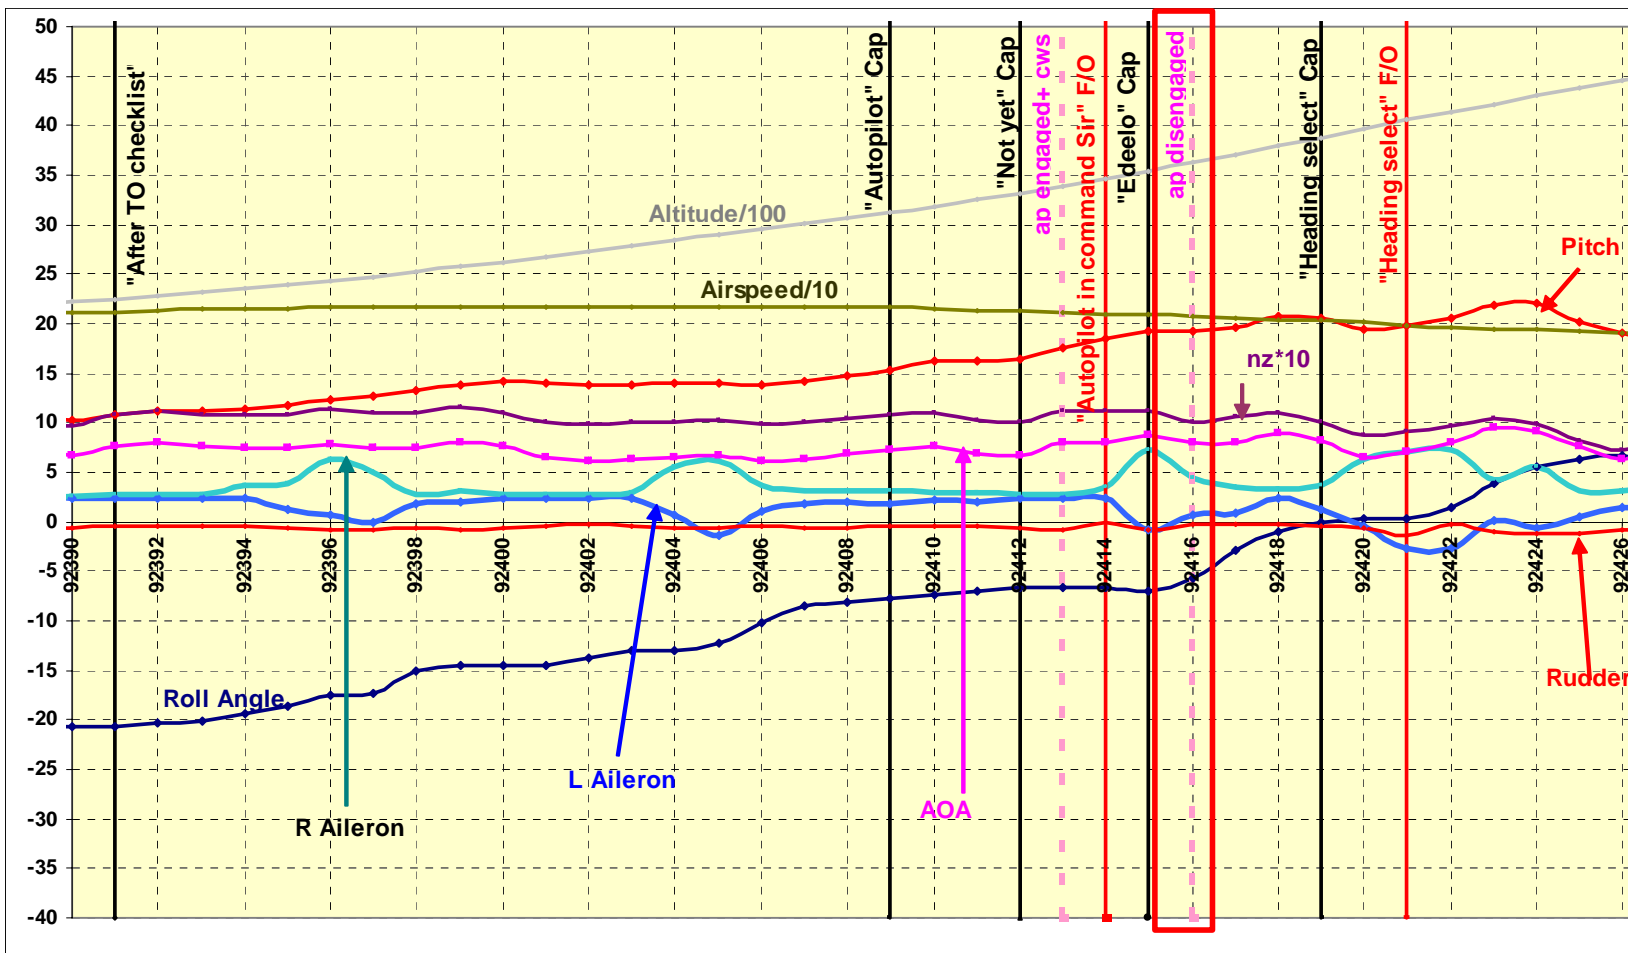
Figure 2.5.10.1 Autopilot Disengagement indications on the FDR and CVR

- At time 02:43:55 (92409), the Captain called "Autopilot".
- At time 02:43:58 (92412), the Captain stated "Not yet".
- At time 02:43:59 (92413), the FDR recorded the autopilot was engaged, and the roll mode transition to CWS-R¹.
- At time 02:44:00 (92414), the F/O stated "Autopilot in command sir".
- At time 02:44:01 (92415), the captain stated "EDEELO", (an Arabic exclamation expressing a sharp response of some kind). At the same time, the FDR records momentary aileron surfaces movements. The right aileron deflected to 7.2 degree TEU for one second
- At time 02:44:02 (92416), the CVR recorded the autopilot disconnect warning and the FDR recorded the autopilot disengaged. The aural warning lasted for 2.136 seconds. During this time, an increase in pitch and decay in airspeed were observed

¹ This transition would have resulted in loss of Heading Select Mode

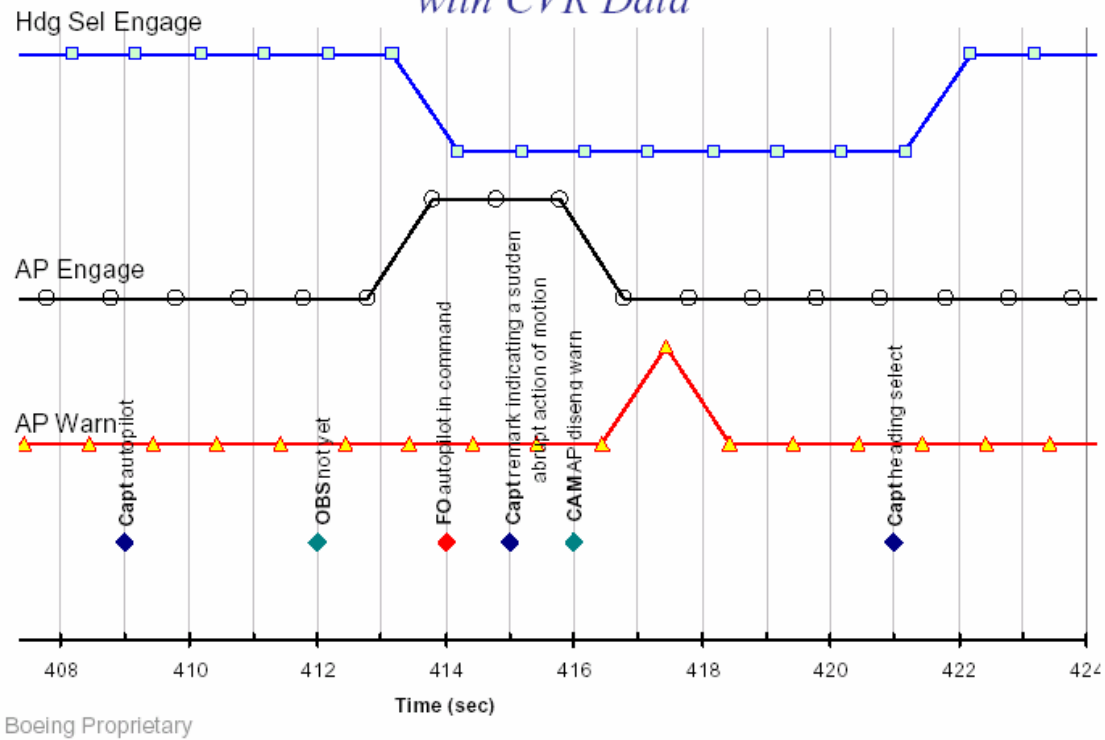
Autopilot Engage Attempt with CVR Data

The CVR statement "Not yet" is not attributed to the observer but to the Captain.

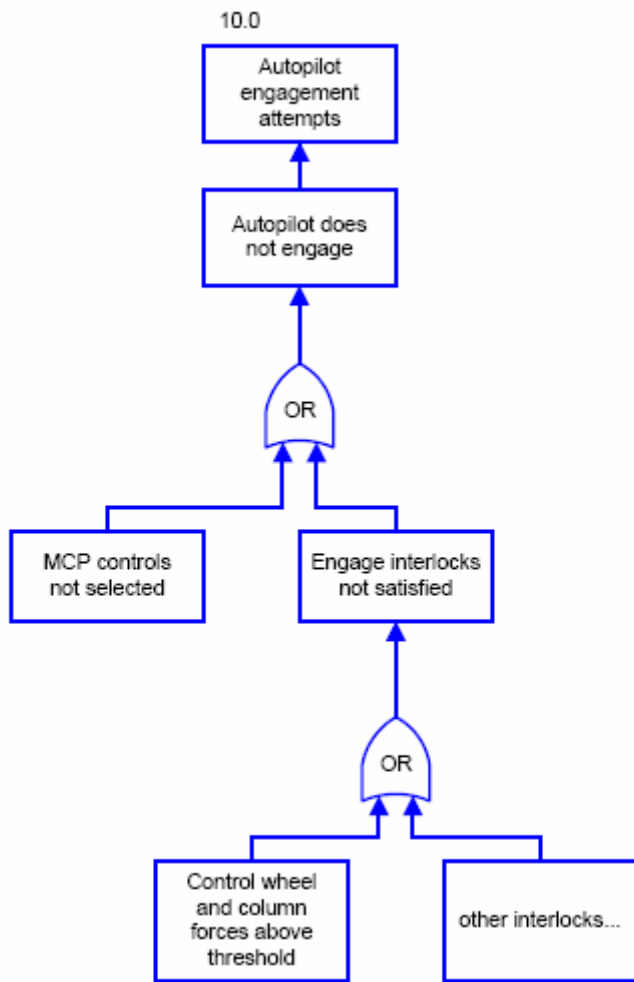
"Engaged" means:
 AP system began an attempt to synchronize so that it could subsequently control the airplane. It does not necessarily mean that the detent pistons were pressurized and that the AP was controlling the airplane.
 This definition is consistent with indications of AP engagement available to crew and FDR.

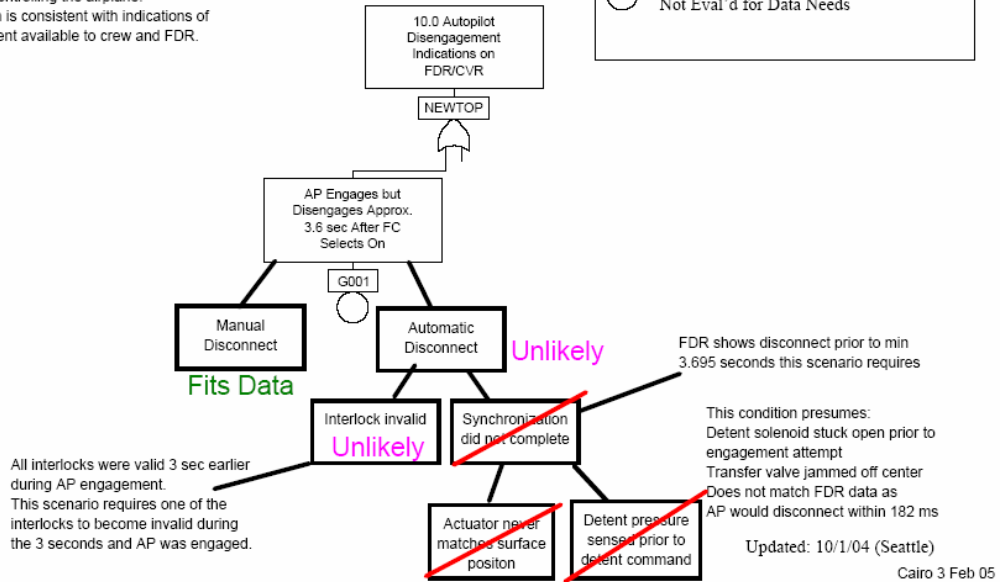
AP system began an attempt to synchronize so that it could subsequently control the airplane. It does not necessarily mean that the detent pistons were pressurized and that the AP was controlling the airplane. This definition is consistent with indications of AP engagement available to crew and FDR.

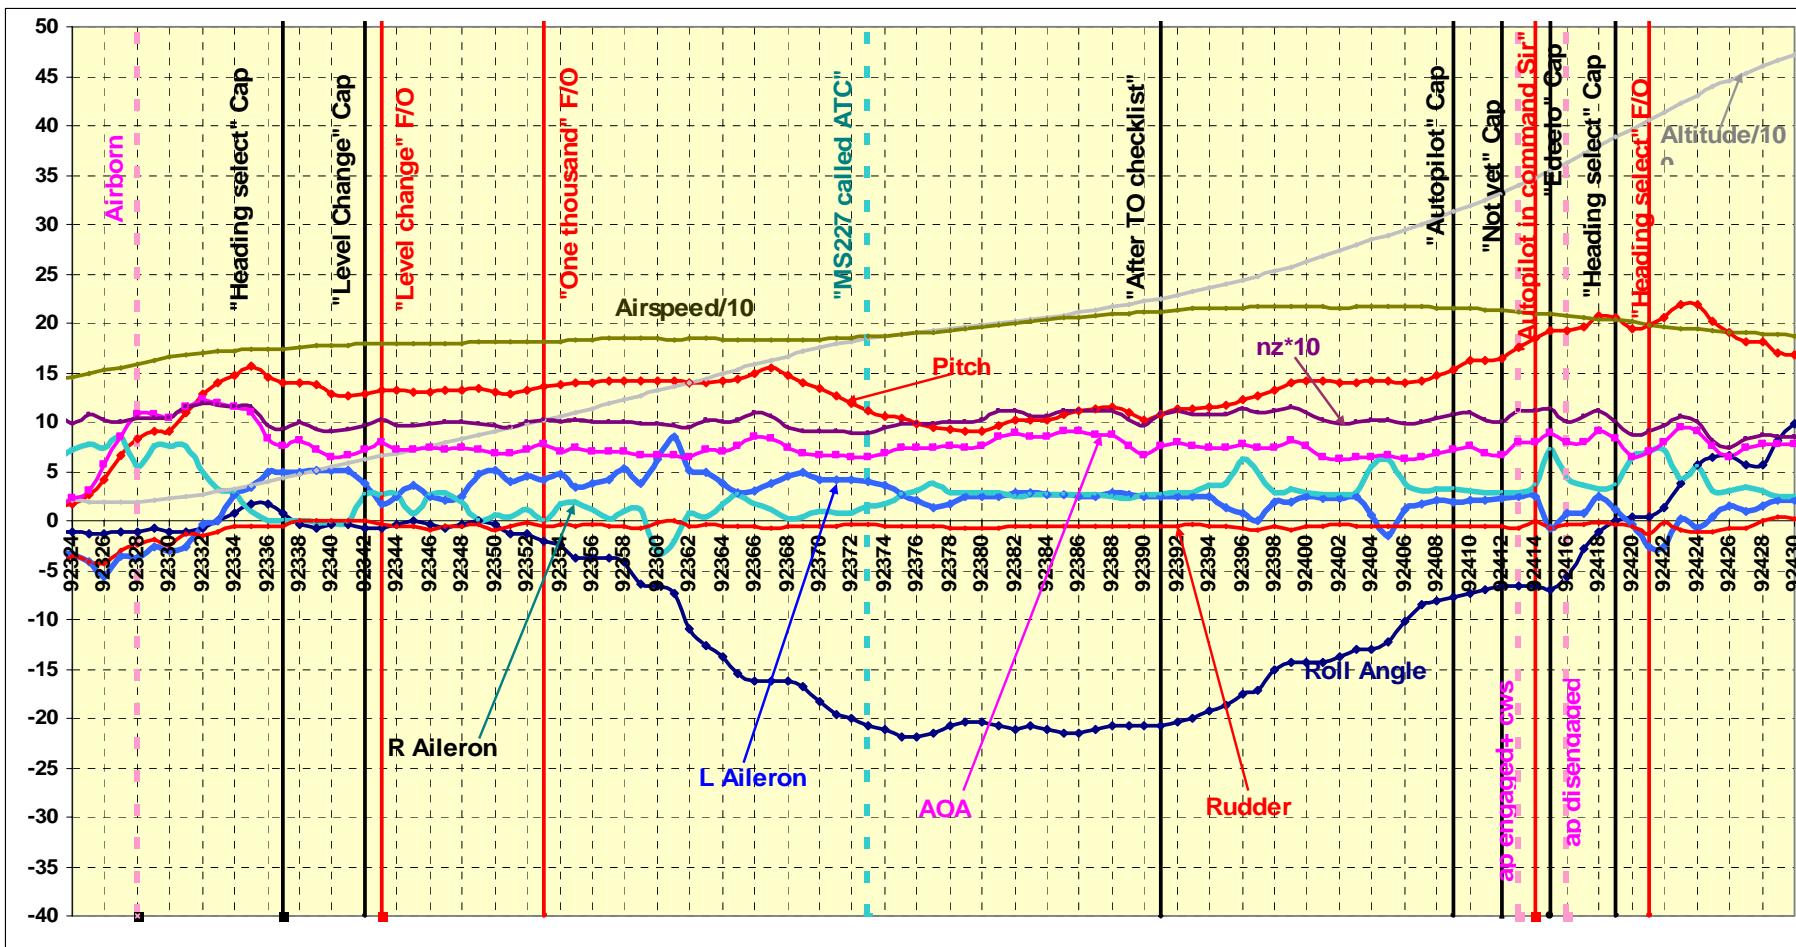
- At time 02:44:05 (92419), the Captain requested "heading select".
- At time 02:44:07 (92421), the F/O states "heading select" and the FDR records heading select mode engaging.

Figure 2.5.12.1 Heading Select engaged

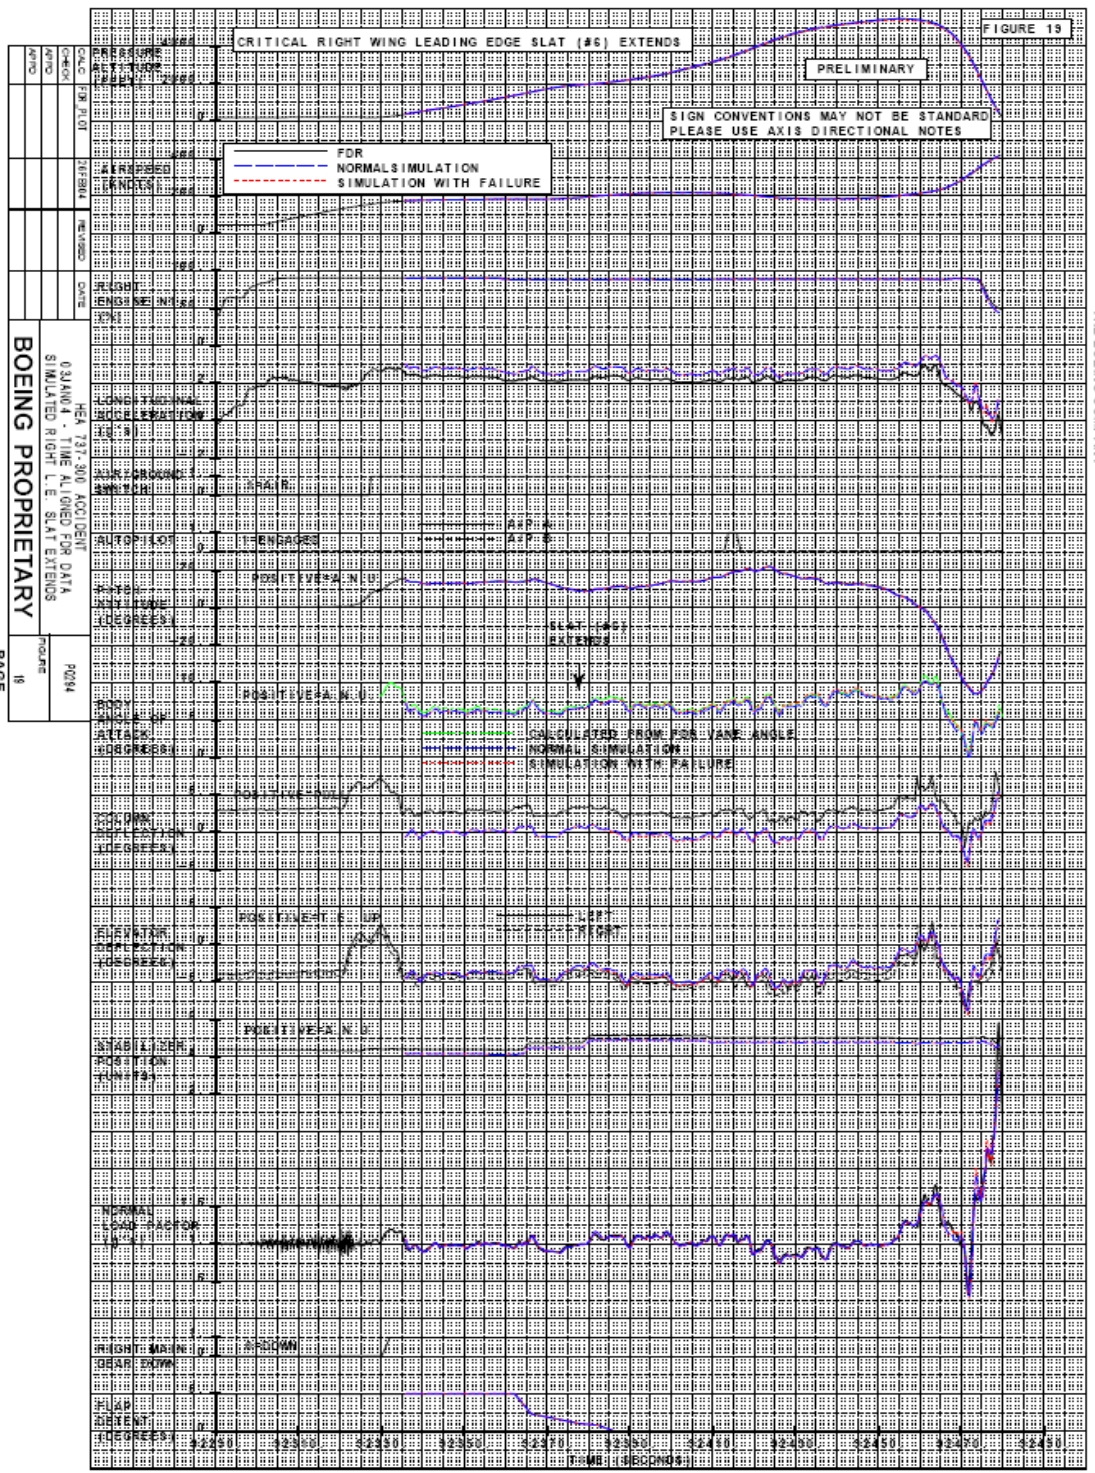
Figure 2.5.13.2a Critical right L.E. Failure- Slat #6 extends (longitudinal)

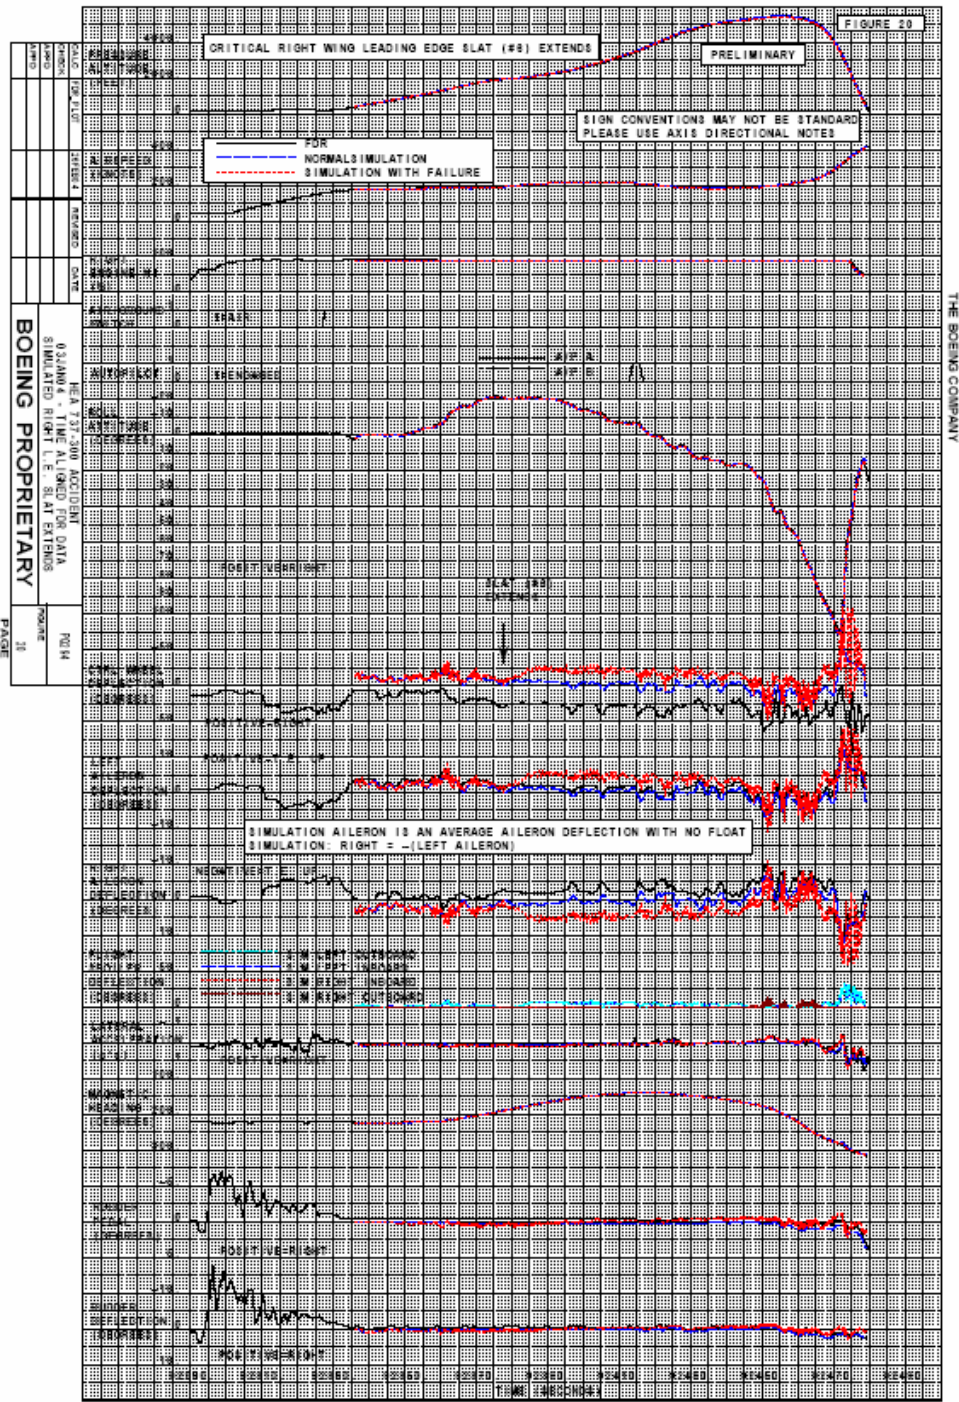
Figure 2.5.13.2b Critical right L.E. Failure- Slat #6 extends (lateral)

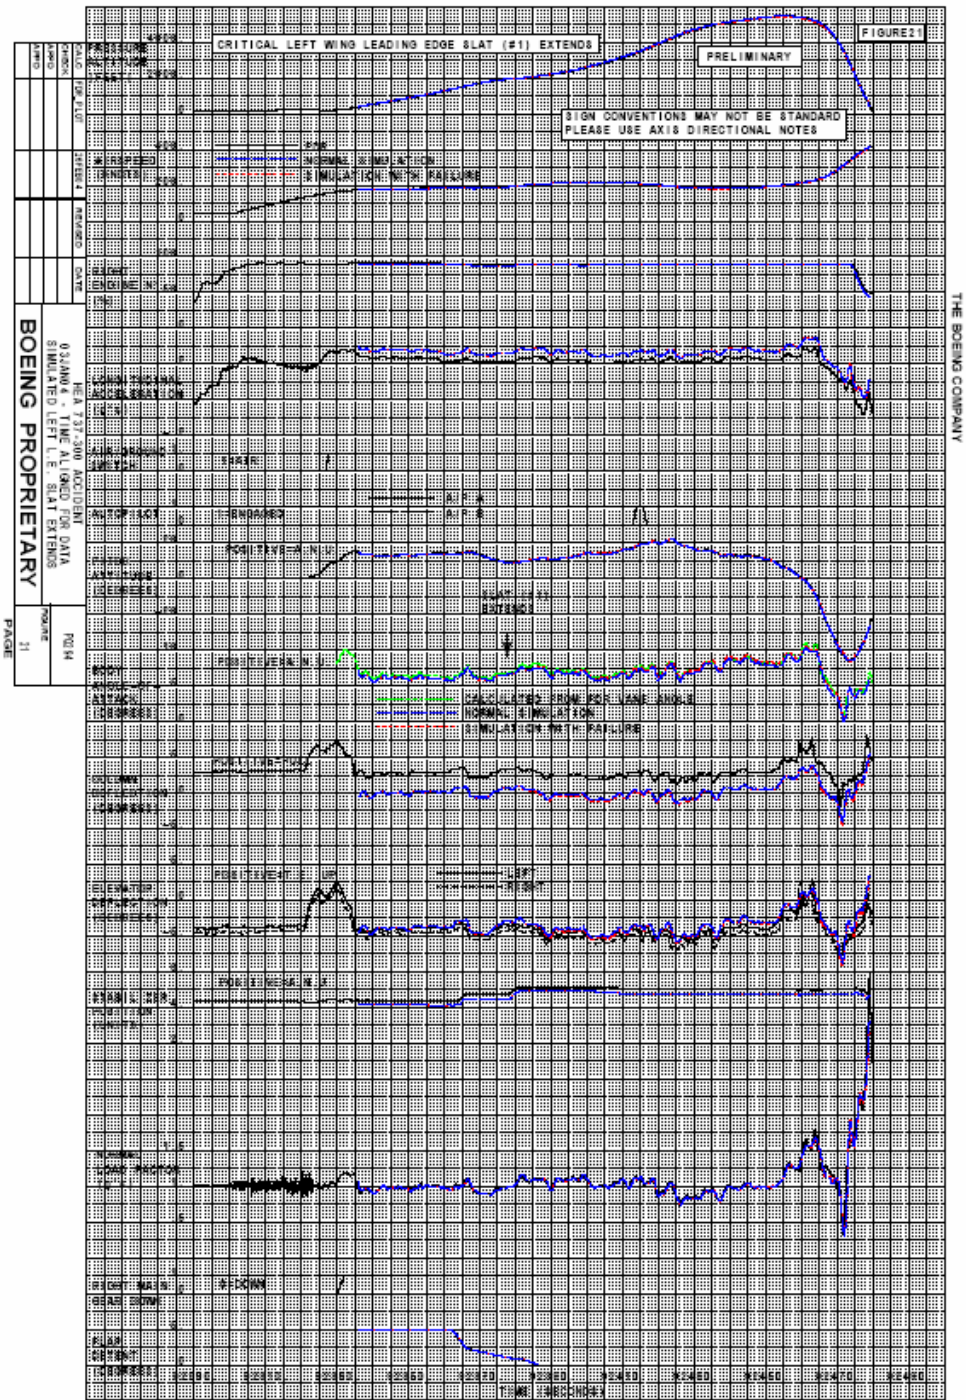
Figure 2.5.13.3a Critical left L.E. Failure- Slat #1 extends (longitudinal)
