Final report of the accident investigation, Flash Airlines Flight 604, Boeing 737-300 SU-ZCF, Red Sea off Sharm El-Sheikh, Egypt, January 3, 2004

FINAL REPORT OF THE ACCIDENT INVESTIGATION

Flash Airlines flight 604

Boeing 737-300 SU-ZCF

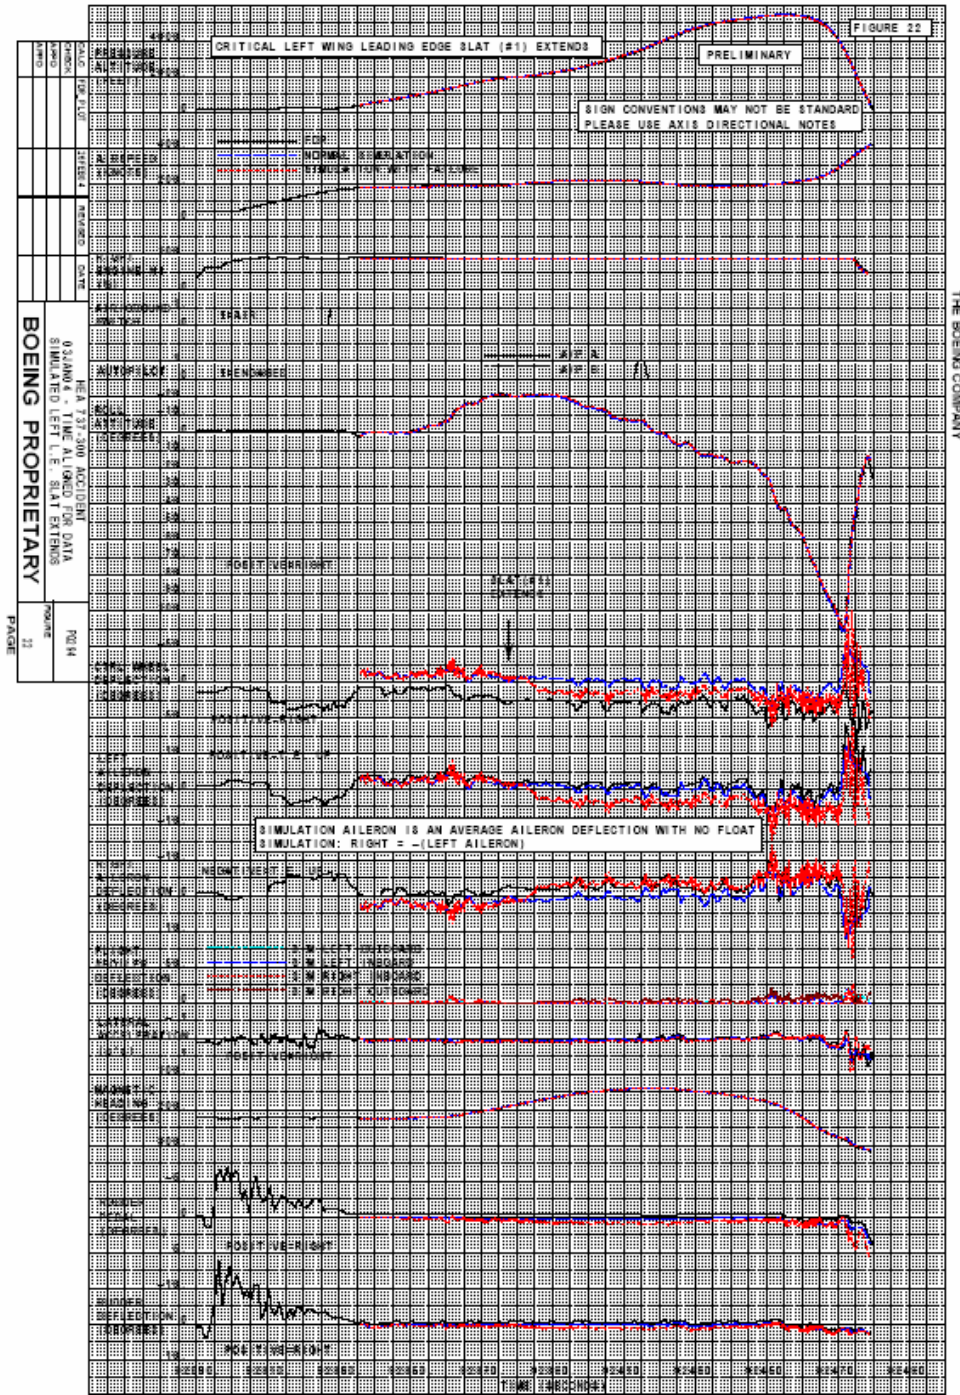
Figure 2.5.13.3b Critical left L.E. Failure- Slat #1 extends (lateral)

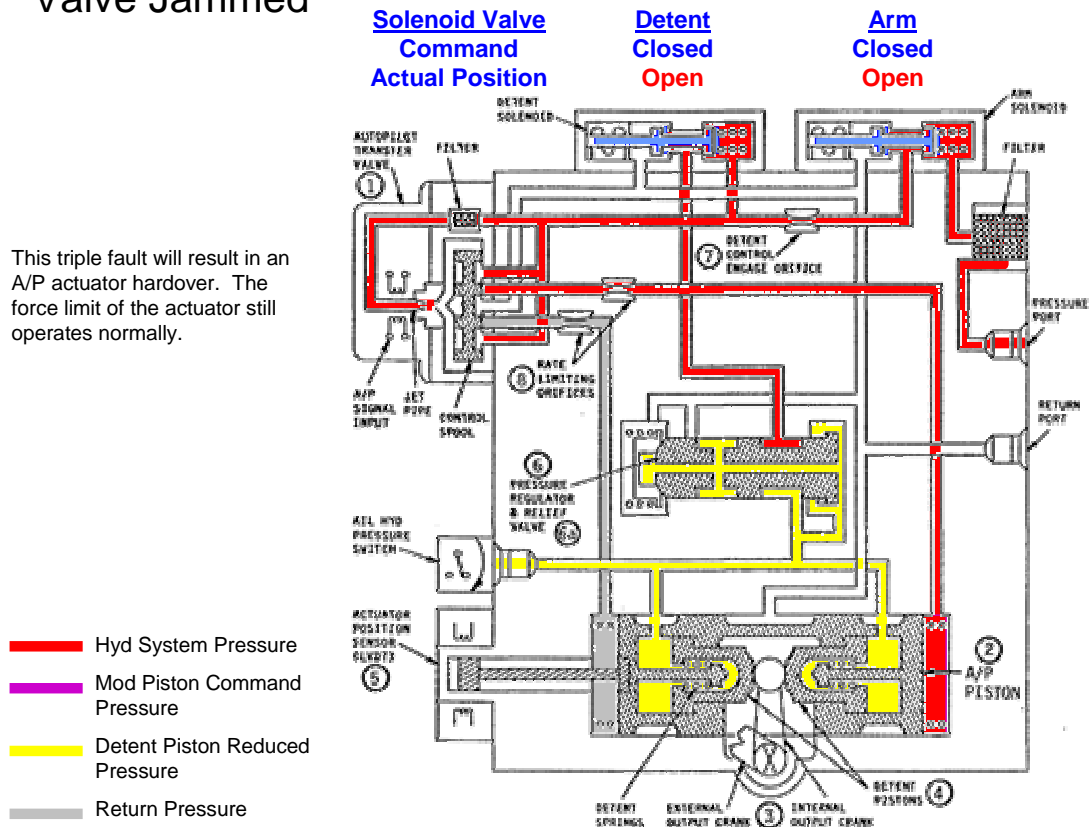
- These faults require 3 concurrent faults. Detent solenoid was in correct position at autopilot engagement. Arm solenoid could be latent failure. Transfer was working on previous flight and could have occurred anytime after last use of autopilot and would have been latent from that point.
- Both the Arm and the Detent solenoid are assumed to fail (stuck open). The transfer valve is assumed to fail in the position commanding right bank

The cause of these failures can not be conclusively identified. However the failure of the arm solenoid (stuck open solenoid) might have been the result of a stuck closed contact (MCP engage relay A). Also these failures might be the result of an electric short within the electrical socket on the autopilot actuator.

Figure 2.5.13.4 Autopilot Actuator

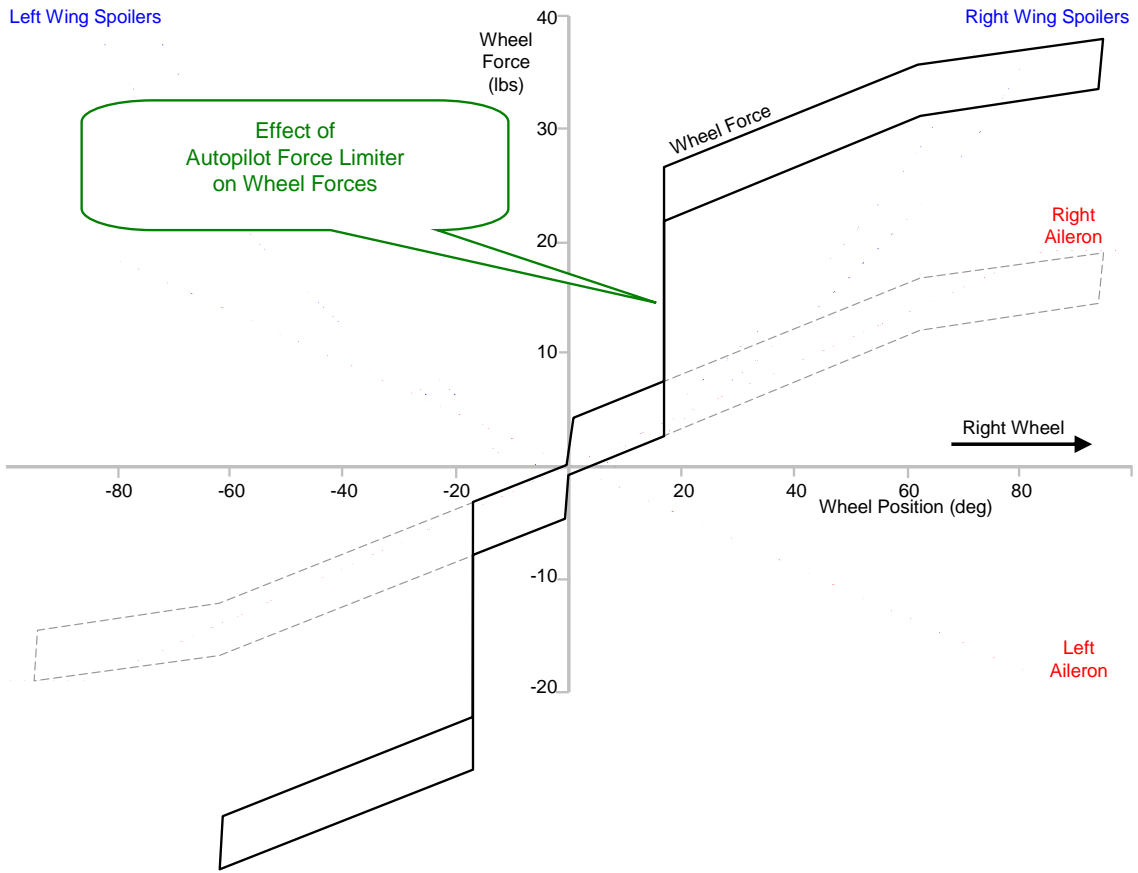
Figure 2.5.13.5 Ailerons and spoilers behavior with autopilot actuator hardover

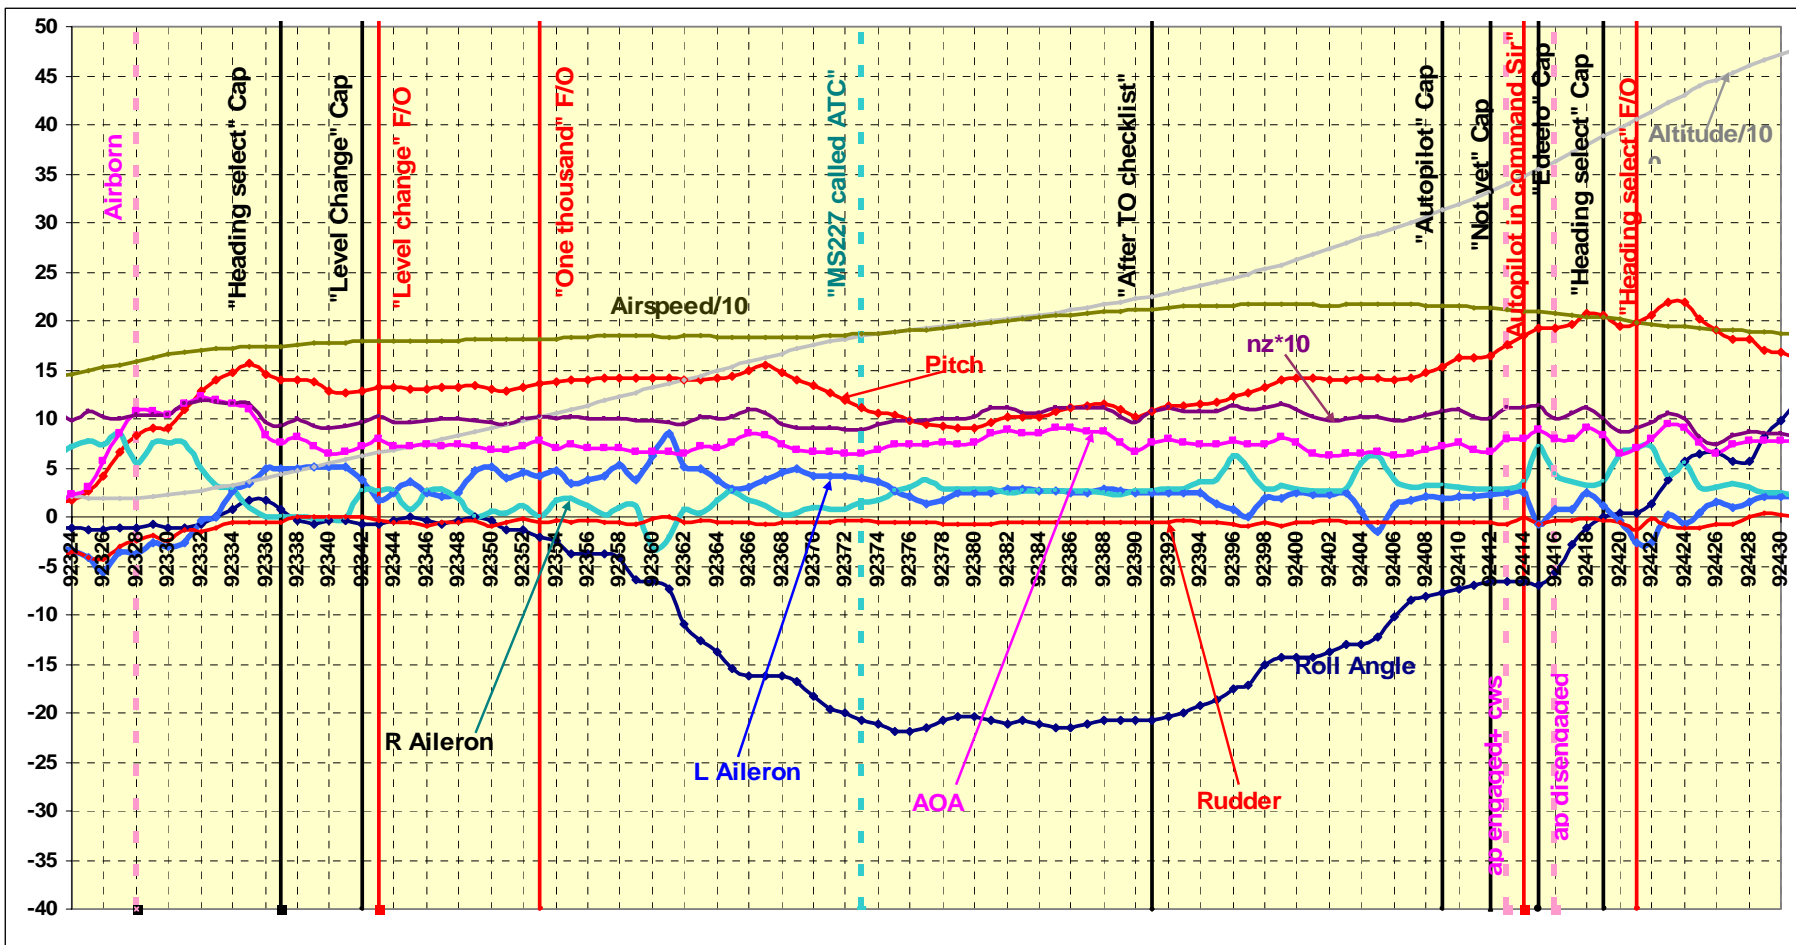
Figure 2.5.13.1b Right roll continues to overbank with ailerons activities

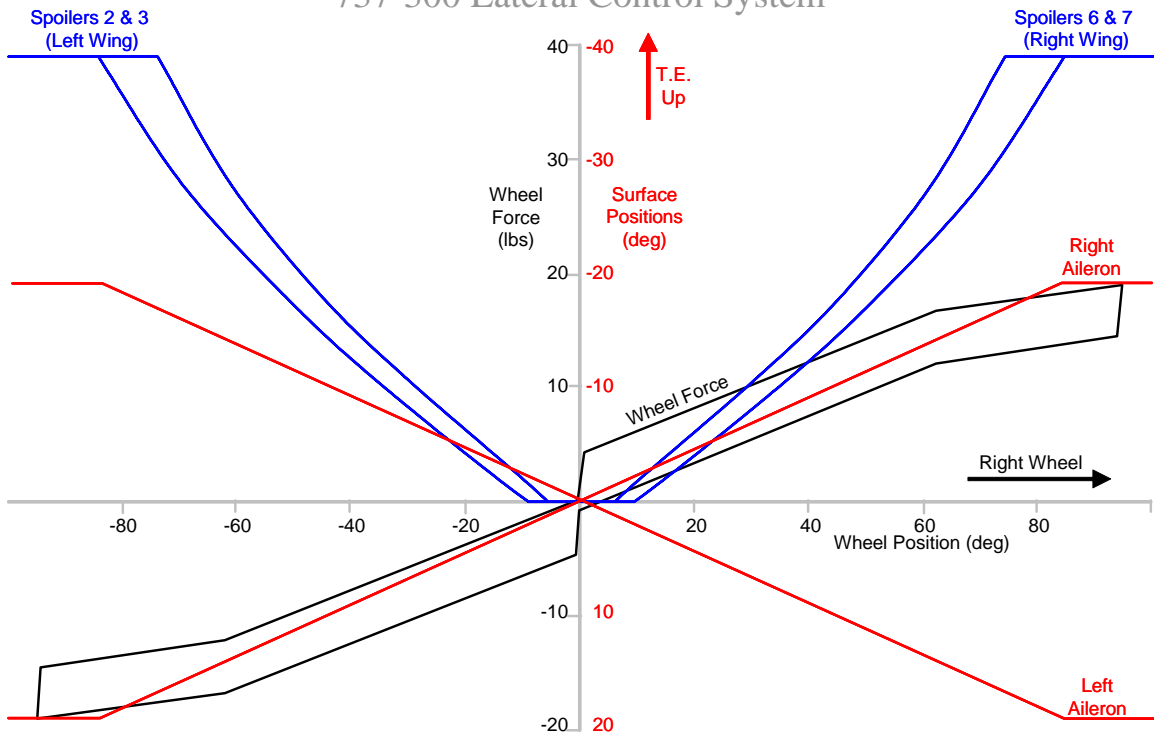
Figure 2.5.13.6 Ailerons and spoilers behavior with zero ailerons trim actuator

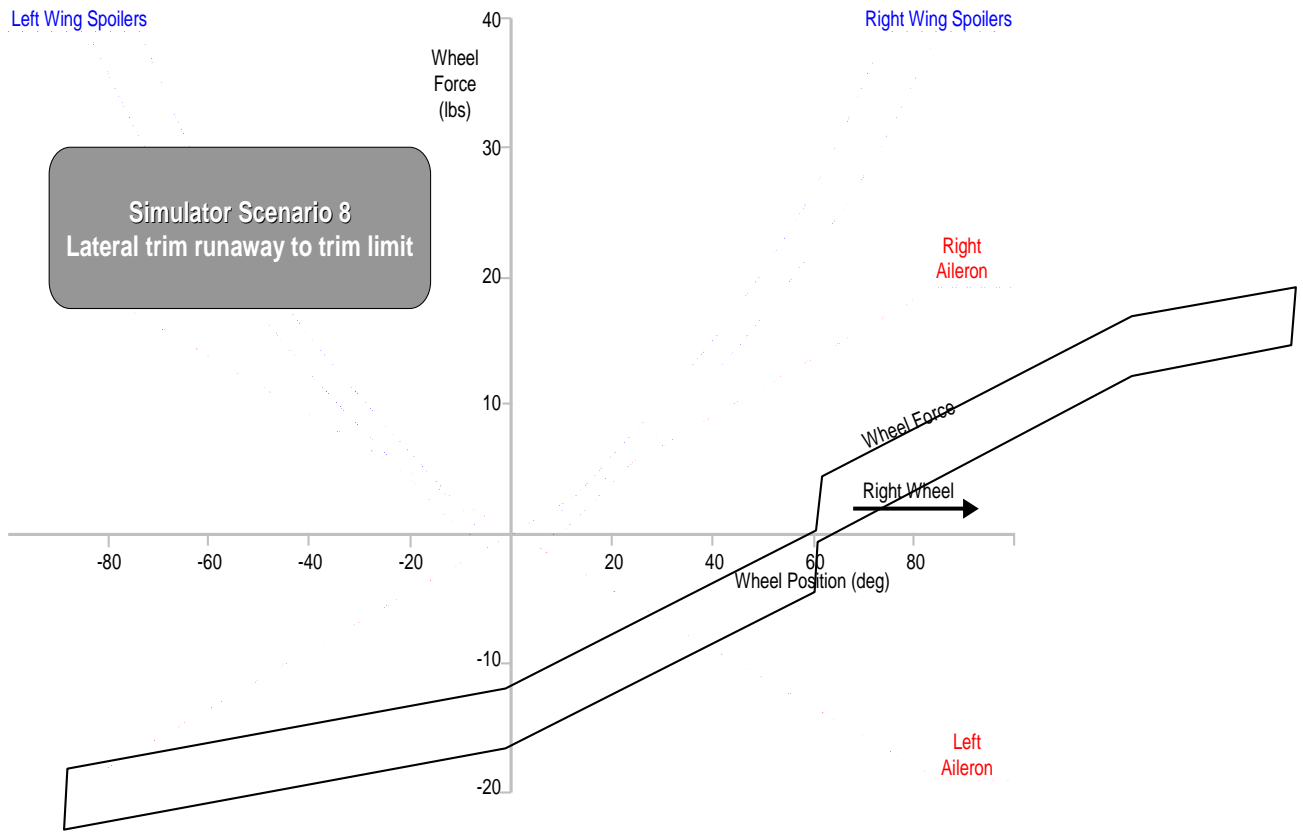
Figure 2.5.13.7 Ailerons and spoilers behavior with aileron trim actuator at its hardover position

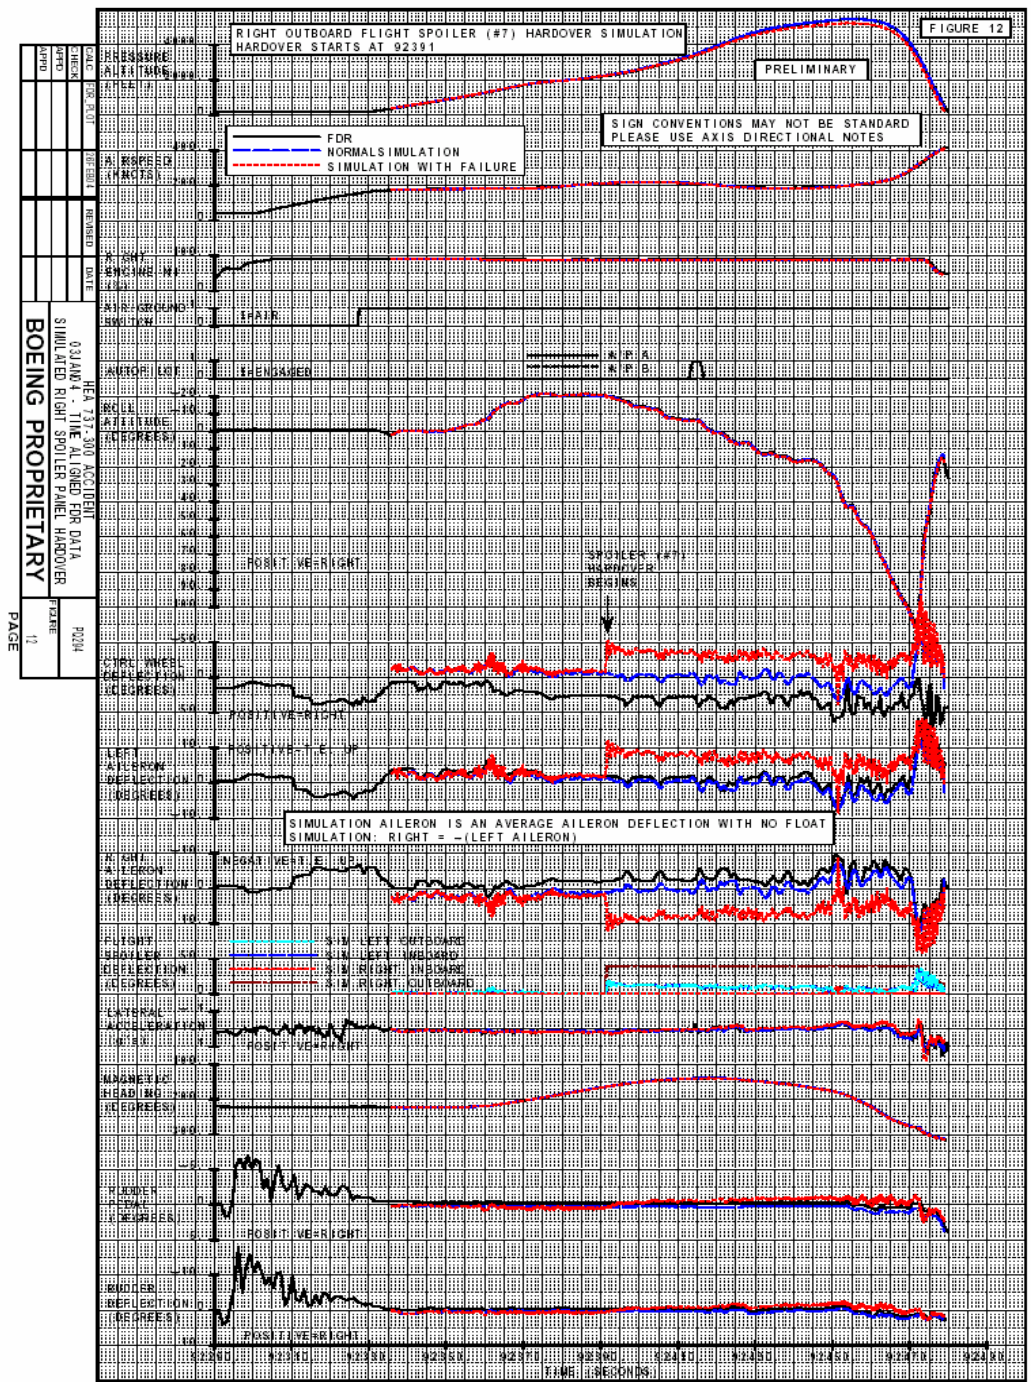
Figure 2.5.13.8b Right outboard flight spoilers (#7) Hardover simulation (hardover starts at 92391) (lateral)

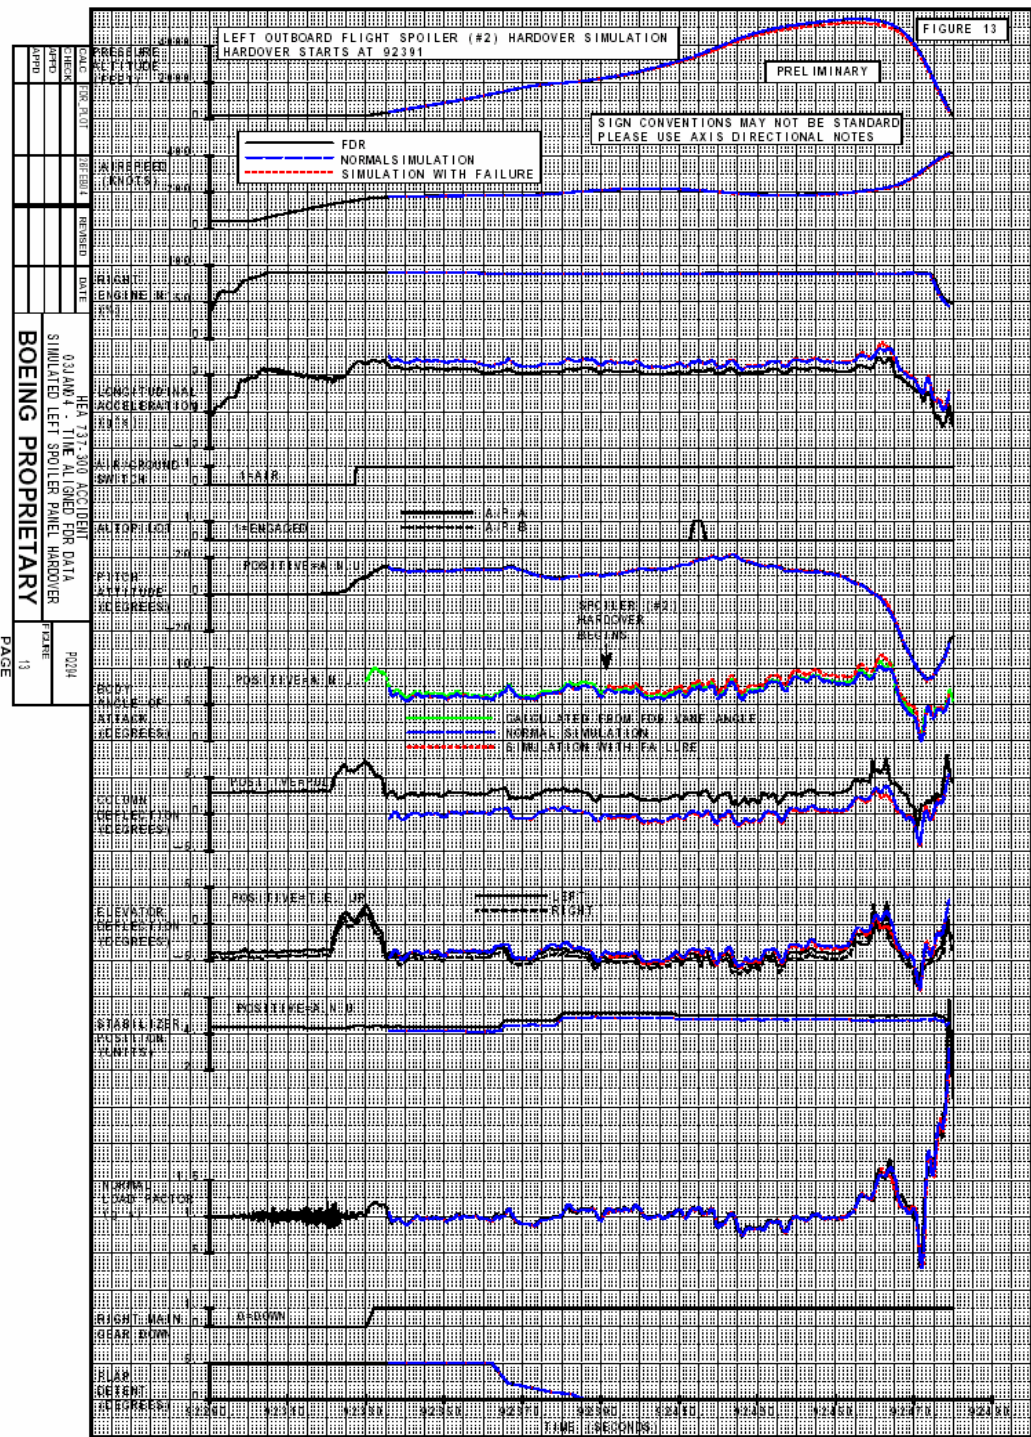
Figure 2.5.13.9a Left outboard flight spoilers (#2) Hardover simulation (hardover starts at 92391) (Longitudinal)

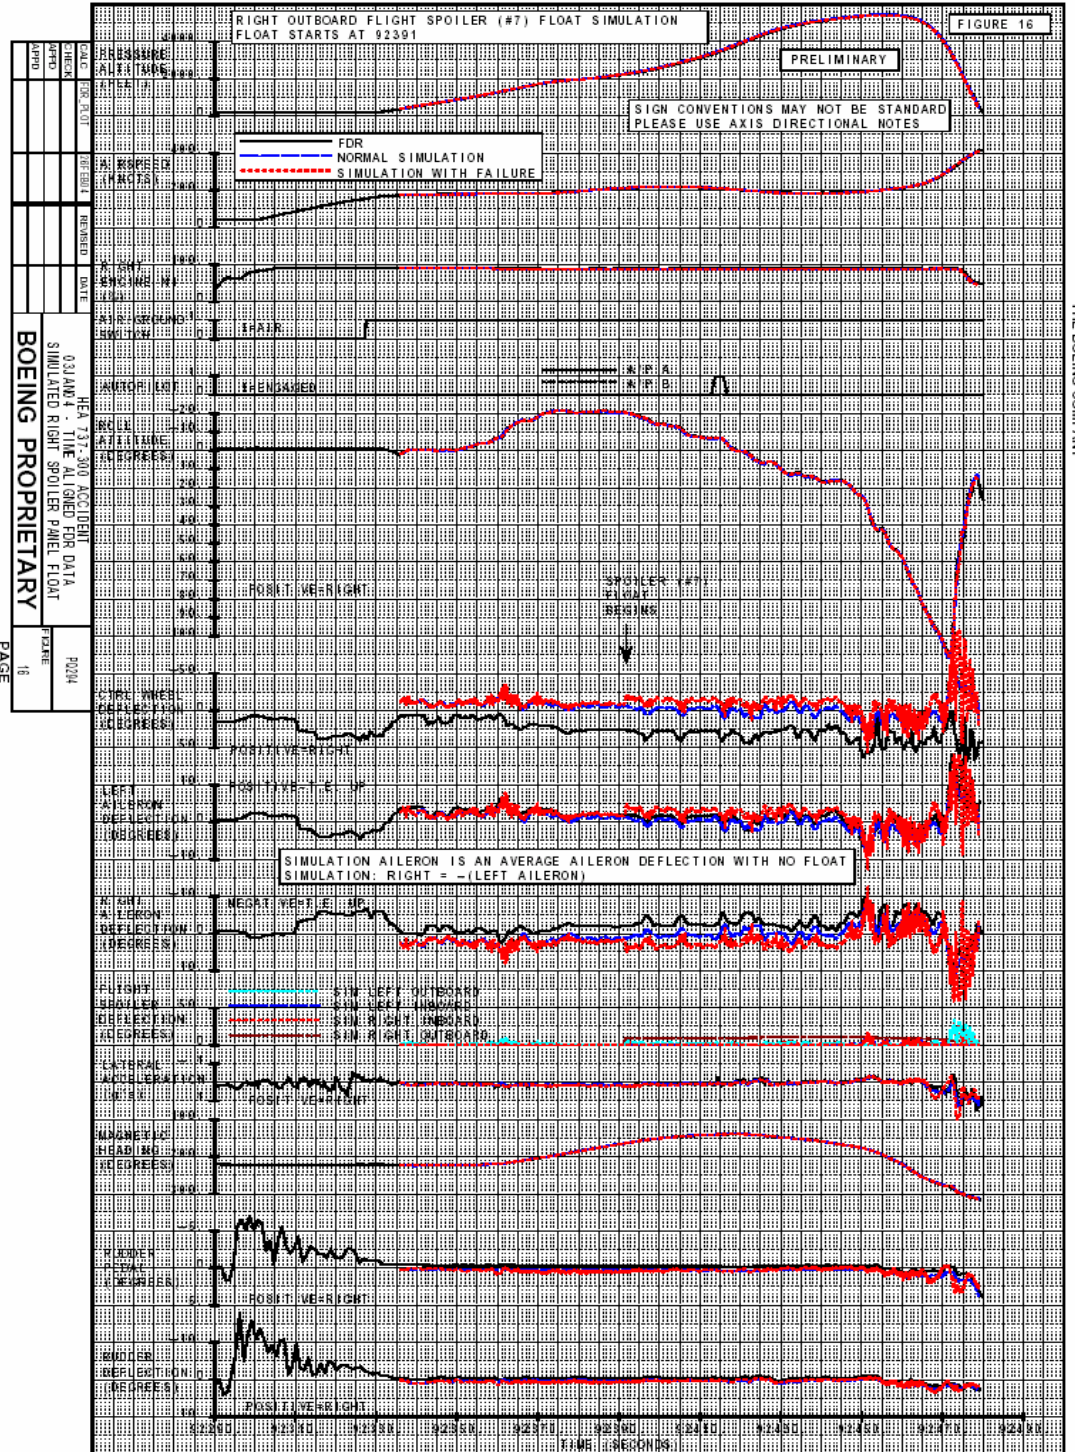
Figure 2.5.13.10b Right outboard flight spoilers (#7) Float simulation (floats starts at 92391) (Lateral)

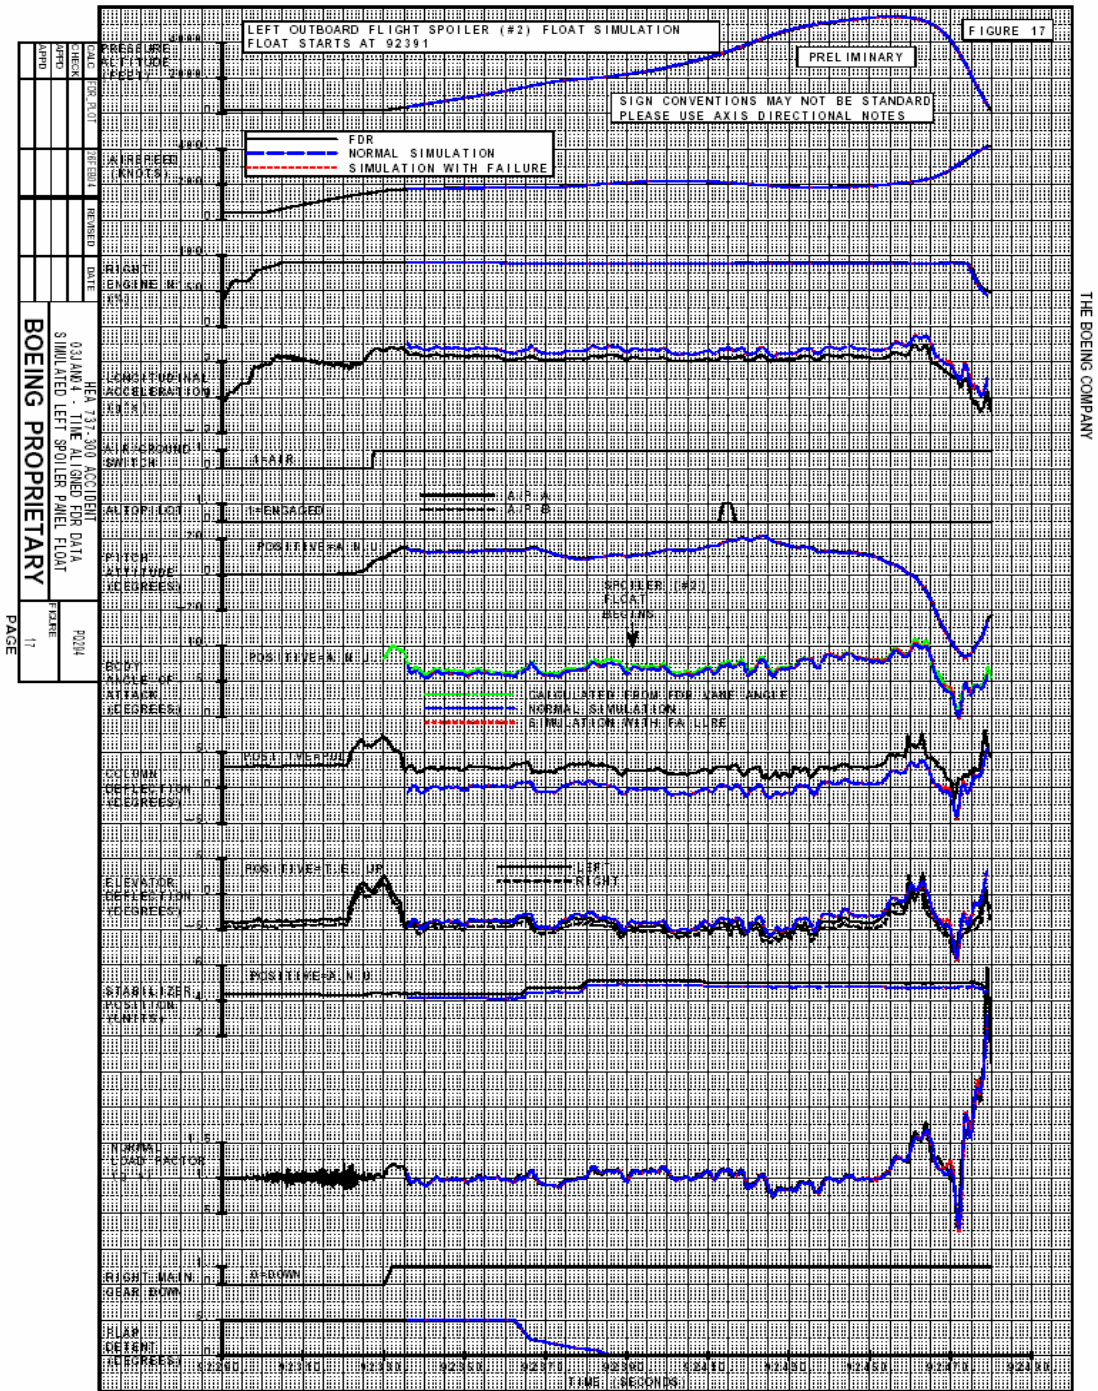
Figure 2.5.13.11a Left outboard flight spoilers (#2) Float simulation (floats starts at 92391) (Longitudinal)

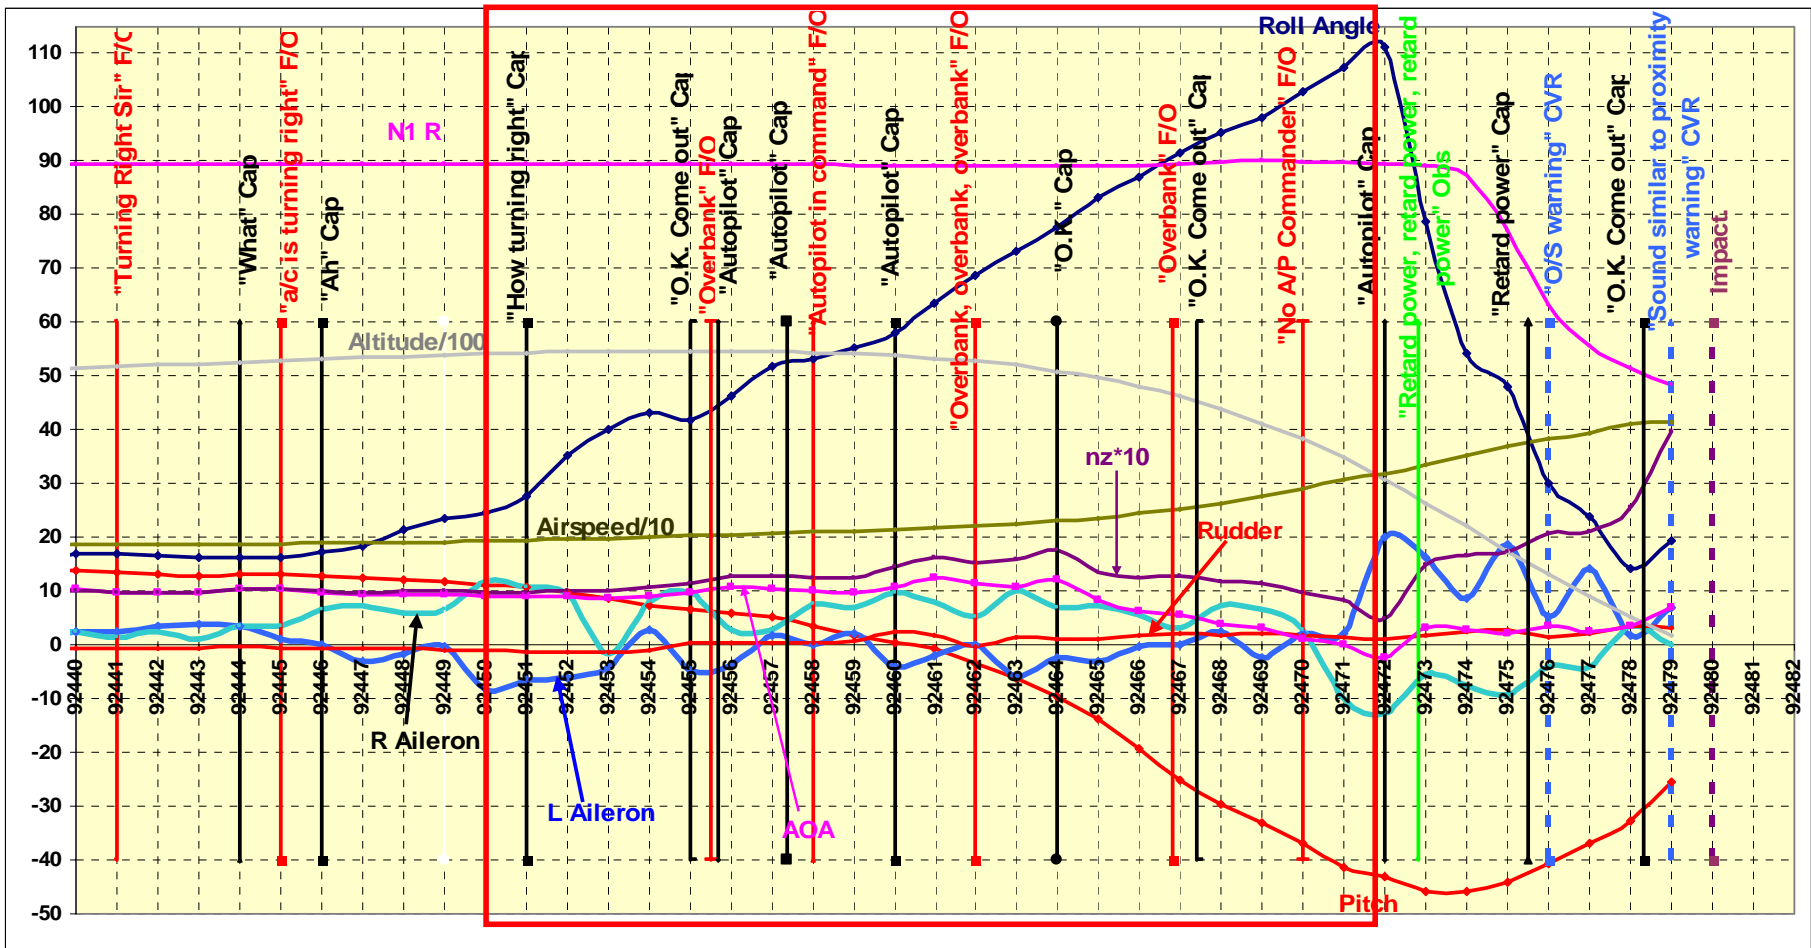
Figure 2.5.13.12 Right roll continues to overbank with ailerons activities (condition F3)

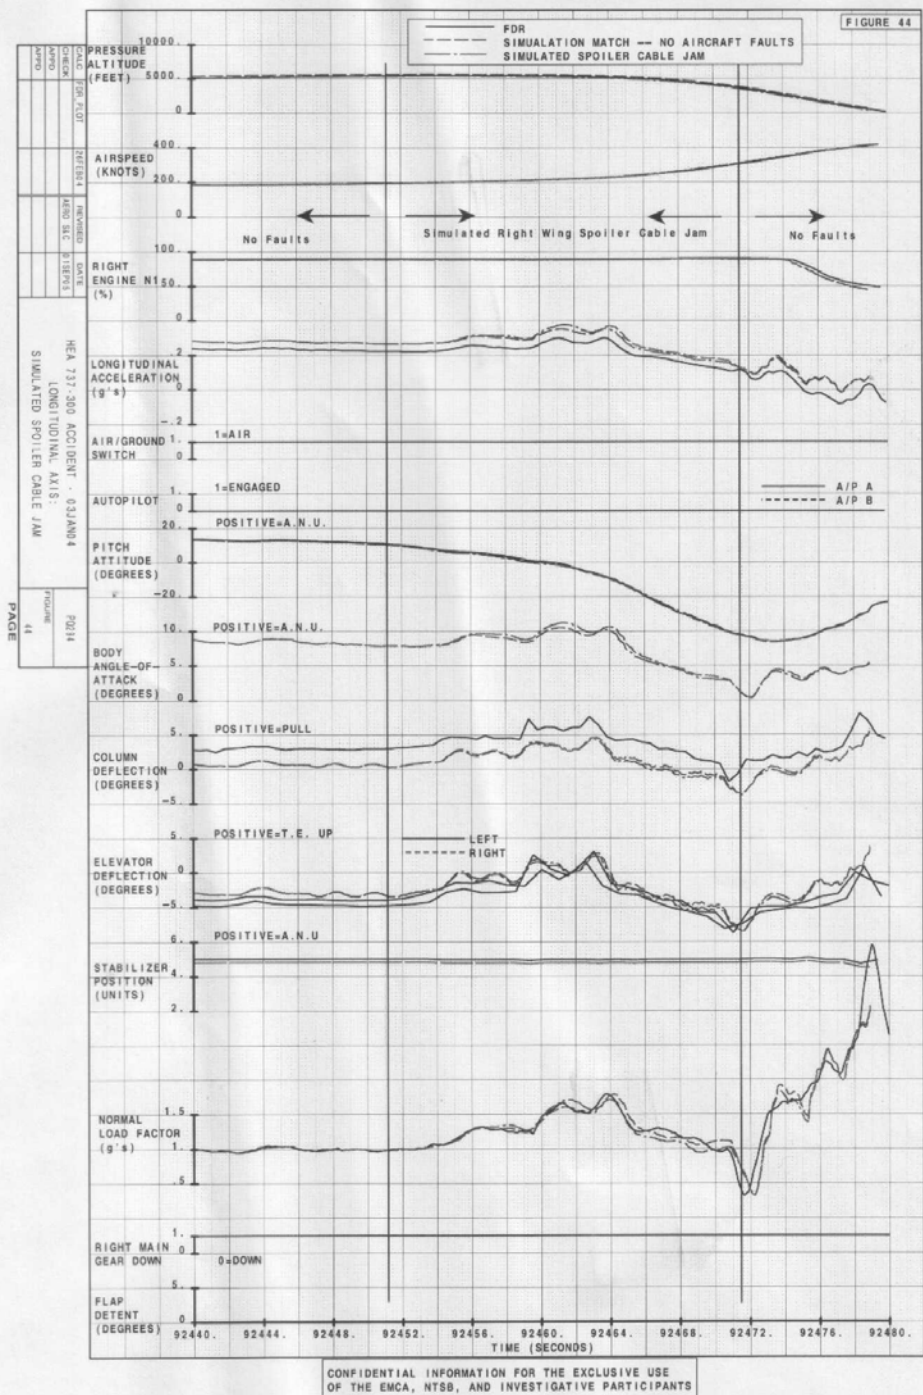
- During the meetings in Cairo on August 05, the MCA asked Boeing to redo simulations of scenarios 10 (spoiler cable jam) with the hypothetical fault inserted at the point of maximum wheel displacement and removed at the beginning of the recovery effort.
- Figure 2.5.13.15a (longitudinal parameters) and Figure 2.5.13.15b (lateral parameters) show the effect of the hypothetical spoiler cable jam fault.

Figure 2.5.13.15a (longitudinal parameters)

- The simulations take into account the effects of blowdown on the ailerons. However, the blowdown effects on the spoilers are not included because of the way in which these hypothetical faults were simulated. The effects of spoiler blowdown are not expected to be large as spoiler deflections remain below 20 degrees and airspeed during the time of the fault remains below 310 knots.

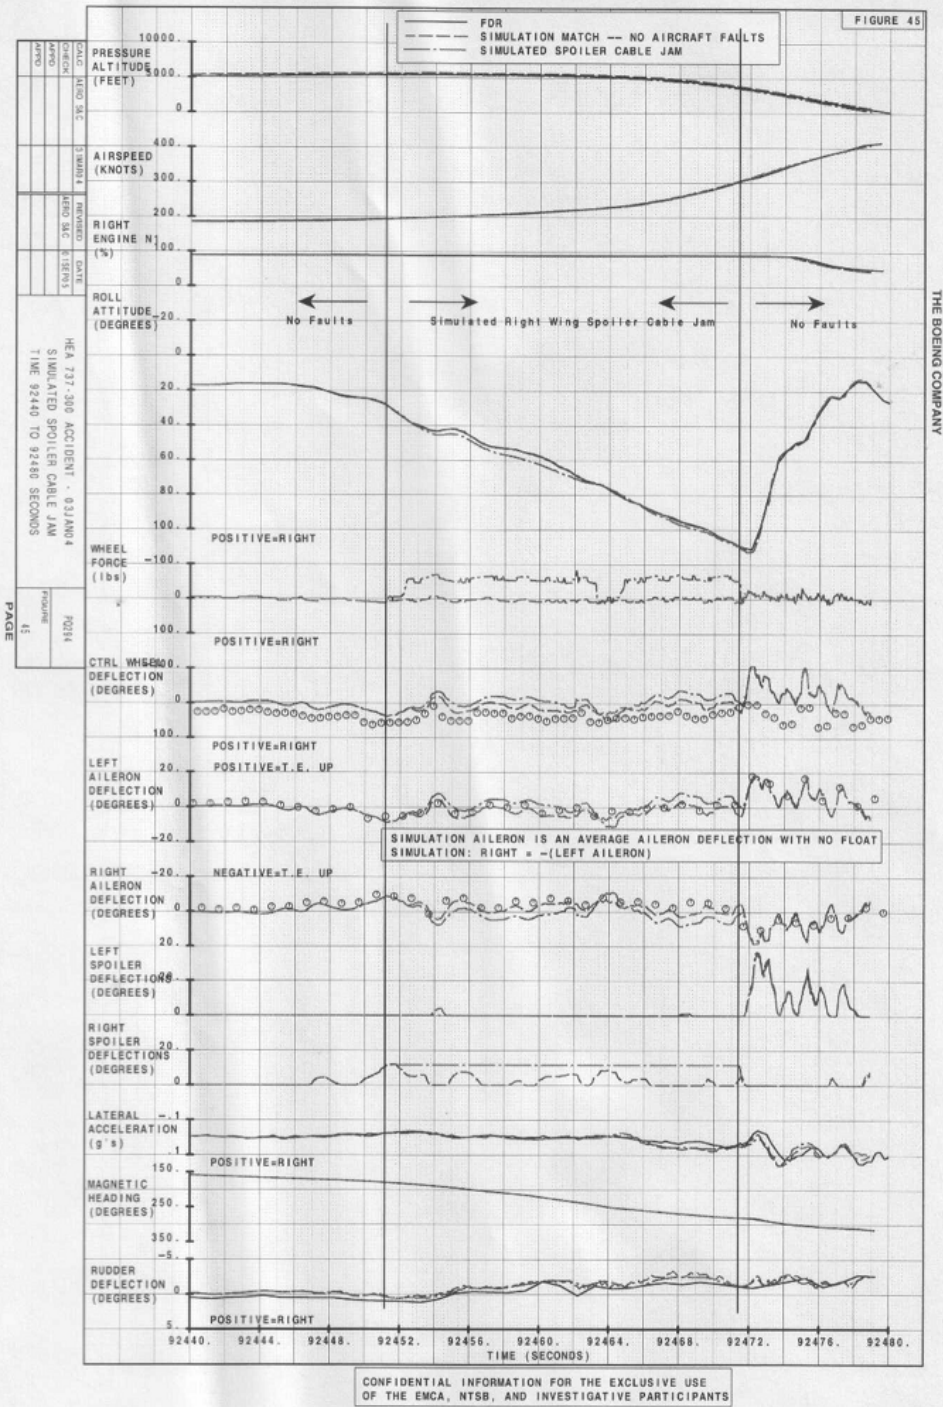
Figure 2.5.13.15b (lateral parameters)

- In this scenario, the jam restricts further motion of the spoilers to the range of the lost motion device. Figure 2.5.13.15b shows that the right wing spoilers are limited to the range of 7 to about 17 degrees and the left wing spoilers are restricted to 0 degrees. The ailerons can still be controlled via the captain's wheel. There is an immediate significant increase in wheel force as the captain must overcome the spring force of the transfer mechanism.
- Both simulations take into account the effects of blowdown on the ailerons. However, the blowdown effects on the spoilers are not included because of the way in which these hypothetical faults were simulated. The effects of spoiler blowdown are not expected to be large as spoiler deflections remain below 20 degrees and airspeed during the time of the fault remains below 310 knots.

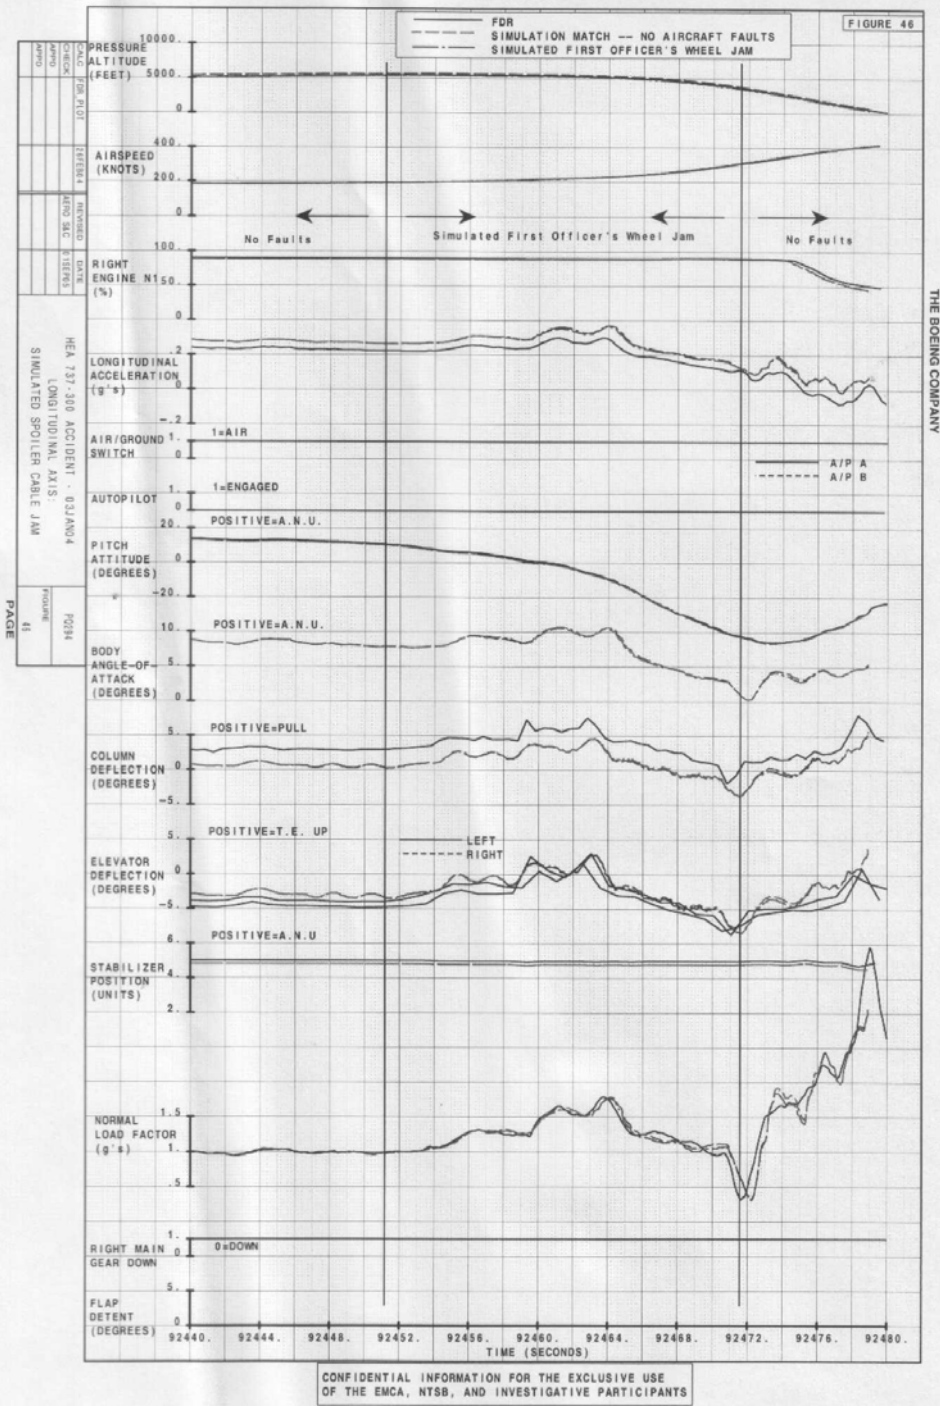
- Figure 2.5.13.15a (longitudinal parameters) and Figure 2.5.13.15b (lateral parameters) show the effect of the hypothetical spoiler cable jam fault.

Figure 2.5.13.16a (longitudinal parameters)

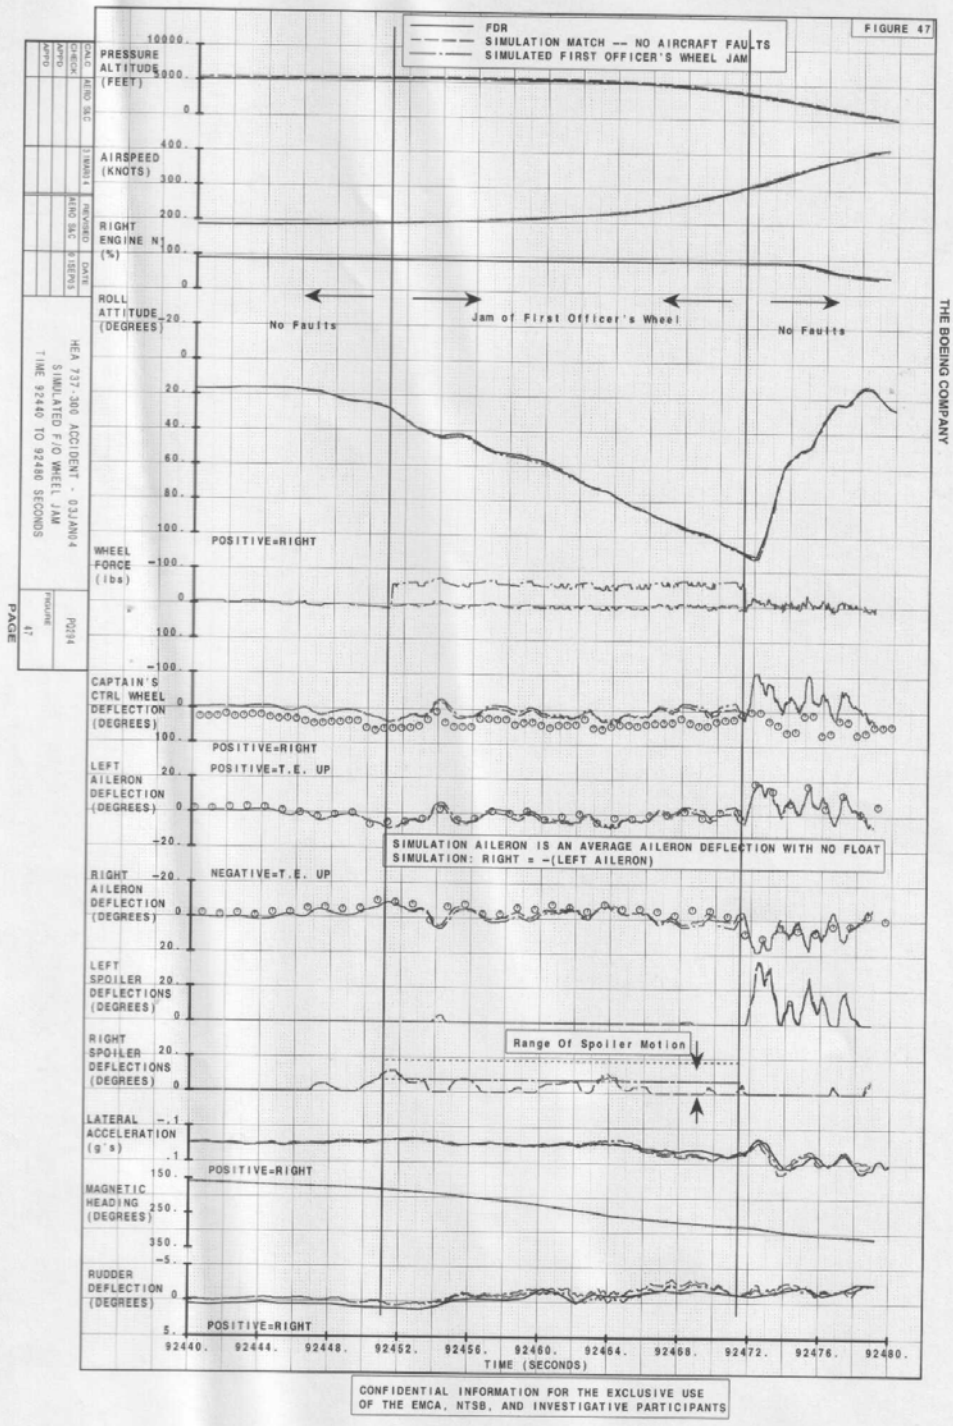
Figure 2.5.13.16b (lateral parameters

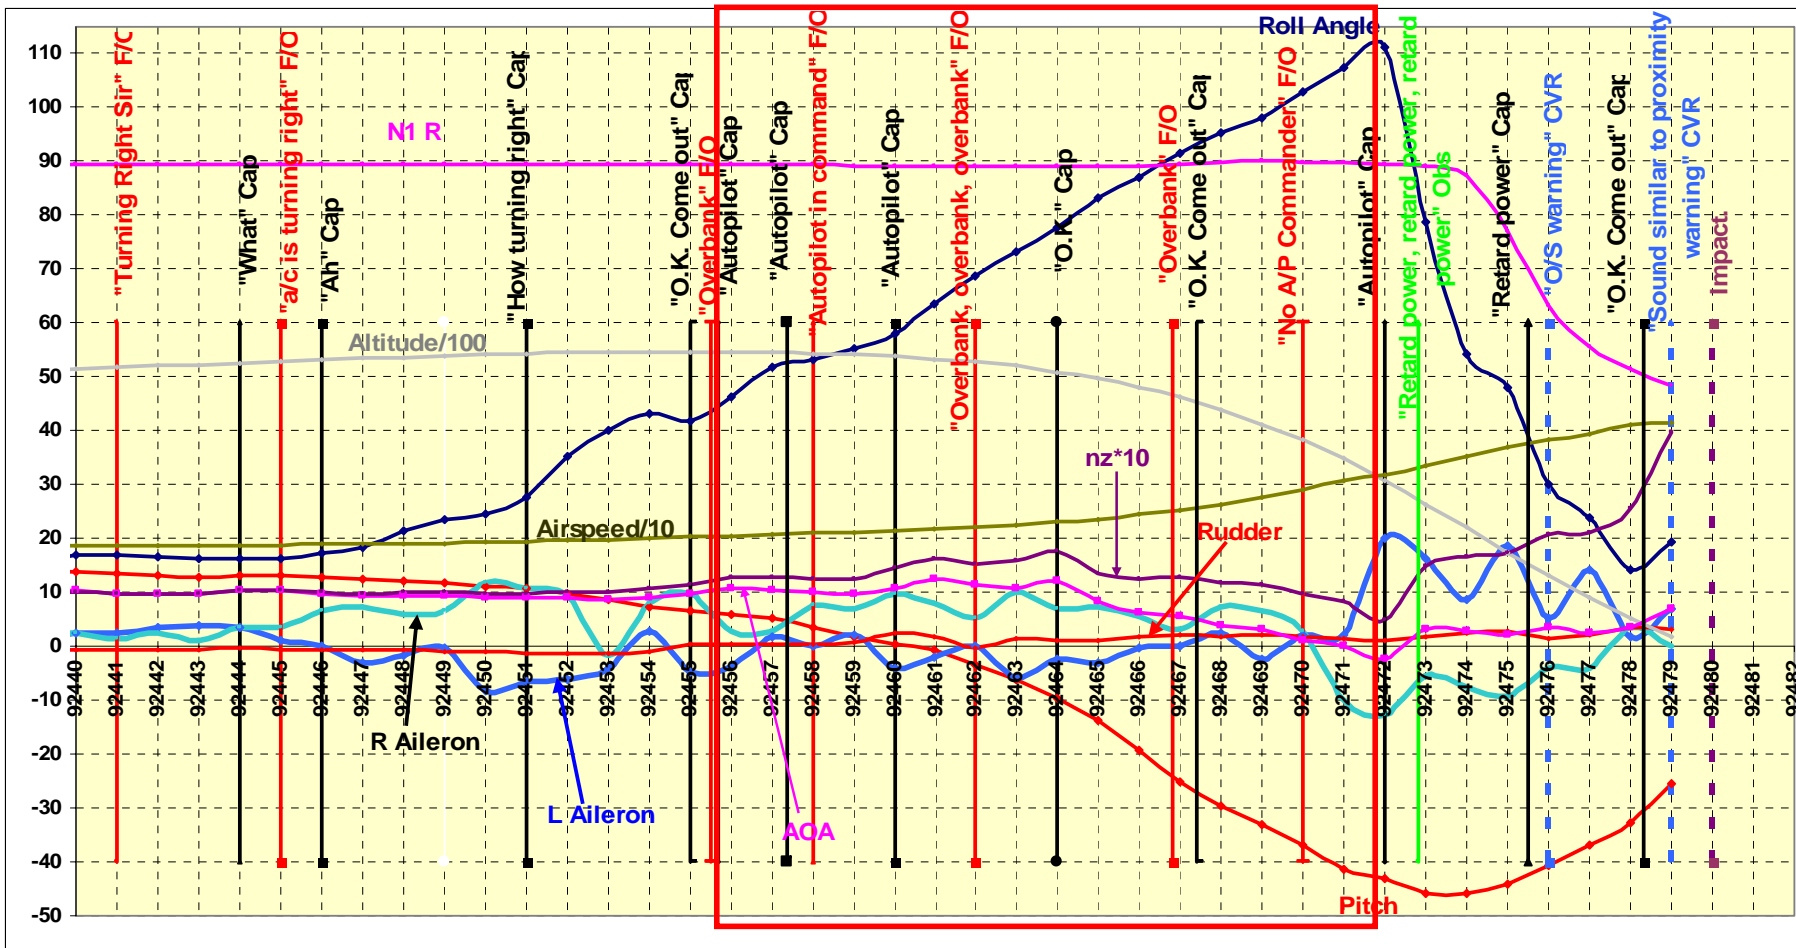
Figure 2.5.14.1 Flight crew CVR autopilot announcements

Flight crew CVR autopilot announcements might be explained by the following¹:

The investigation could not determine a higher possibility to any of the above conditions based on the given data.

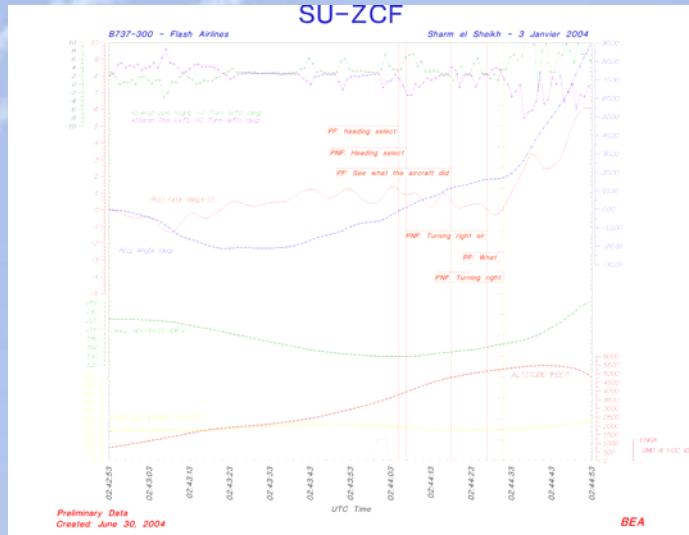
Roll, Roll rate and aileron movements

- Possible sub-threshold roll input
 - ⇒ Inducing "the leans" at the end of the turn
- Prolonged angular motion
 - ⇒ Approximately 50 seconds of slow roll rate to the right
 - ⇒ Large aileron input to the right at the end of the slow roll rate
