Final report of the accident investigation, Flash Airlines Flight 604, Boeing 737-300 SU-ZCF, Red Sea off Sharm El-Sheikh, Egypt, January 3, 2004

FINAL REPORT OF THE ACCIDENT INVESTIGATION

Flash Airlines flight 604

Boeing 737-300 SU-ZCF

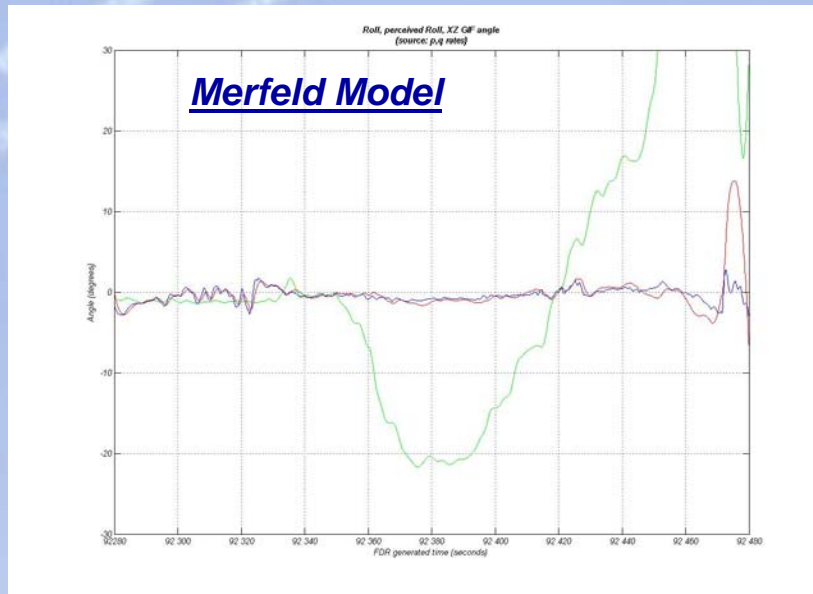
Roll, YZ GIF angle, Perceived Roll

- Low sensation of the sustained and prolonged roll rate to the right
- Low sensation of bank during turn to the right
 - ⇒ Confirmation of Mc GRATH results

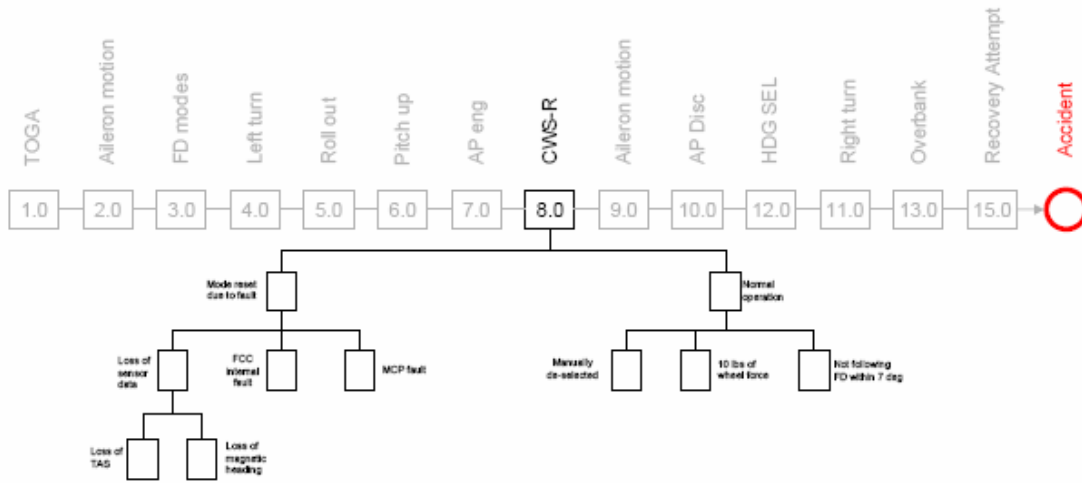
Step 2 – Develop candidate scenarios for each event

Example shows scenario tree structure for event 8.0

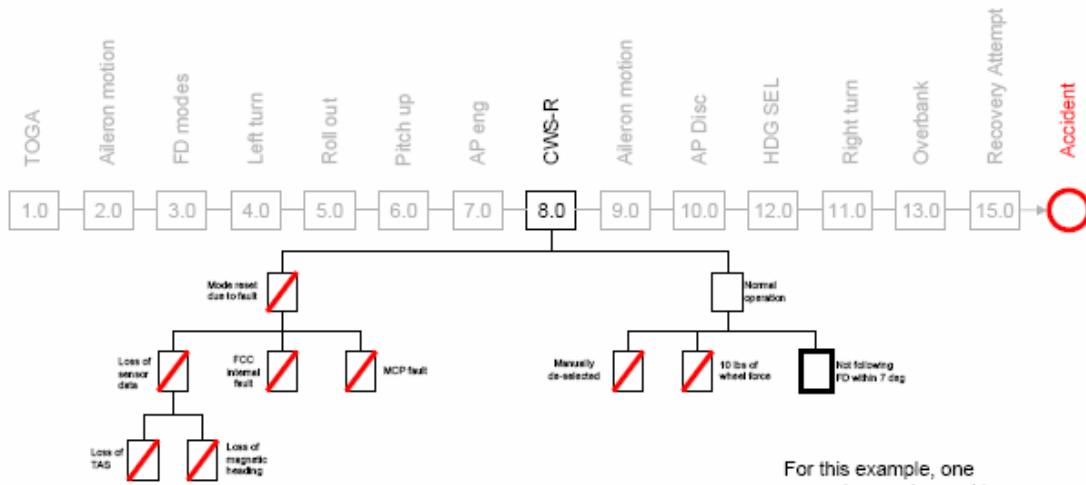
Step 3 – Rule out scenarios based on known information

For this example, one scenario was deemed to match the data. The rest were ruled out.

For other events, multiple scenarios remained as they could not be ruled out.

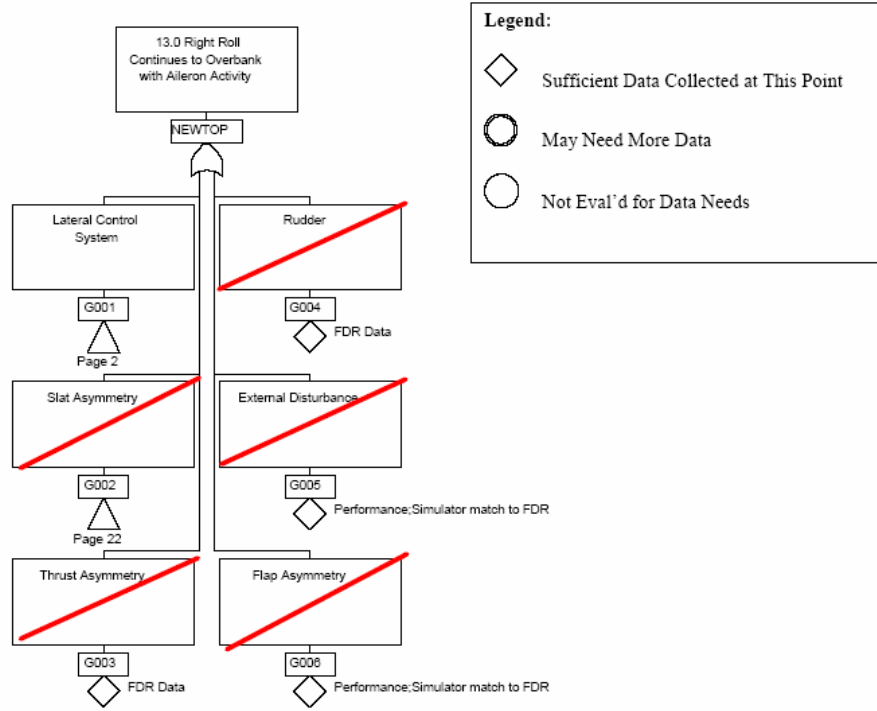
13.0 Right Roll Continues to Overbank with Aileron Activity

1- Autopilot Actuator Fault (Actuator Hardover without Force Limiter 17 to 20 lb Force) was not ruled out (refer to pages 1, 2, 9 and 11 of the fault tree)

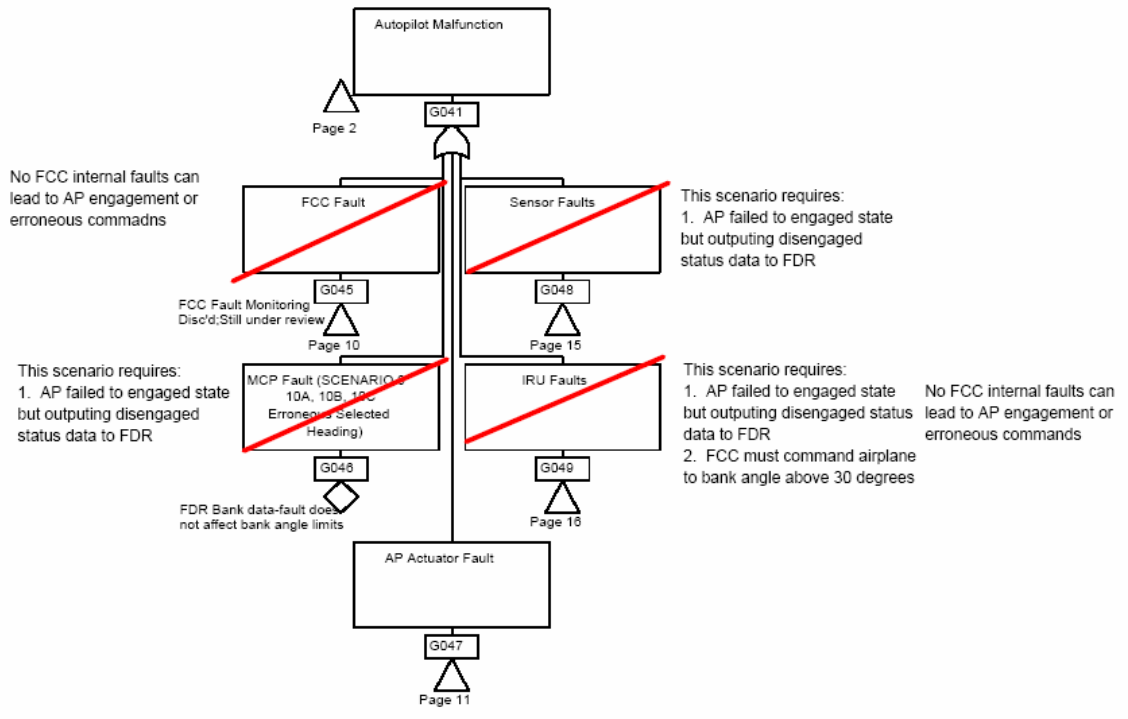
13.0 Right Roll Continues to Overbank with Aileron Activity

N.B.
For the "Lateral System Fault" block, See Appendix 2-1 lateral control analysis

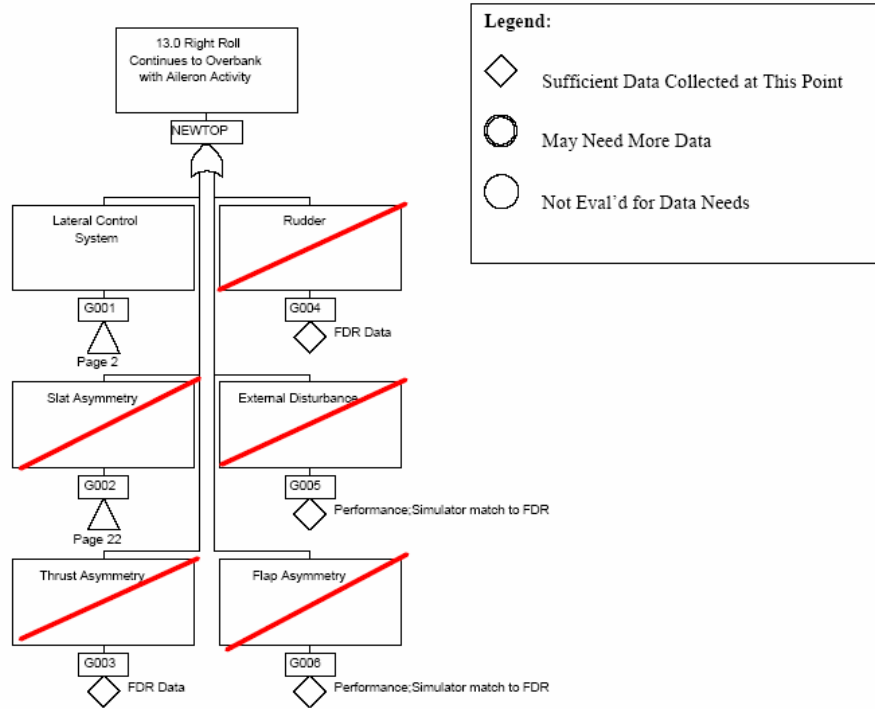
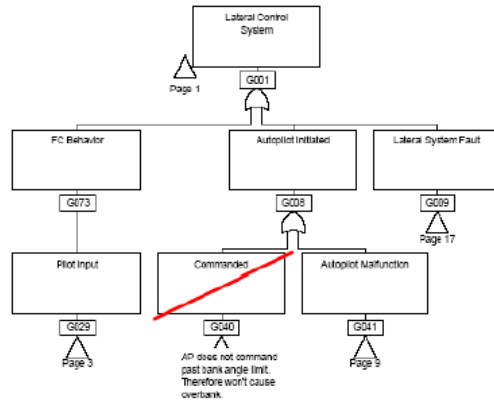
2- Trim/Feel Unit Fault was not ruled out (refer to pages 1, 2, 17, 20 of the fault tree)

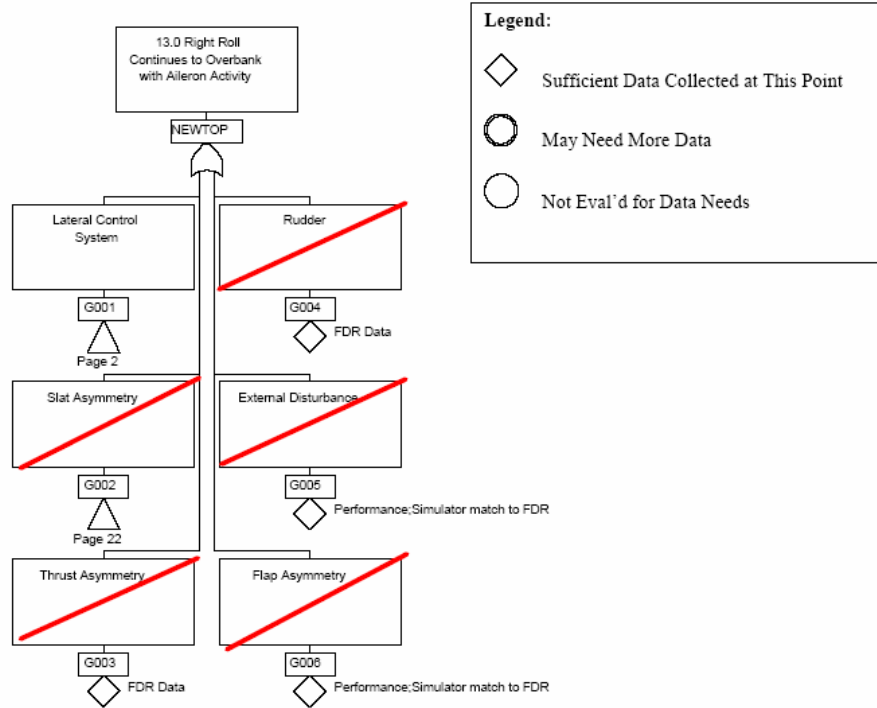
3- Spoilers wing cable jam and F/O wheel jam were not ruled out (refer to pages 1, 2, 17, 21 of the fault tree)

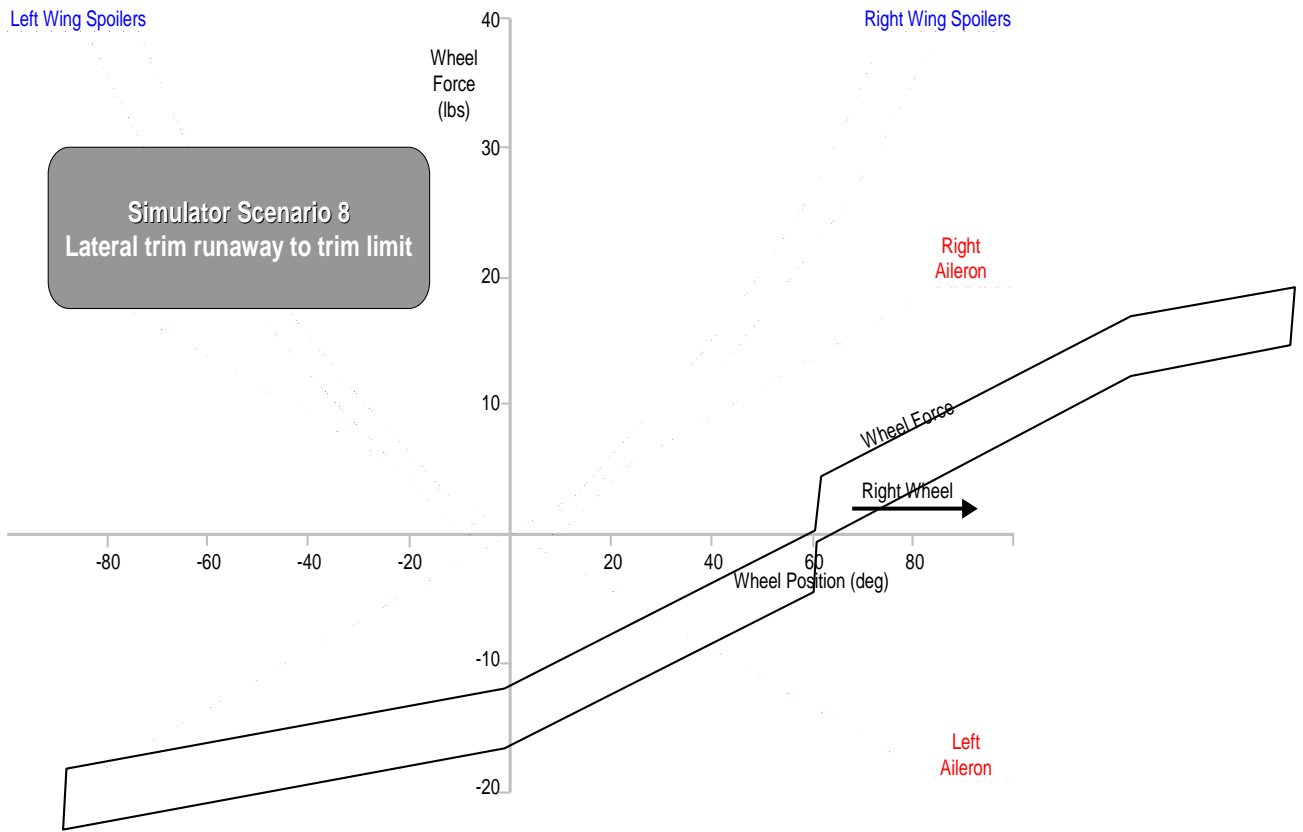
Figure 2.5.13.7 Ailerons and spoilers behavior with aileron trim actuator at its hardover position

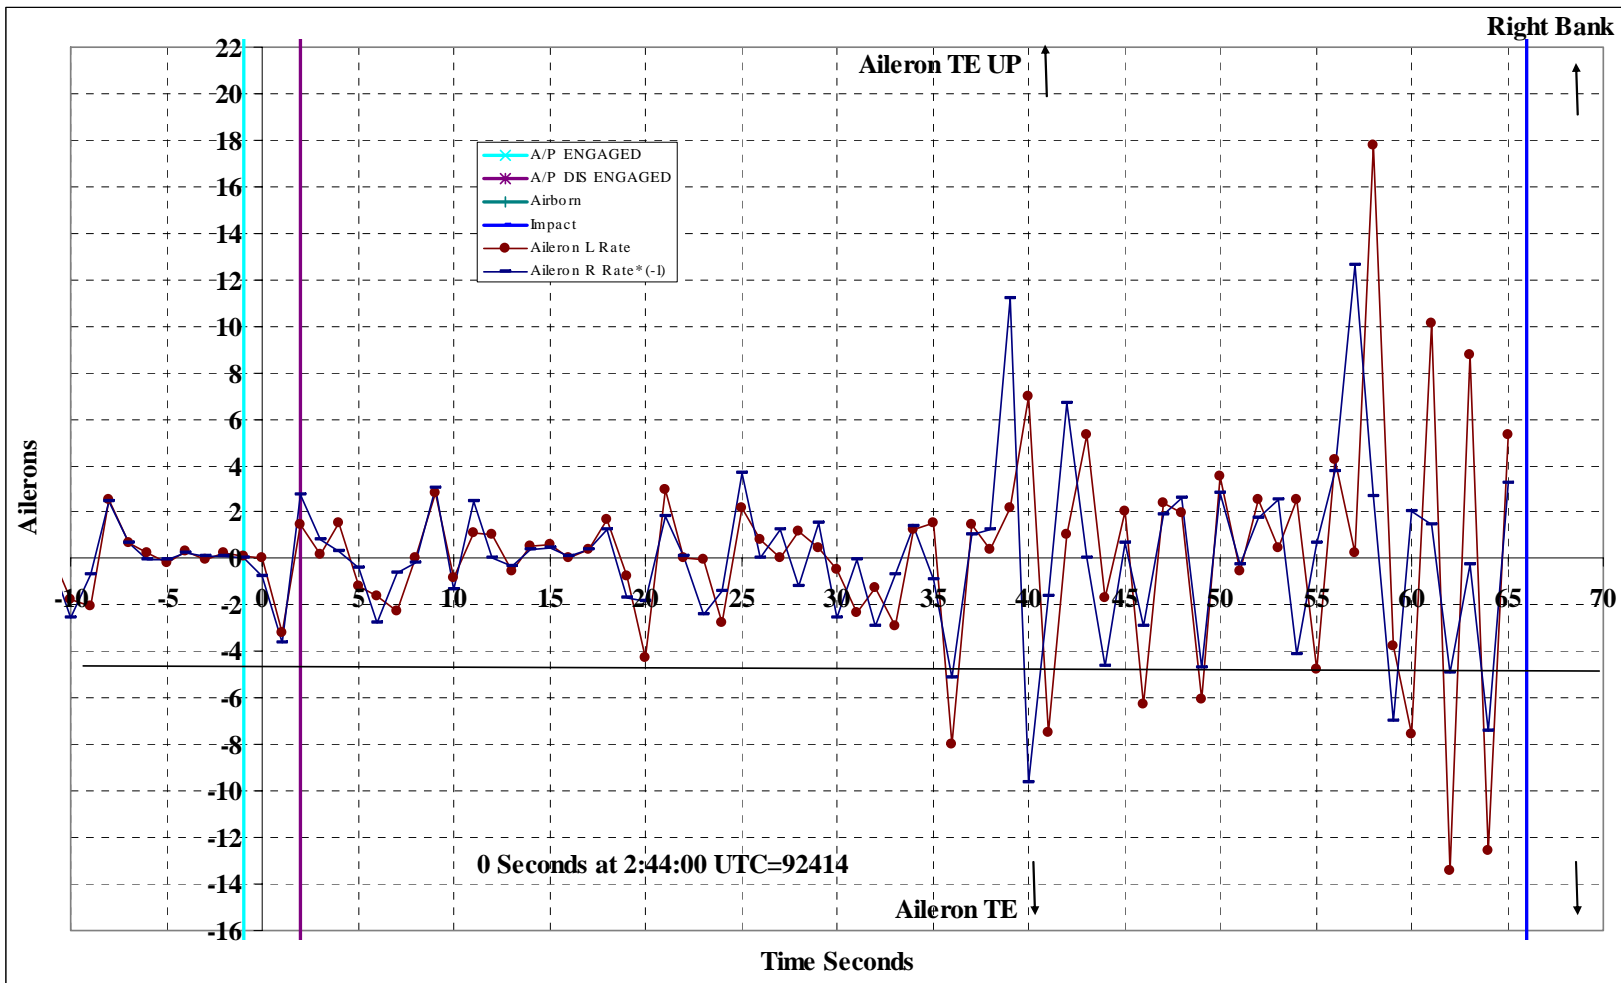
Derived Aileron Rate²

² Using the average linear rate before and after each point, the right aileron rate is sign inverted for comparison

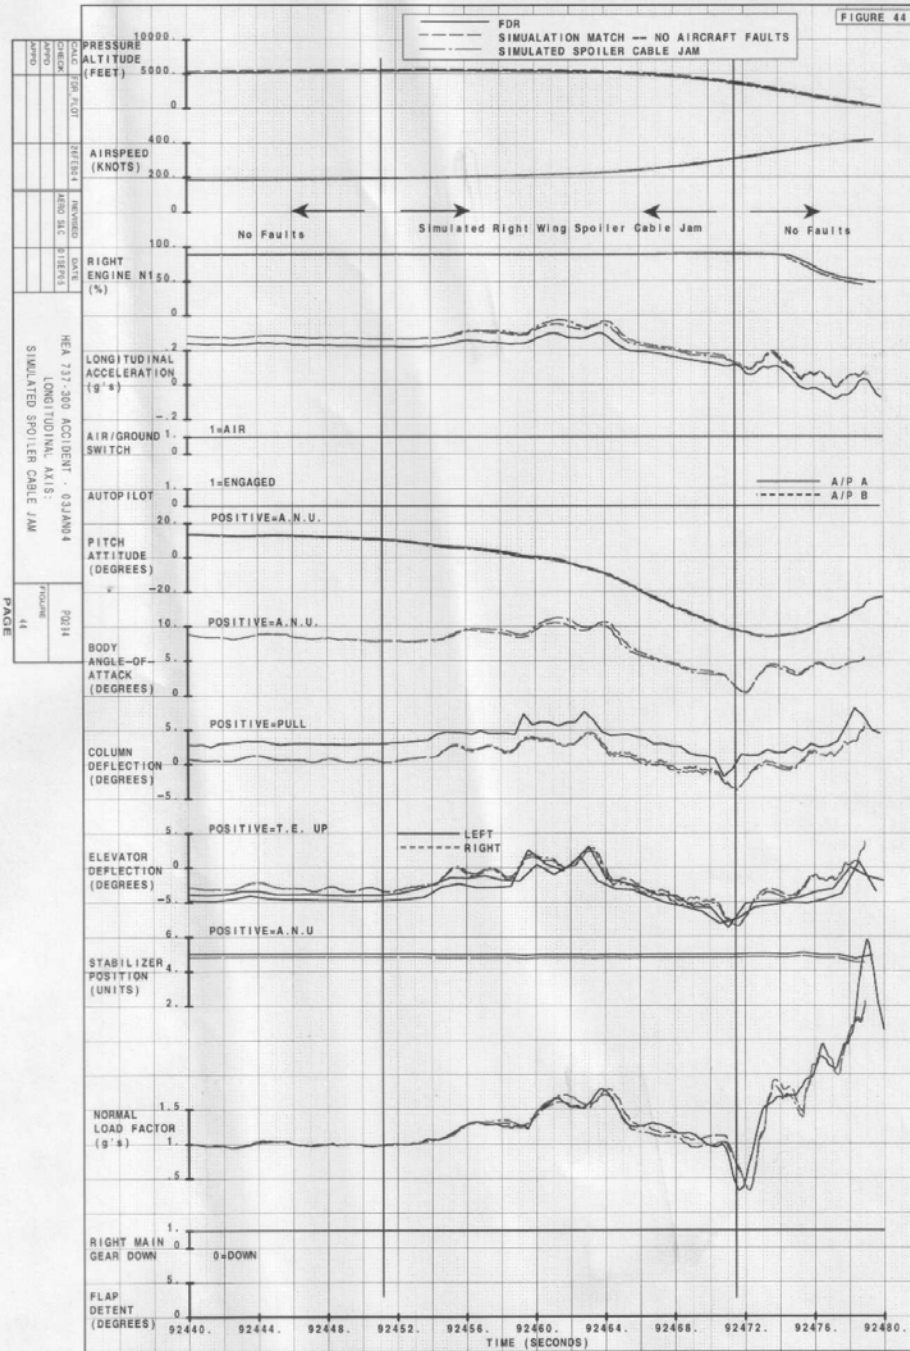
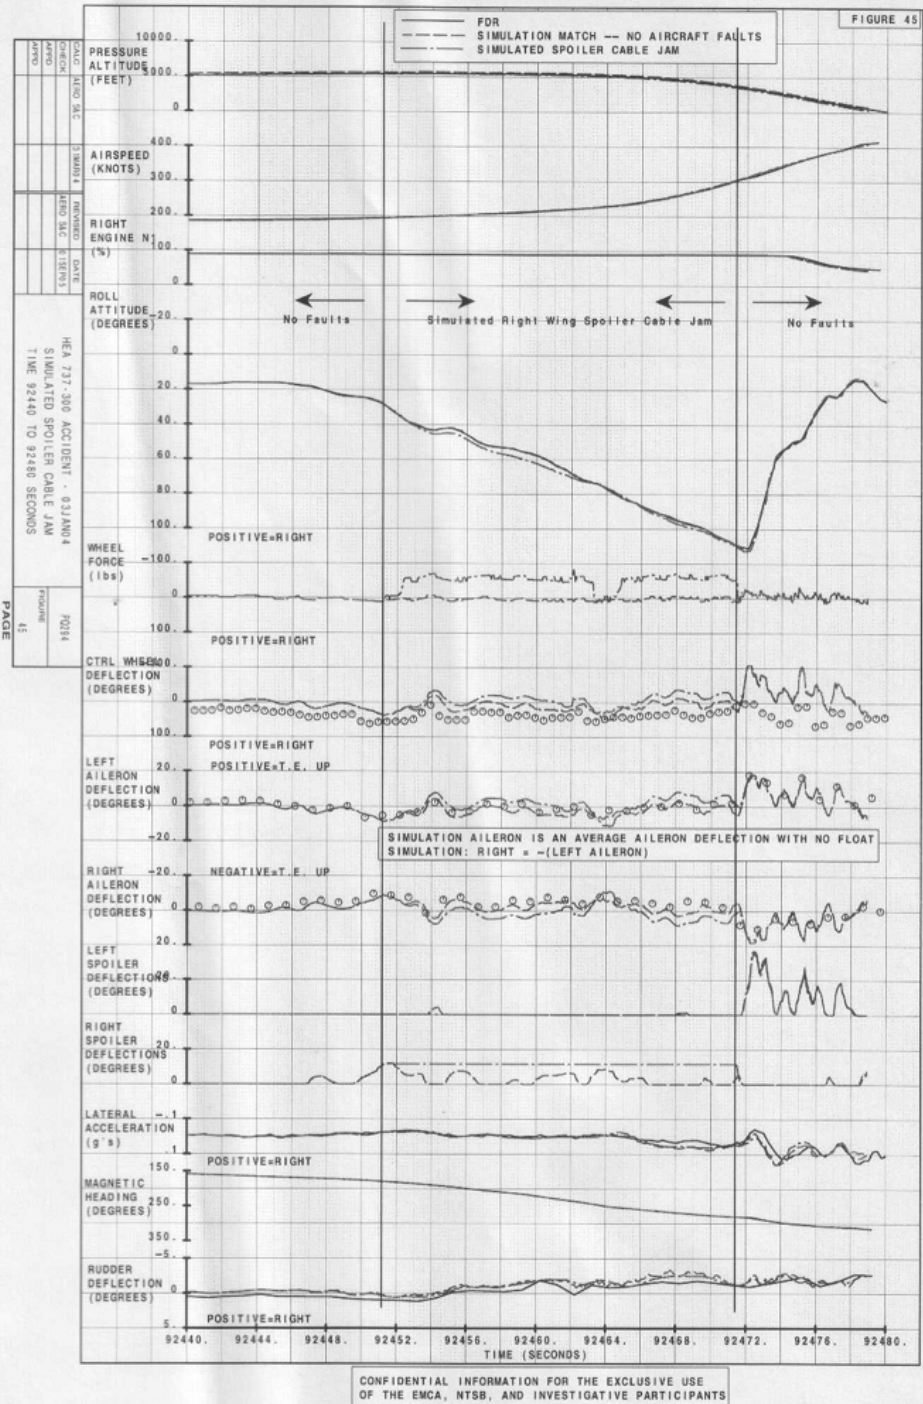
re 2.5.13.15a Scenario 10 - Spoiler wing cable jam (longitudinal parameters)

Figure 2.5.13.15b Scenario 10 - Spoiler wing cable jam (lateral parameters)

As shown from the two plots, the results obtained from the M-Cab test show a very close consistency with the FDR data which may explain this event. The estimated aileron wheel forces needed to move the wheel to correct for the right turn tendency is ~ 50 lbs.

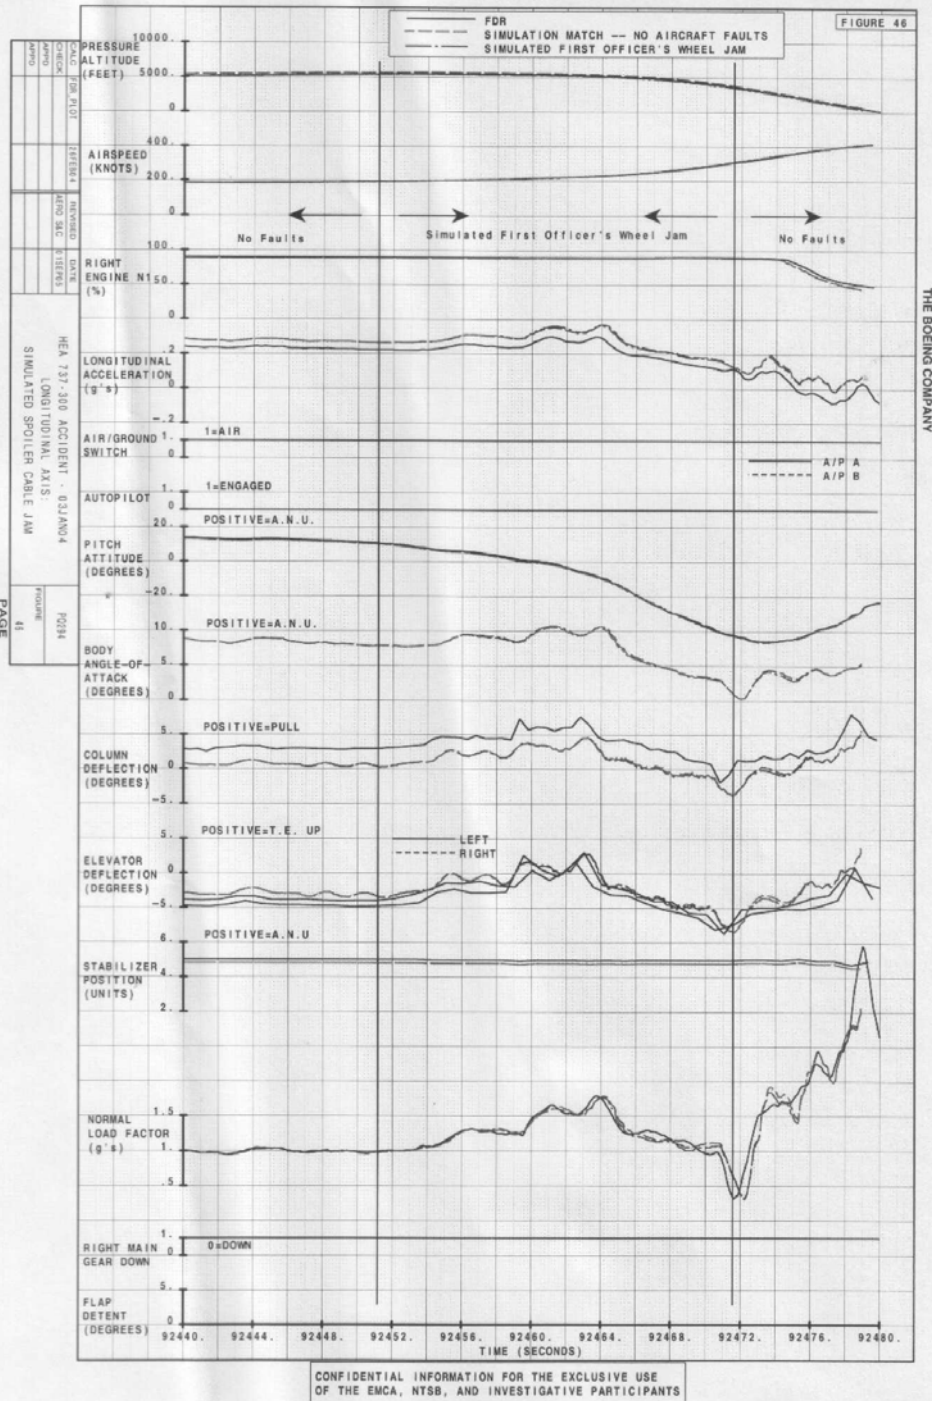
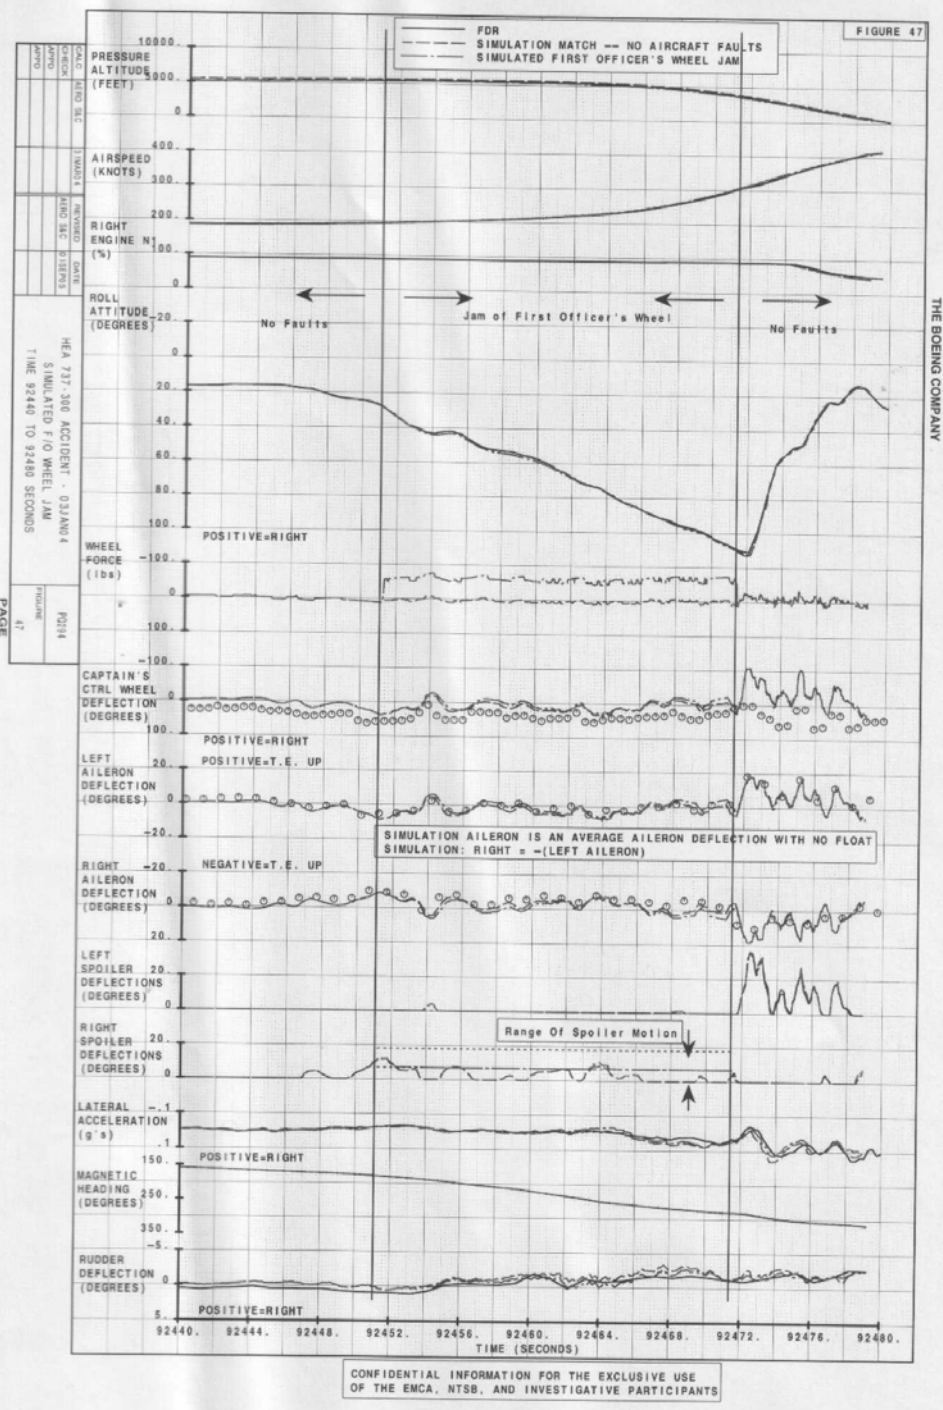
Figure 2.5.13.16a Scenario 10a - F/O wheel jam (longitudinal parameters)

2.5.13.16b Scenario 10a - F/O wheel jam (lateral parameters)
