## Engine damage at Helsinki-Vantaa Airport on 17th October, 2000

B 3/2000 L

# Engine damage at Helsinki-Vantaa Airport on 17th October, 2000

OO-SSH  
Airbus A319

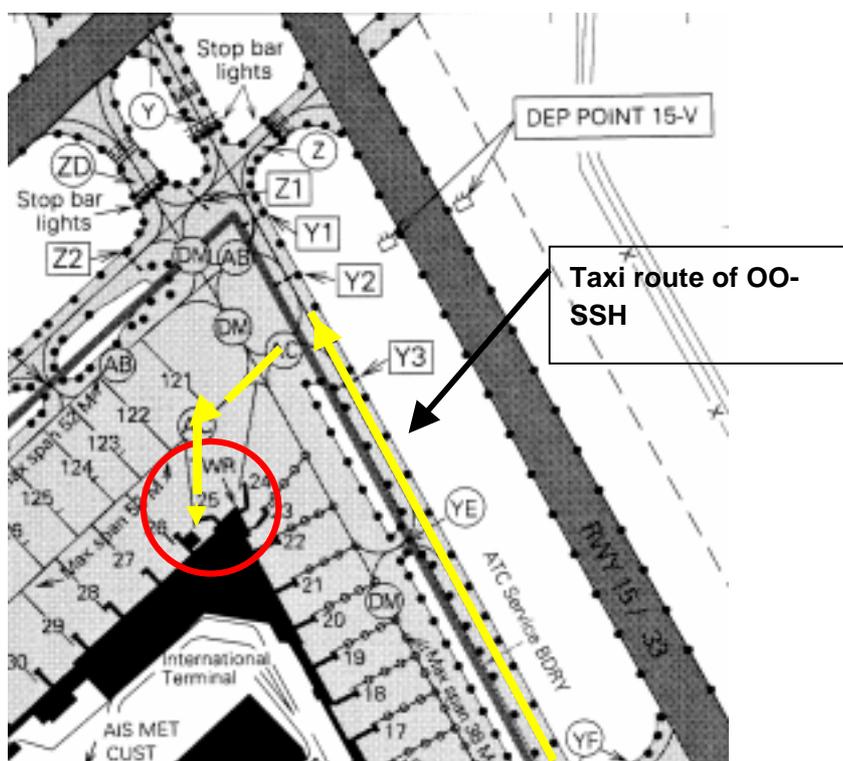
Picture 1. The Helsinki-Vantaa Airport general arrangements at the apron area and the taxing route of OO-SSH to aircraft stand number 25, where the engine incident occurred

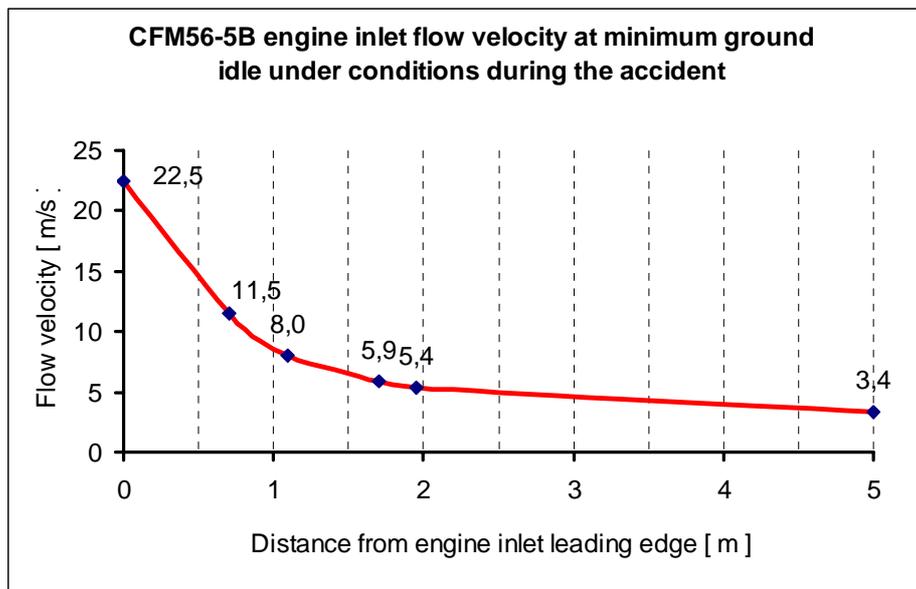
The speed of airflow accelerates in this area significantly when distance reduces. The speed of airflow just in front of the leading edge of inlet opening is approximately 22.5 m/s (81 km/h) and at the edges of the area at a distance of 2.2 m approximately 5 m/s (18km/h).

Picture 7. The speed of air flow of engine CFM56-5B

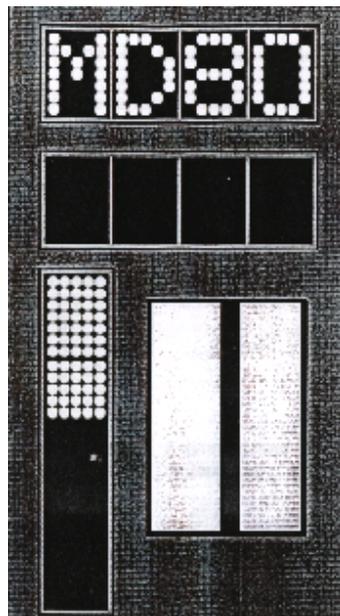
Picture 8. APIS display, when aircraft type MD80 selected into the system is on the parking centerline within a distance of 6.61-7.19 meters from the stop position

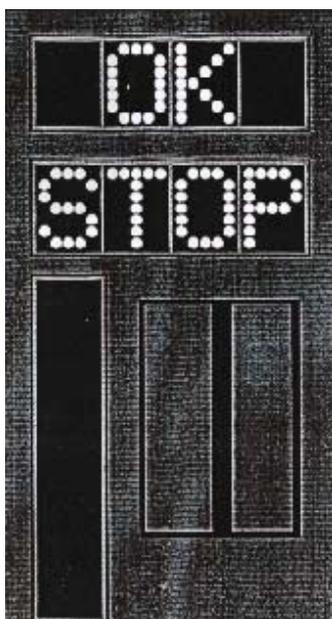
Picture 9. APIS display, when aircraft is within the correct parking area according to the system
