Aircraft damage in hailstorm west of Helsinki on 21.7.2001

Investigation report

B 5/2001 L

LN-RMT

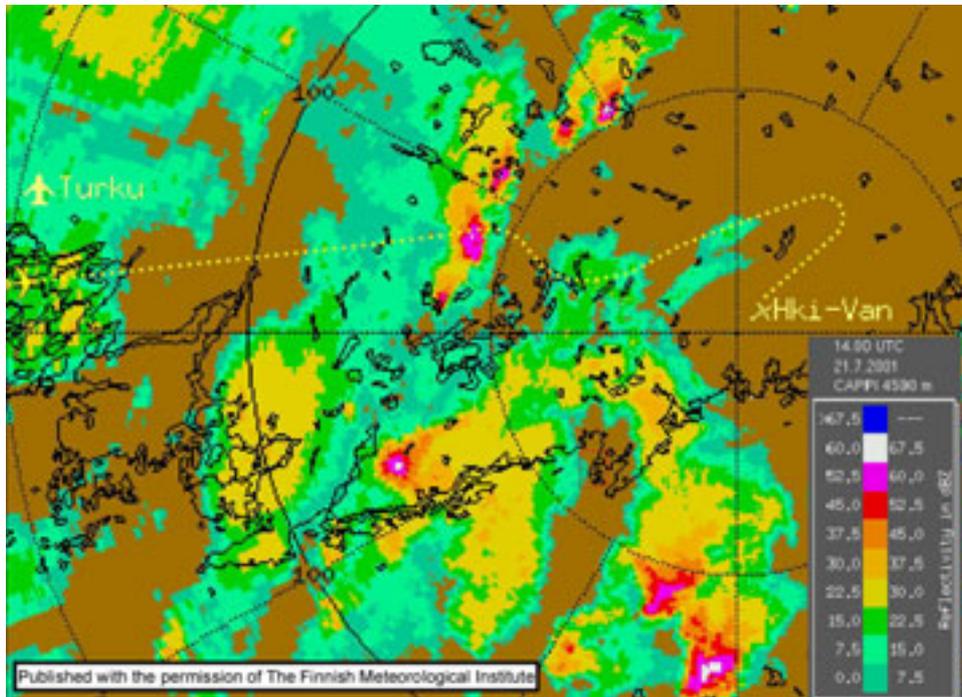
Figure 3. Weather radar image at 14.00 from the altitude of 4500 m

SAS1700 flew into a cell in the CB cloud at 14.07. Figure 3 depicts the aircraft at flight level 290 before commencing the descent. The future flight path is marked with a dotted line. In figure 4, the plane is approaching runway 22. The actual flight path is marked with a solid line. The cloud moved north-northeast between the times of figure 3 and 4.
