## Crash short of runway, Boeing 737-400, G-OBME

**Micro-summary:** This Boeing 737-400 crashed short of the runway following an engine failure and incorrect shutdown of the good engine.

# Boeing 737-400, G-OBME: Main document

Report on the accident to Boeing 737-400 - G-OBME near Kegworth,  
Leicestershire on 8 January 1989

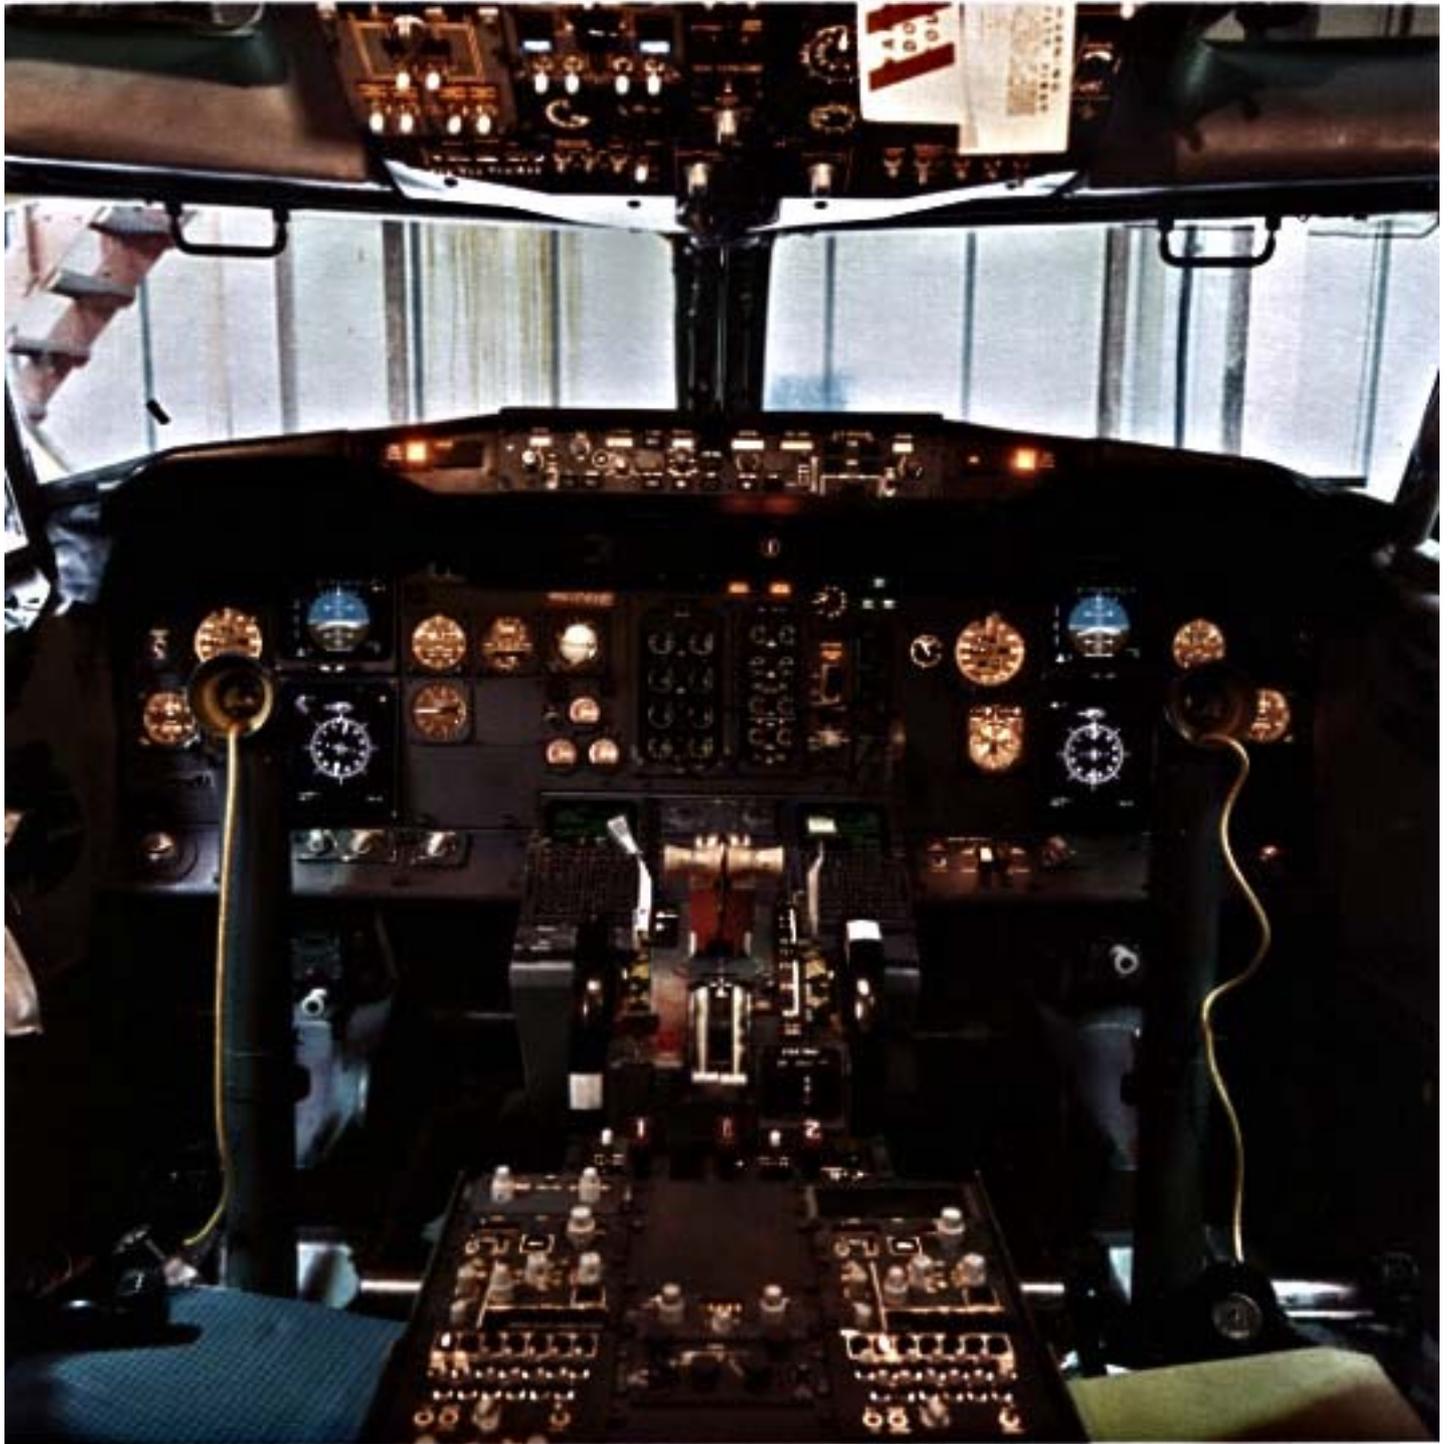
**FIG. 2: SHOWING SOLID-STATE ELECTRONIC ENGINE INSTRUMENT SYSTEM (EIS), AS FITTED TO G-OBME, WITH VIBRATION INDICATORS ARROWED**

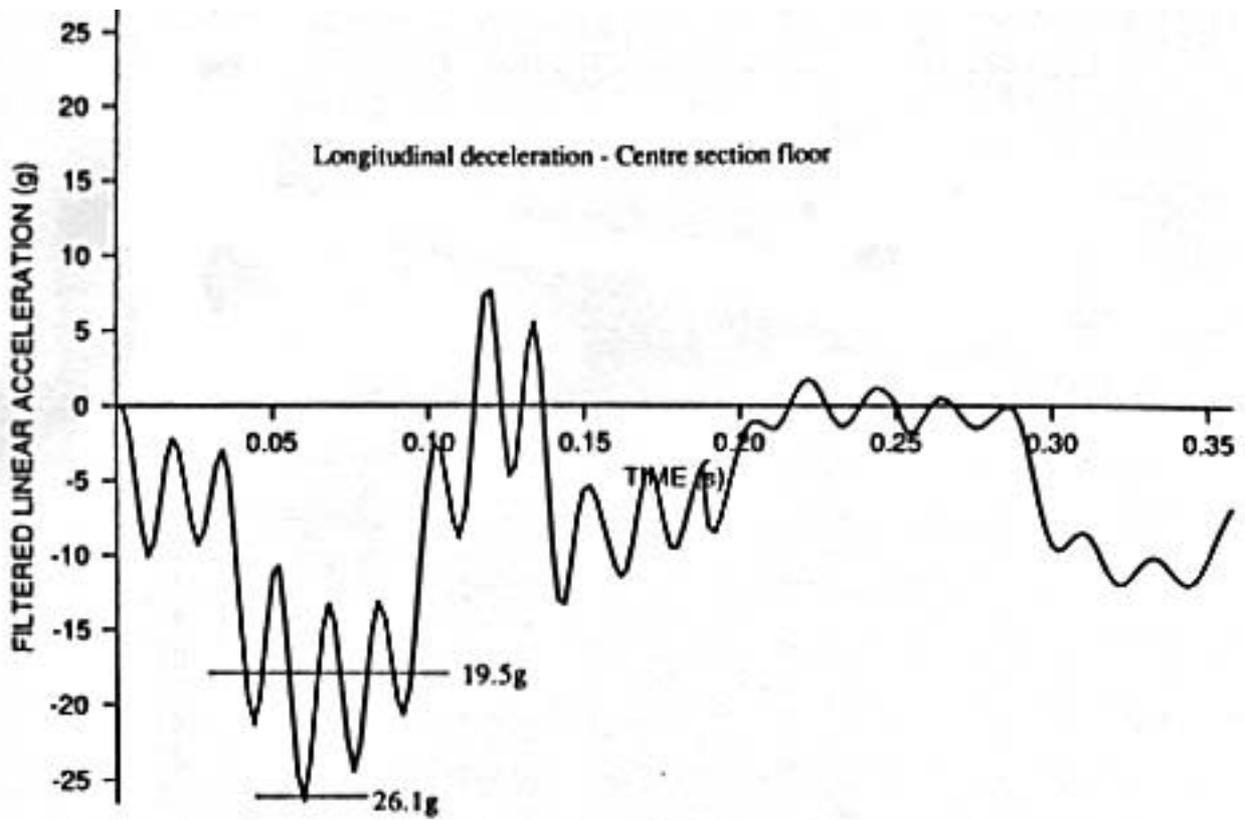
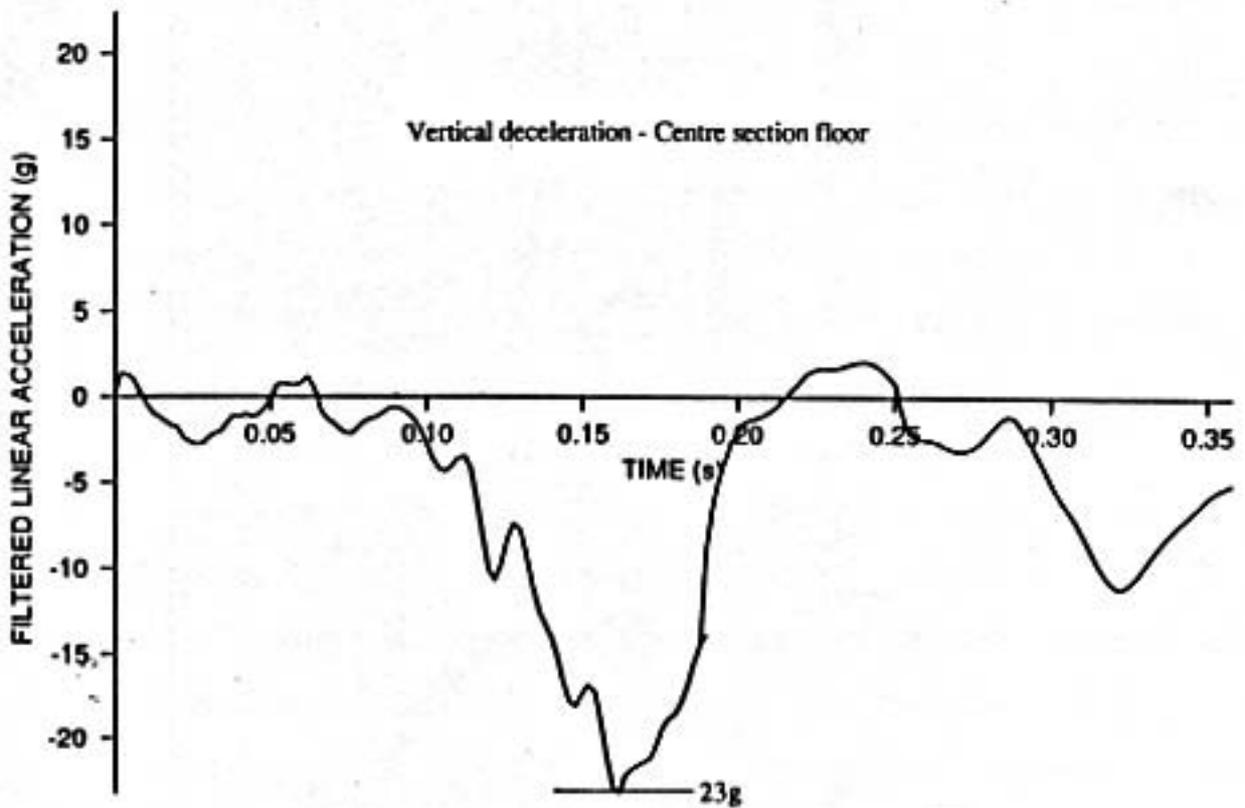
Appendix 3, figure 22 (a) - KRASH longitudinal deceleration - Run 2

Run 2 represented the second impact after ballistic flight from the first impact, giving horizontal and vertical velocities of 48.9 metres/sec and 14.4 m/sec respectively. Peak deceleration values for the centre section (Appendix 3, figs 22a and 22b) were 26.5g (longitudinal axis) and 23g (vertical axis): the peak resultant coincided with the 26.5g longitudinal peak.

In Runs 2 and 3 the longitudinal deceleration signals (figs 22a and 23a) were composed of a vibratory component of about 60 Hz, superimposed on a fundamental signal of approximately sine-curve shape. The 60 Hz signal represented the low-amplitude elastic deformations, whereas the fundamental wave represented the actual plastic deformation. The maximum values of this fundamental signal were 19.5g (Run 2) and 15.5g (Run 3).

On the balance of evidence, therefore, the KRASH simulation which best represented the velocity conditions at the second impact was Run 2 (Appendix 3, figure 22), which gave mid-fuselage longitudinal decelerations (mass 2) of 26.1g (peak) and 17.8g (fundamental). Of these two values, the fundamental signal represented the plastic deformation signal transmitted to the seats and should be used for comparison purposes. The pulse shapes (appendix 3 fig 22) indicated that the initial impulse in the second impact was primarily longitudinal followed by a vertical pulse when the engine nacelles and the fuselage centre section contacted the carriageway. The corresponding value for the vertical deceleration was 23g (peak).

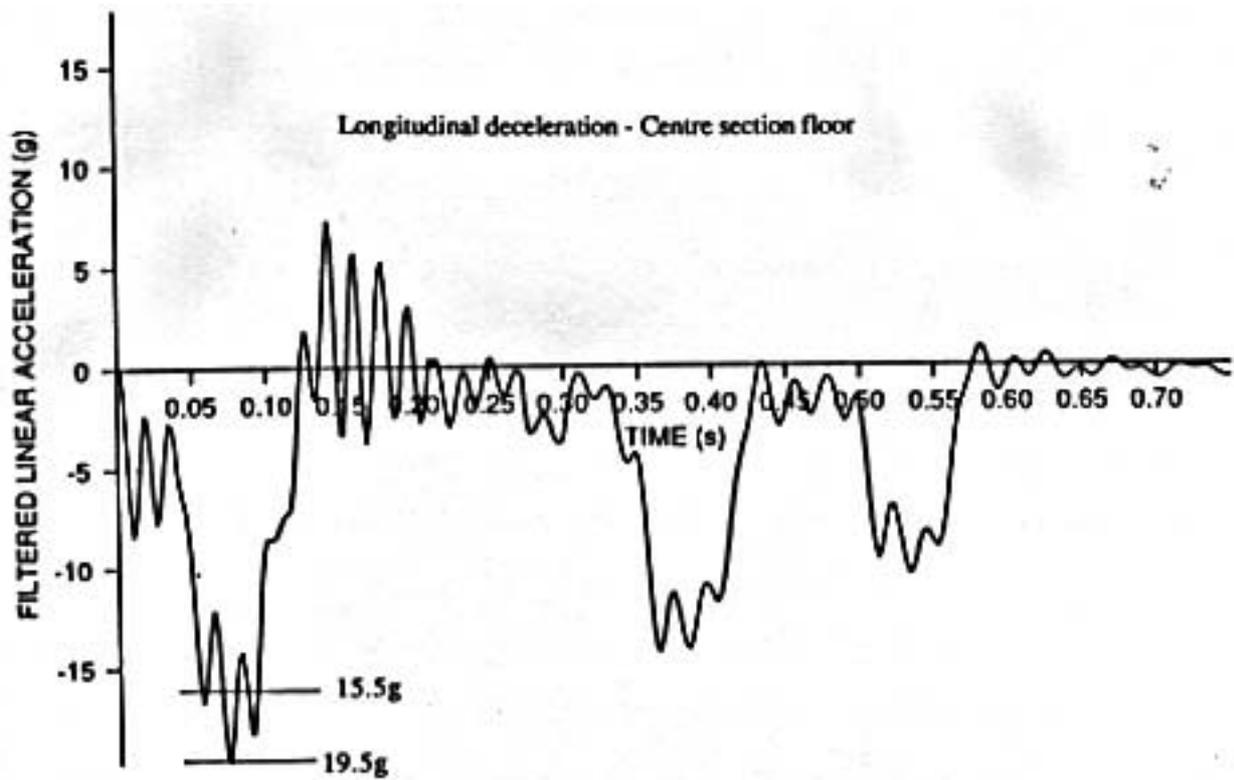
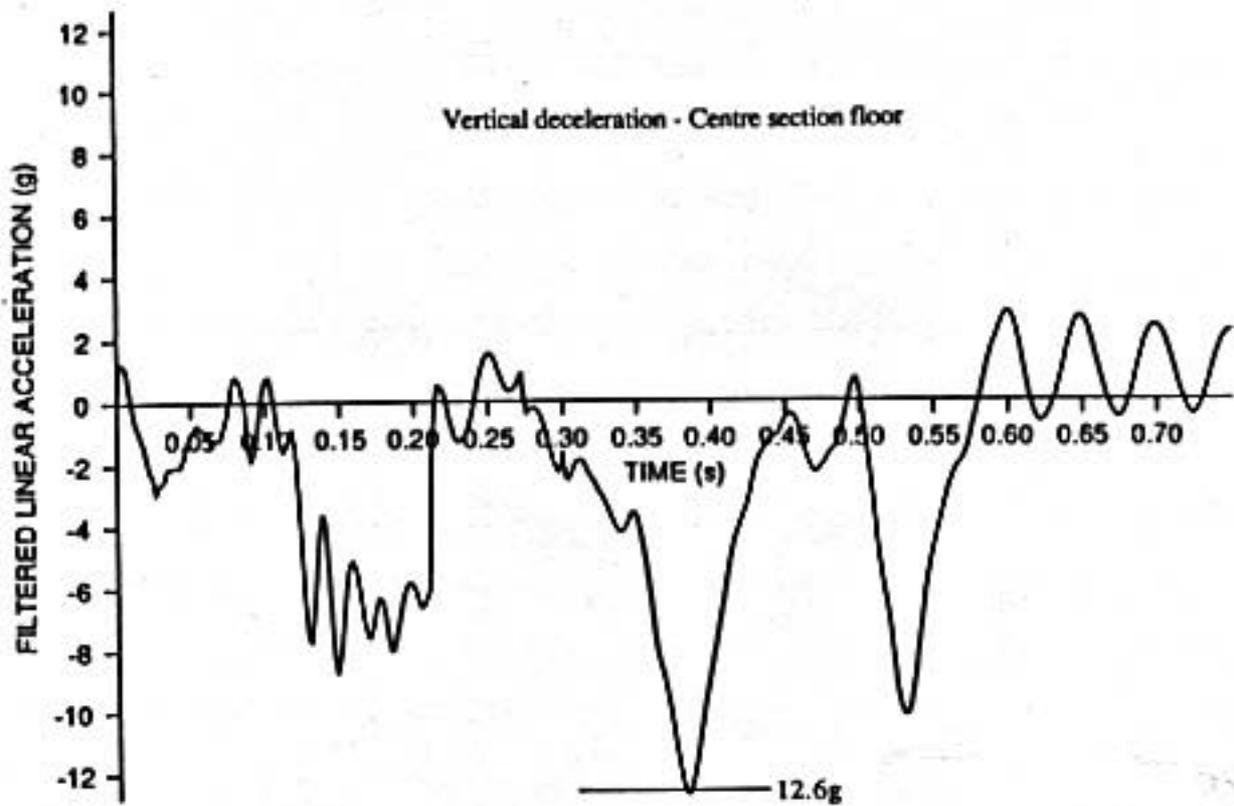
Appendix 3, figure 23 (a) - KRASH longitudinal deceleration - Run 3

Run 3 represented the second impact after a trajectory in which the wing was assumed to produce residual lift equivalent to approximately 40% of the weight of the aircraft. This gave horizontal and vertical velocities of 37.9 metres/sec and 11.1 metres/sec respectively. Peak deceleration values (figs. 23a and 23b) were 19.5g (longitudinal axis) and 12.6g (vertical axis): again, the peak of the resultant deceleration coincided with the longitudinal peak (19.5g).

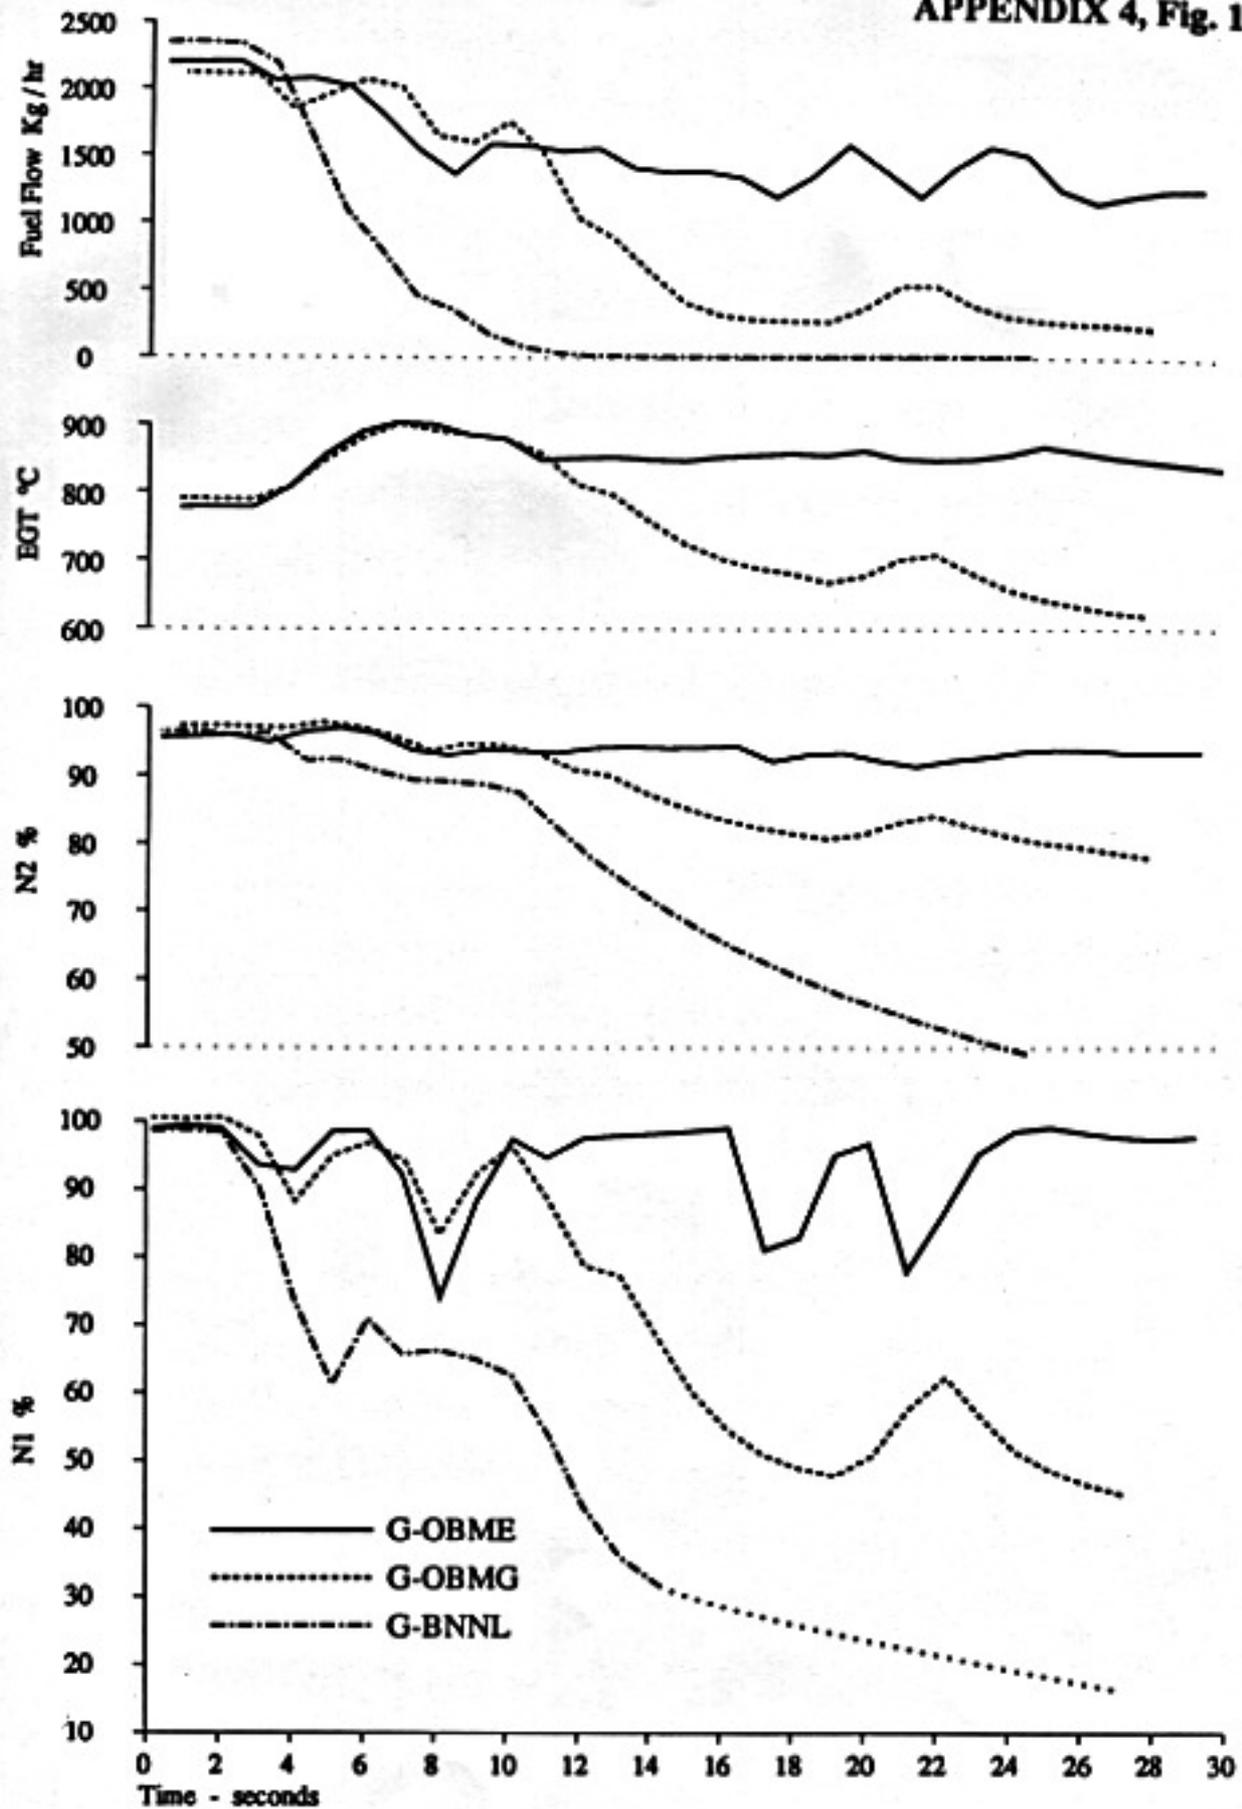
Comparison of engine parameter response following fan blade outer panel separation on three aircraft (G-OBME, G-OBMG, G-BNNL)

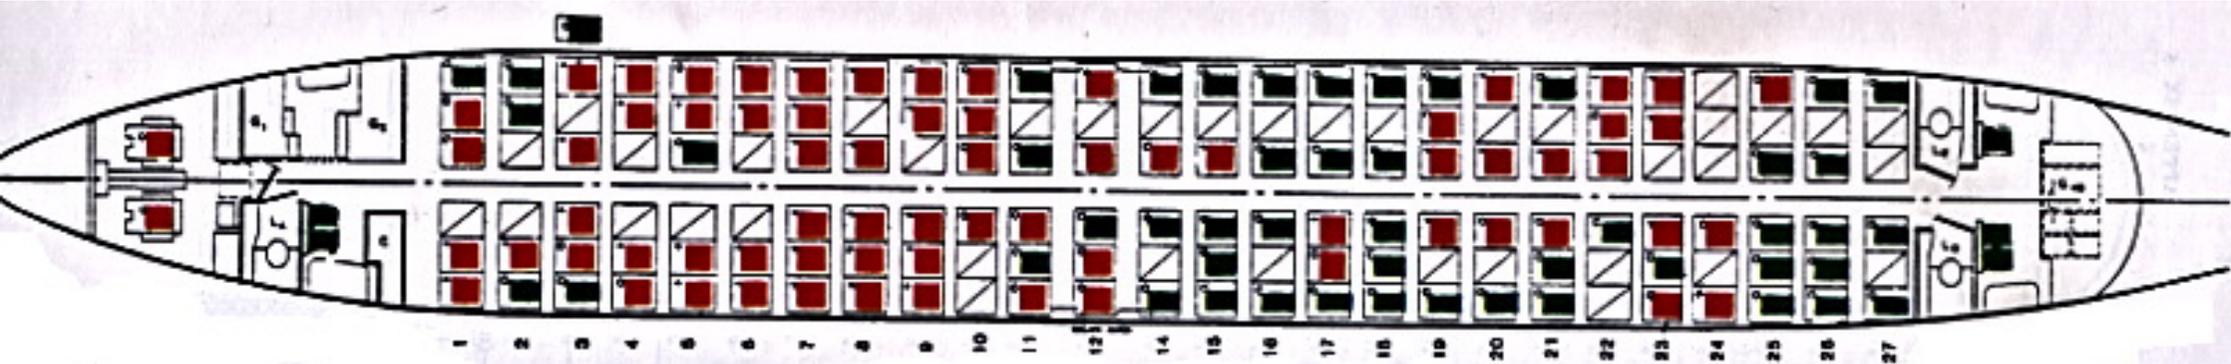
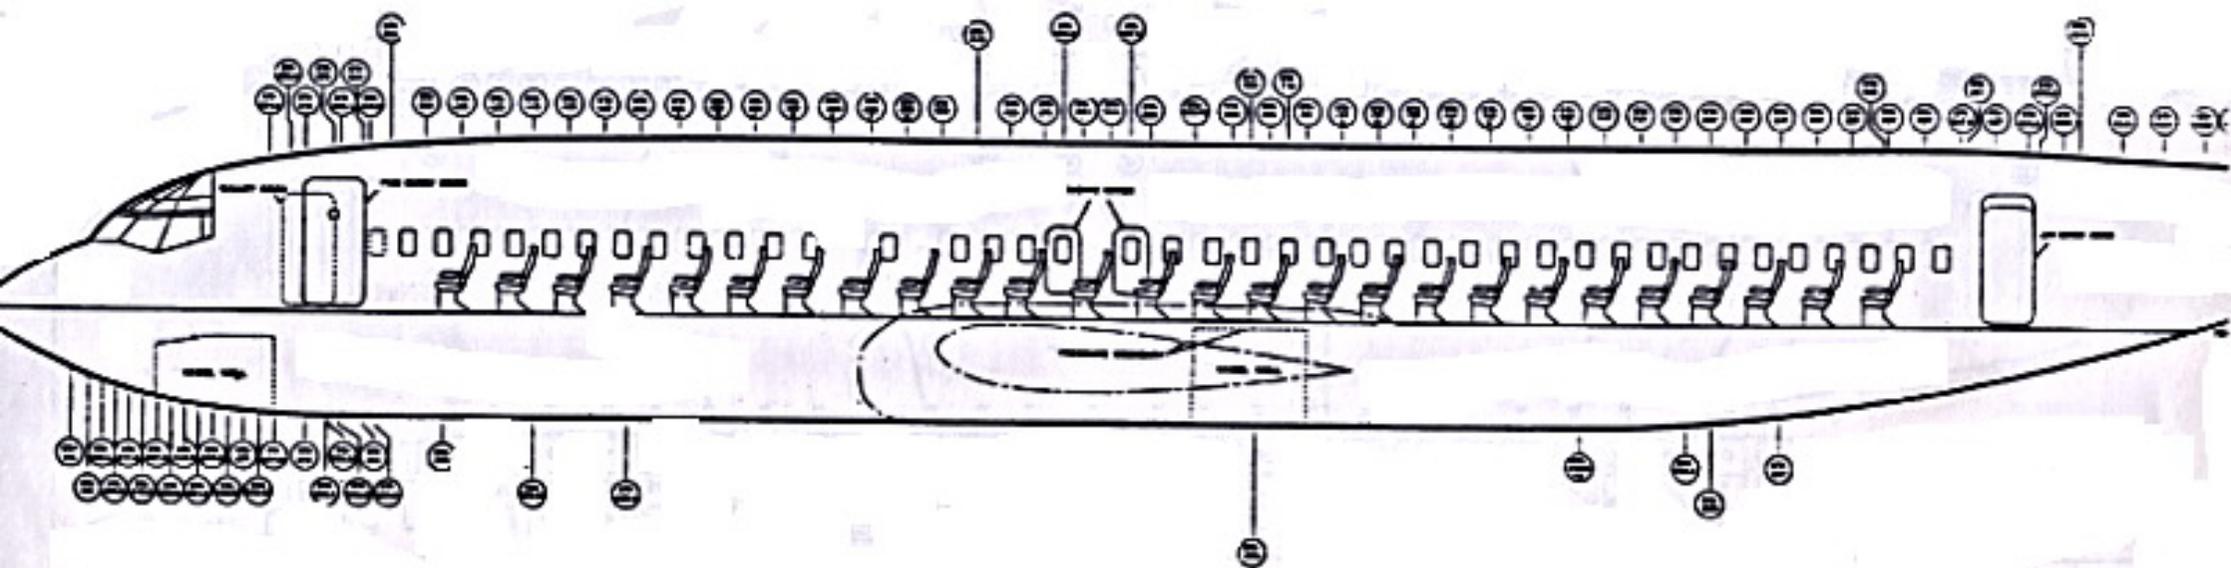
FIG 3: SHOWING DISTRIBUTION OF INJURY SEVERITY

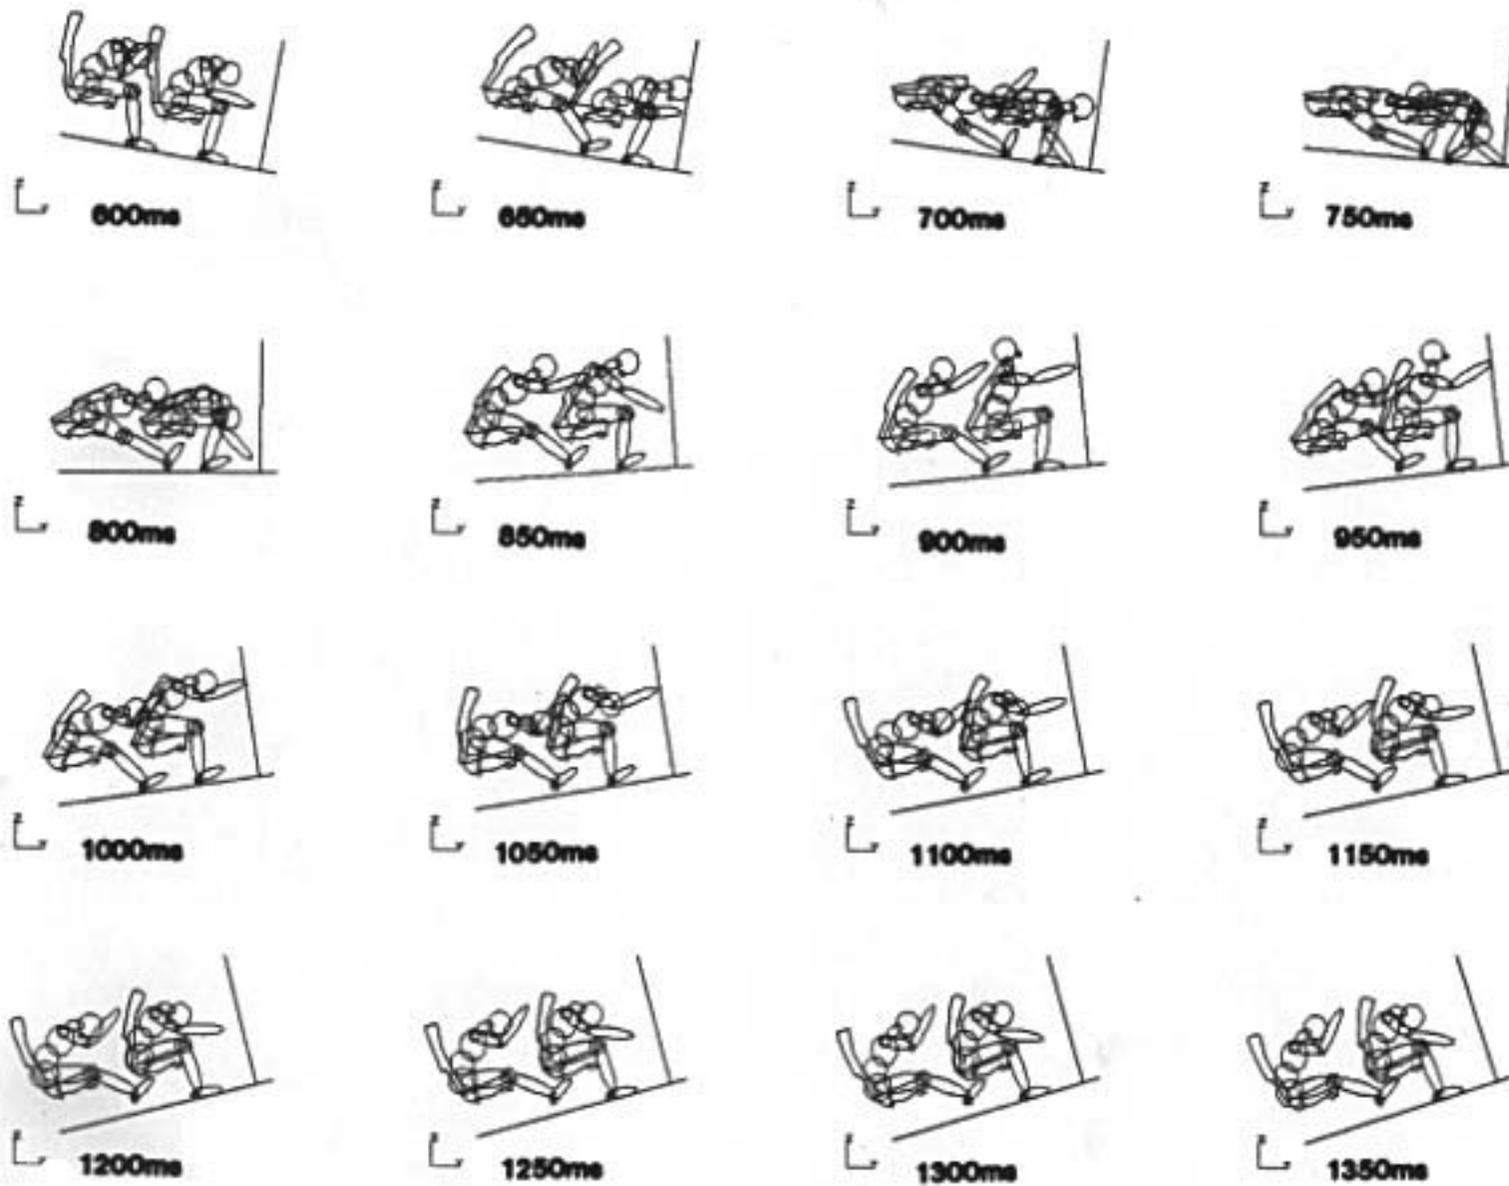
**APPENDIX 5**

**FIG 4: SHOWING COMPUTER SIMULATION OF IMPACT INDUCED OCCUPANT DISPLACEMENT, WITH LAP BELT RESTRAINT**

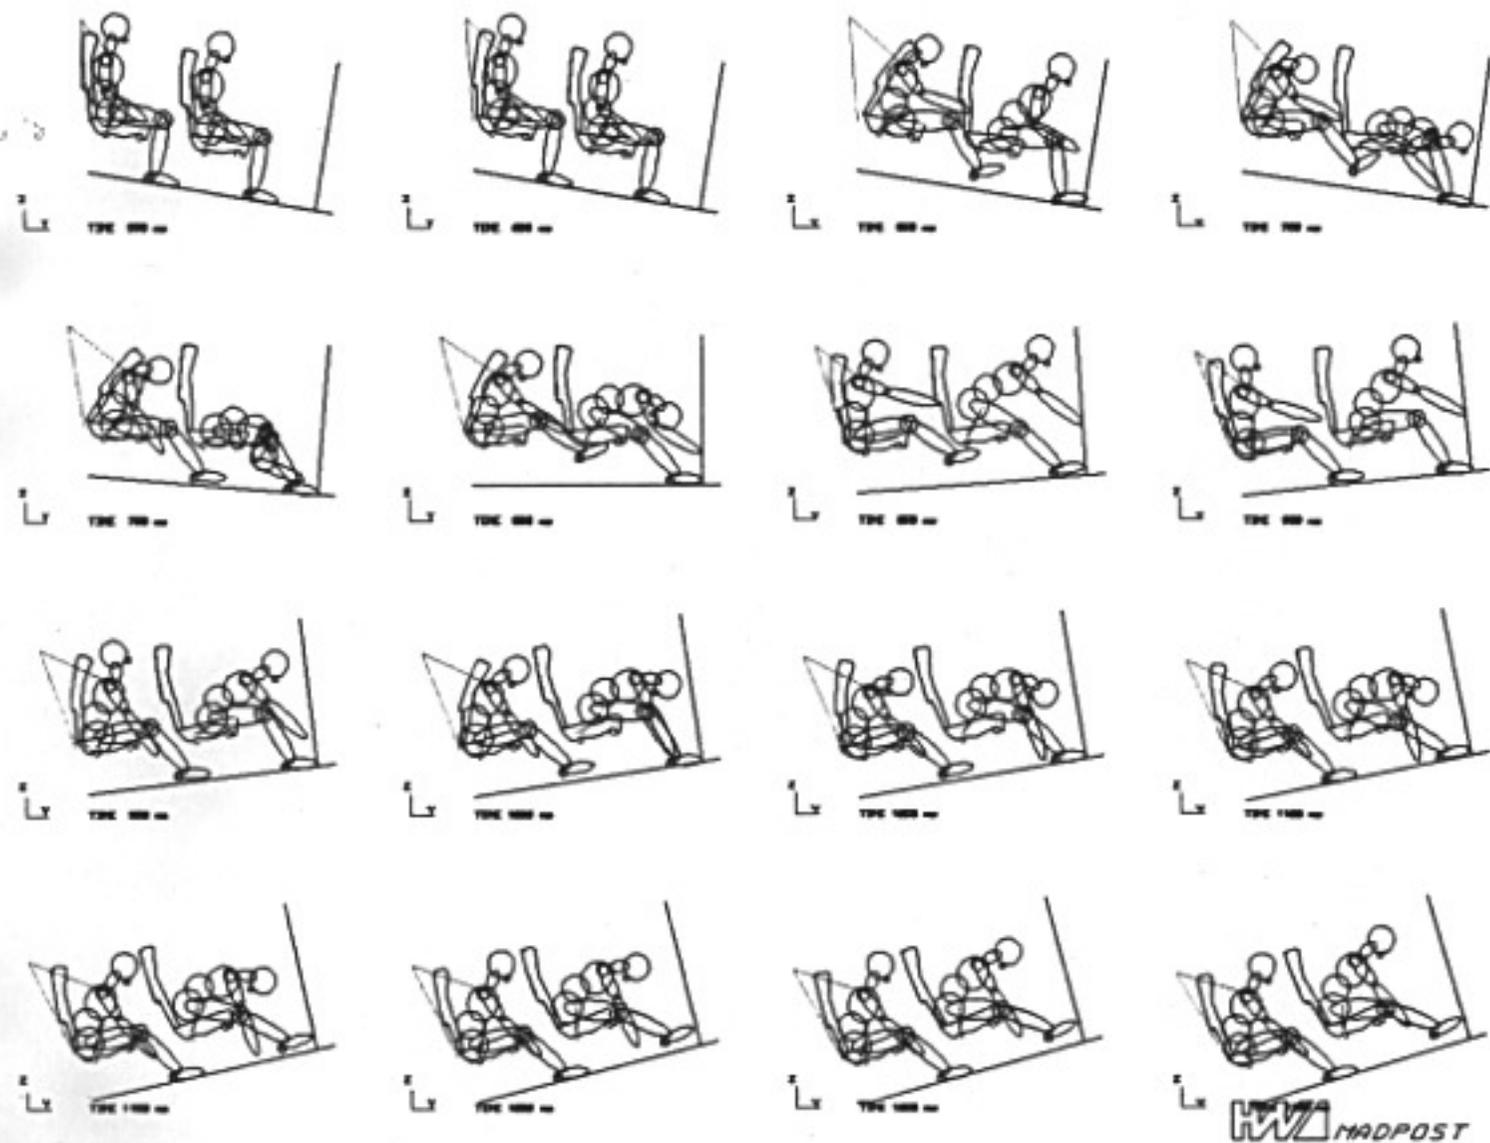
**FIG 5: SHOWING COMPUTER SIMULATION OF IMPACT INDUCED OCCUPANT DISPLACEMENT, WITH LAP BELT AND UPPER TORSO RESTRAINT OF REAR OCCUPANT**

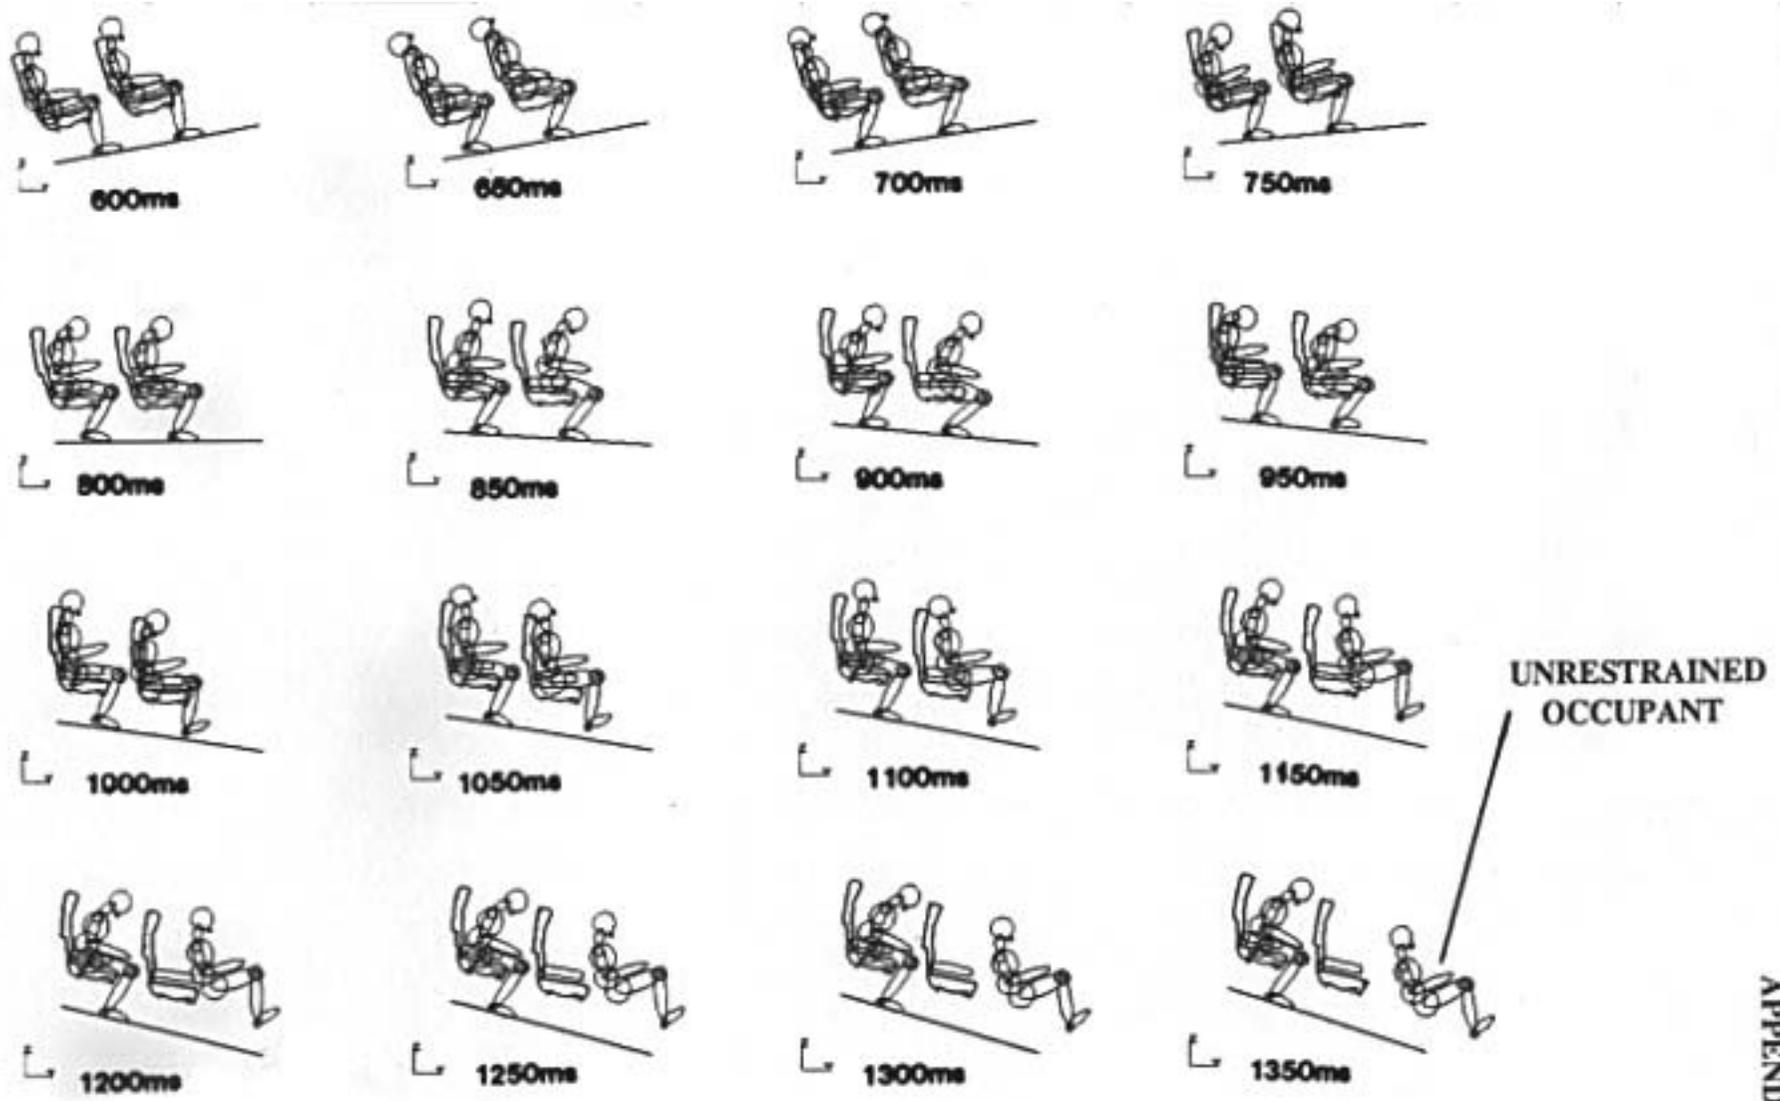
**FIG 6: SHOWING COMPUTER SIMULATION OF IMPACT INDUCED OCCUPANT DISPLACEMENT, WITH AFT-FACING SEAT (STANDARD SEAT)**
