Crash at airshow, Lockheed P-38J Lightning, N3145X

Lockheed P-38J Lightning, N3145X

AAIB Bulletin No: 5/97 Ref: EW/C96/7/4 Category: 1.1

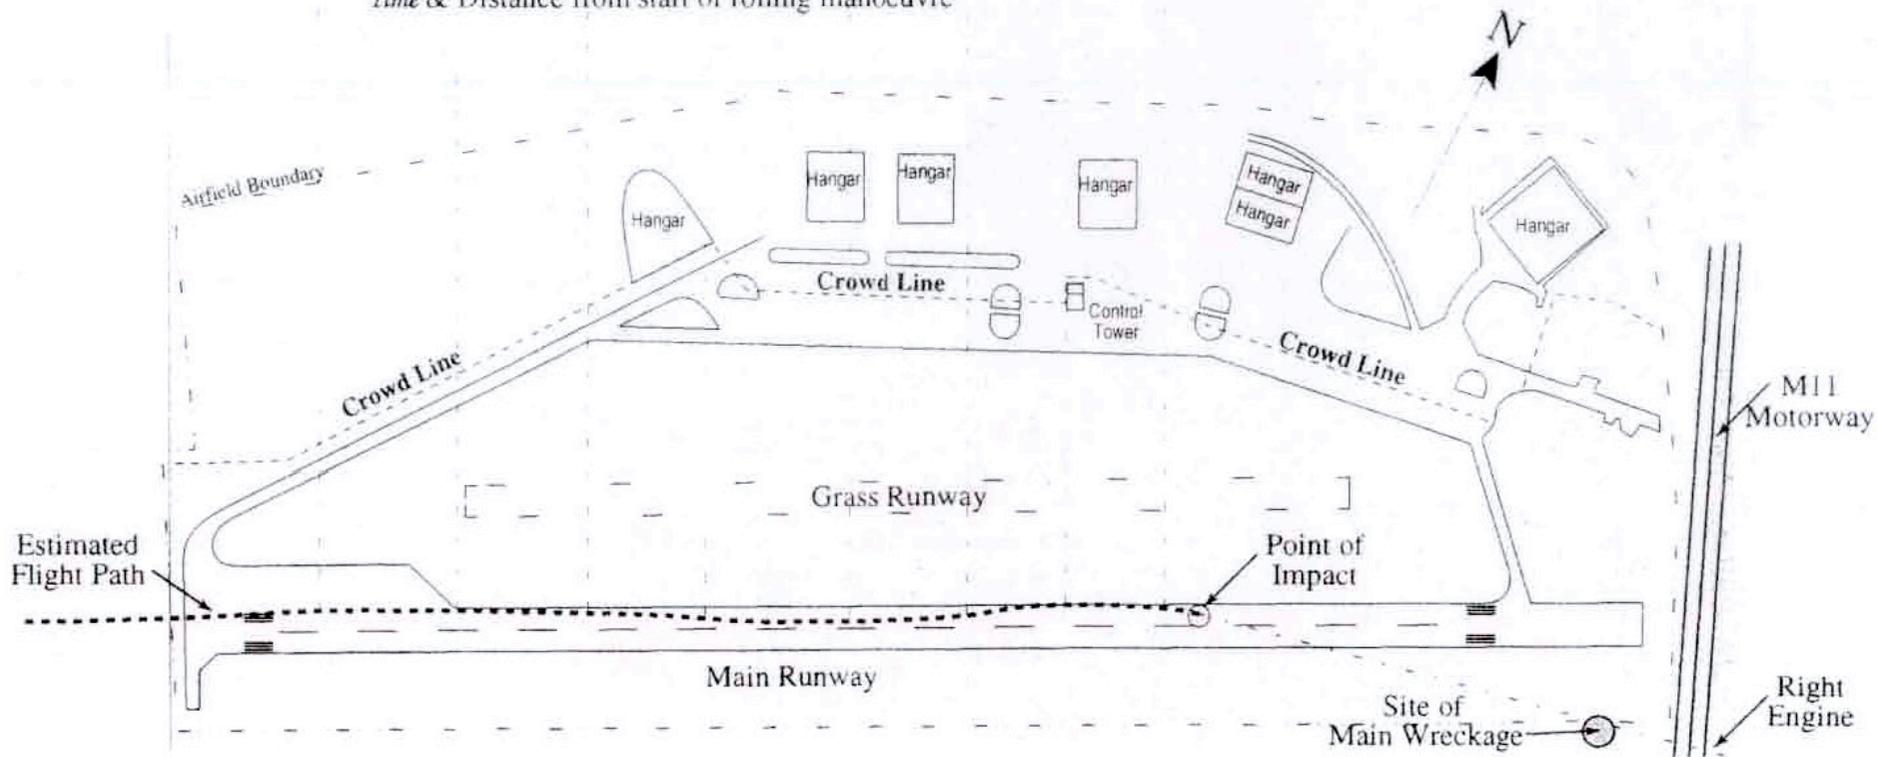
Consideration of the flight profile (Figure 1) indicates that the start of the final manoeuvre occurred over the western end of the hard surfaced runway. At the end of the first roll, the aircraft was still in a location which was to the right (west) of the centre of the crowd. It is considered unlikely that the pilot would have intended to stop manoeuvring at this position as the display would then have appeared 'asymmetric' from the crowd's viewpoint.

Figure 1
 Graphical representation of aircraft's Height, Rate of Roll and Speed Relative to Airfield Ground Features derived from Video Analysis and site Wreckage Plot.
