## Elevator jam on takeoff, HS748 Series 2A, G-ATMI

# HS748 Series 2A, G-ATMI: Main document

Report on the accident to HS748 Series 2A, G-ATMI at Liverpool Airport on 16 August 1996

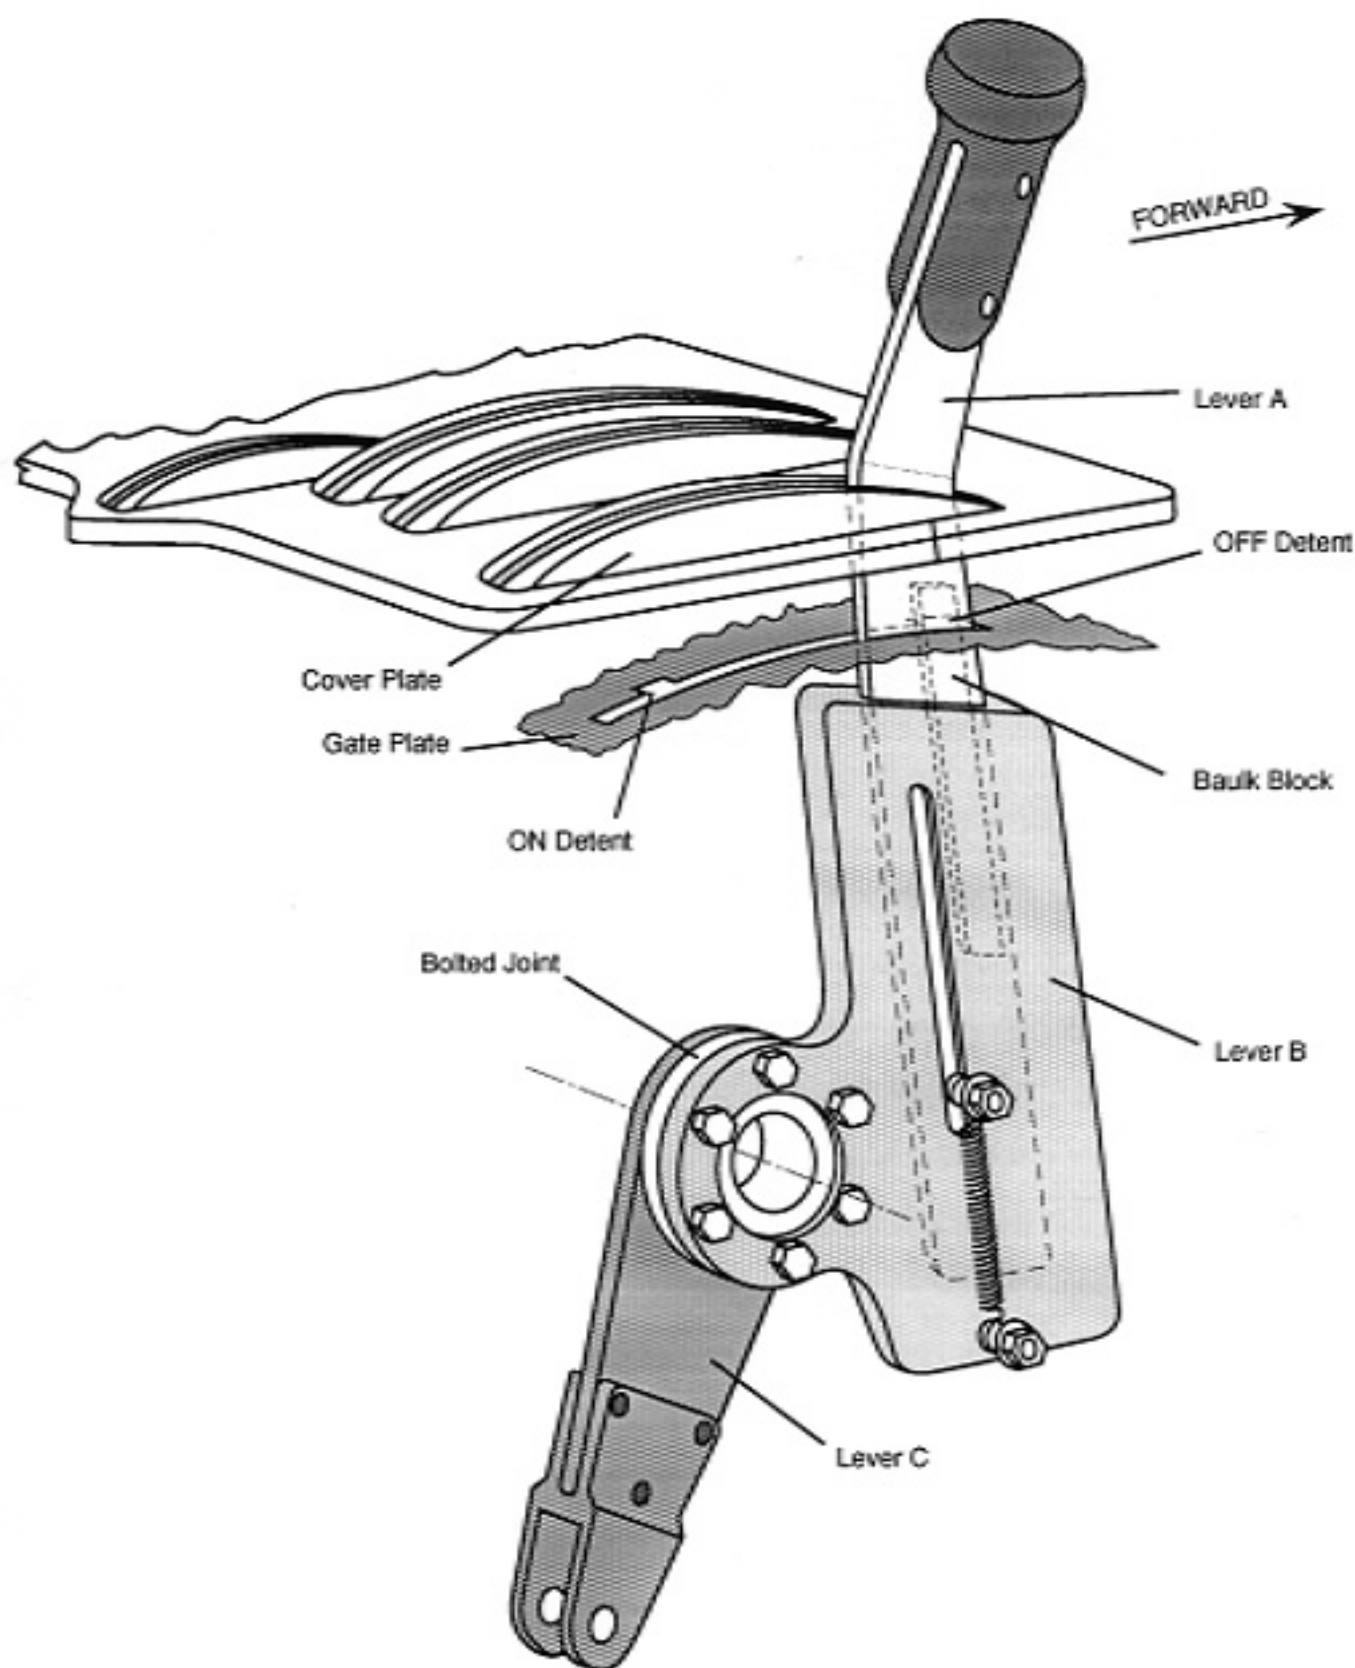
Fig 4

Fore and aft relative play of 0.04 inch (1 mm) present between A and B appeared normal. However, slack between B and C of approximately 0.24 inch (6 mm) was significant and, with the two effects in combination, Lever A moved 0.28 inch (7 mm), out of a travel between detents of 2.4 inch (60 mm), without motion of the output linkage. Levers B and C should have been rigidly fastened together by 6 bolts ( $\frac{5}{32}$  inch diameter) and nuts (Figure 4). However, these were found loose within the pilot's lever and/or the output lever, and the holes had worn oval. The joint could be seen, without disassembly, through the slot in the gust lock lever assembly gate plate.

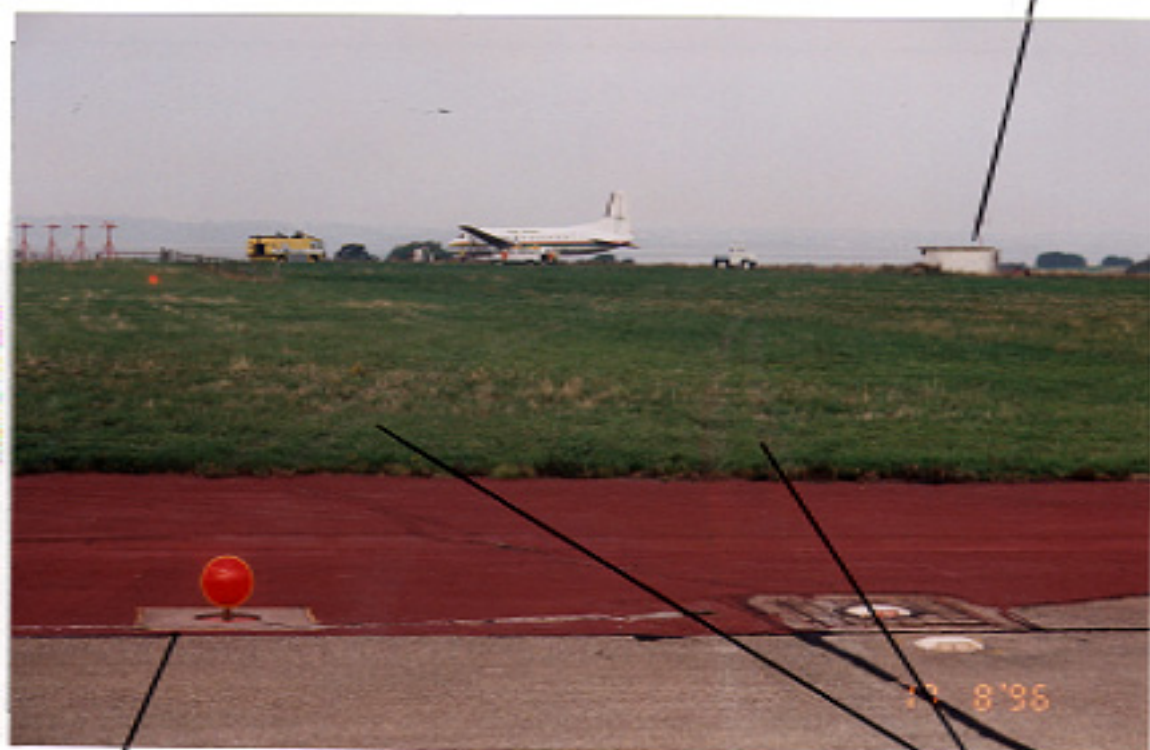
PHOTO 1.1 - RUNWAY OVERRUN AREA

The overrun took place within the boundaries of Liverpool Airport. Ground marks showed that the aircraft had run off the end of Runway 27 near its right edge and had continued on a track somewhat to the right of the runway heading, running on firm ground with short, dry grass cover (Photo 1.1). After an initial fairly straight run, the aircraft had begun a large radius turn to its left, shortly before it struck the ILS power supply building. The latter was a small, unmanned, single storey building, 8 feet high, with a flat roof. An intruder video surveillance camera and an associated relay unit were located together above the building, each attached to the building by means of robust steel mounts. Both units were substantial pieces of equipment; their tops were approximately 11 feet above ground level. It was clear that the aircraft's right wing had struck the video camera, relay unit and associated mountings causing their detachment from the building. The tyre ground tracks showed that aircraft had continued in a tightening left turn, crossing an airfield track. The ground marks did not indicate that the final turn had greatly reduced the stopping distance. The aircraft came to rest approximately 250 metres (820 feet) beyond the end of Runway 27 and 61 metres (200 feet) to the right of the runway extended centreline, heading 200°M.

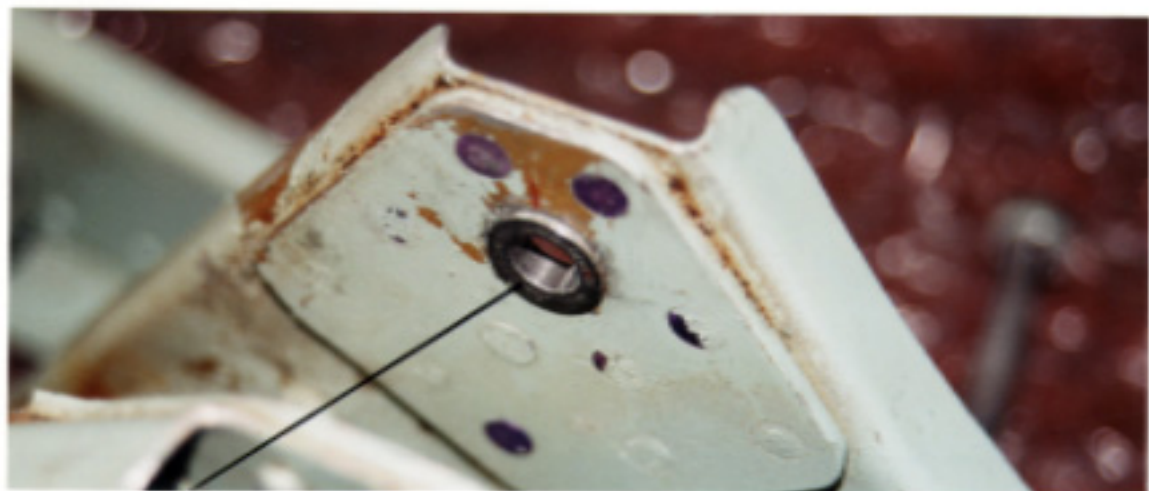
PHOTO 5.3 - ROLLER LEVER PIVOT - RIGHT SIDE

The elevator gust lock roller lever was found to be in firm contact with the side of the elevator lock plate (Figure 7.1). Extensive rubbing between the inner face of the roller lever sideplates and both side faces of the forward limb of the lock plate was apparent (Photo 4.2). This was indicative of the roller lever having operated for a prolonged period in a plane angled relative to the plane of the lock plate. On disassembly it was found that the bush for the roller lever pivot bolt intended to be fitted in the left-hand support bracket was absent (Figure 7.1, see Photo 5.2 and 5.3). This had resulted in a radial clearance of 0.05 inch between the 0.3 inch diameter bolt and the 0.4 inch diameter bracket hole on this side and it was apparent from associated witness markings that the system had operated with the left side of the bolt off-centre and in contact with the edge of the bracket hole. The IPC showed (Section 27-70, Figure 6 illustration and associated parts list at page 25) only one lever bush and one bracket bush per assembly. The BAe Aircraft Overhaul Manual (Section 27-70-1, Figure 2) showed two bushes per assembly.

Roller Lever  
Pivot Bolt Bush
