Loss of overwing slide, Boeing 747SP-100, N204 AE

Boeing 747SP-100, N204 AE

AAIB Bulletin No: 6/98 Ref: EW/C96/8/10 Category: 1.1

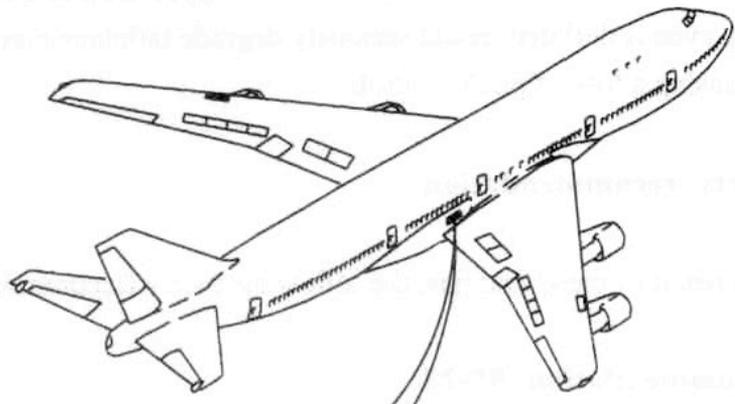
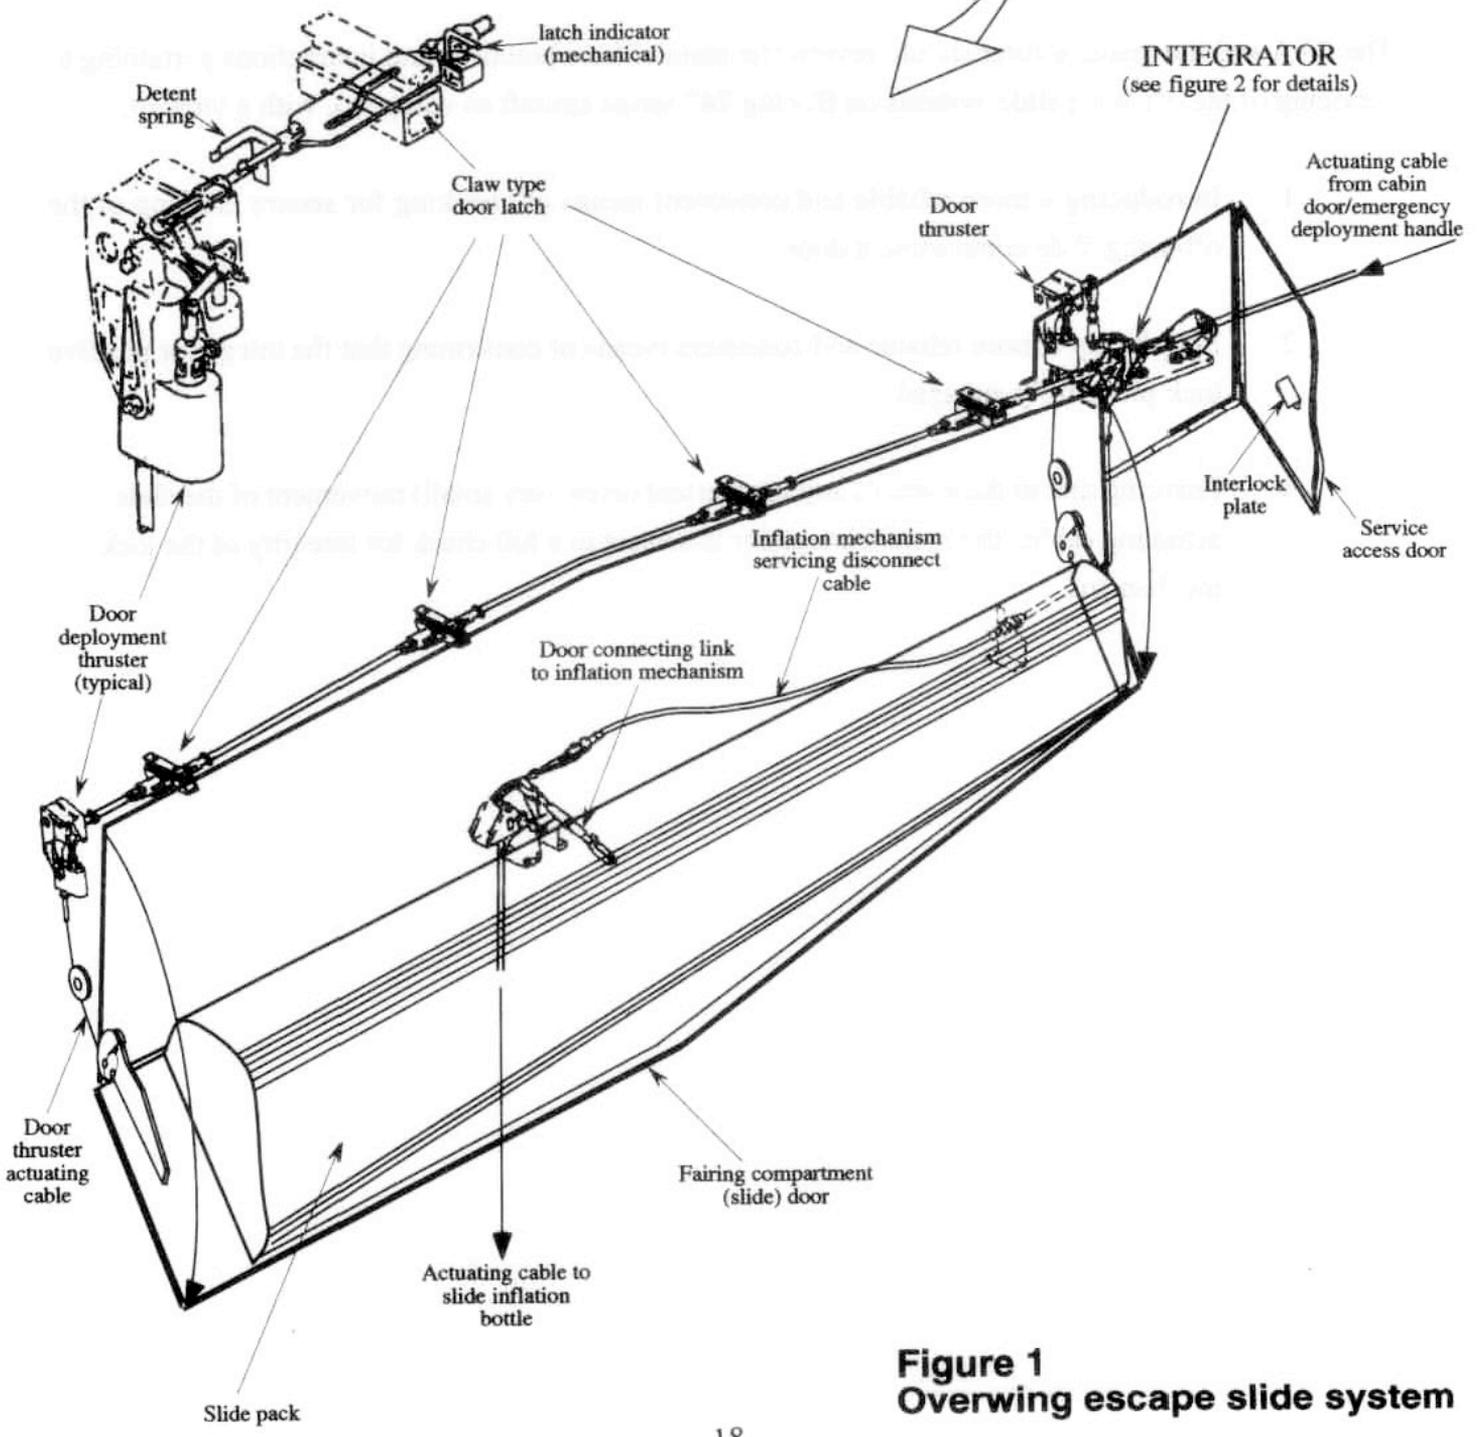
Figure 1
Overwing escape slide system

The operator later reported that whilst undertaking post-incident repairs and rigging checks in preparation for the installation of a new right hand off-wing slide, it was found that the detent spring at the rearmost latch (see Figure 1) had been inserted upside down. This would have rendered the system even more prone to unlatching in the absence of an effective positive lock in the integrator itself.

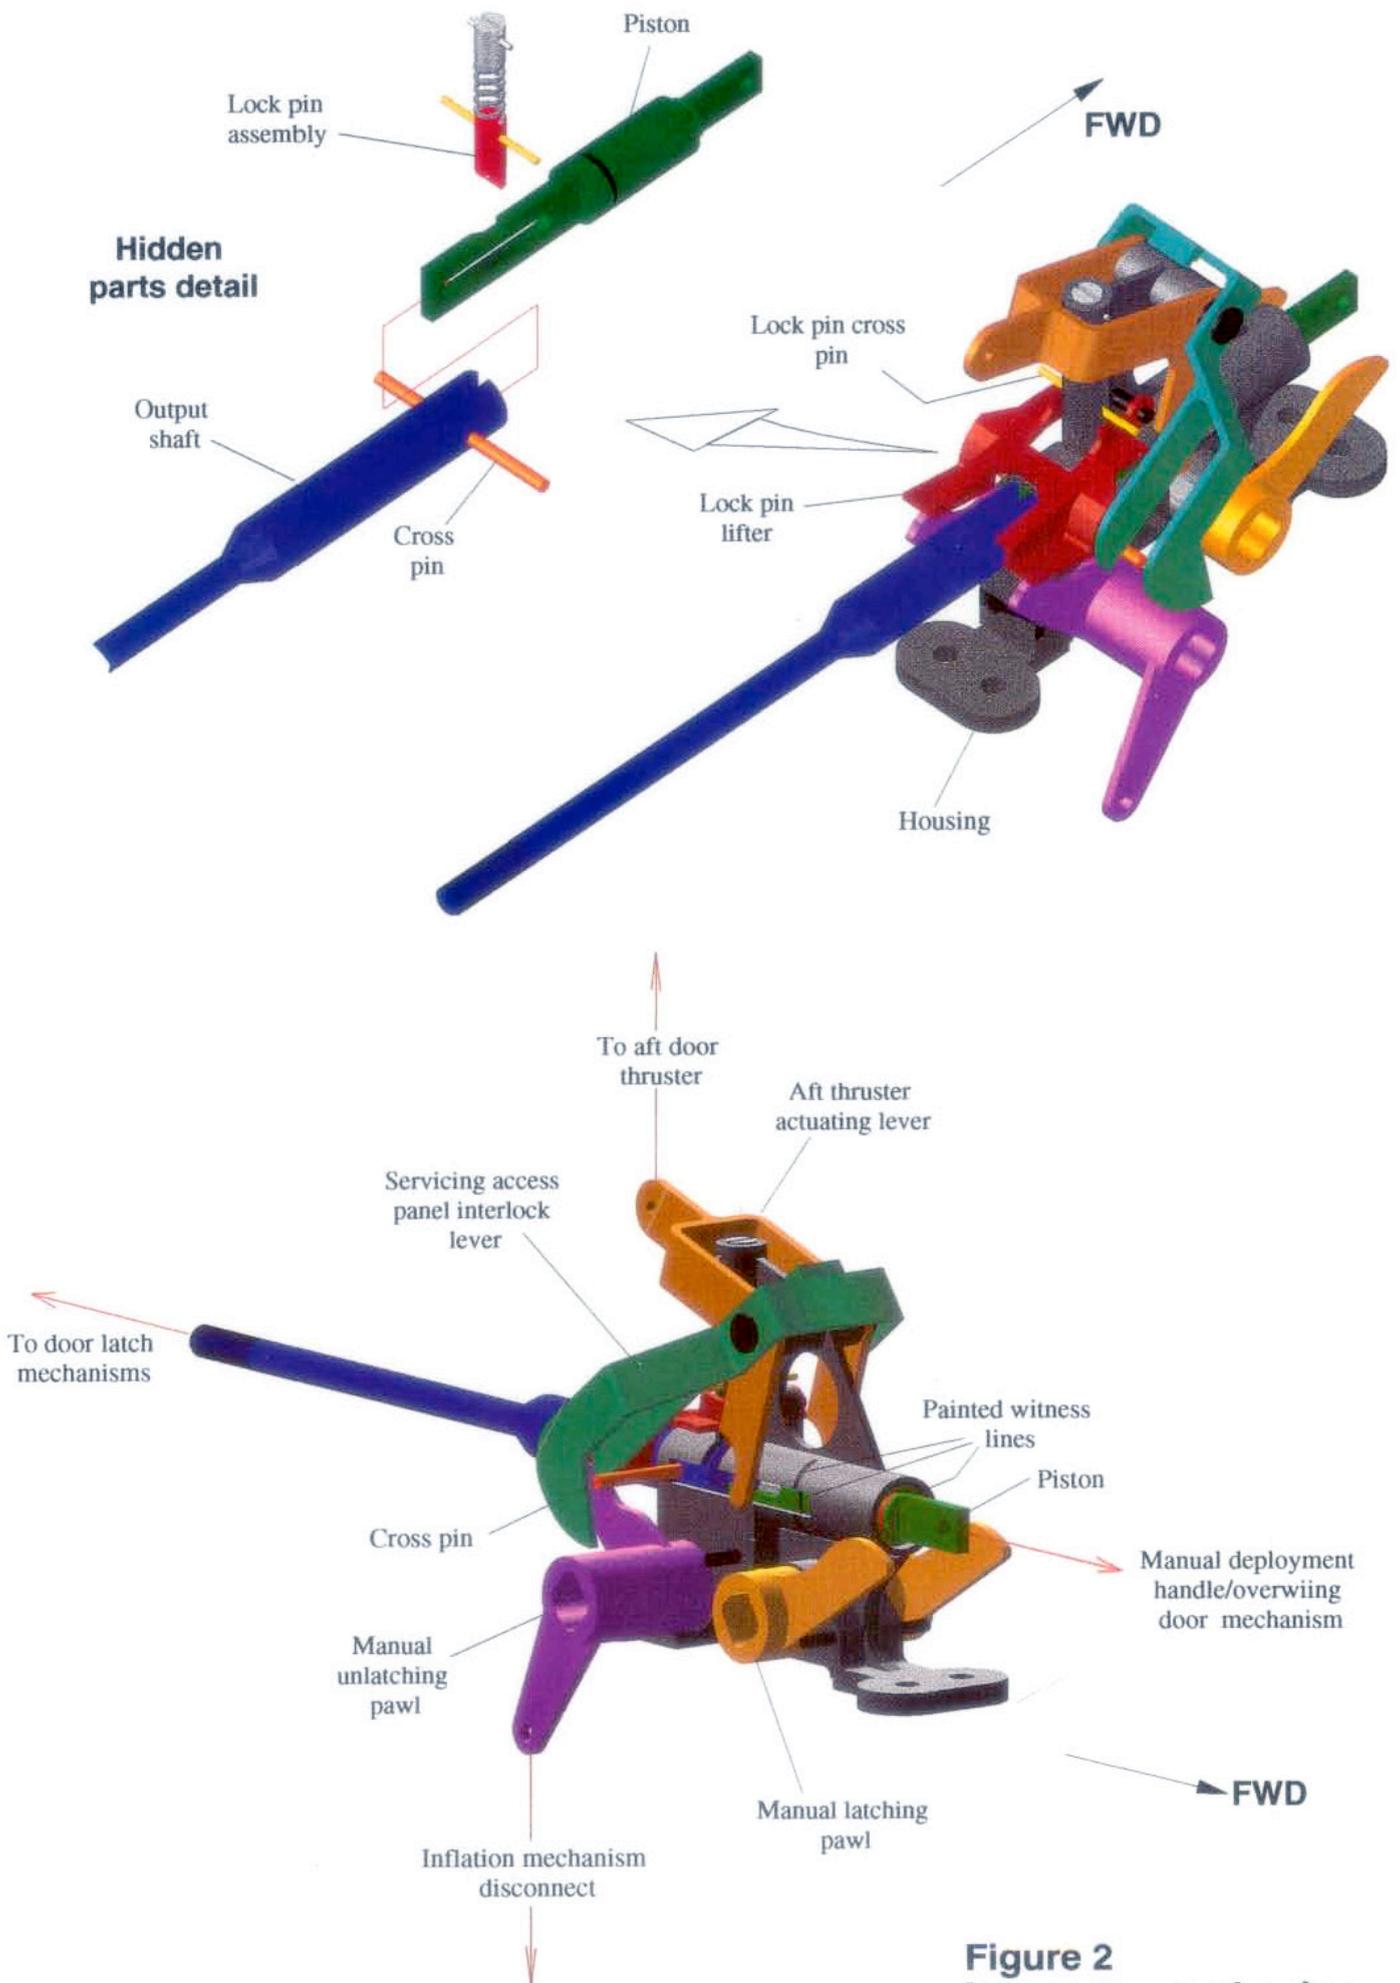
Figure 2
Integrator mechanism

A spring-loaded lock pin (coloured red in the exploded view at Figure 2) descends behind the forward end of the output shaft when the latter moves to the fully aft (latches locked) position, preventing subsequent unlatching movement of the output shaft. A small cut-out in the top edge of the piston blade (see exploded view) provides the necessary clearance for the lock pin to descend behind the shoulder of the output shaft.

Further safety issues were apparent in relation to possible mispositioning of the input piston, the correct setting of which relies heavily upon the alignment of painted reference lines on the piston body and the integrator housing (see lower diagram at Figure 2). For example, if the piston is displaced rearward by an amount equivalent to 1/4 of the black reference line's thickness, then the lockpin will sit on the shoulder of the piston blade cut-out, rather than dropping down into the cut-out as intended. The output shaft will then be free to slide forward into the unlatched position. In these circumstances, the requirement for the red part of the piston to be inside the housing would be met fully and there would be no obvious misalignment of the black reference lines, yet there would be no positive lock to prevent the door from unlatching. Similarly, if the output shaft were to be displaced forward by more than about 1 mm from its fully aft position, then the lockpin would sit on the shoulder of the output shaft, with exactly the same result. This condition could arise in practice if the output shaft failed to be driven fully rearward during manual rotation of the latch pawl. It could even occur without any explicit interference to the integrator itself, eg if the deployment cable was disturbed in such a way as to move the piston forward by about 5 mm. This would be sufficient to lift the locking pin (via the ramped cut-out in the piston blade) and pull the output shaft forward by about 1 millimetre, sufficient for the lock pin to sit on the shoulder of the output shaft. In these circumstances, even if the movement of the deployment cable system was reversed and the piston returned to its original position, the lost motion mode of operation would prevent the output shaft from being returned to a safe position, and the lock pin would continue to sit on the shoulder of the output shaft.
