In-flight electrical problems, Boeing 767-322ER, N653UA

Aircraft Accident Report 5/2000 (EW/C98/1/3)

Report on the accident to Boeing 767-322ER, N653UA at London Heathrow Airport on 9 January 1998

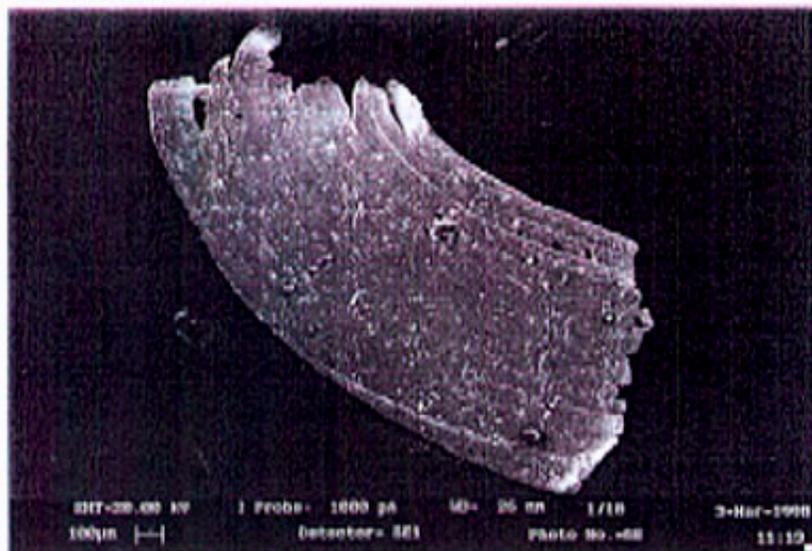
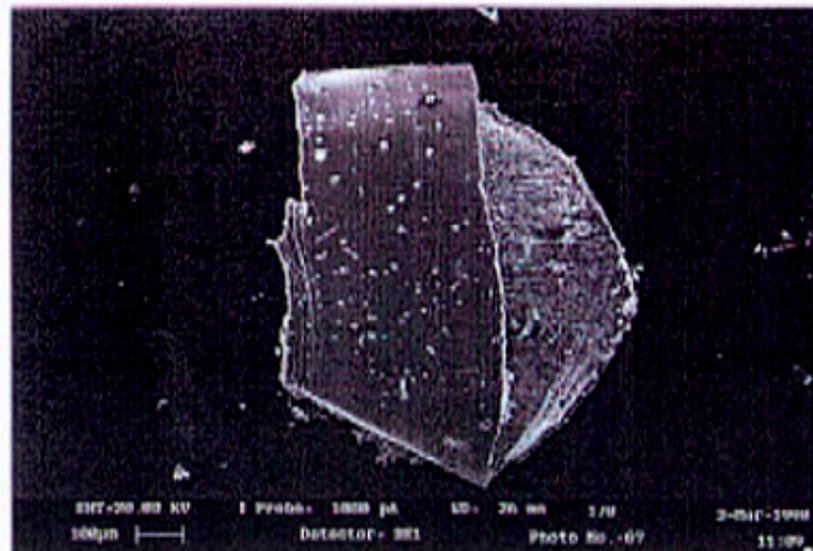
Debris from vacuum box - micrograph and EDX spectrum of aluminium swarf particle 1/10

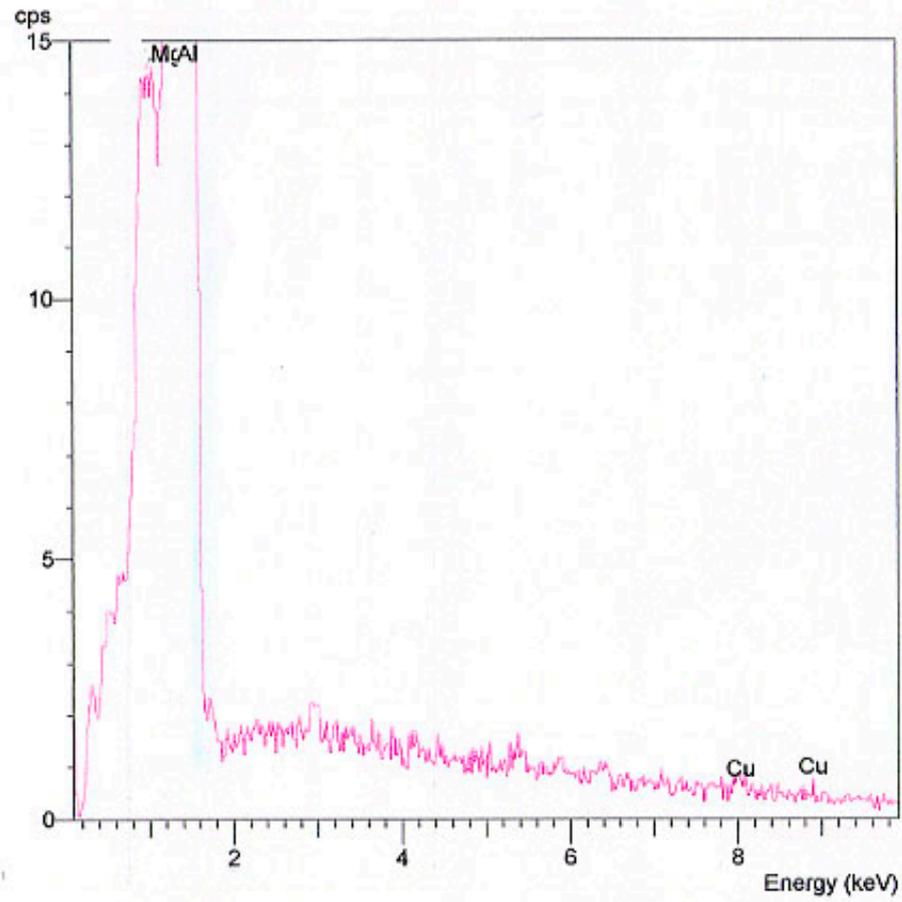
D-3

Box covering refrigeration unit
 Typical EDX spectrum of aluminium alloy
 from which box is made
