## Uncontained engine failure, Fokker F27 Mk 500 Friendship, G-CEFX

# Fokker F27 Mk 500 Friendship, G-CEXF

<b>Aircraft Accident Report No: 4/2004 (EW/C2001/6/5)</b> .....	<b>3</b>
<b>Synopsis</b> .....	<b>4</b>
<b>1. Factual Information</b> .....	<b>6</b>
1.1 History of the flight.....	6

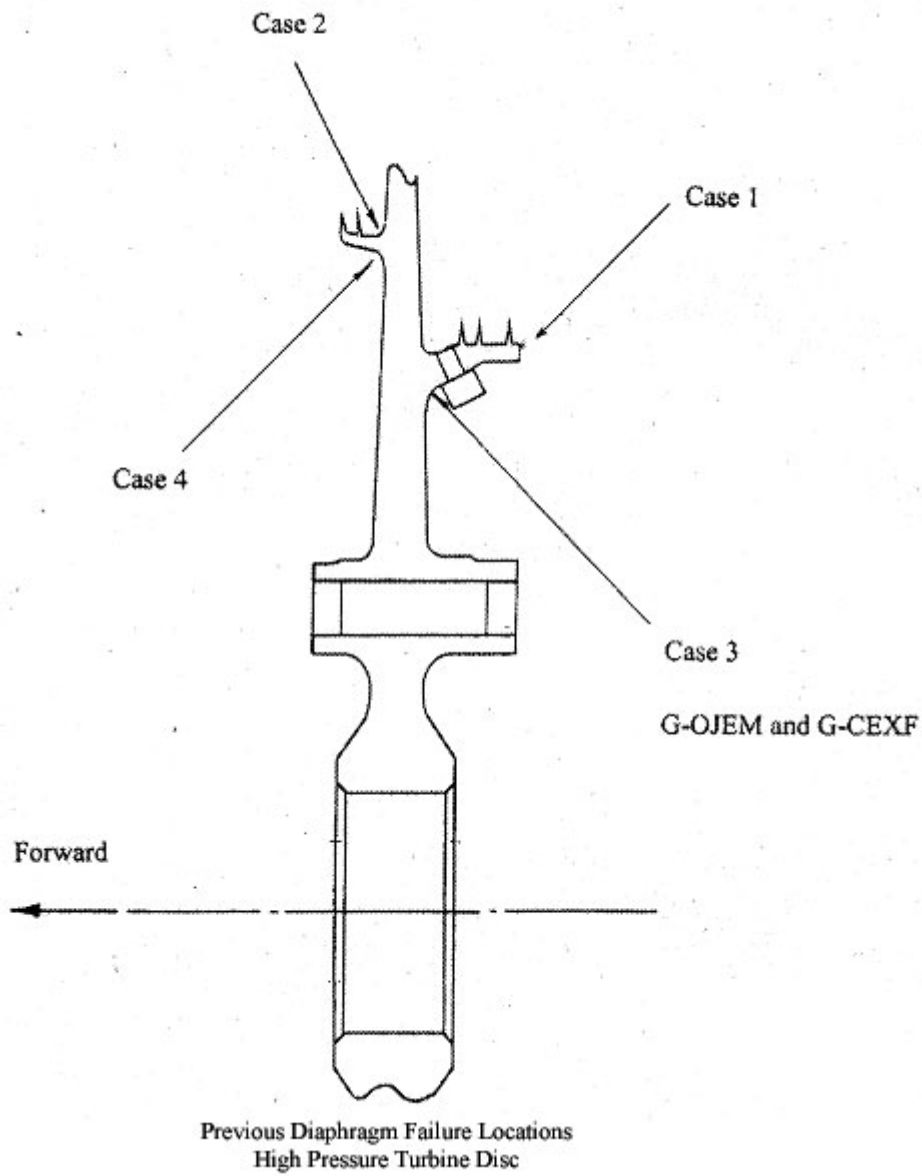
Figure 9 Previous diaphragm failure locations - high pressure turbine

#### *1.18.4.5 Diaphragm Failure Case Summary, Figure 9*

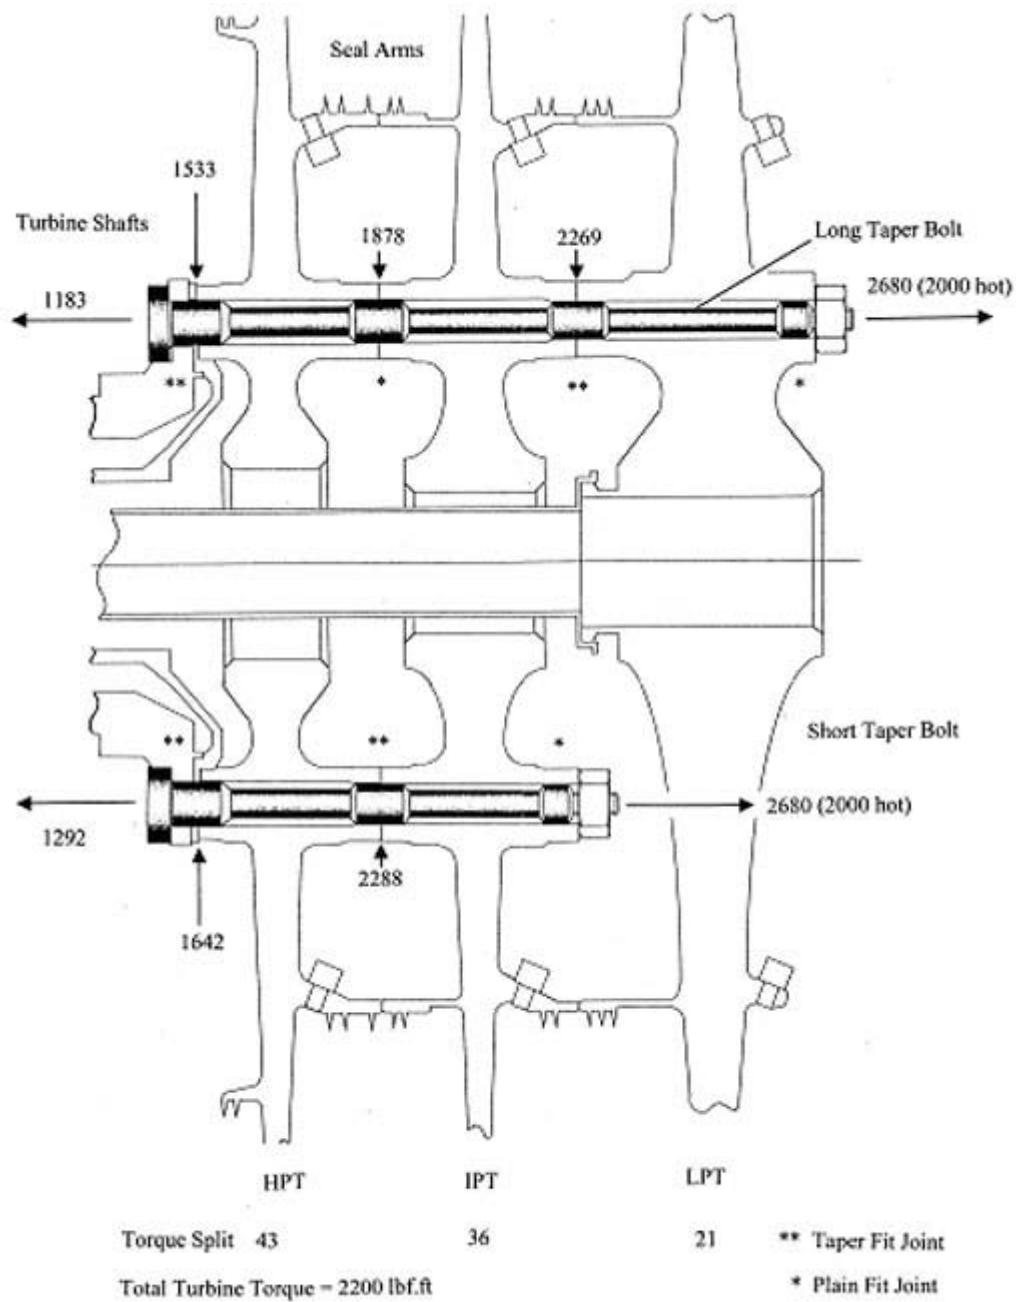
Figure 12 Relative damage locations HPT / IPT seal arm abutment faces / Fatigue Cracking

Visual examination of the condition of the HPT/IPT seal arm abutment faces not directly affected by accident damage revealed areas of light/heavy fretting damage at specific locations around the circumference. The locations of this damage on both discs are shown relative to the boss locations, the fatigue cracks and their origins in Figure 12. An assessment of any damage in the sector of the fatigue cracks could not be made on the HPT disc as the missing segment was not recovered.
