## Collision between Boeing 767-204, G-SATR and Boeing 737-37Q, G-ODSK, while taxiing.

**Event Date:** 2004-11-04 at 1620 UTC

**Investigative Body:** Aircraft Accident Investigation Board (AAIB), United Kingdom

**ACCIDENT**

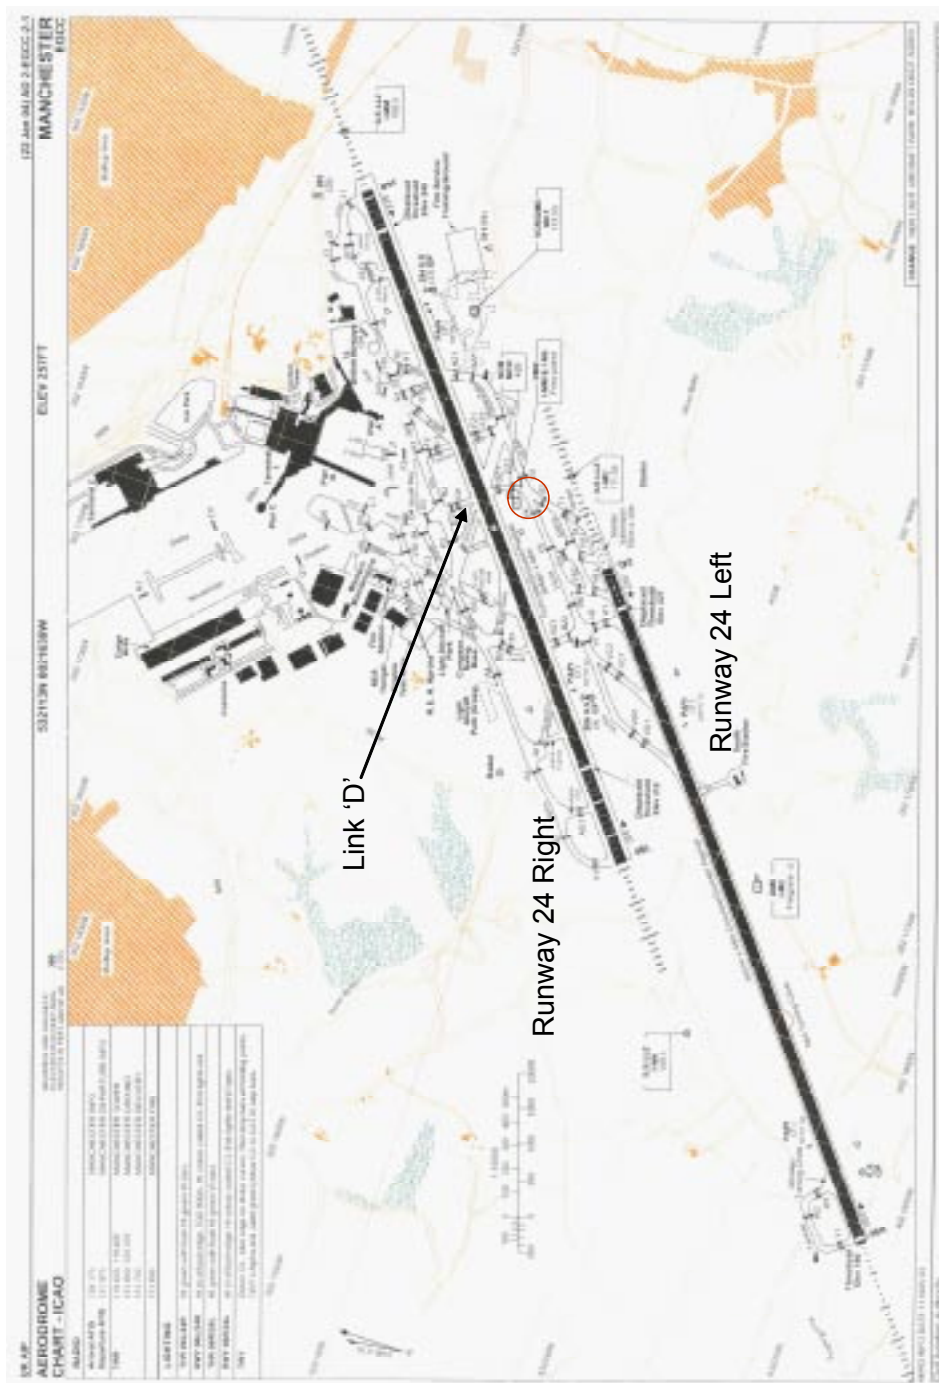
**Figure 1**  
Manchester Airport - General layout

Air 1 controller, who issued a clearance to cross Runway 24 Right and to taxi to holding point ‘V5’. The general layout of Manchester Airport is shown at Figure 1 and the accident area in detail is shown at Figure 2.
