Serious Incident to MD-11 N803DE at Dublin Airport, 3 February 2002

FINAL REPORT

**MD 11
N803DE**

AAIU Report No: 2003/004
AAIU File No: 2002/005
Published: 11 April 2003

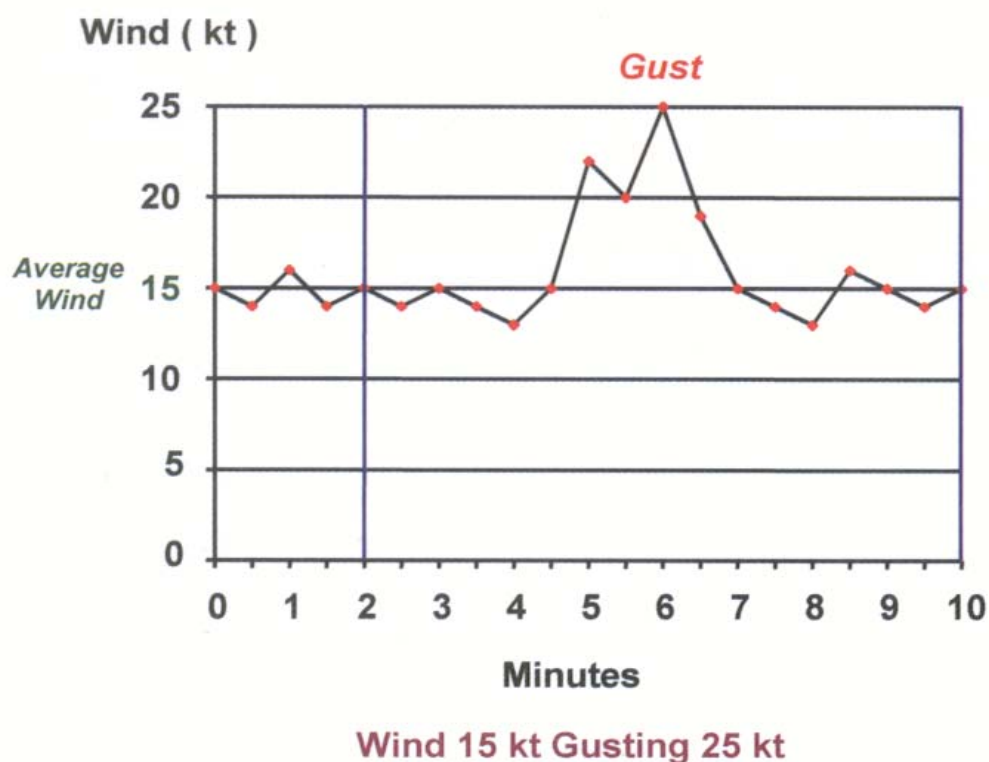
Figure 1 below shows a 10-minute wind profile featuring:

- A 2-minute average wind of 15 KT; and,
- A 10-minute gust of 10 KT (i.e., a 25 KT peak wind velocity during the 10-minute period).

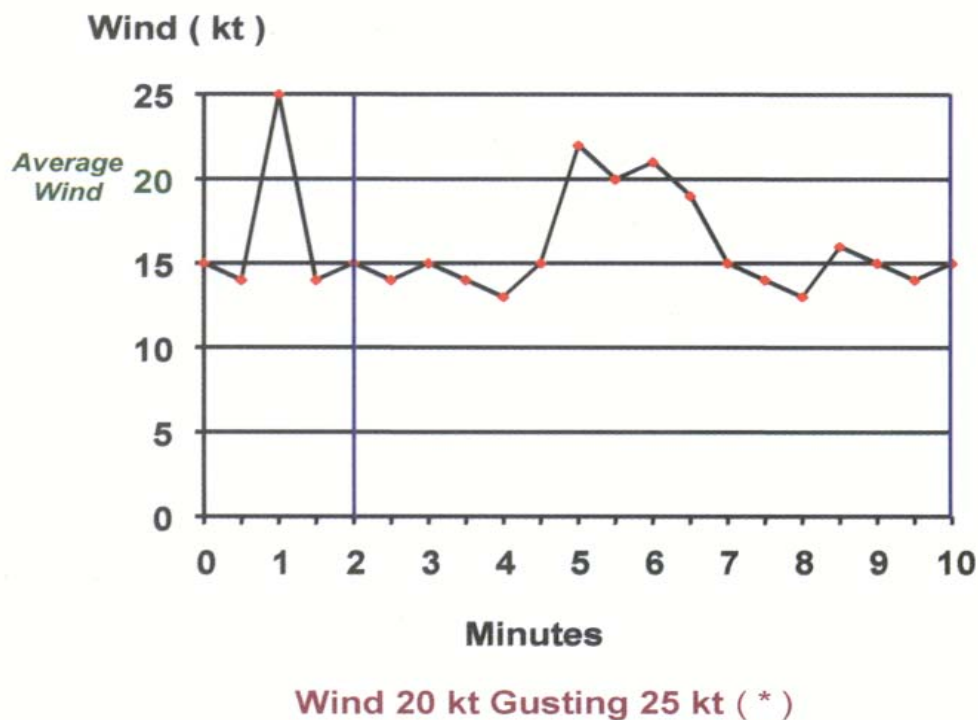
Figure 2

If the wind peak value is observed during the last 2-minute period, the gust becomes part of the average wind, as illustrated by Figure 2.

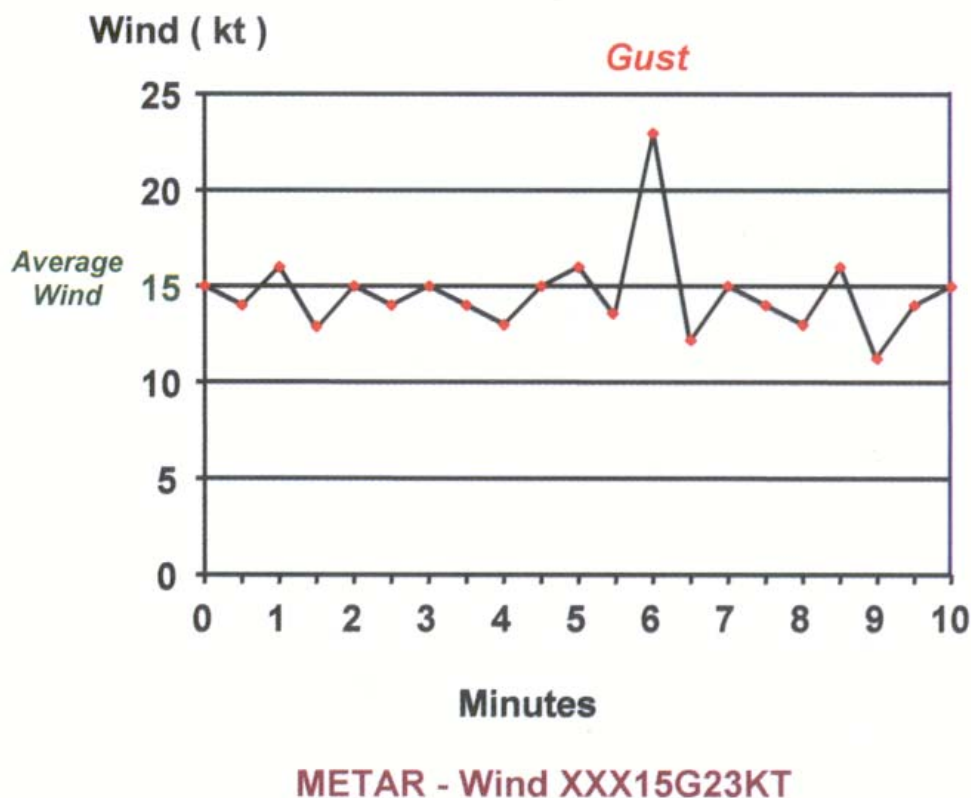
METAR observation messages include a 10-minute average-wind and the 10-minute gust, as illustrated by Figure 3 (XXX is the wind direction, referenced to the true north).
