Runway overrun, Incident involving aircraft G-FLTA at Arvidsjaur airport, BD County, Sweden, on the 22nd of February 2002

Micro-summary: Following touchdown in poor weather, this BAe 146 ran off the end of the runway.

Report RL 2003:08e

***Incident involving aircraft G-FLTA at
Arvidsjaur airport, BD County, Sweden,
on the 22nd of February 2002***

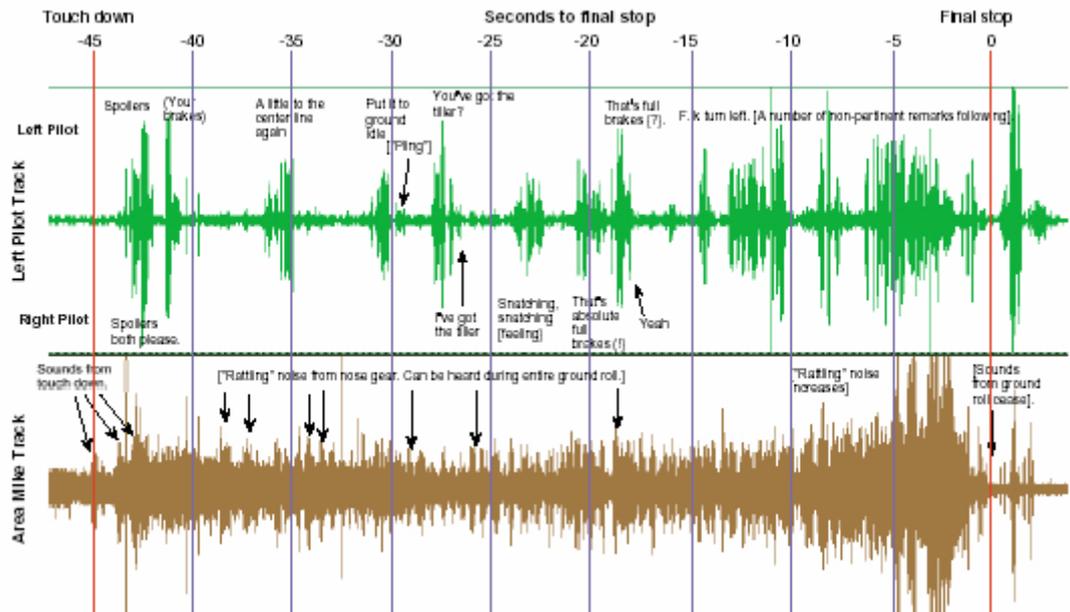
After the incident the aircraft cockpit voice recorder was sent to the AAIB in England for transcription. Sounds and conversations in the cockpit during the entire approach have been recorded with good quality from 12:47 hours. A transcript of the recorded sound has been compiled (Appendix 1.). From the touchdown and rollout on the runway, an illustration has been produced based on a time-amplitude diagram of the CVR sound with the pilots’ communications inserted - see below.

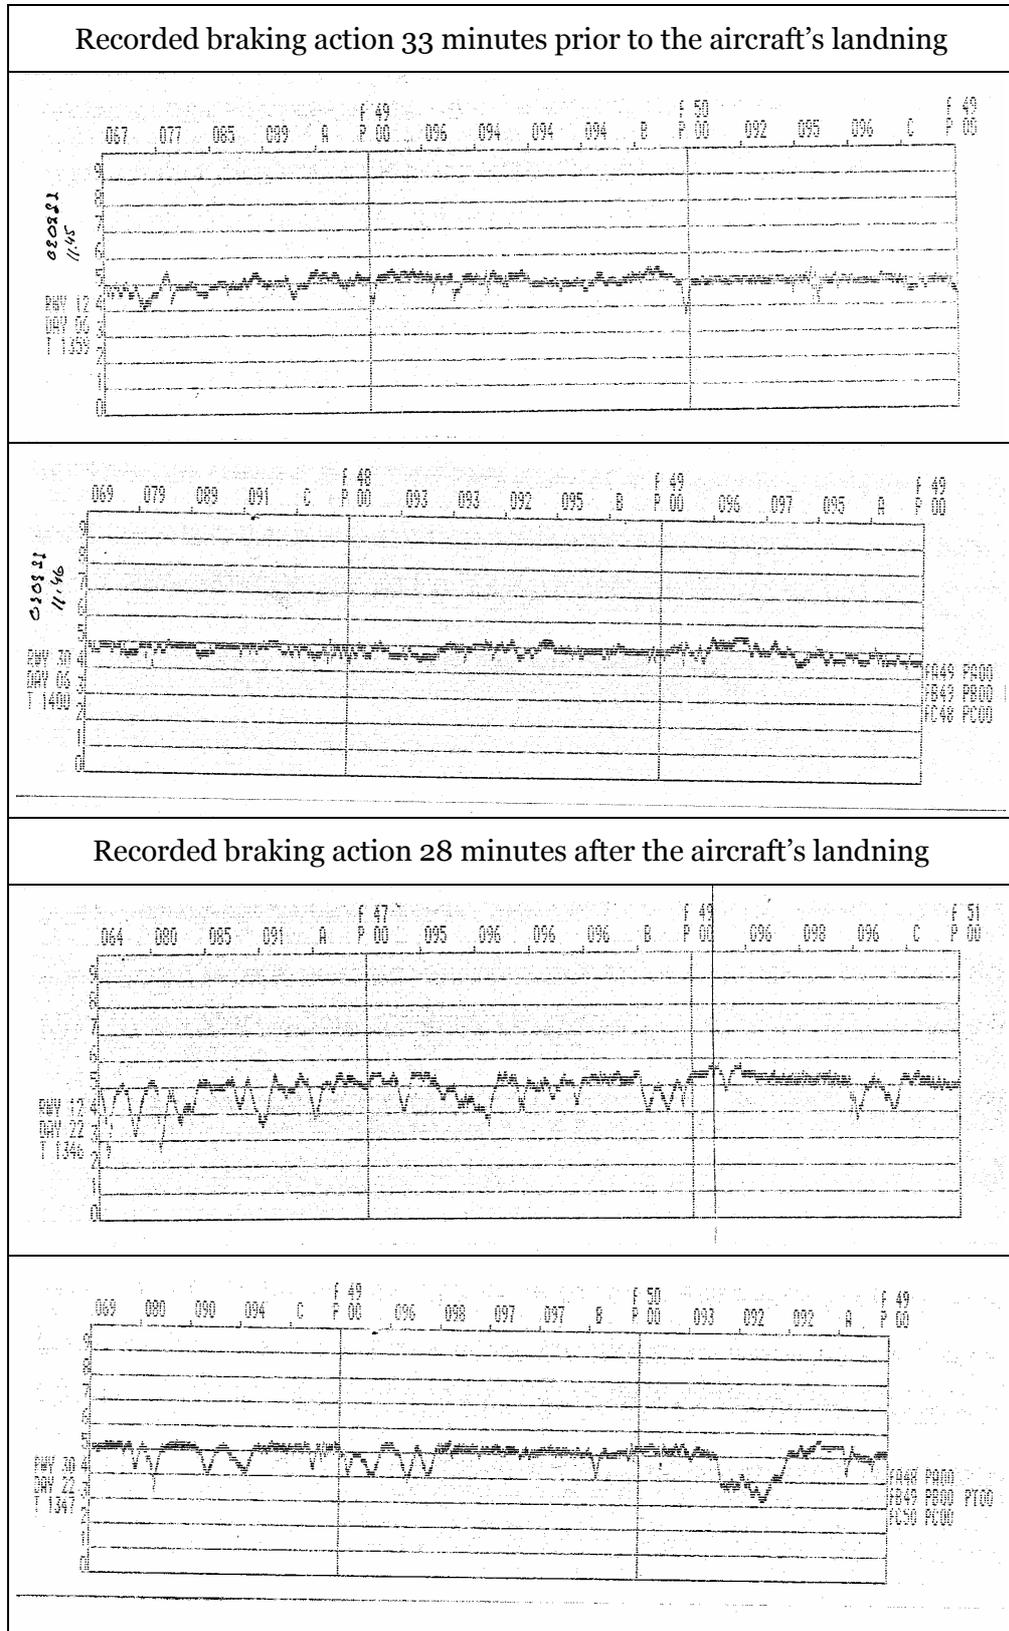
Appendix 2

Compilation of recording protocol from performed measurements of the braking action.

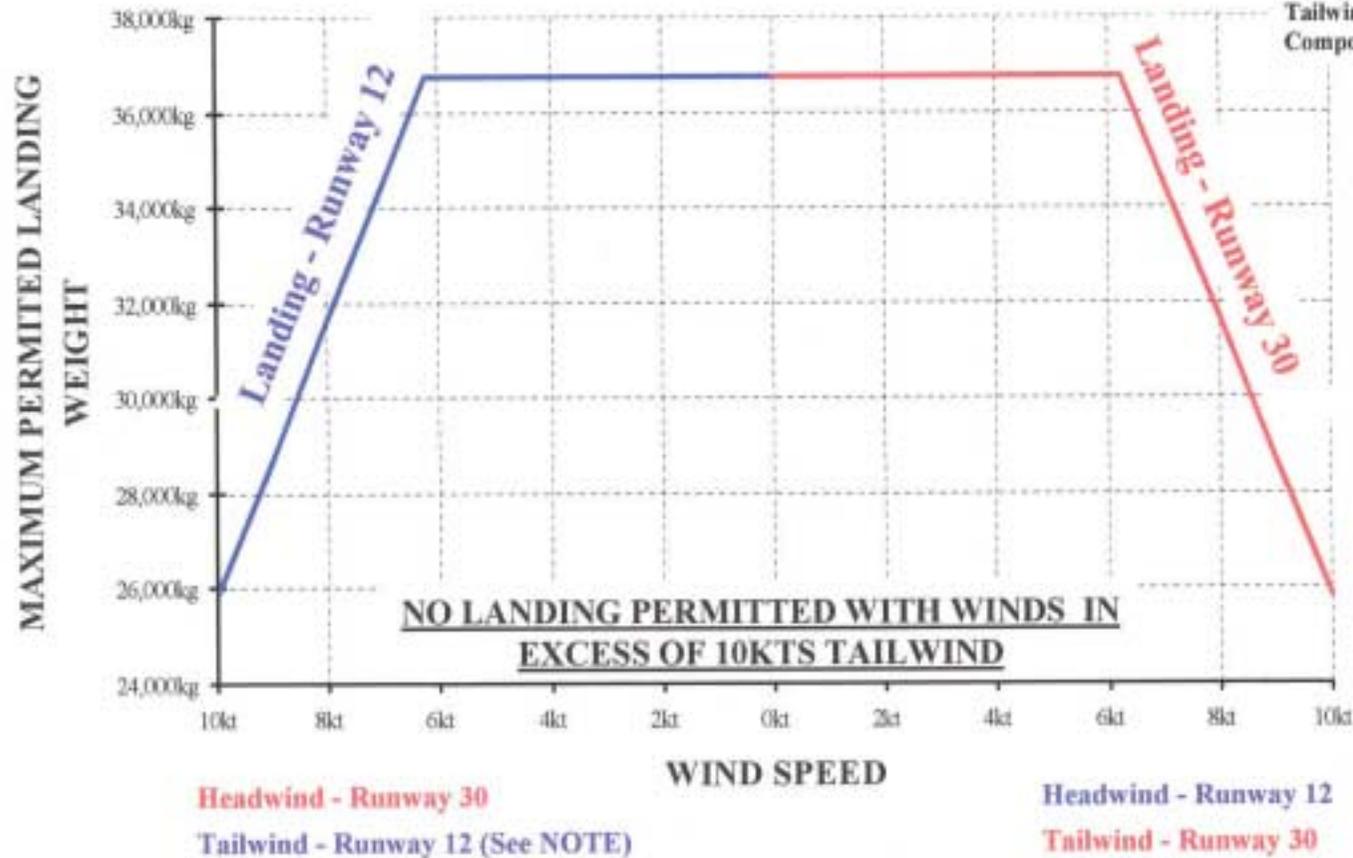
CONTAMINATED - COMPACTED SNOW

NOTE
BAE SYSTEMS
does not advise
landing on Downhill
runways with ANY
Tailwind
Component

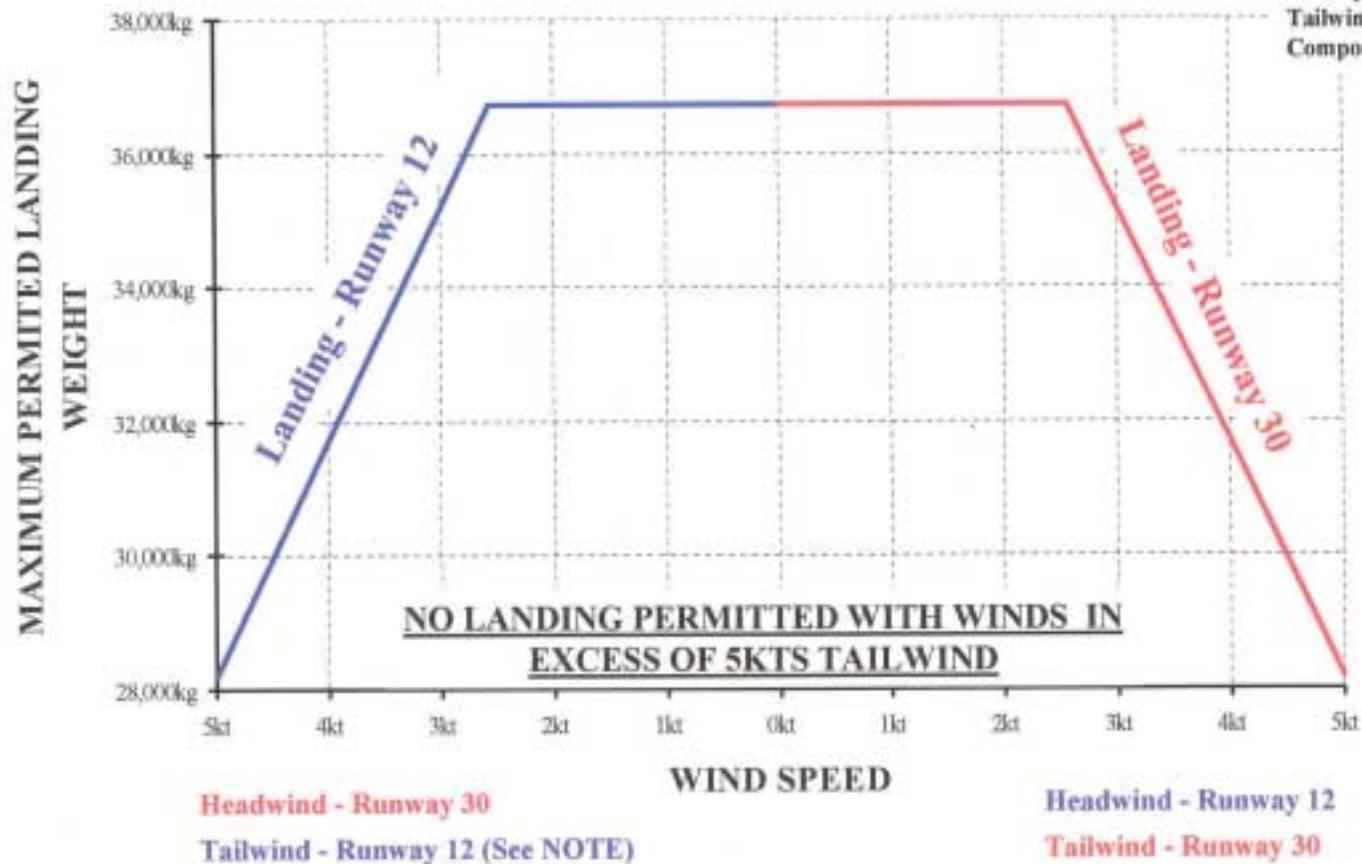
BAe146-200 Regulated Landing Weights on Contaminated Runways to JAR-OPS Requirements

CONTAMINATED - DRY or WET SNOW

NOTE
BAE SYSTEMS
does not advise
landing on Downhill
runways with ANY
Tailwind
Component
