In-flight structural breakup, Boeing 747-200 B18255, May 25, 2002 in the Taiwan Straits approximately 23 nm northwest of Makung

CI611 Accident Investigation

Factual Data Report

ASC-AFR-03-06-001

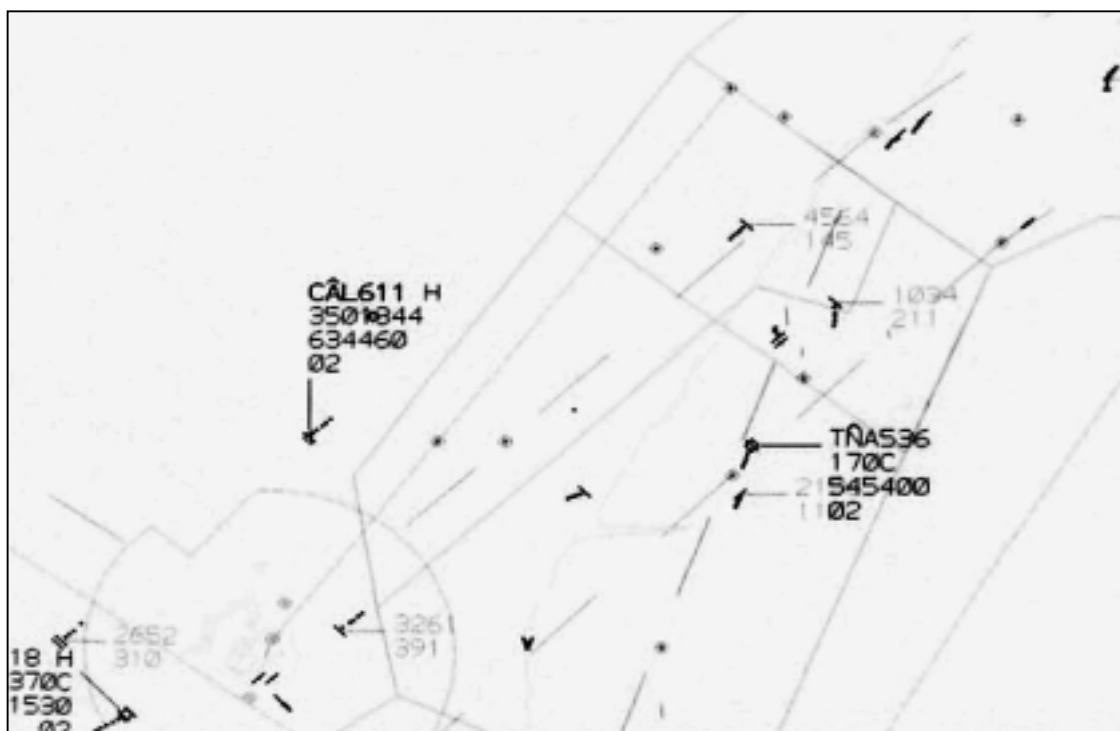
Figure 1.8-1 Secondary signal returns from the MaKung radar at 07:26:51UTC, Mode-C altitude is 34,400 ft.

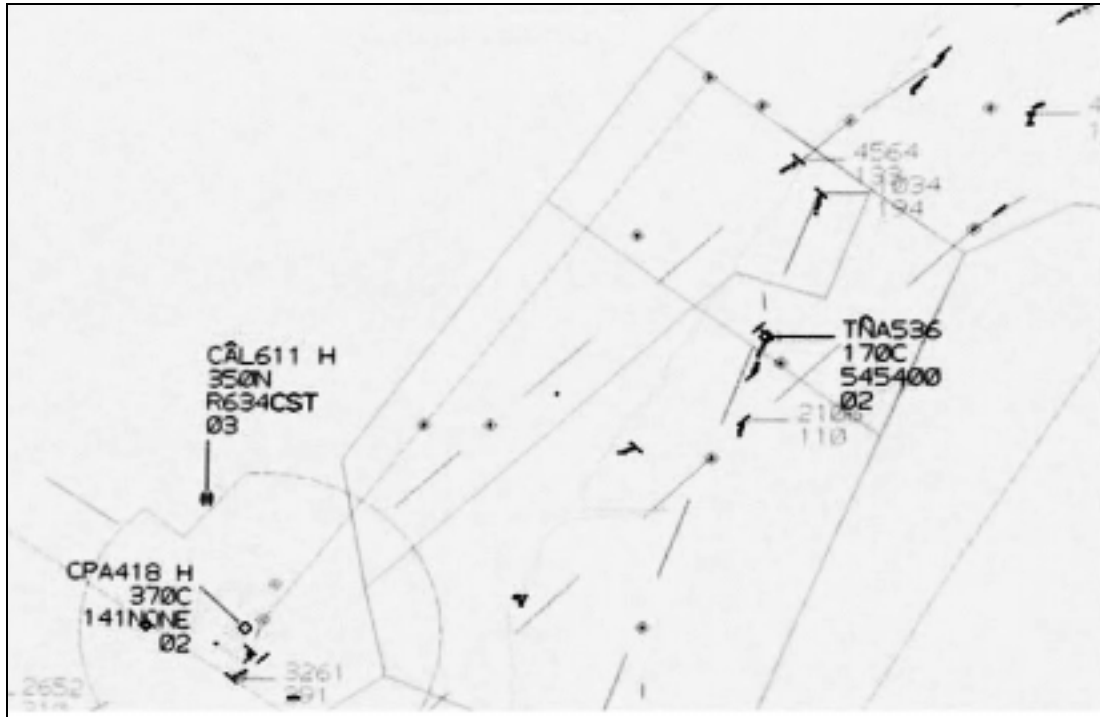
According to TACC radar record, the last SSR return of CI611 received from Makung radar was at 07:28:03UTC, the altitude was 34,900 ft. After the CI611 SSR return disappeared, a "CST" status appeared on radar screen at time 07:29:15 (Figure 1.8-2) Since then, the PSR returns were continuously recorded by Makung radar, its raw data was exported from the Micro-ARTS system. Figure 1.8-3 shows the primary returns of Makung radar between 07:28:03UTC to 07:29:40UTC.

Figure 1.8-2 SSR returns from the Makung radar at 07:29:15UTC, Both SSR return and Mode-C altitude disappeared.

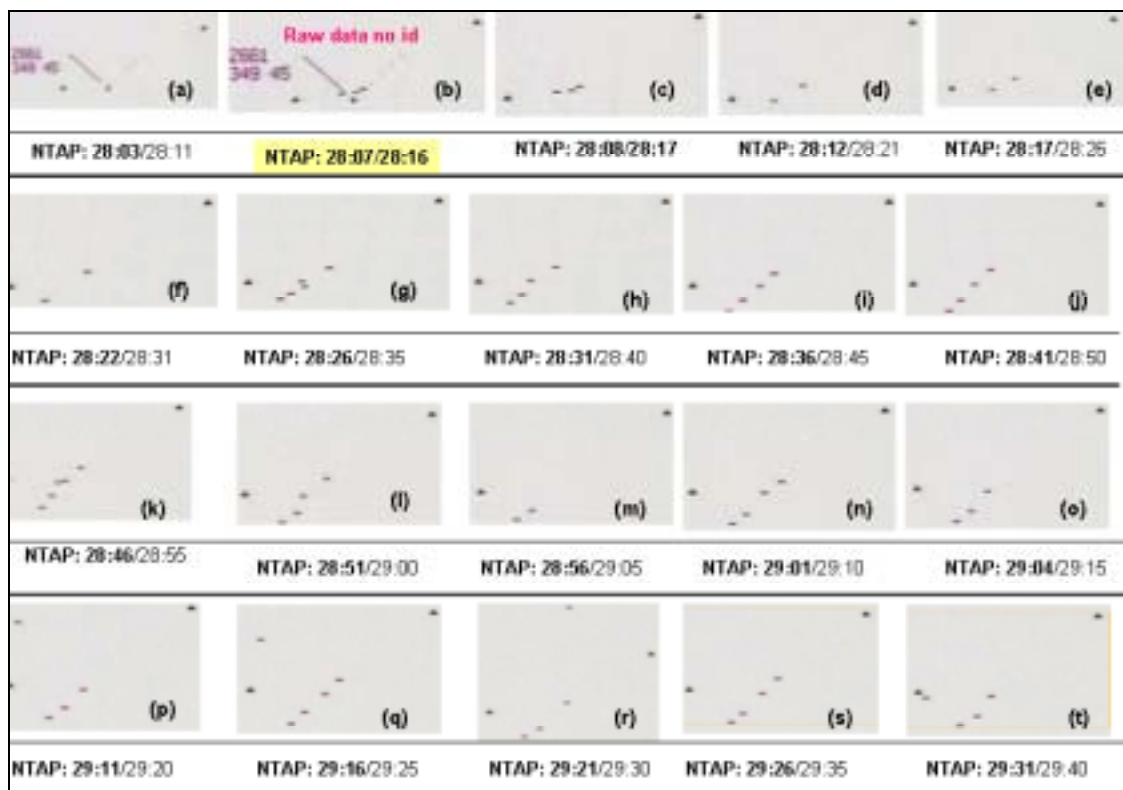
Figure 1.8-3 PSR returns from the Makung radar between 07:28:03 to 07:29:40

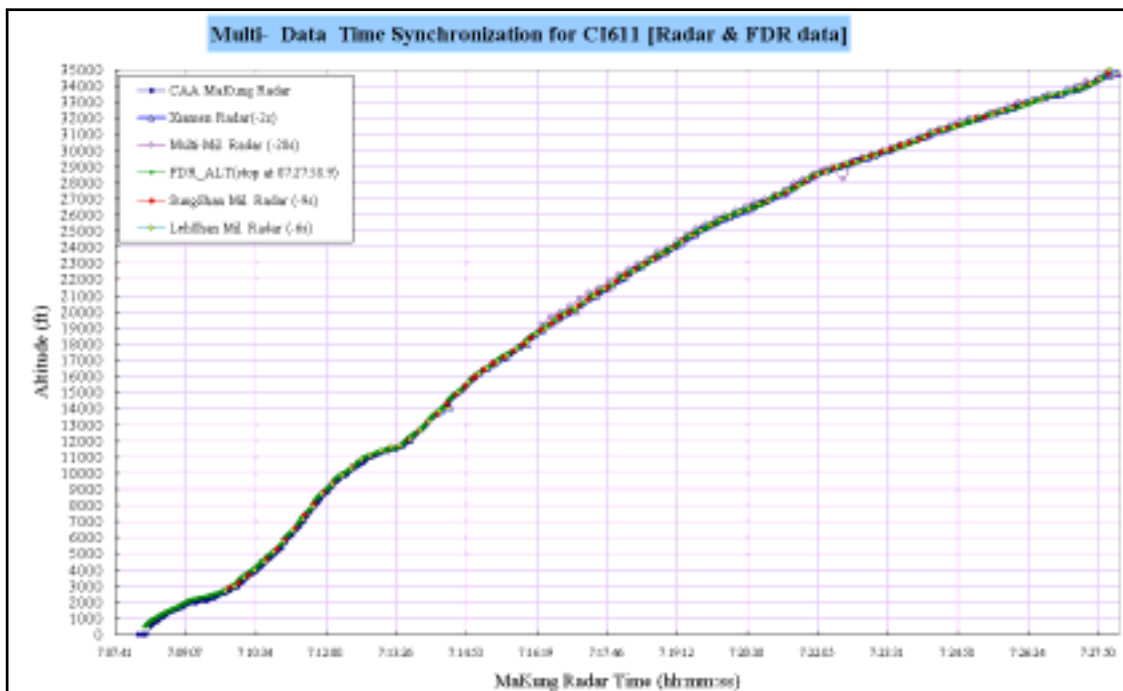
Figure 1.8-4 CI611 Mode-C altitude returns, and the FDR recorded altitude with UTC time (from initial climb to the last SSR return)

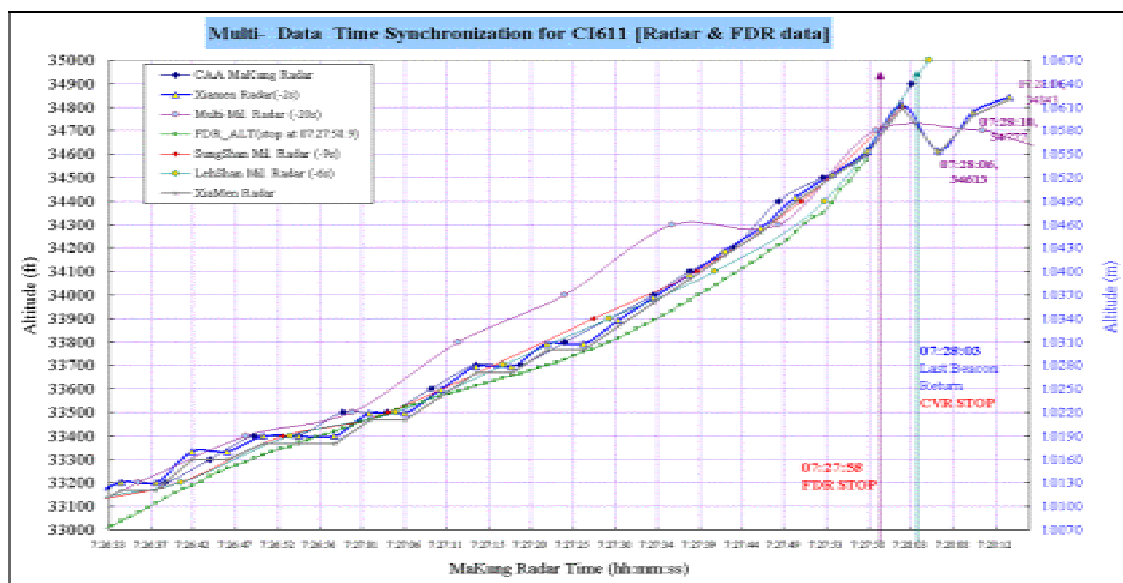
Figure 1.8-5 CI611 Mode-C altitude returns, and the FDR recorded altitude with UTC time (from FL330 to the last SSR returns)

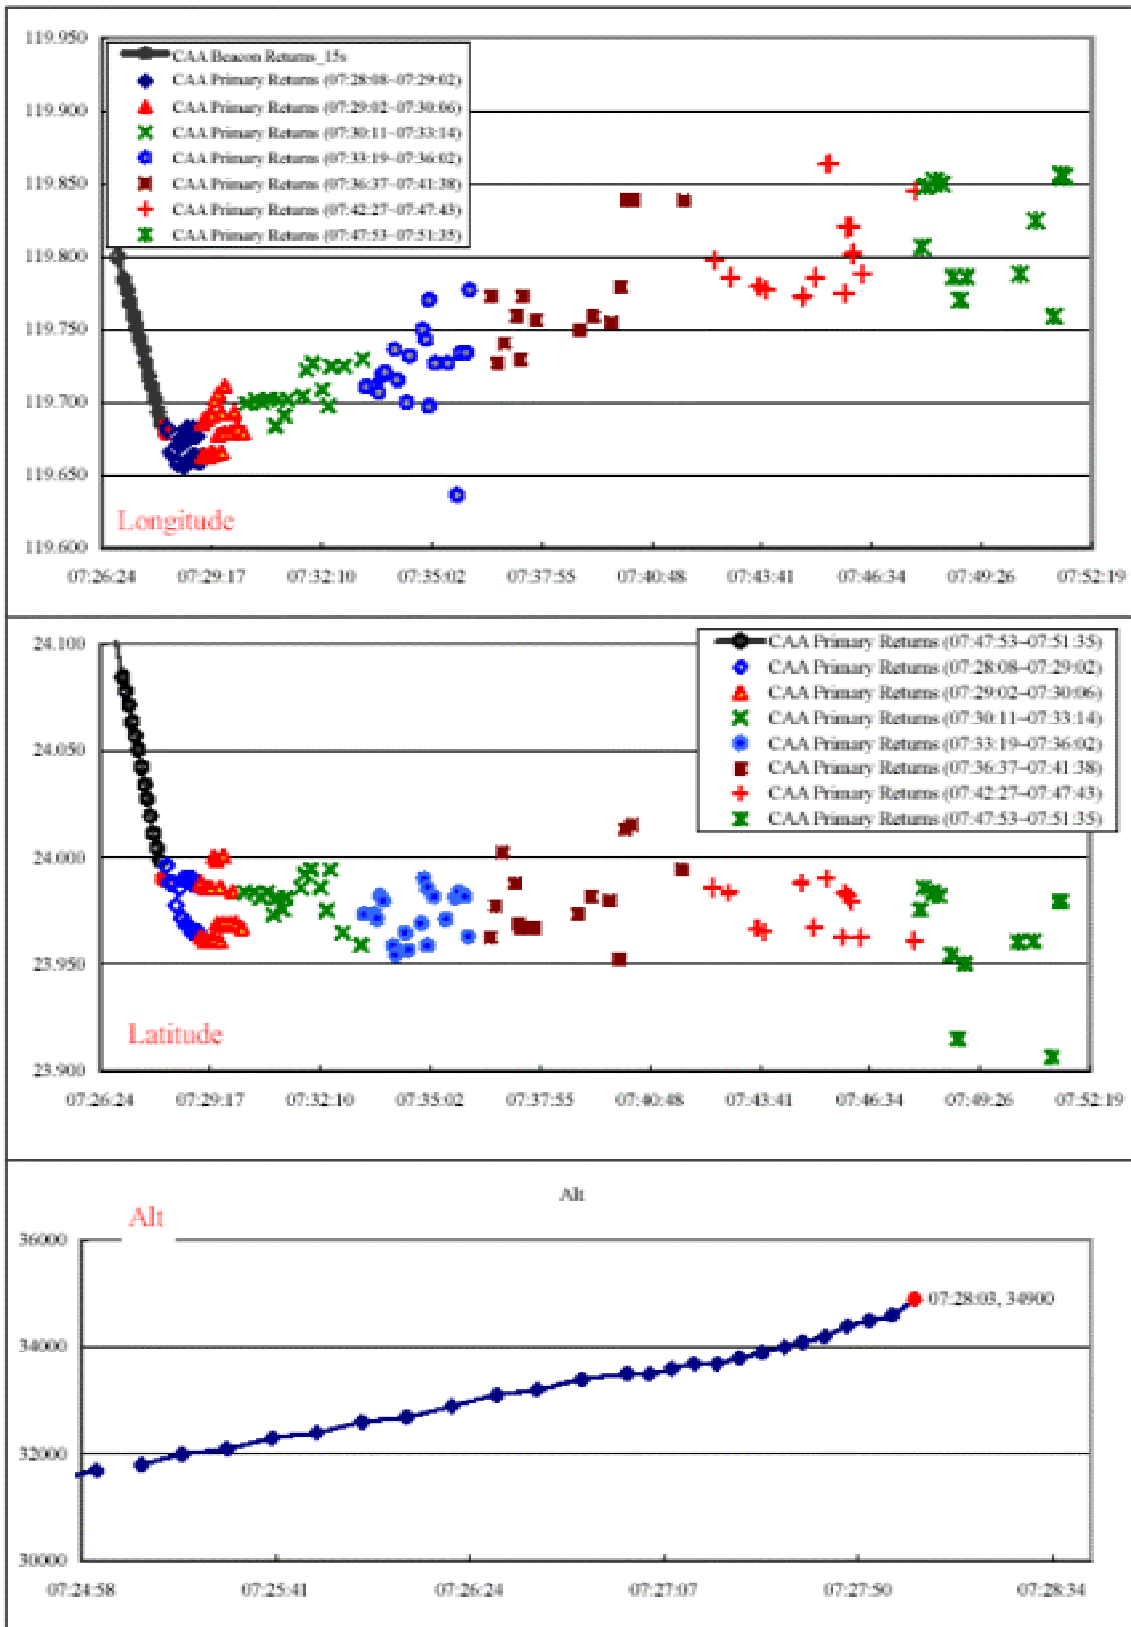
After synchronization, the last SSR return received by TACC SSR radar systems was at time 07:28:03 UTC, the last SSR return received by Xiamen SSR radar was at time 07:28:14 UTC. There were three additional Mode-C altitude readouts received by the Xiamen radar. According to the Makung PSR returns, first record was detected at time 07:28:08 UTC, and continued until to 07:51:35UTC. During this twenty-three-minute period, the PSR returns were separated into four groups. Figure 1.18-10 shows the last six SSR data and three minutes of PSR data. The "CST" signal was generated at time 07:29:15 UTC.

Figure 1.8-6 Latitude and longitude of the PSR and SSR returns from the CI611 (top). Mode-C altitude returns of the CI611 (bottom)

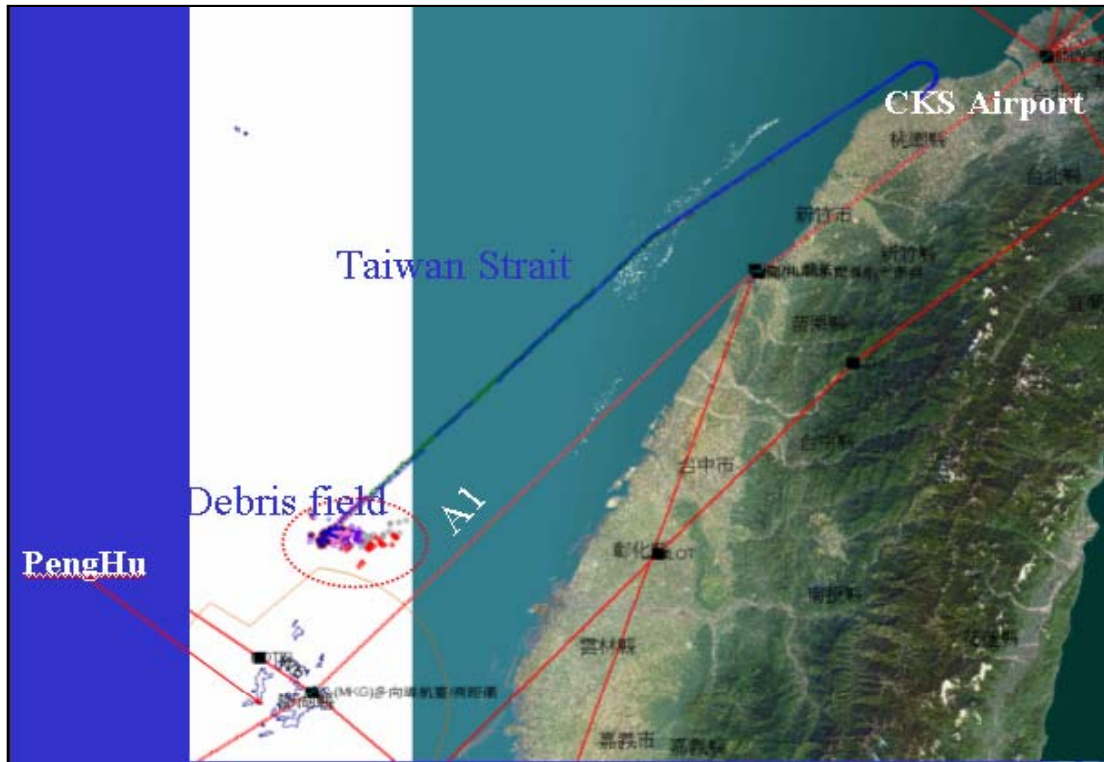
Figure 1.8-7 CI611 radar track and debris spread (radar track: blue line; debris spread: red circle)

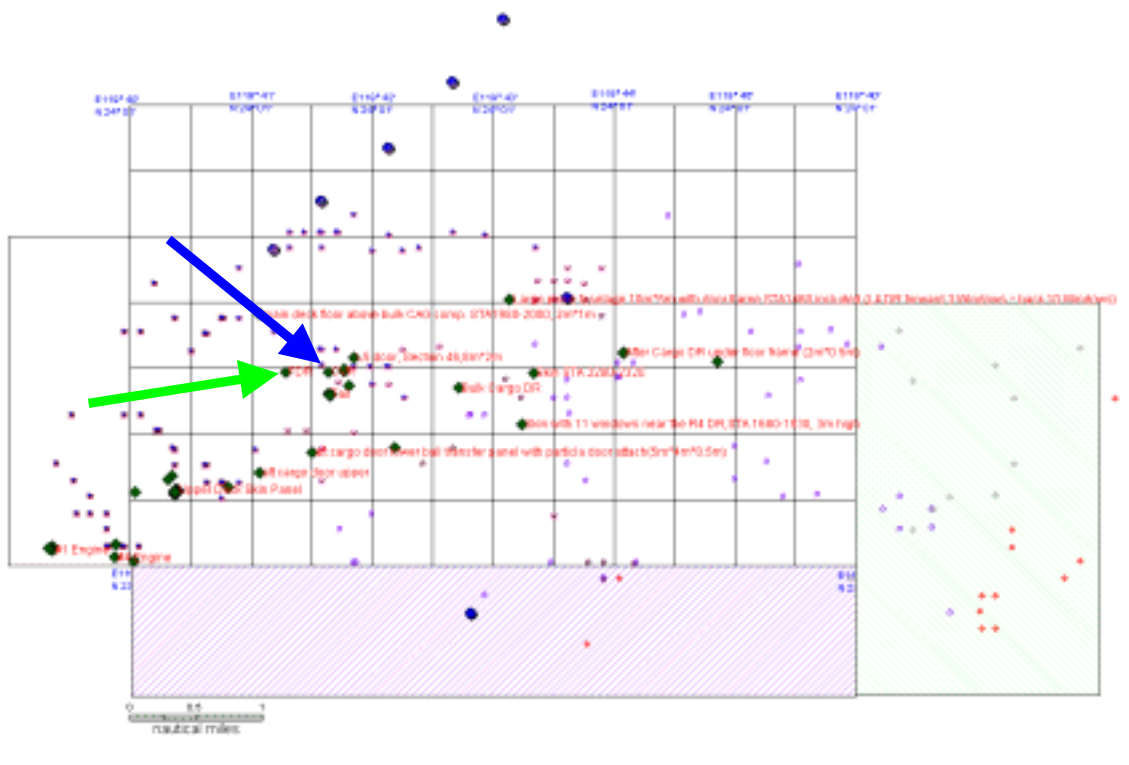
Distance between two recorders was about 610 meters. Relative positions of the two recorders, as well as the wreckage distribution are shown in Figure 1.18-13.

Figure 1.18-13 Relative position of the two recorders (FDR pointed by green arrow, CVR pointed by blue arrow) , as well as the wreckage distribution

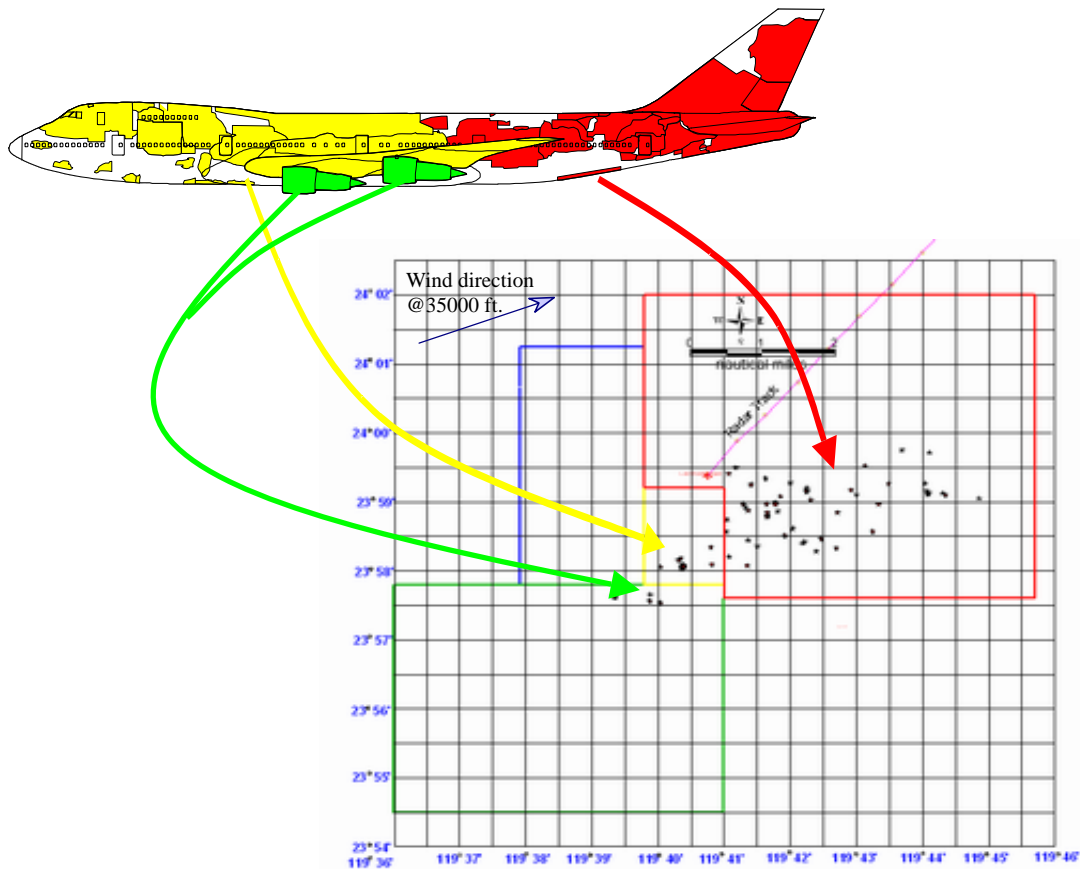
Figure 1.18-14 Divers within areas that were divided into four distinct zones retrieved the majority of the wreckage. These were color-coded red, yellow, green, and blue

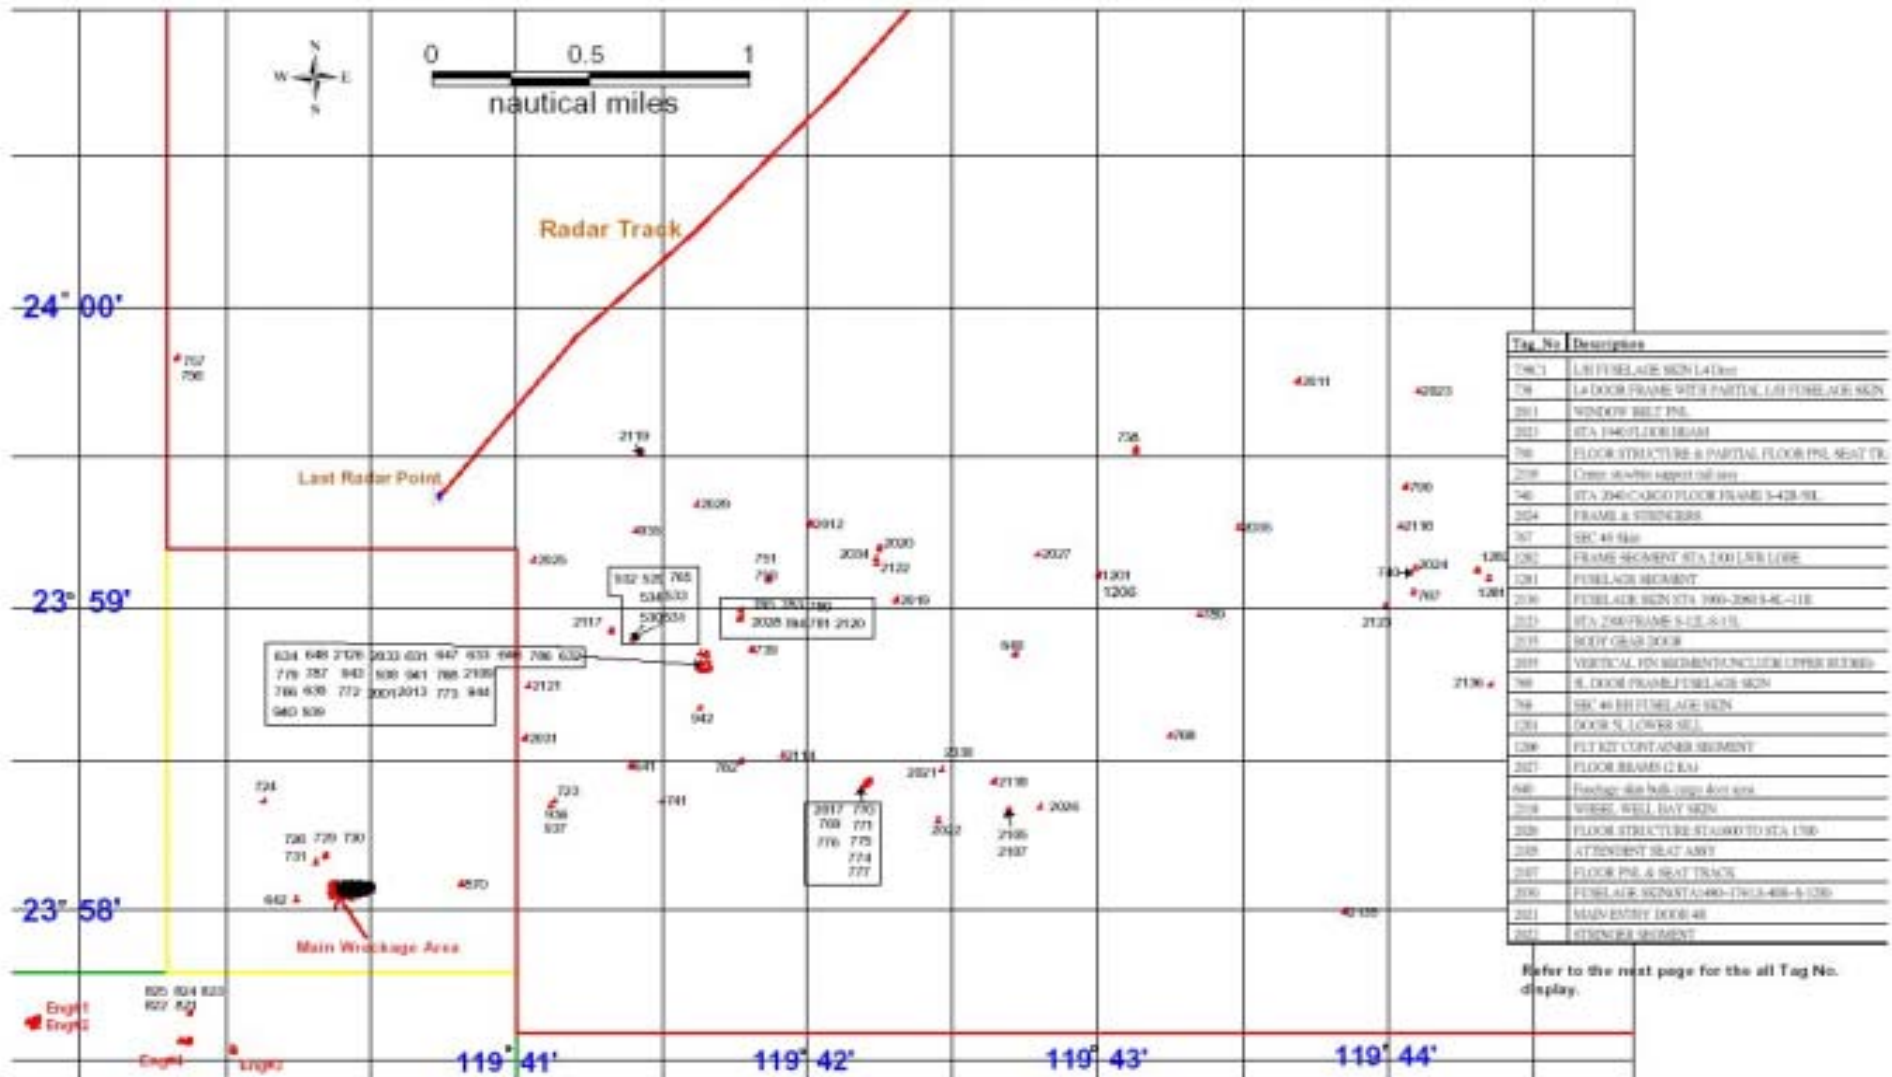
still 50 bodies and a major portion of the Section 46 remained uncovered.

Figure 1.18-22 The wreckage map

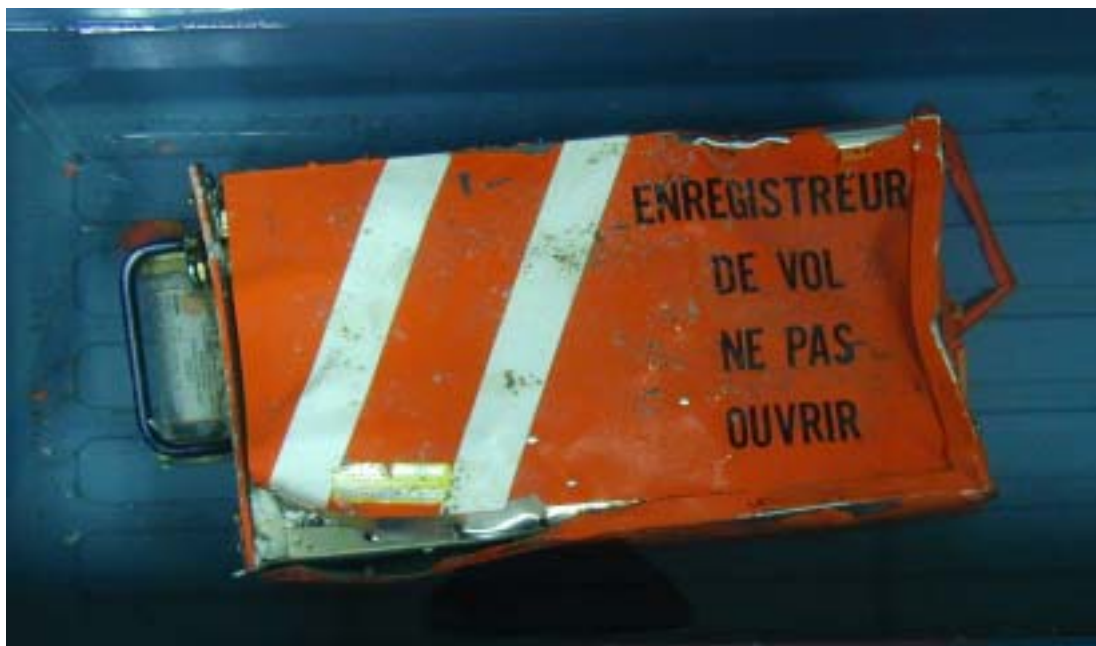
The CVR unit arrived at the ASC lab in a water cooler submerged in fresh water (Figure 1.11-1). The exterior of the CVR was seriously dented and distorted. The front panel including the handle and underwater locator beacon was still attached. The protective dust cover had to be cut in several places before it could be removed. The interior crash enclosure appeared to be in good condition. There were only a few minor scratches and dents noted. The interior tape reel assembly was wet. The recording media was wet but otherwise appeared to be in good condition. The tape was not broken but had minor damages. There were no signs of any fire or heat damage noted to either the exterior or the interior of the unit. The Dukane underwater locator beacon that was installed on the CVR was seriously contaminated but operated normally during underwater recovery process.

Figure 1.11-1 Damaged CVR in the cooler

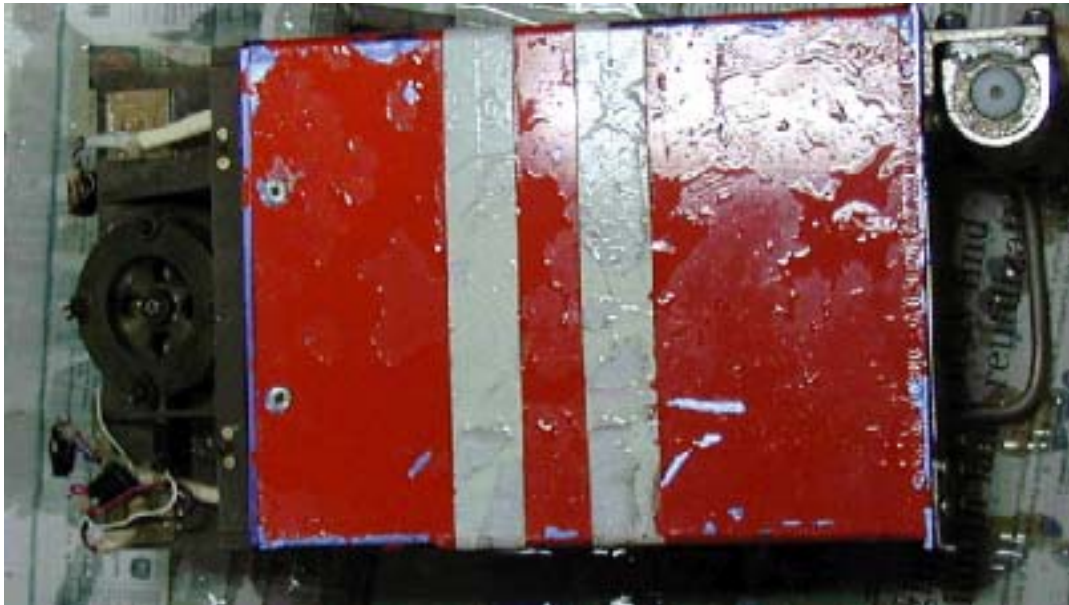
Once arrived at the ASC Investigation Lab, the FDR was removed from the cooler and were examined for damage. The FDR broken into two major pieces, only the memory module with driven motor and underwater locator beacon (ULB) were still attached. The FDR's outer sleeve and internal electronics were damaged. The FDR's faceplate was partially torn from the casing; only the ULB held the faceplate to the FDR. The faceplate which indicates the part number and serial number was lost. After removal of the armored closure, the casing of tape reel was found intact. However some of the tape was out of the reel and stuck on the top of the reel. Six minor damages were found along 2.5 meters of the tape, which did not include the data of the accident flight (only for the previous flight, CI645). Pictures of the damaged FDR were shown in Figure 1.11-2 to 1.11-4. There are six crinkle marks located on the oldest part of the tape.

Figure 1.11-2 Damaged FDR in the cooler

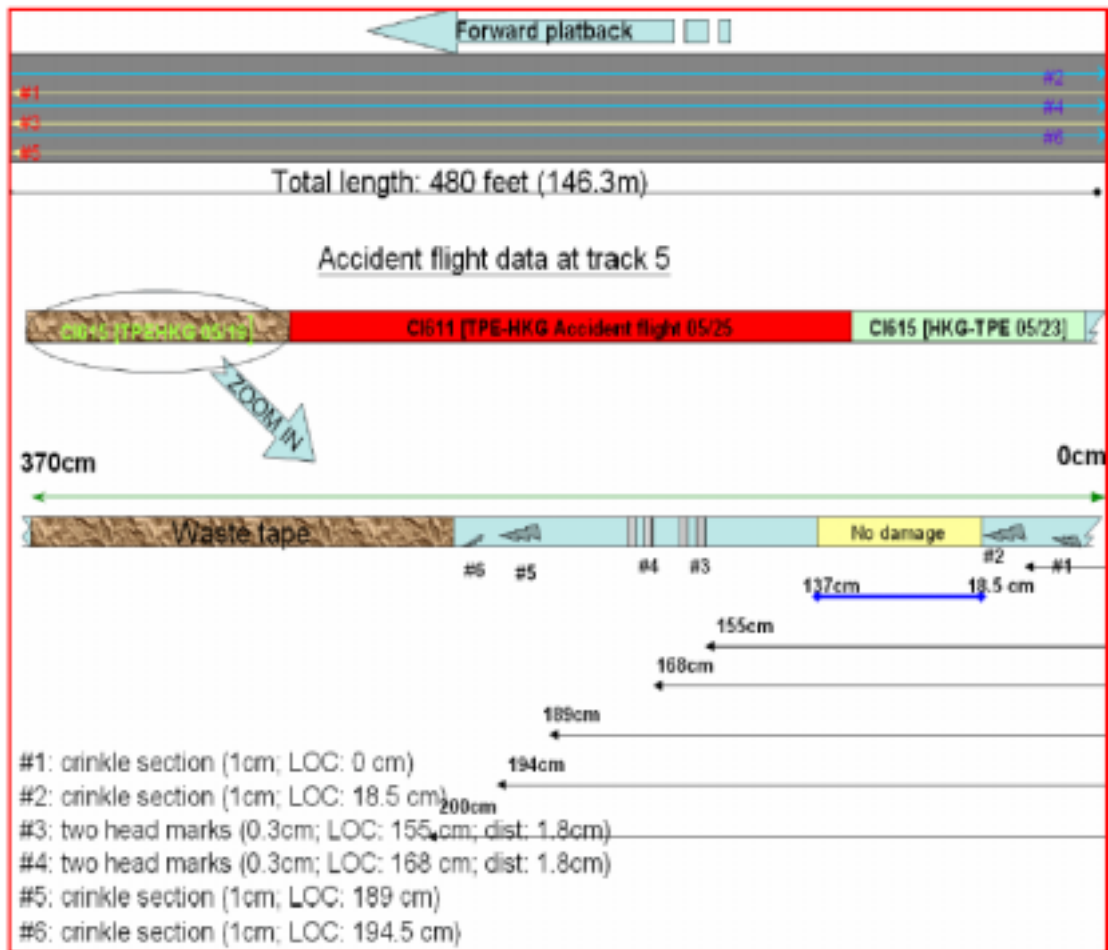
Figure 1.11-4 Sketch of damaged tape locations and conditions

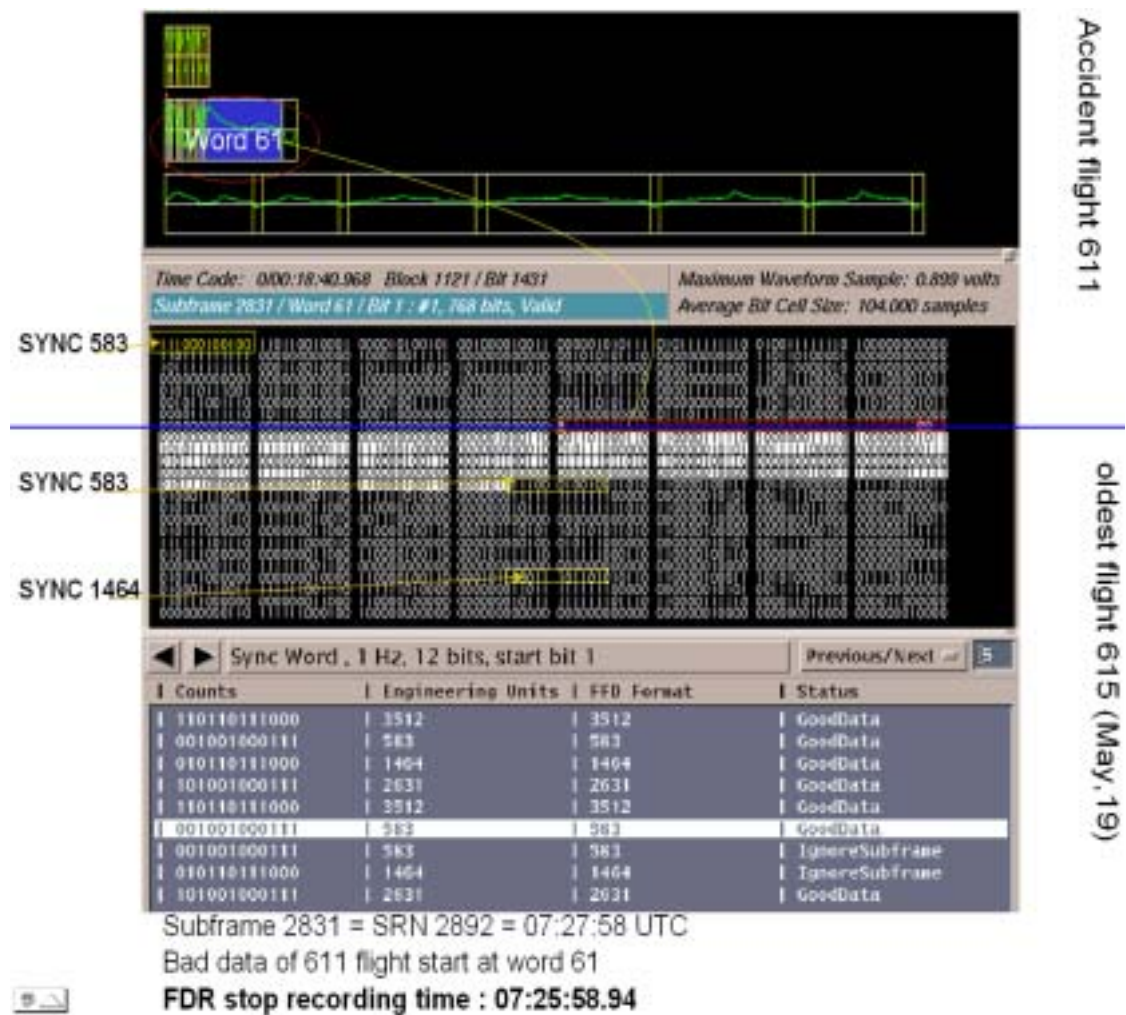
Function of the bit-wave analysis is also used to determinate the condition of FDR stop recording. Figure 1.11-5 shows the weak signal and bad data for the accident flight CI611 exist between words 61 to 64. Therefore, the FDR stop recording time of CI611 was 1527:58.94. It also illustrates a “more than four second” weak signal between flights CI611 and CI615.

Figure 1.11-5 Weak signal and bad data for the accident flight 611 (word 61-64)

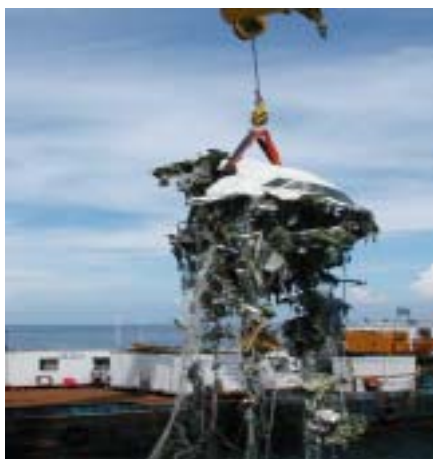
Figure1.12-63 Cockpit section

The cockpit section was recovered relatively intact (Figure 1.12-63). The pilots' and the flight engineer's instrument panels remained attached to the cockpit section by wire bundles. The entire cockpit section was brought to the dock. Later, the cockpit section was lifted with a crane and the instrument panels were removed.

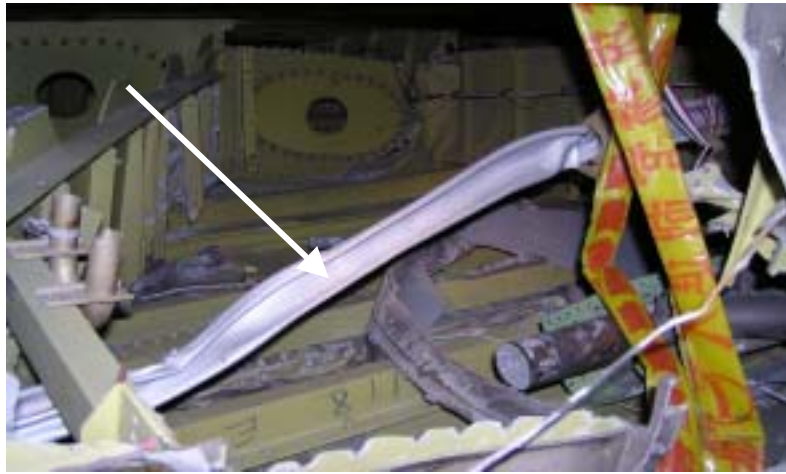
Figure 1.12-72 Fuel Jettison Manifold Tubing

The left wing jettison manifold tubing (Figure1.12-72) and Left jettison nozzle valve (Figure1.12-73) were examined. The manifold tubing was found

collapsed outboard of wing station 1007. The left wing fuel jettison nozzle valve was found in the closed position.

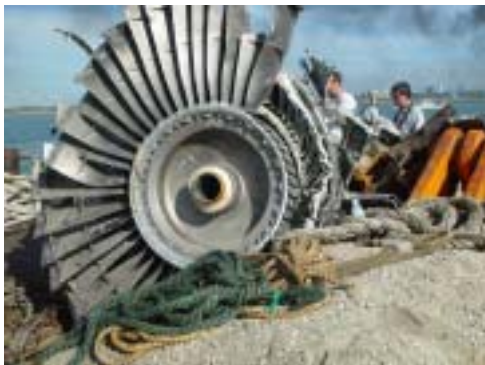
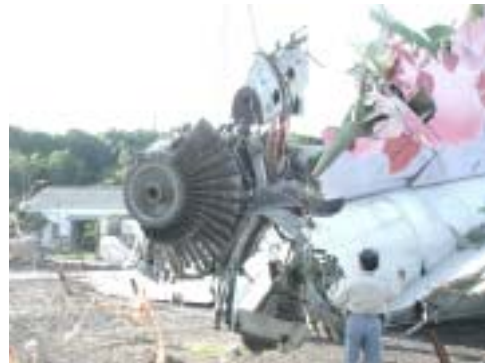
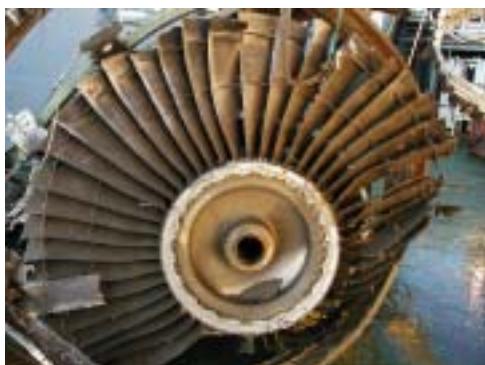
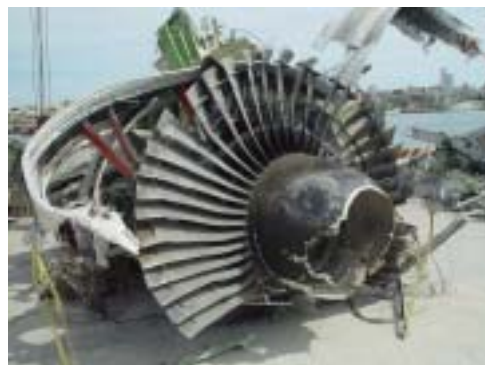
Field inspection of the four Pratt & Whitney JT9D-7A turbofan engines, installed on China Airlines B747-209B operated as flight CI-611, found damage to all engines consistent with impact with water. The four engines (See Figure 1.12-74~77) were recovered from the Straits of Taiwan over the period of 24 June to 30 July 2002. The engines were located more than 1,000 meters from aircraft wing wreckage. None of the four engines exhibited any indications of an uncontained disk, a blade separation, or of an engine fire prior to impact. Fan blade tip and turbine blade tip wear indications suggest that each engine experienced abnormal dynamic loading just prior to engine shutdown. Detail description is shown in, Appendix 6.1 Power plants – Engine Inspection Report, 23 August 2002, by Pratt & Whitney.

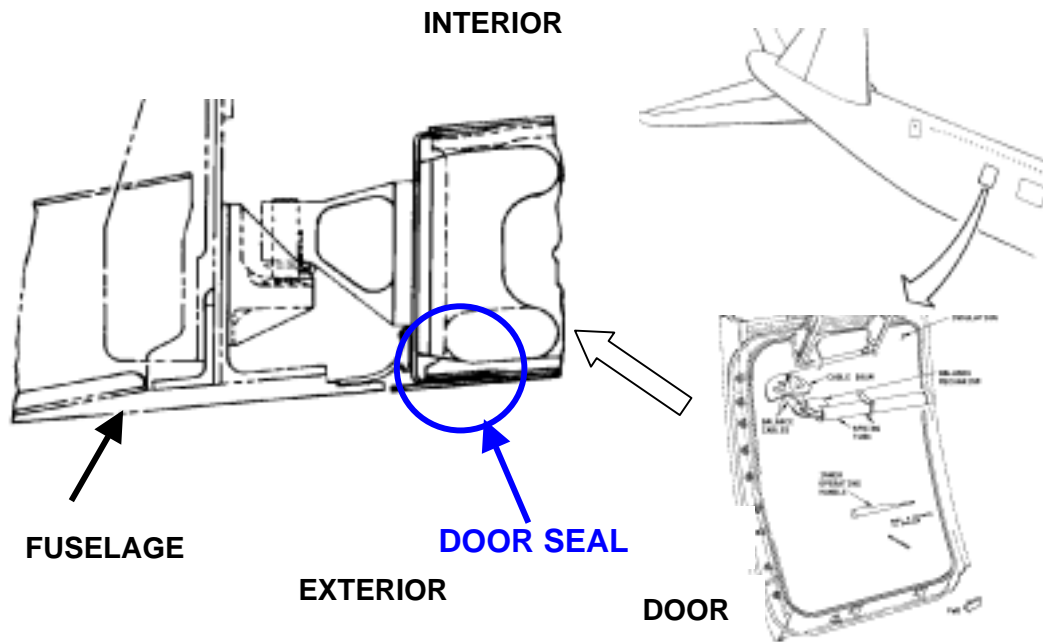
Figure 1.12-79 Bulk Cargo Door

The bulk cargo door is located on the right side of the lower fuselage aft of the aft cargo door. The door was recovered in the closed position. The door includes a blade seal as part of the pressure seal, which normally rests against the interior surface of the door cutout. (Figure 1.12-79)

A painted stencil marking reading “RAP-14” was found on repair doublers just below the door threshold. According to the China Airlines, the stencil indicates that the repair had been identified for further evaluation in accordance with the Repair Assessment Program.

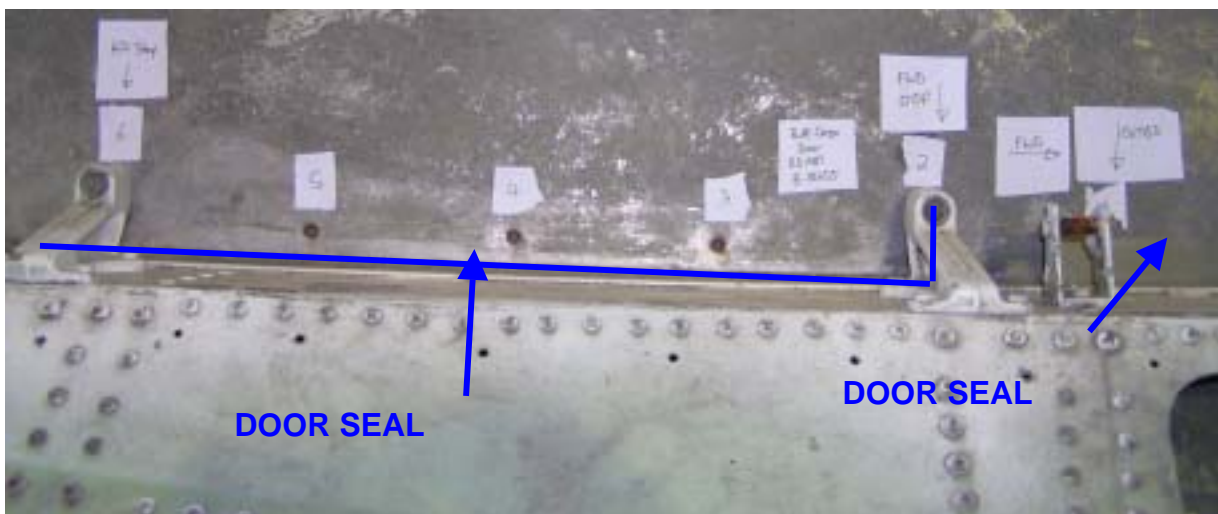
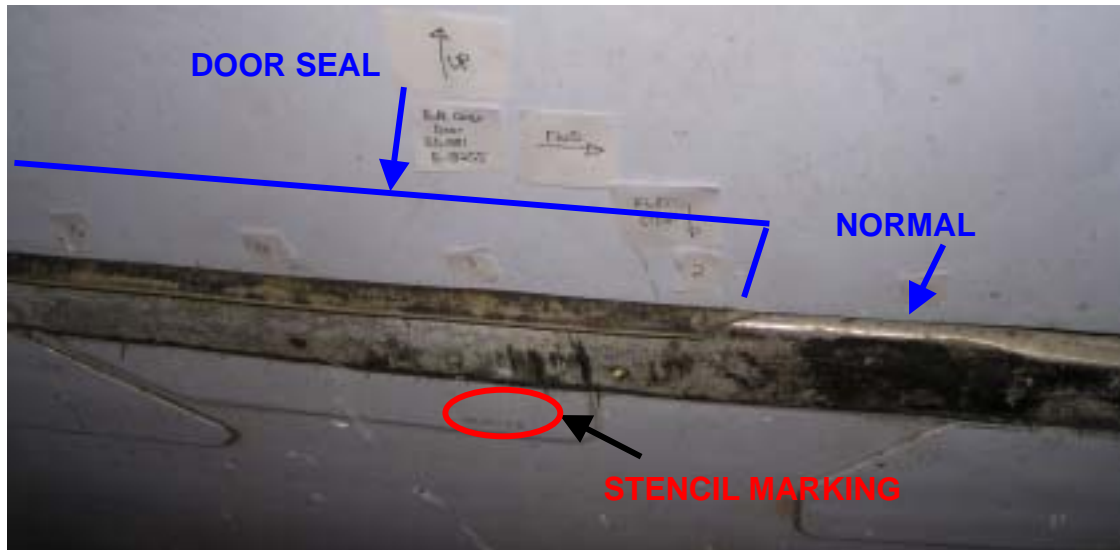
During examination of the Bulk Cargo Door, the blade seal was observed to be protruding through the gap between the lower edge of the bulk cargo door and the fuselage from the location of the forward lower stop aft along the lower edge of the door and up around the aft corner. The edge of the seal was visible from the exterior side. (Figure 1.12-80 and Figure 1.12-81)

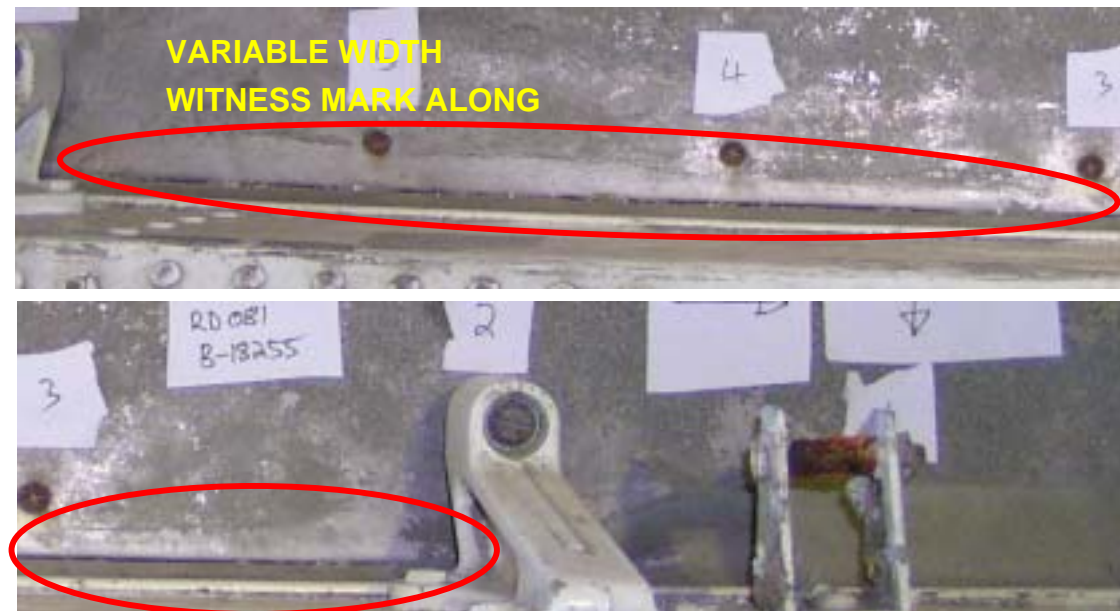
Figure 1.12-82 Witness marks

A witness mark was observed along the lower edge of the door in the area where the door seal contacted the threshold. The witness mark varied in width along the length of the door as shown in the Figure 1.12-82. The variability in the width of the witness mark is consistent with uneven contact between the seal and the threshold.

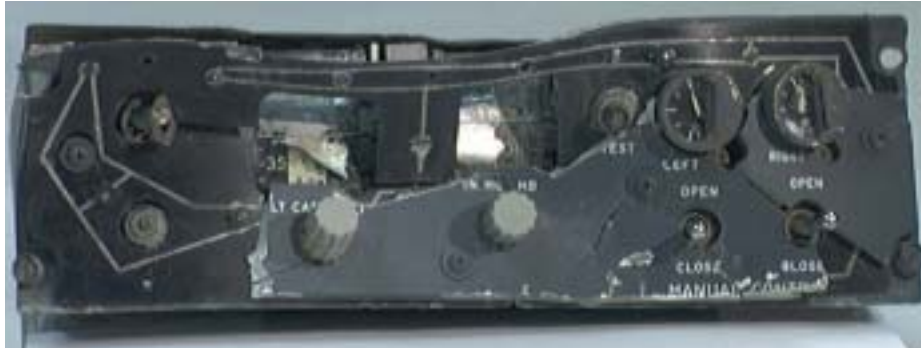
Figure 1.16-1 Flight Engineer's Cabin Pressure Control Selector Panel

- The BARO SET knob appears to be aligned correctly but the knob cannot be manually turned.
- The continuity tests suggest the mode select switch was in manual and the disassembly of the switch confirmed the switch was set in manual setting.

- Both the left and right outflow valves indicator case were removed to inspect the inside, No impact indication was evident on the inside surface of the glass.

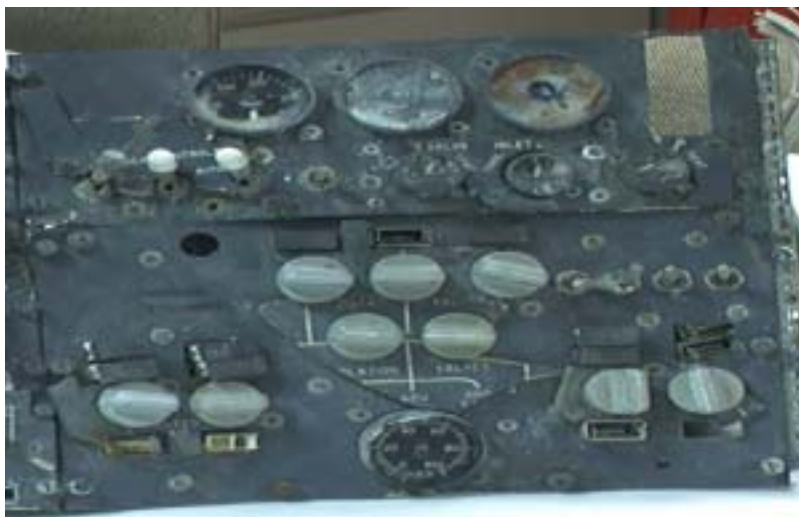
Figure 1.16-2 Air Conditioning Panel

switch position unknown. ZONE 2, 3, and 4 toggles are in the ON position.

- Duct dual pressure gage lens and needles are missing. No indication of pressure apparent.

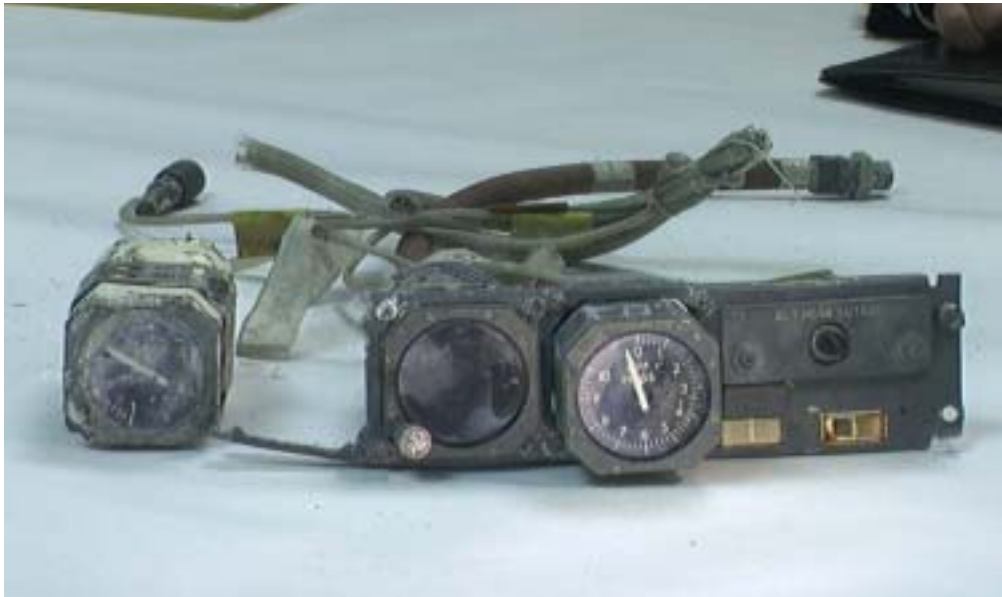
Figure 1.16-3 Cabin Altitude Pressure Panel

The panel frame is bent inward on left and broken at Vertical Speed Indicator frame. AUTO FAIL legend plate and the PRESS RELIEF lower Indicator light cover is missing. After tear down examinations, Cabin Altitude indicator reads 13,765 +/- 5 and internal bellows are fractured. Vertical Speed Indicator's needle frozen at 500 FPM, the internal inspection revealed damage to internal components as a result of external impact to housing. The Differential Pressure Indicator needle shows at less than zero. During the case removal, the Cabin pressure line was cut to remove indicator from case. When pressure line was cut, the indicator dial returned to zero. There is no apparent damage visible to internal parts.

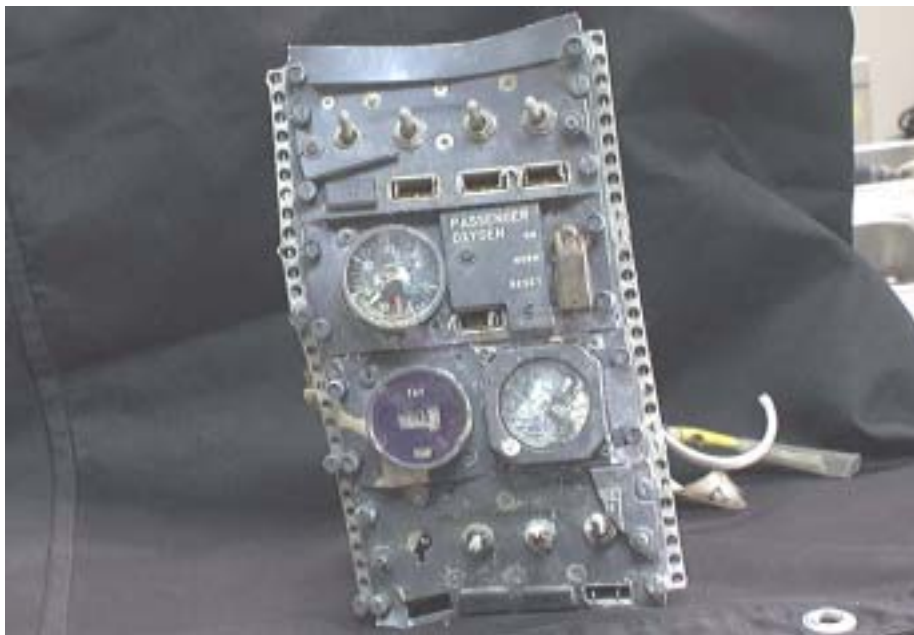
Figure 1.16-4 Partial Flight Engineer's Panel

The Galley Power light plate and number 2, 3, 4 TRIP OFF indicator are missing. All toggles switch are in on position. The PASSENGER OXYGEN indicator needles show at 700 PSI for passenger and 1250 PSI for crew and there is no indication of needle strike on indicator face. PASSENGER OXYGEN control switch was found to be in the NORM position as received. Continuity tests indicated that the switch functioned properly in the ON, NORM and RESET positions. The Clock glass is fractured, Hands set at approximately 0825 and after removal of bezel the actual time on clock reads 0722. TAT reads 1.8 deg. C and off. DC BUS ISOLATION Light plate, ESS BUS, & OPEN indicators legend plates, bulbs and retaining assemblies are missing. All three switches' toggles are in up (CLOSE) position.
